# FINAL MITIGATION PLAN

**Barefoot Site**  
**Sampson County, North Carolina**

**Neuse River Basin**  
**HUC 03020201**

**DMS Project #: 100044**  
**Contract #: 7418**  
**USACE Action ID: SAW-2018-00433**  
**DWR Project #2017-01-01505**  
**RFP: 16-007279**

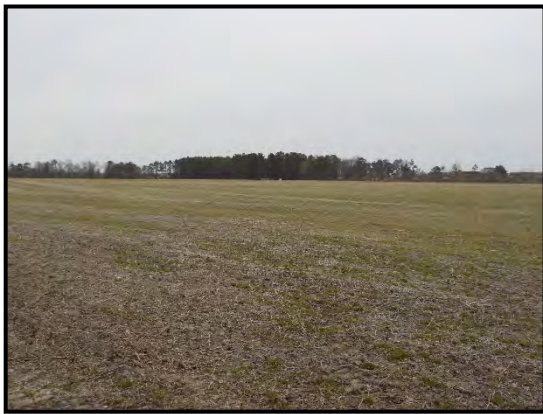
Looking east towards the farm access road from the field that will be W1

Wetland re-establishment area W1 is approximately 20 acres of agricultural fields in row-crop production that are drained by ditches on all four sides and through the middle, as well as drainage tiles running east to west. The area does not currently exhibit wetland hydrology, although the soils have hydric indicators (**Appendix G**). Ten groundwater monitoring gauges were installed in two transects across the field to capture the drainage effects of the ditches and drain tiles (**Figure 5**). These gauges recorded groundwater elevations from May 4, 2018 through October 16, 2018. Based on this season of monitoring, seasonal high water tables appear to reflect the depth of the drain tiles and ditches, as shown in the field groundwater transect charts in **Appendix B**. Groundwater gauges also showed groundwater at the site staying consistently below the required 12 inch depth for wetland jurisdiction throughout the growing season, except after significant rainfall events (Groundwater gauge charts, **Appendix B**).

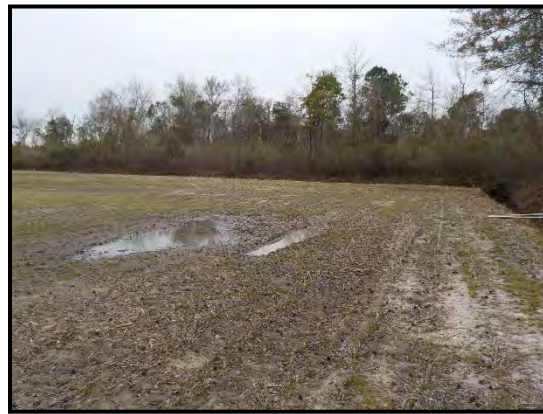
Looking south into the southwest corner of the field that will be W1

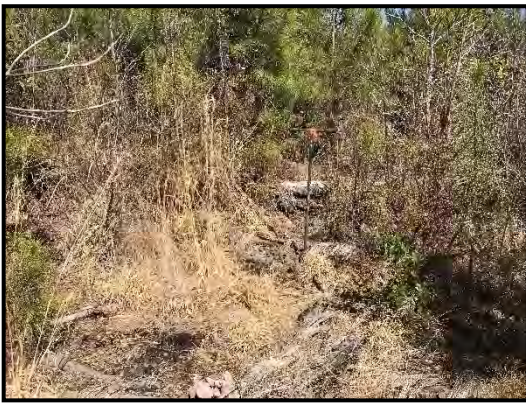
Looking along old skid trail in clear-cut

Wetland re-establishment area W2 is approximately 10 acres in timber production that is drained by ditches on all four sides. This area was originally thought to be existing wetland area, so was not proposed for re-establishment at the Proposal stage. However, an approved jurisdictional determination concluded that this area did not exhibit the hydrology to be considered a wetland (**Appendix H**). This area was likely wetland before being drained for silvicultural use, as soil survey revealed that the soils have hydric indicators, so re-establishment is appropriate for W2 (**Appendix G**). Two groundwater monitoring gauges will be installed on the ends of the proposed wetland areas (**Figure 5**). These gauges will record groundwater elevations from July 2019 through construction and through the monitoring period of the project. This area is currently vegetated with a mixture of young trees, shrubs, and herbaceous plants, so does not require wetland planting. Re-establishment will be claimed at a lower credit ratio to account for the lack of planting. Further explanation of the approach may be found in section 6.2.1.

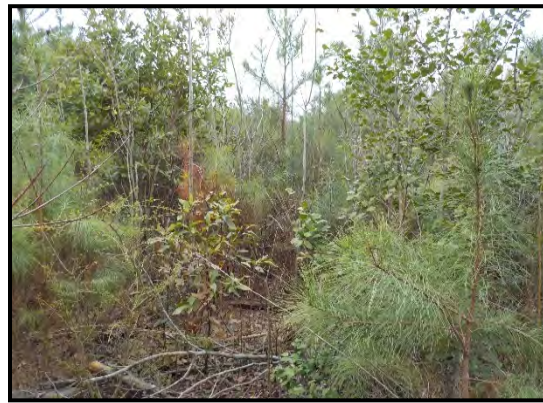
Typical vegetation within W2

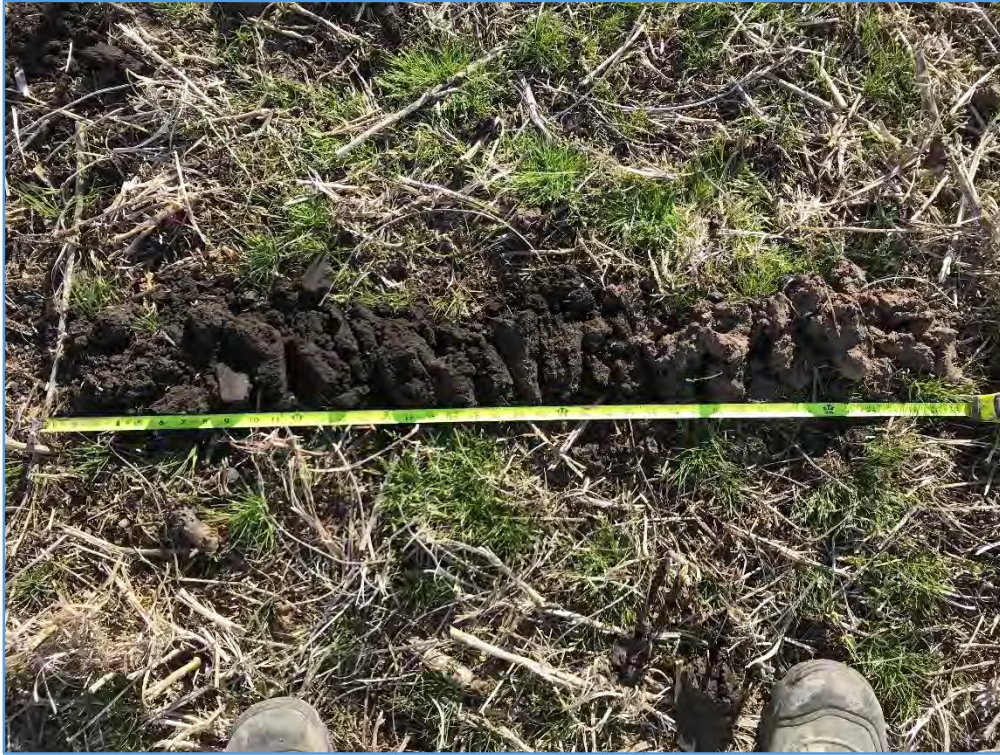
1. A12 Thick Dark Surface in cultivated field.

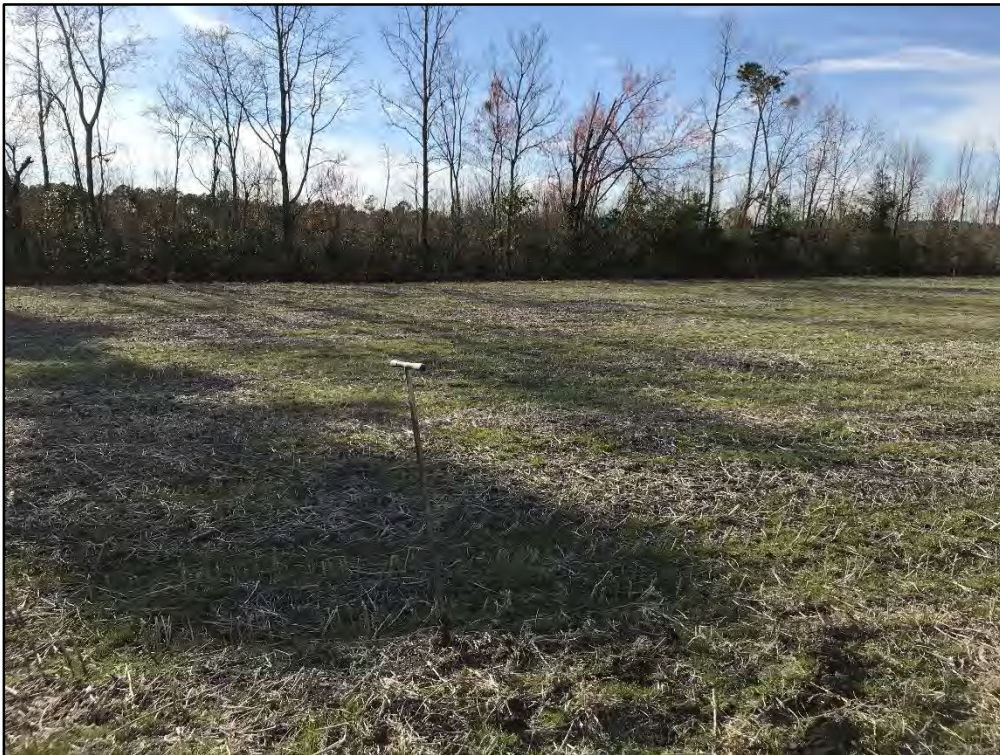
2. Soybean field after harvest facing cutover.

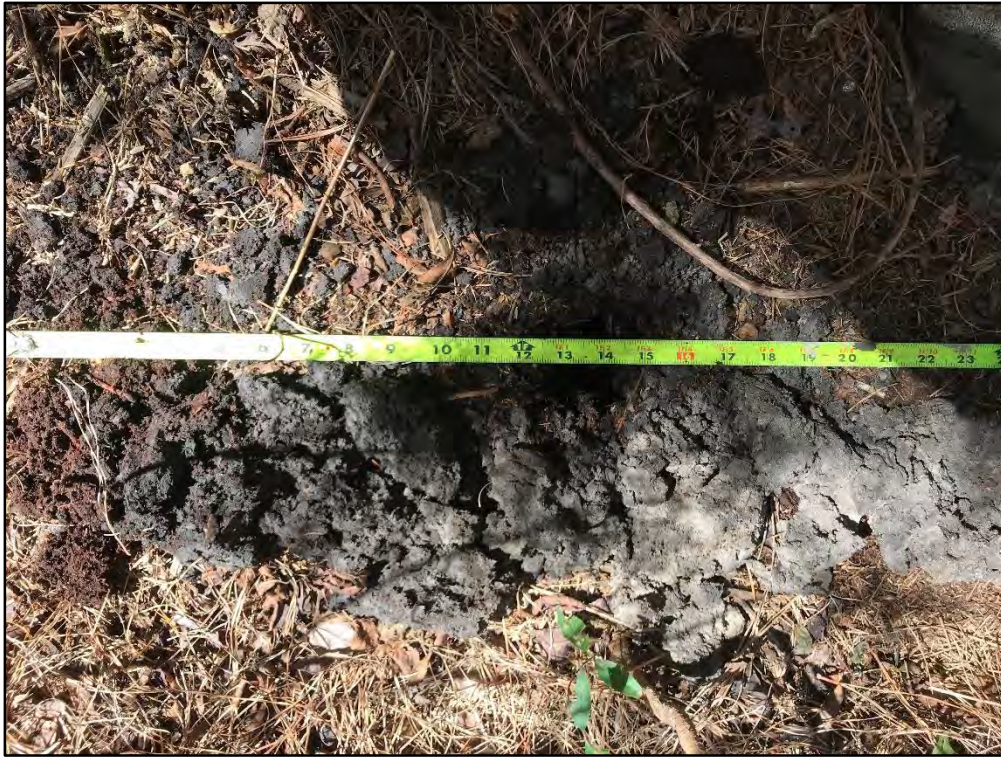
3. A12-Thick Dark Surface in cutover.

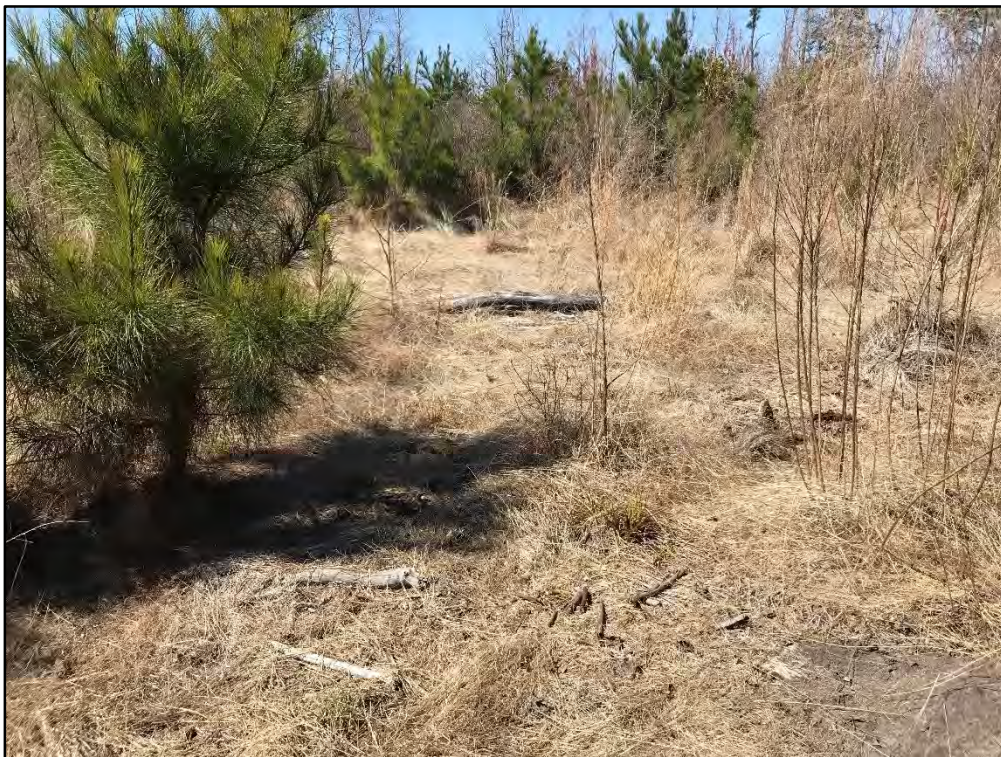
4. Old skidder path in cutover.
