**Year 4 Monitoring Report**

**BAREFOOT SITE**

NCDMS Project # 100044 (Contract # 7418)  
USACE Action ID: SAW-2018-00433  
DWR Project # 2018-0235

Sampson County, North Carolina  
Neuse River Basin  
HUC 03020201

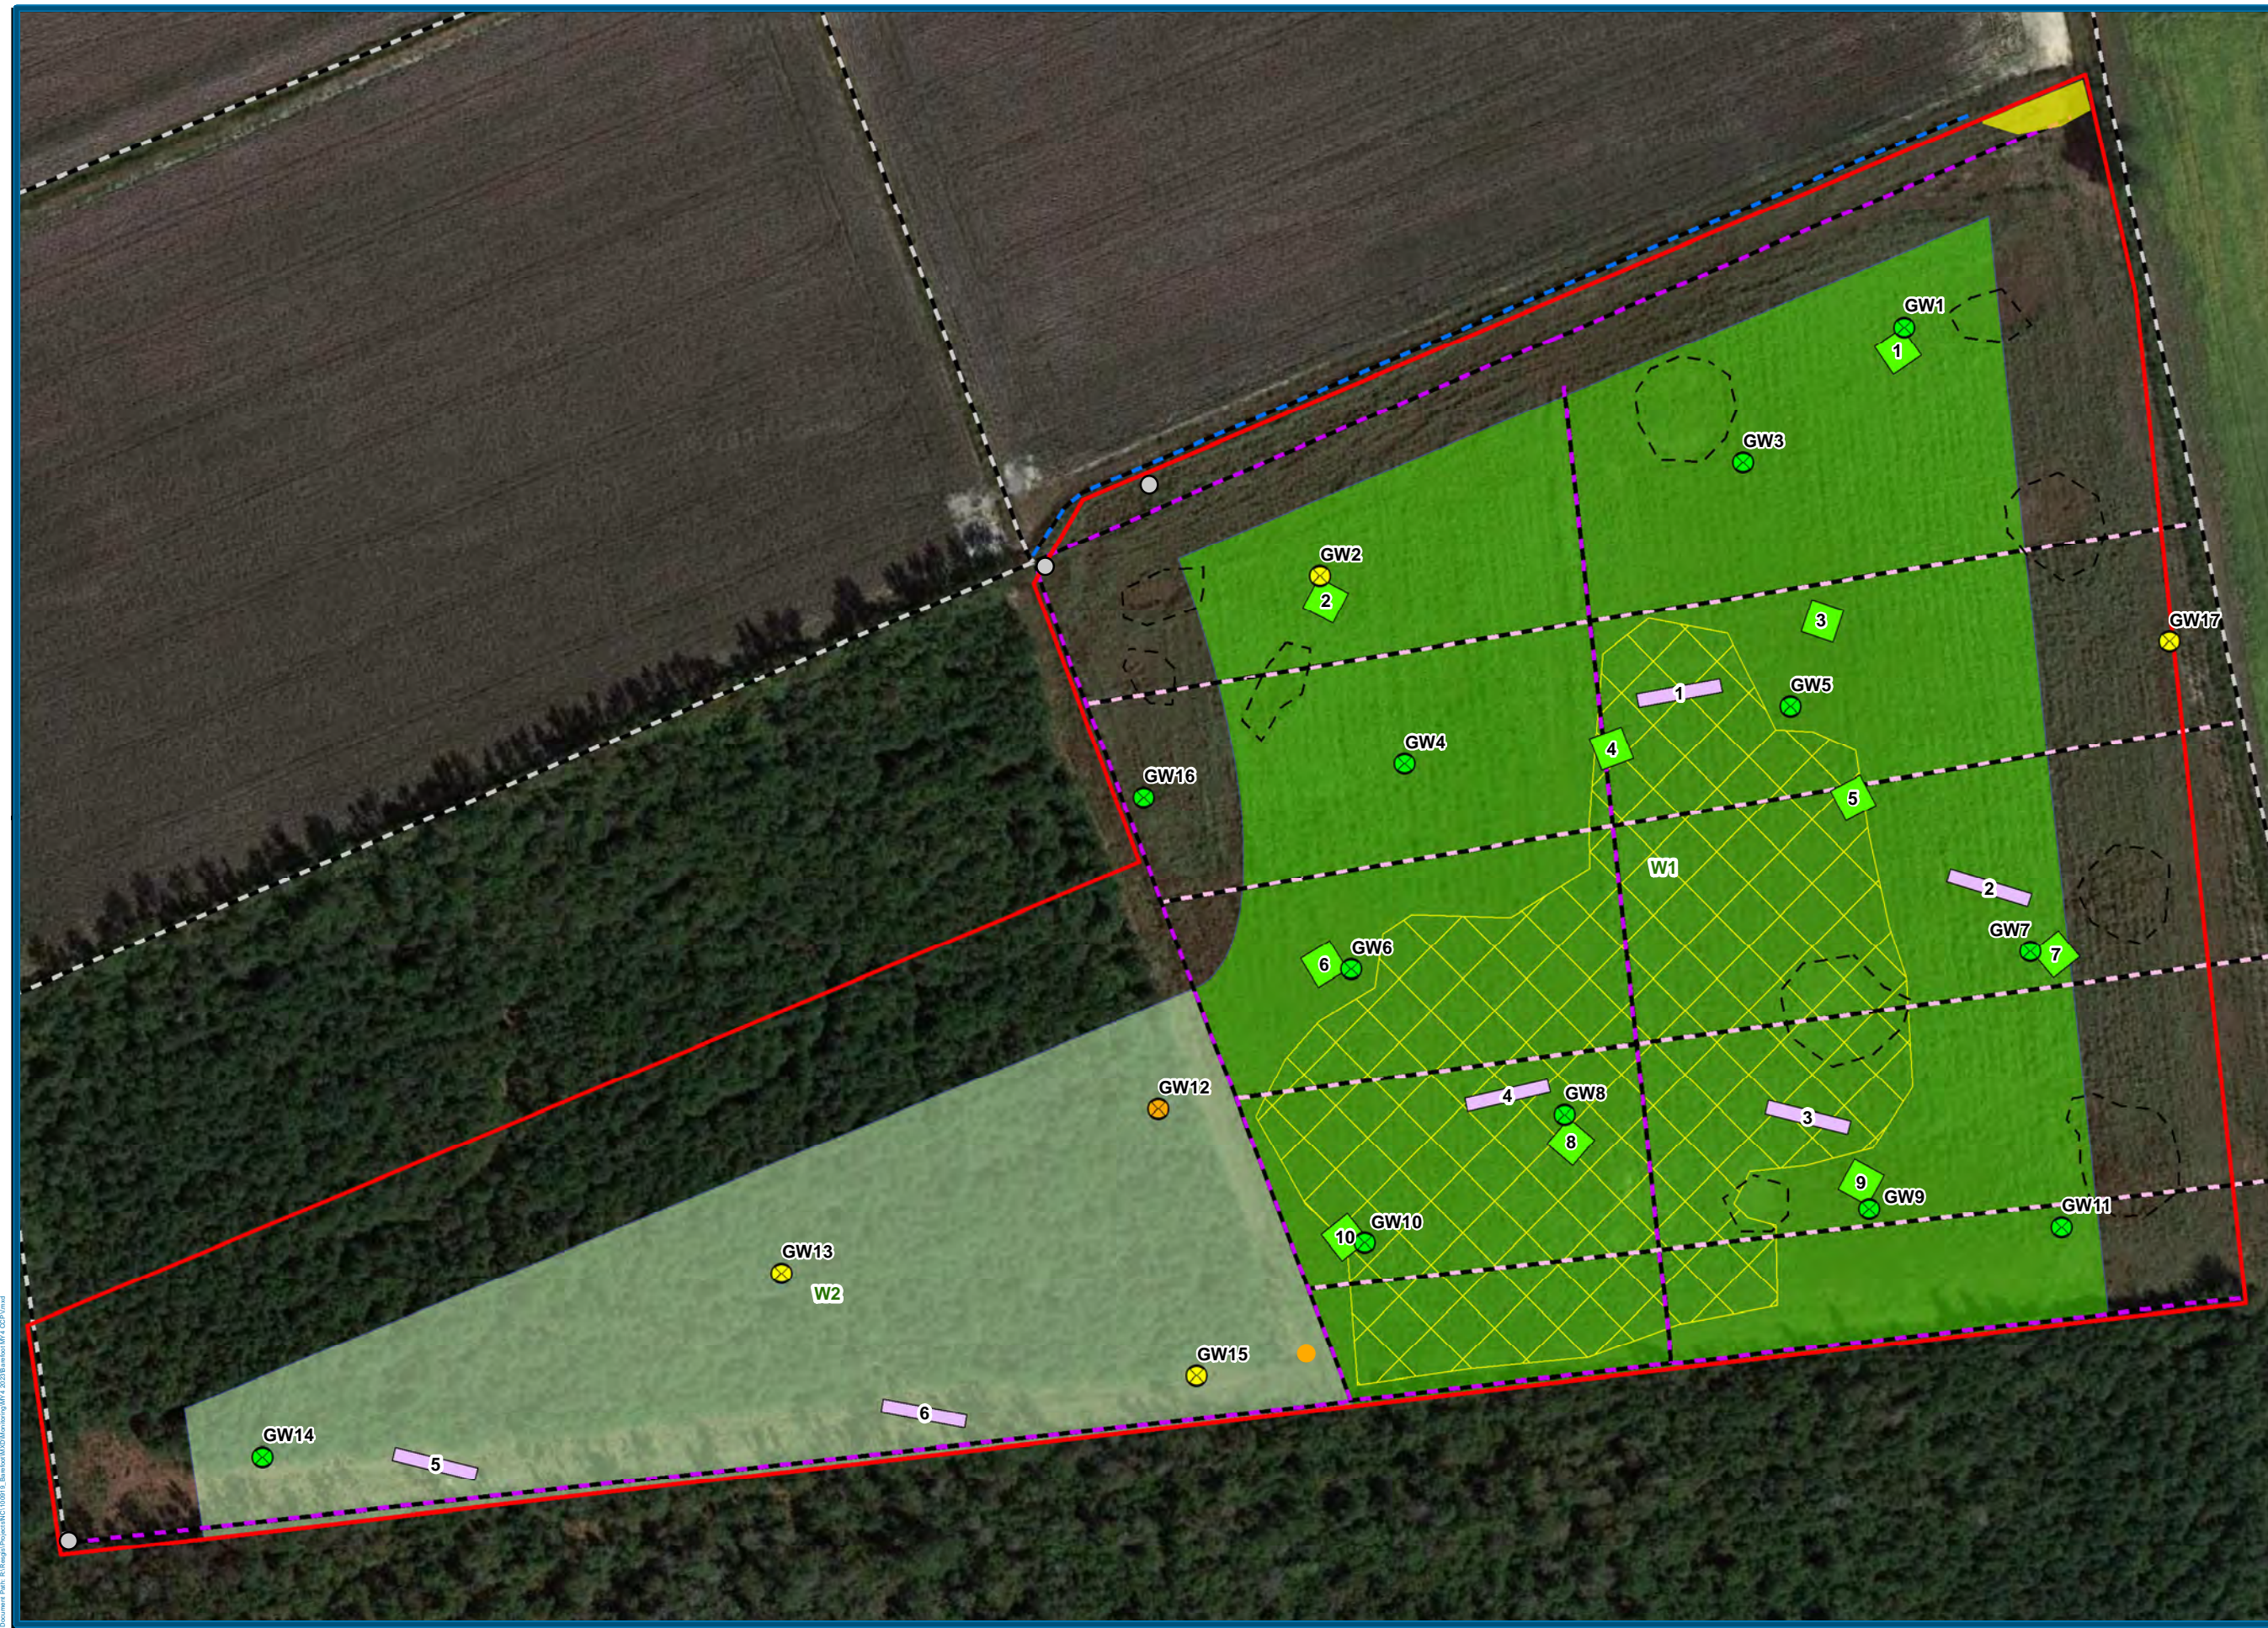
**Figure 2**  
Current Conditions Plan View

The previous encroachment area in W2 of hunting equipment and hog fencing has been removed. A pile of debris near the forested section and an encroachment area of approximately 300 feet in the northeast

corner of the project was observed during the site visit on January 3<sup>rd</sup>, 2024. The debris will be removed, and the encroachment area will have extra easement signs and horse tape installed in 2024.

1. Encroachment of approximately 300-400 sq. ft observed during site visit at the northeast corner of project (35.255497, -78.391228). Please indicate what corrective action will be taken. Encroachment area has been added to CCPV and was mentioned in Section 1.7. In 2024 t-posts with easement signs will be added and horse tape will be strung up between t-posts.
2. Please continue to watch for the spread of cattails. During the site visit we observed that the cattails did not appear to be inhibiting planted stem growth in the wetland. Cattail area will continue to be monitored.
3. While in the field we saw an old tent near the forested section (35.252489, -78.394008) which will need to be removed before IRT closeout. Location of debris was added to CCPV and was mentioned in Section 1.7. The debris will be removed in 2024.

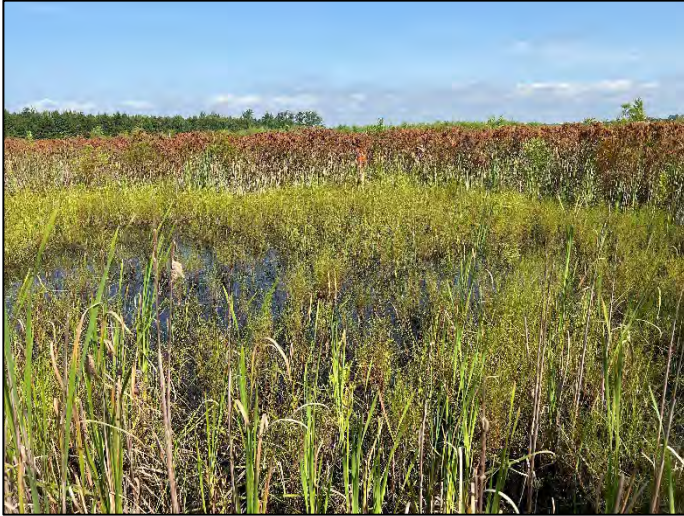
Shallow Depression (08/15/23)

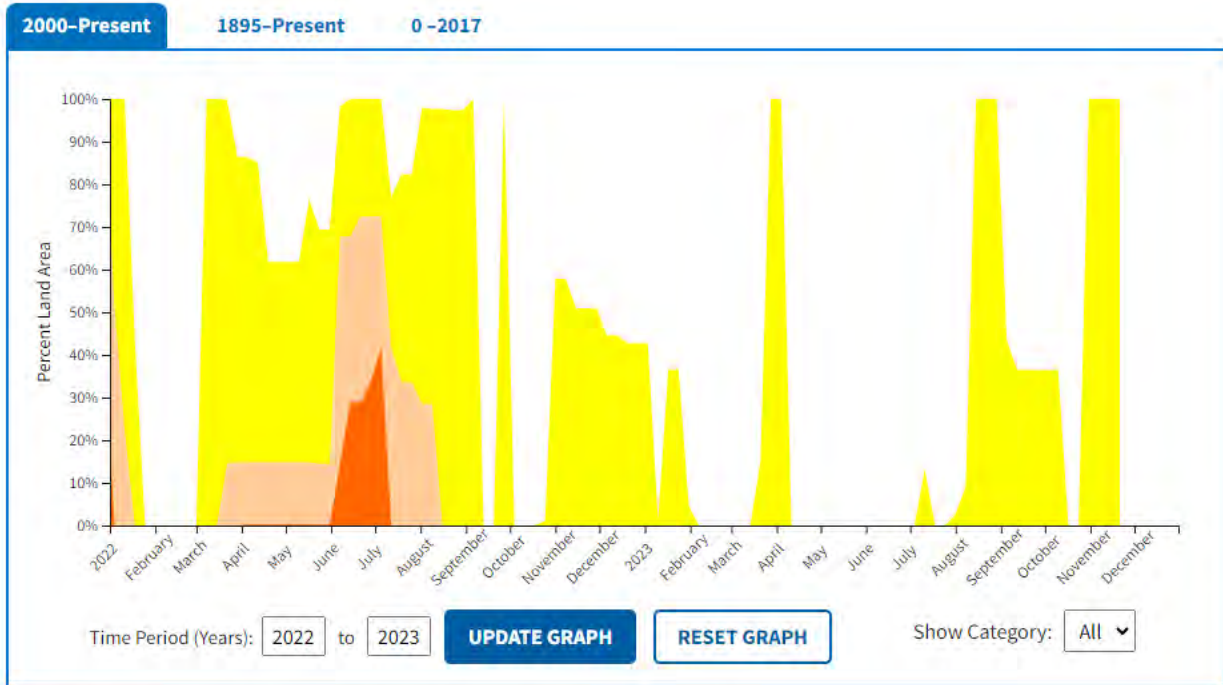
**Table 10B. Drought Summary.**

The U.S. Drought Monitor (2000-present) depicts the location and intensity of drought across the country. Every Thursday, authors from NOAA, USDA, and the National Drought Mitigation Center produce a new map based on their assessments of the best available data and input from local observers. The map uses five categories: Abnormally Dry (D0), showing areas that may be going into or are coming out of drought, and four levels of drought (D1–D4). [Learn more.](#)

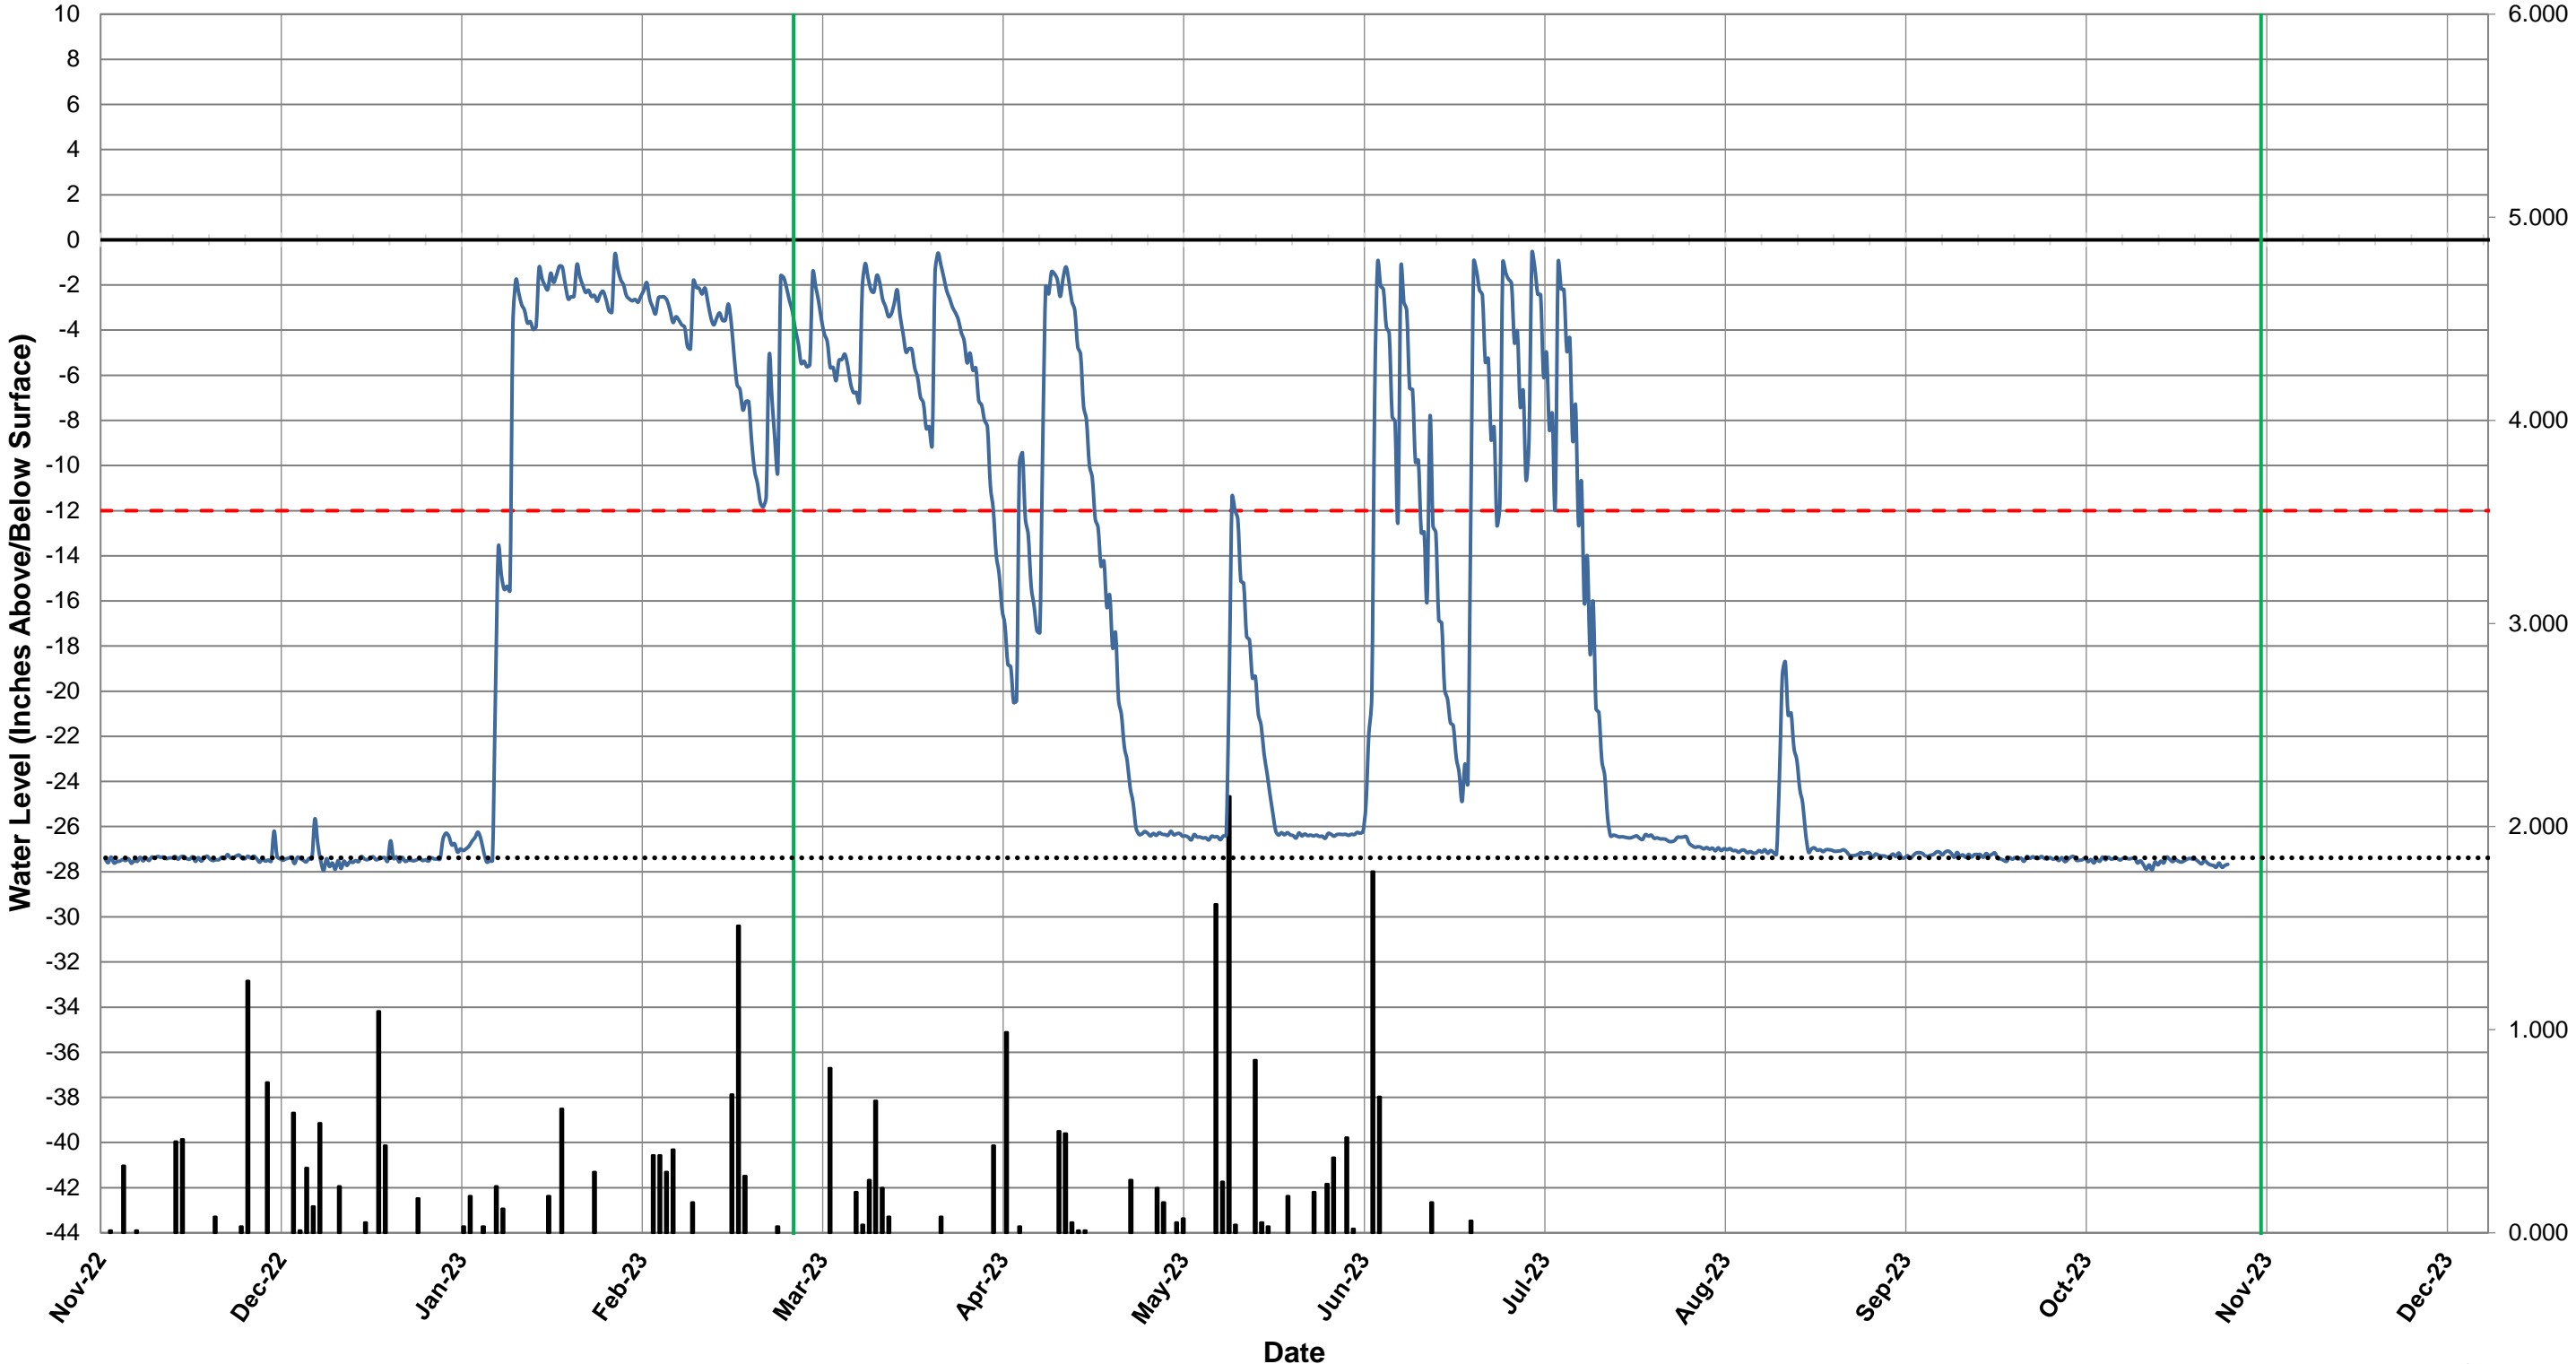
# 2023 Barefoot GW1

34.5 Consecutive Days of Hydrology  
03/15/2023 - 04/18/2023

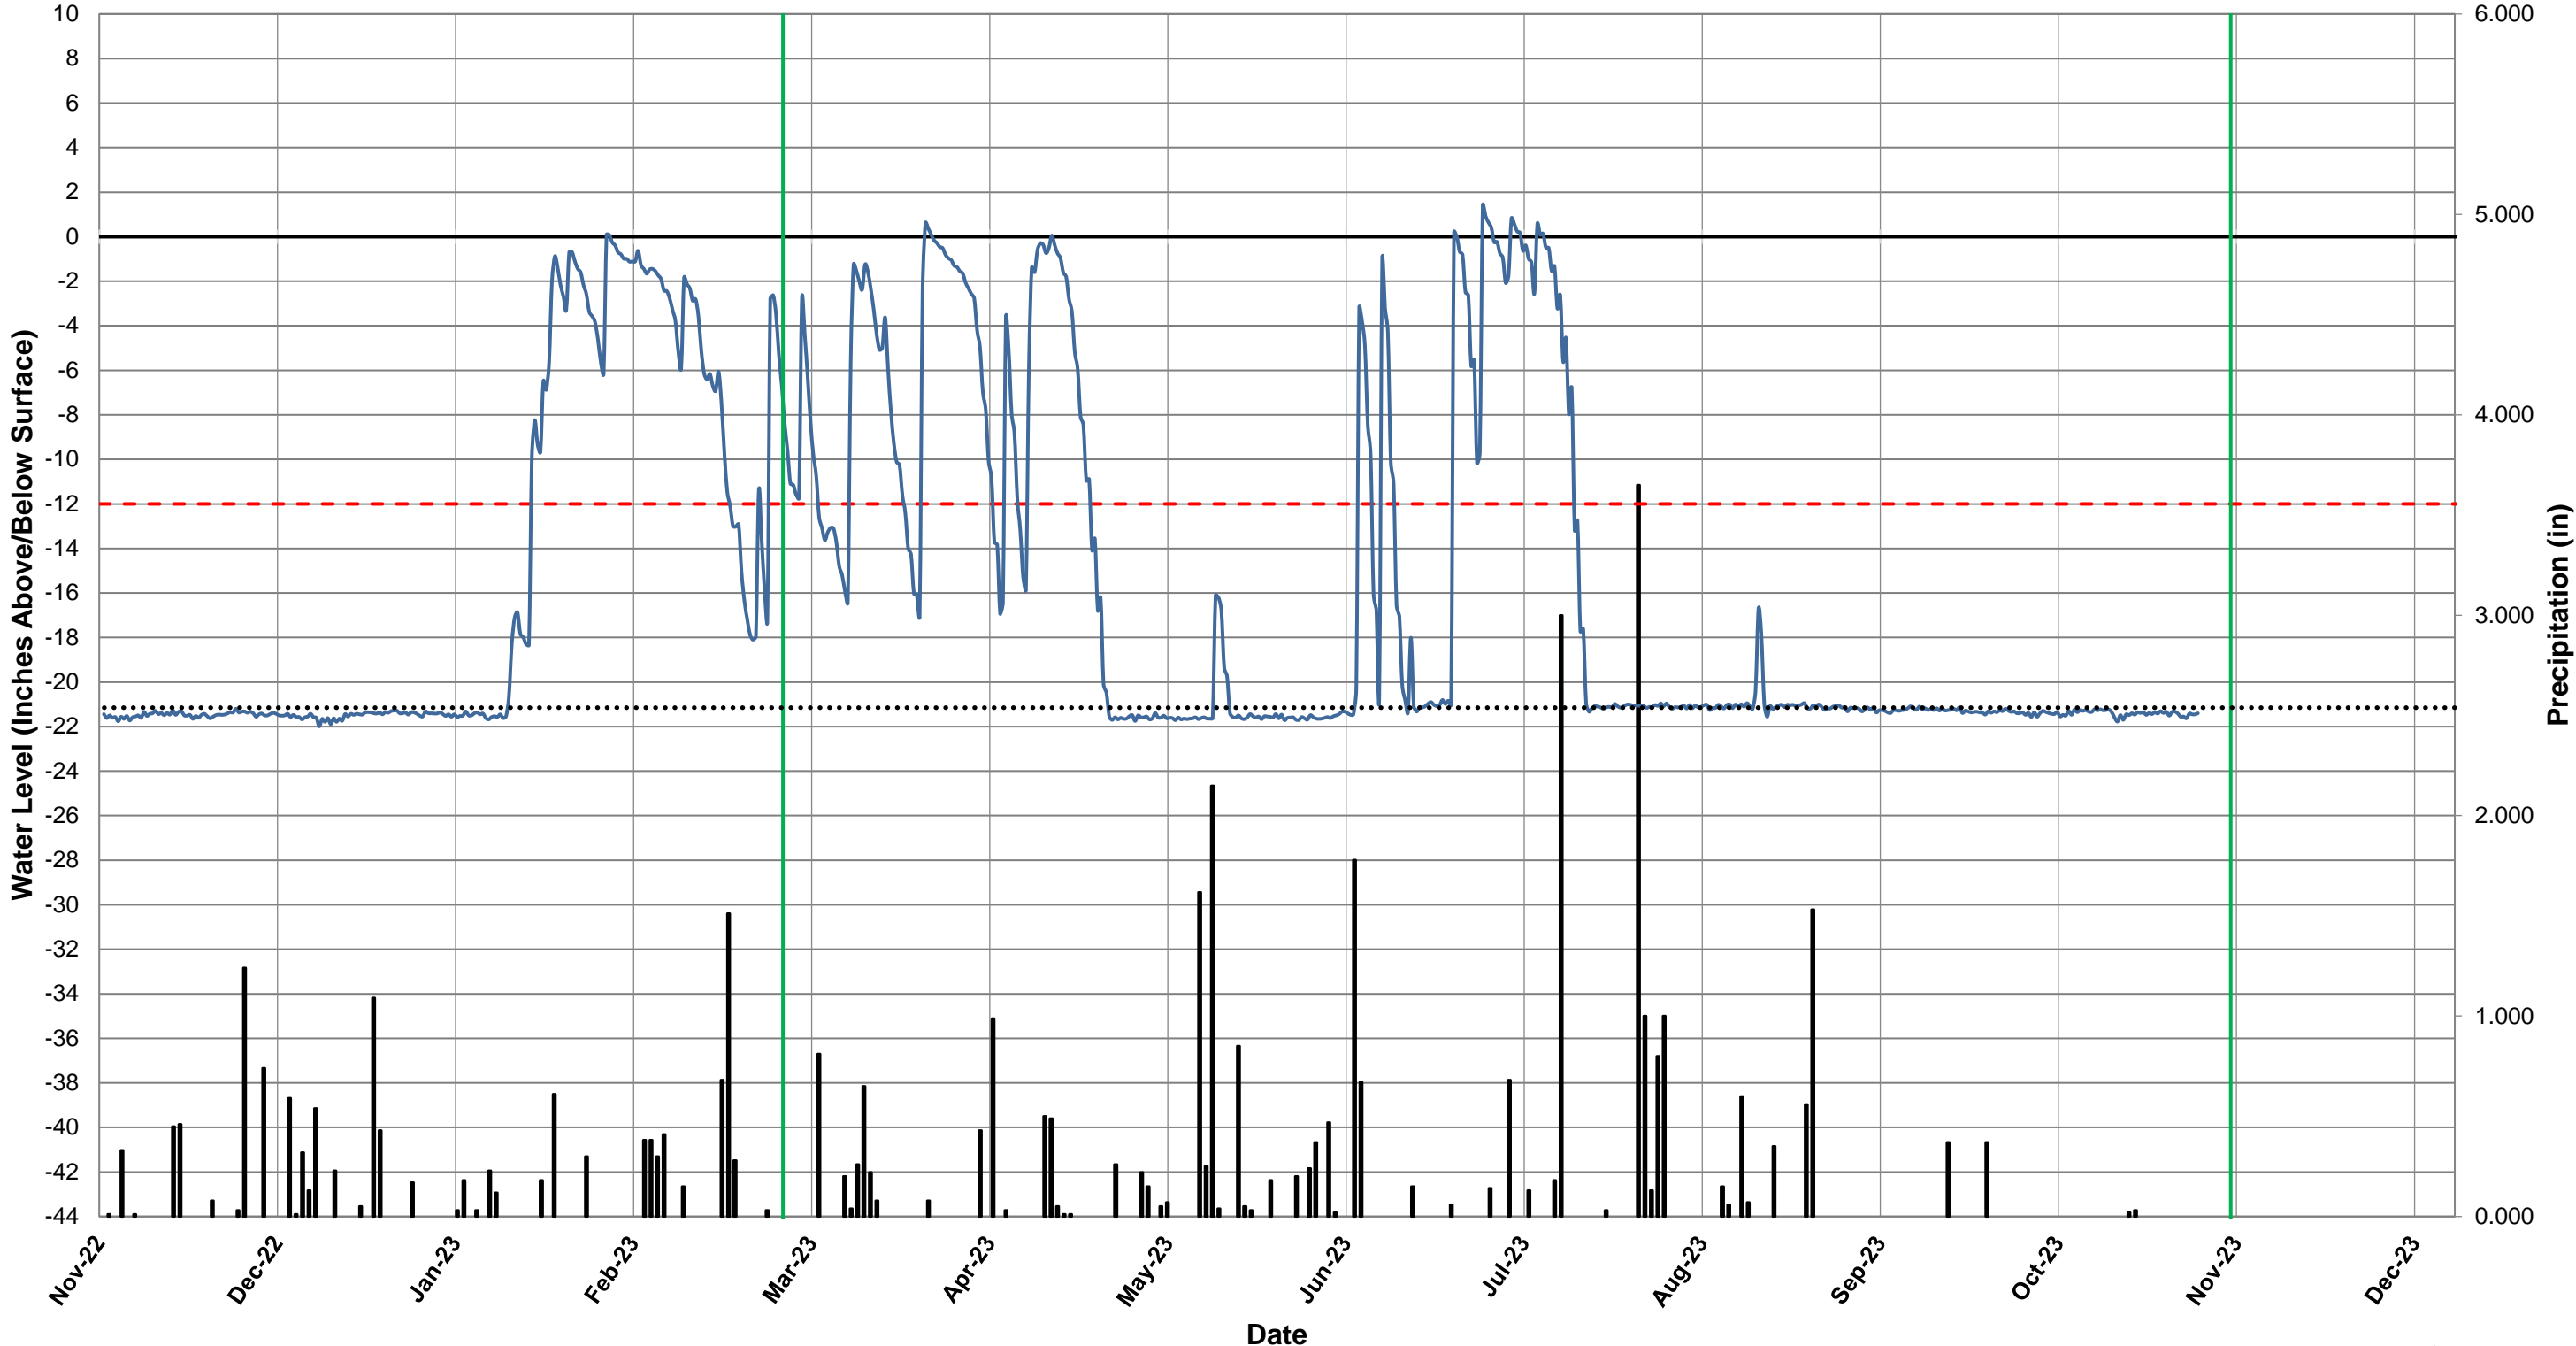
# 2023 Barefoot GW2

The lower hydroperiods in MY4 in wells 2, 12, 13, and 15 was due to a very low rainfall year, with five months of the growing season having below average rainfall. Johnston County has experienced abnormally dry and moderate drought conditions in 2022 and 2023 (U.S. Drought Monitor, **Appendix D**). Due to this non-riparian wetland being a mineral flat, with a ditched similar elevation landscape surrounding it, almost all of its hydrology is driven by precipitation and is more vulnerable to drought. RES expects the gauges on the periphery of the wetlands, closer to open ditches, to have lower hydroperiods as the data shows. Additionally, the well with the lowest hydroperiod, GW12, is the only well located above 194 feet elevation. Exact well locations can be found on **Figure 2** and associated data is in **Appendix D**.

21 Consecutive Days of Hydrology  
07/09/2023 - 07/30/2023

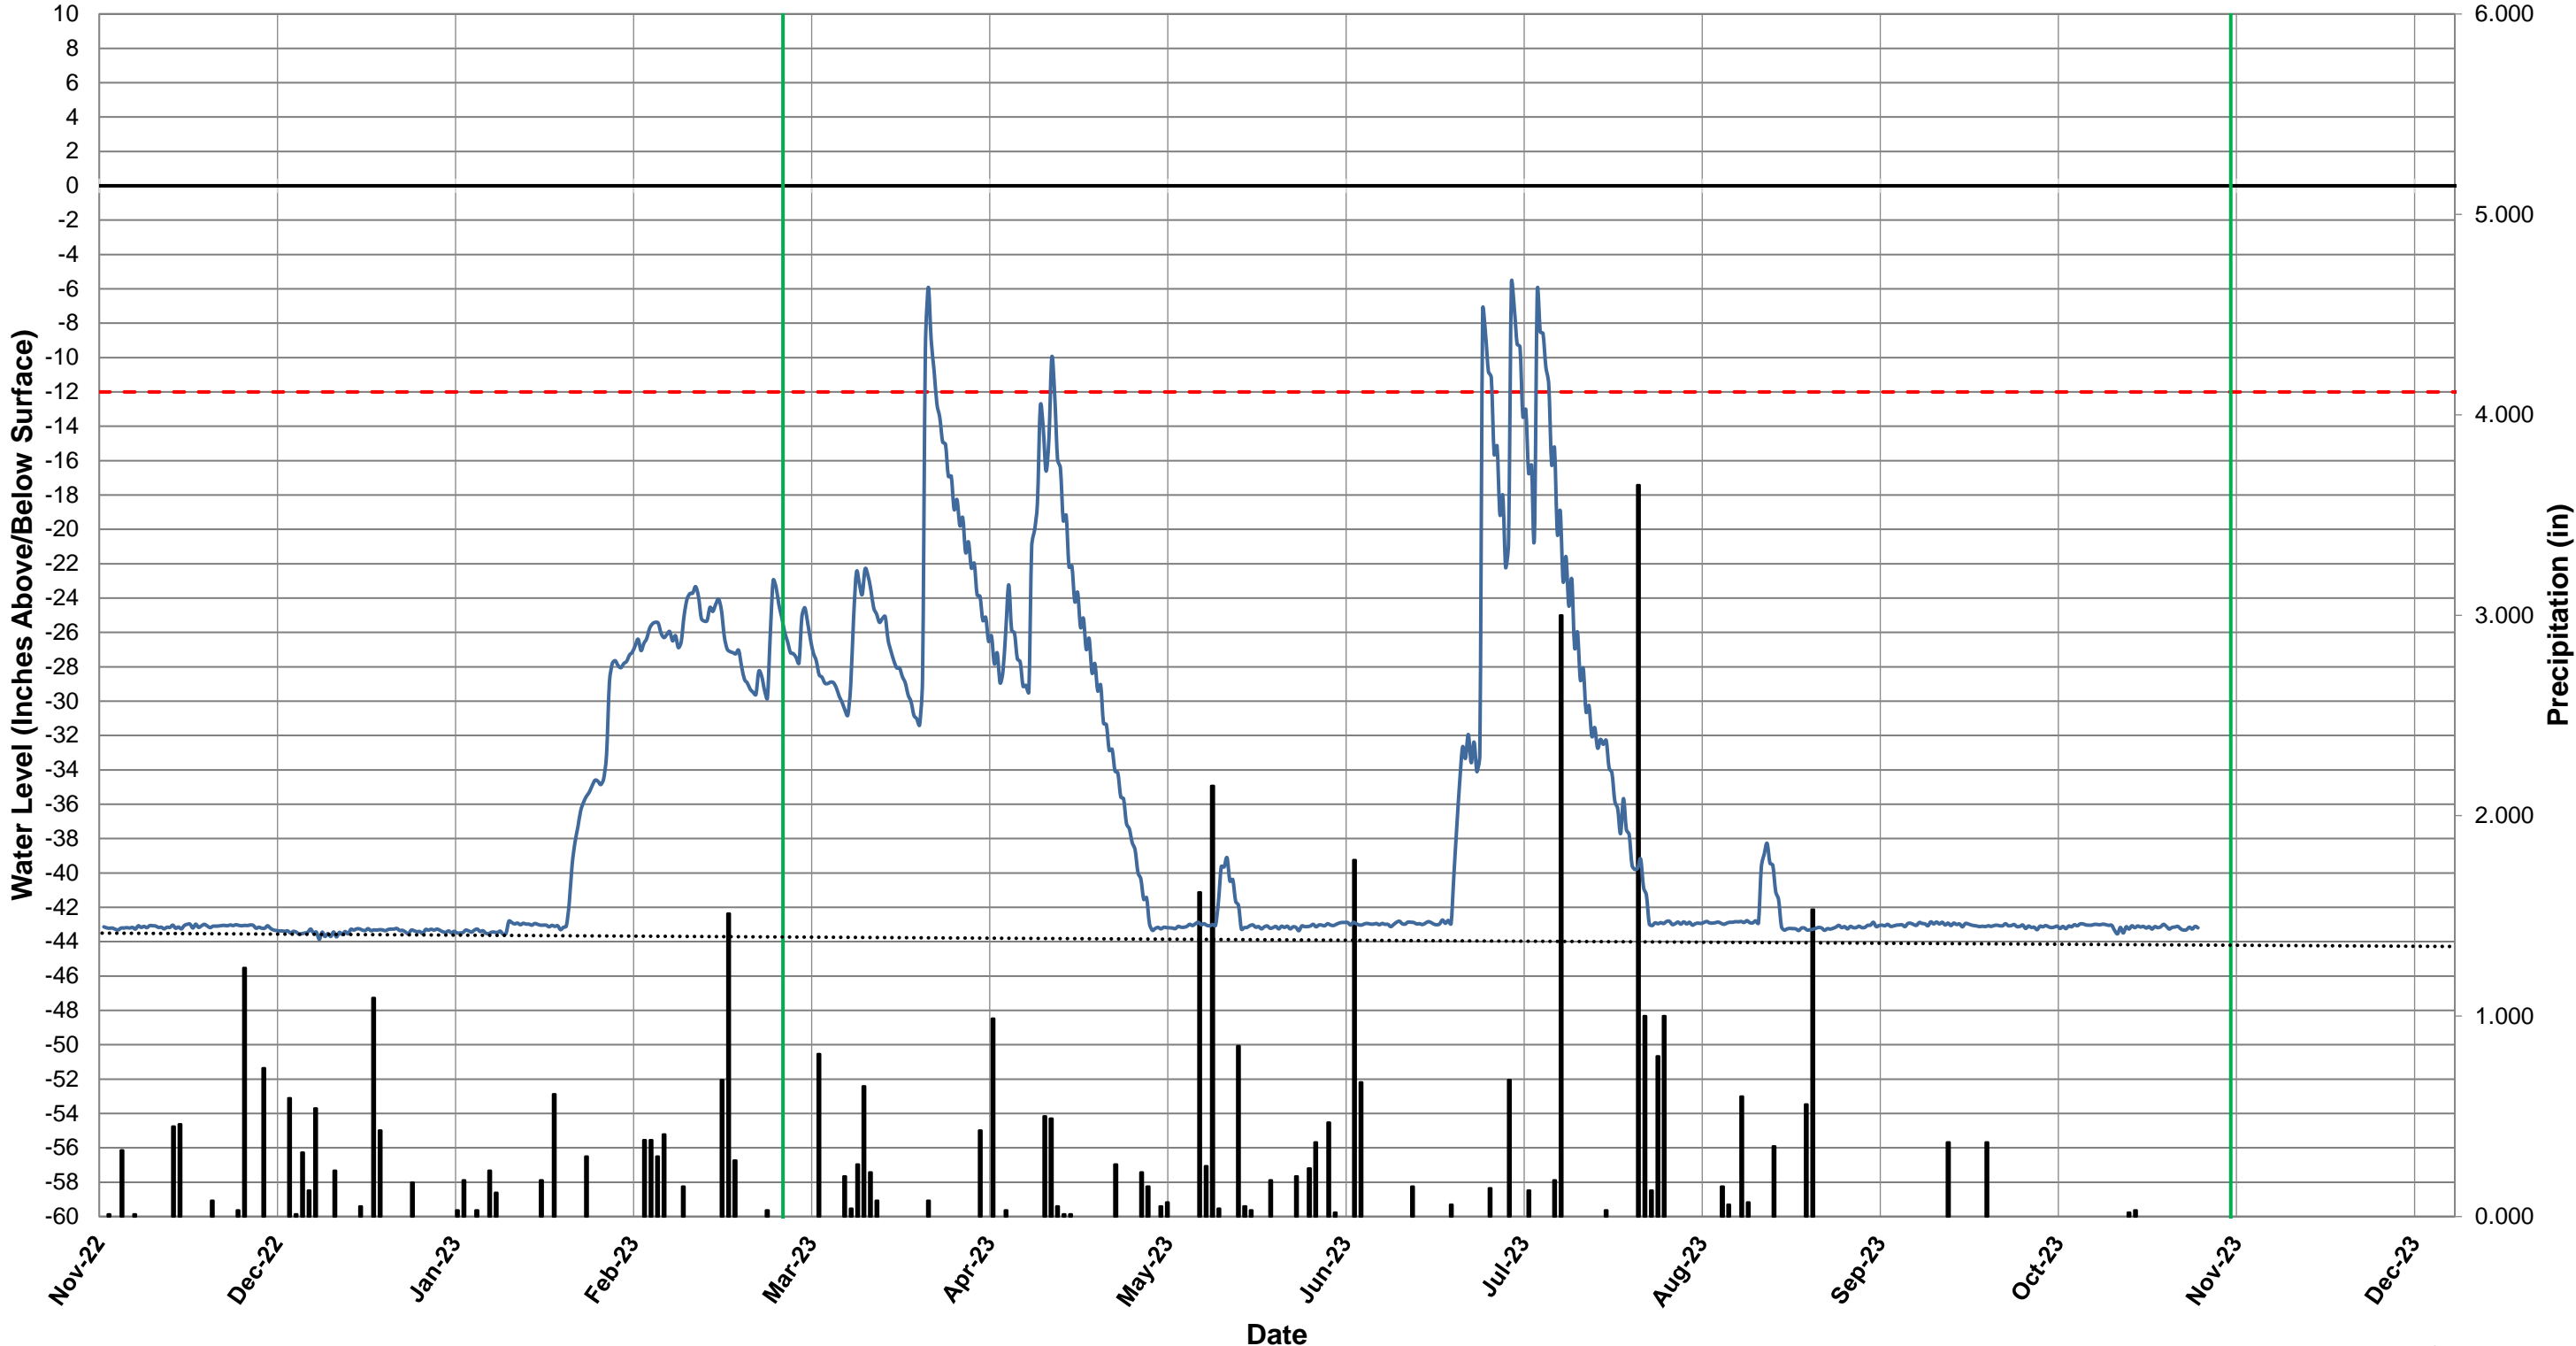
# 2023 Barefoot GW12

2.5 Consecutive Days of Hydrology  
07/24/2023 - 07/26/2023

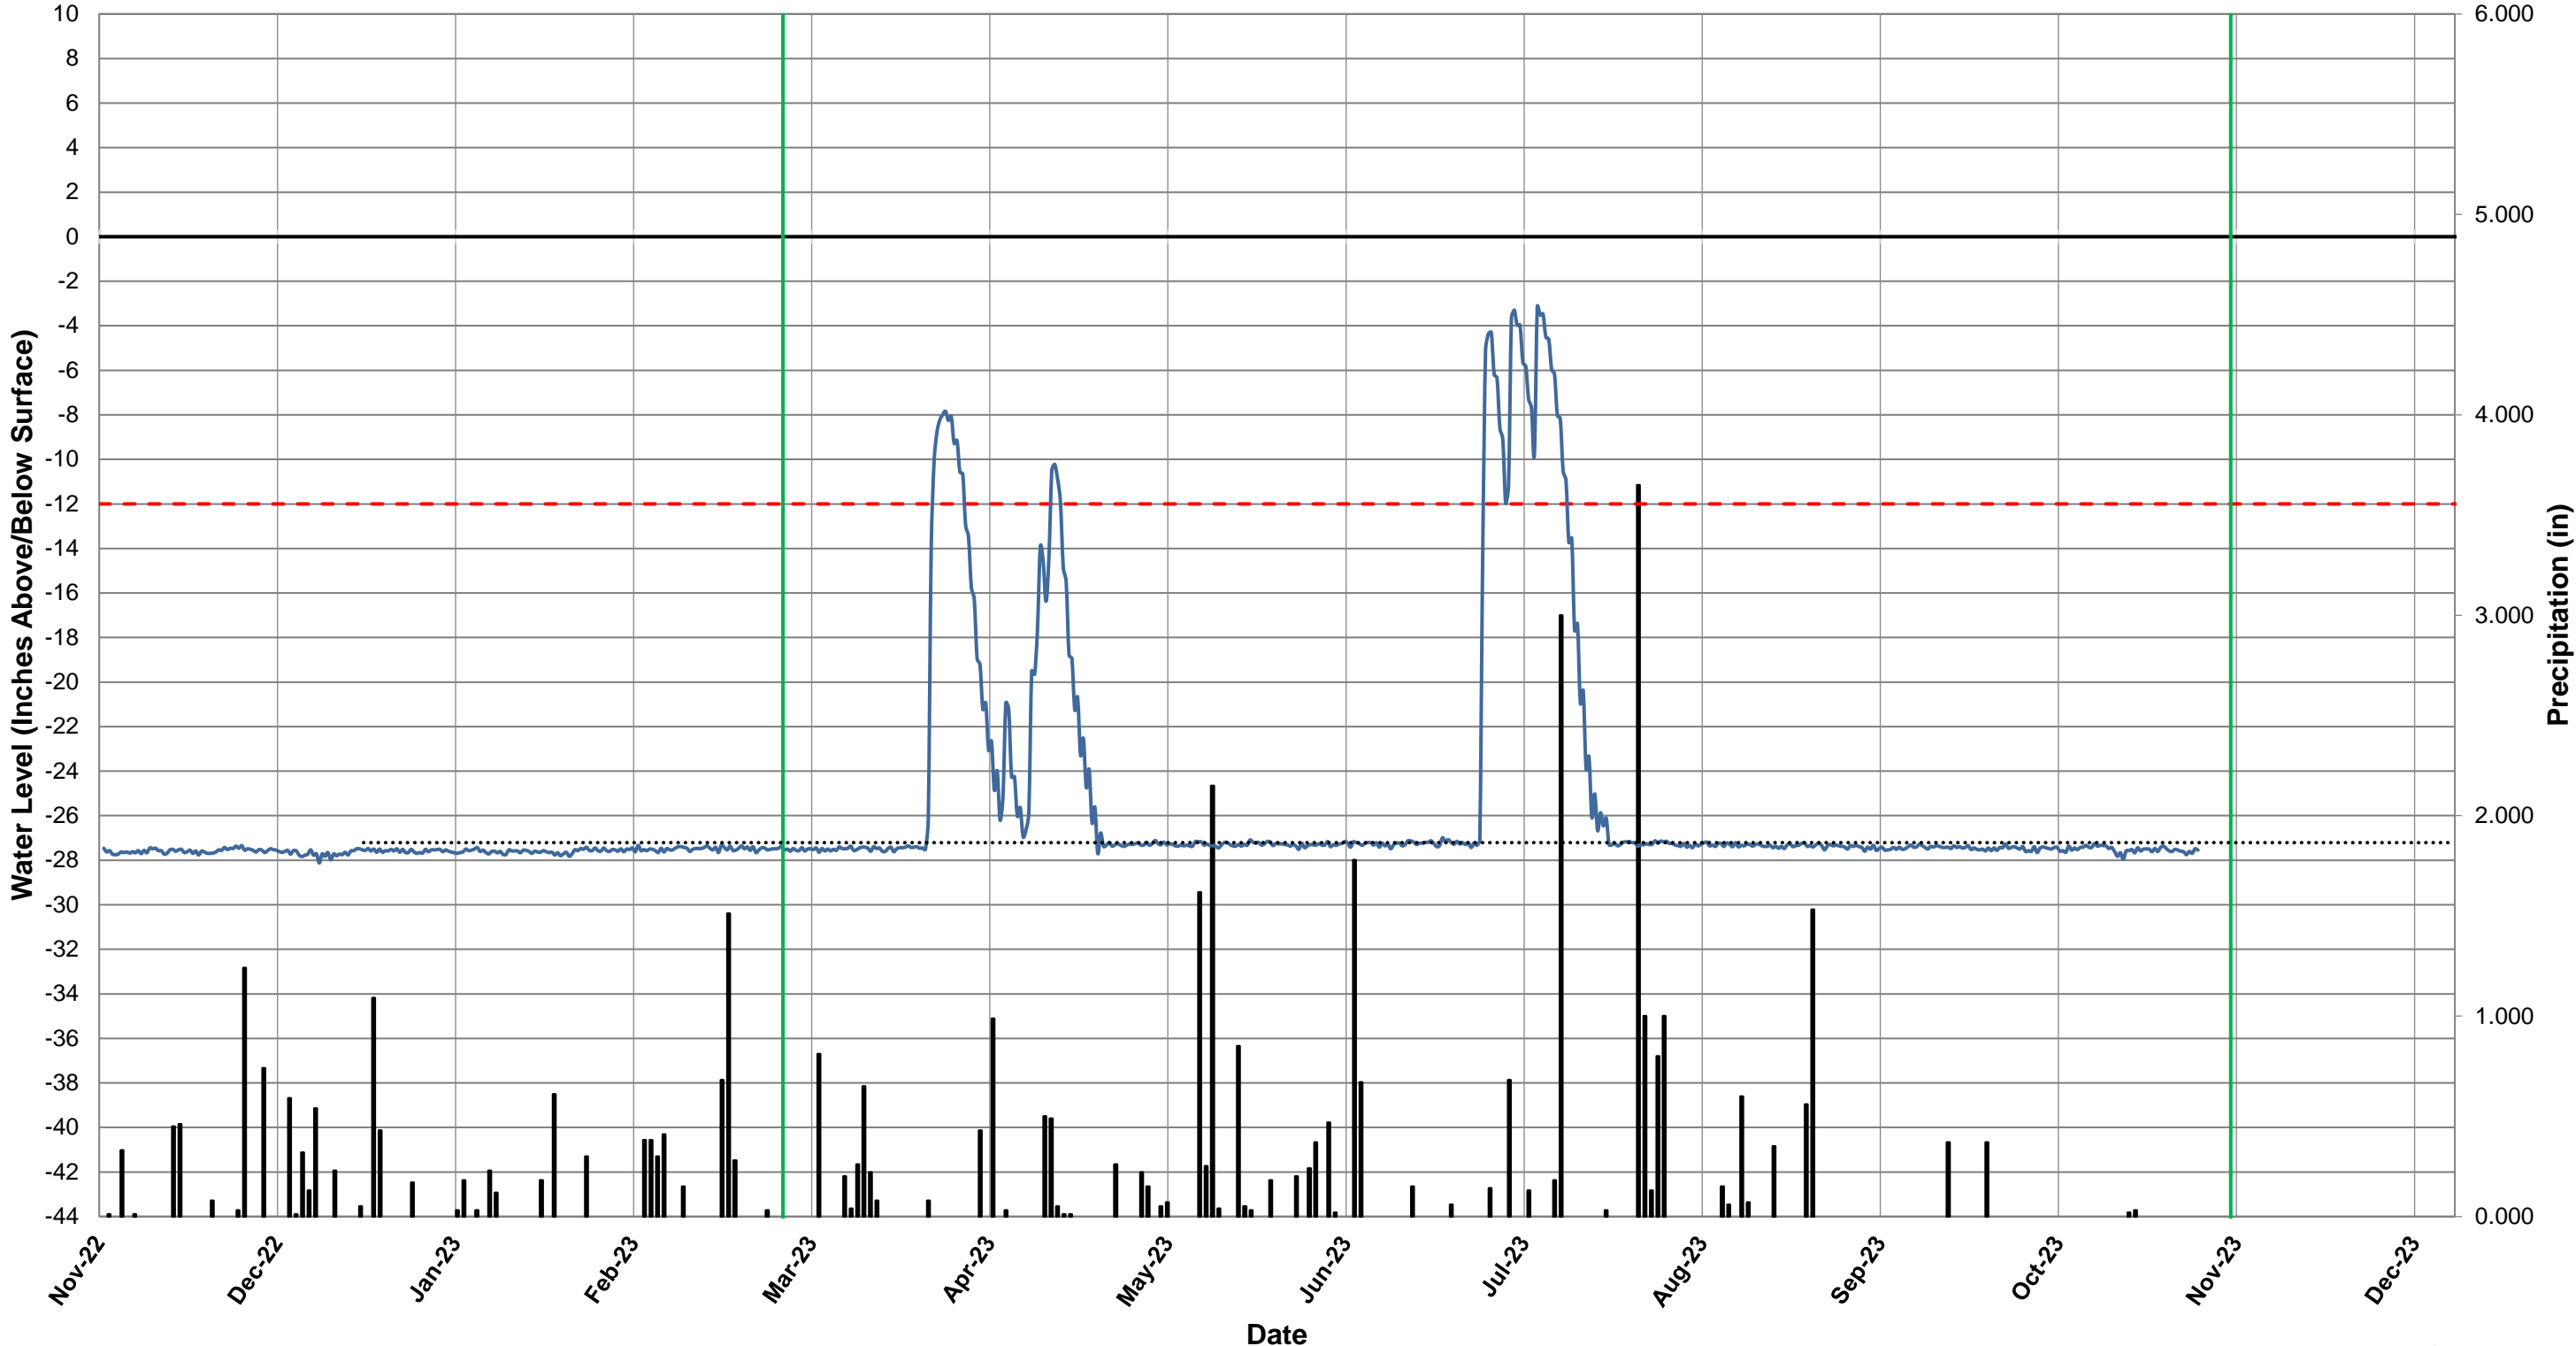
# 2023 Barefoot GW13

14.5 Consecutive Days of Hydrology  
07/15/2023 - 07/29/2023
