**Year 4 Monitoring Report**

**BAREFOOT SITE**

NCDMS Project # 100044 (Contract # 7418)  
USACE Action ID: SAW-2018-00433  
DWR Project # 2018-0235

Sampson County, North Carolina  
Neuse River Basin  
HUC 03020201

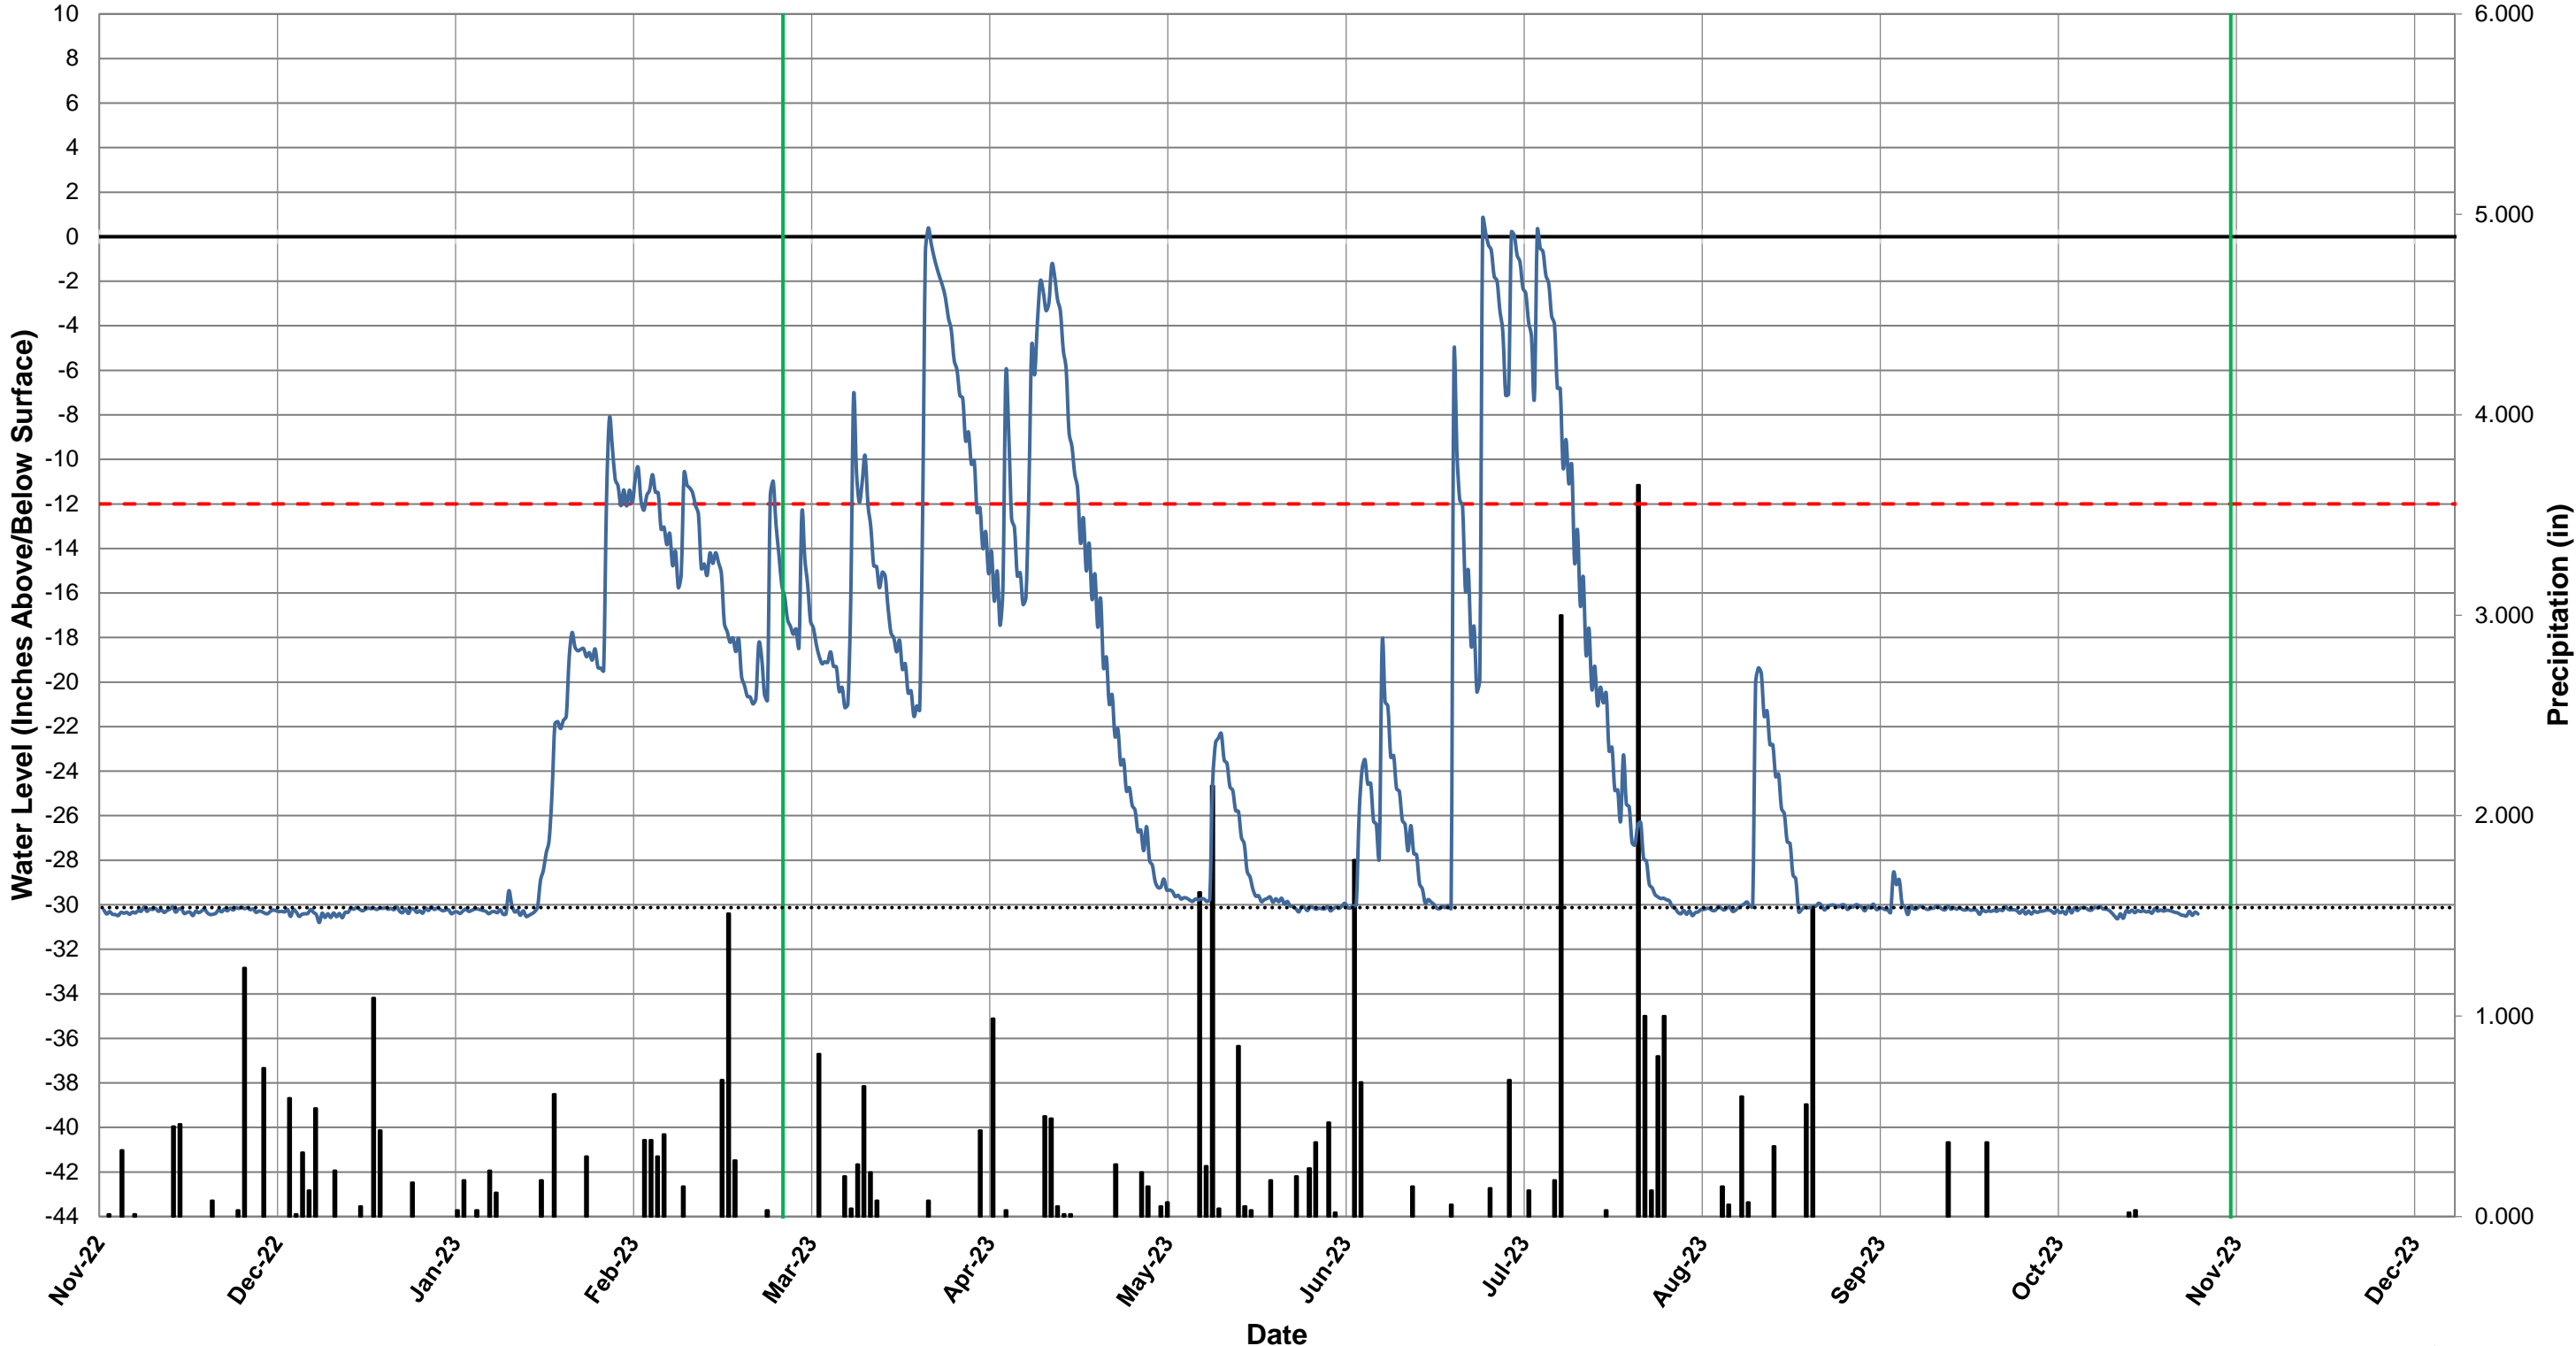
# 2023 Barefoot GW15

The lower hydroperiods in MY4 in wells 2, 12, 13, and 15 was due to a very low rainfall year, with five months of the growing season having below average rainfall. Johnston County has experienced abnormally dry and moderate drought conditions in 2022 and 2023 (U.S. Drought Monitor, **Appendix D**). Due to this non-riparian wetland being a mineral flat, with a ditched similar elevation landscape surrounding it, almost all of its hydrology is driven by precipitation and is more vulnerable to drought. RES expects the gauges on the periphery of the wetlands, closer to open ditches, to have lower hydroperiods as the data shows. Additionally, the well with the lowest hydroperiod, GW12, is the only well located above 194 feet elevation. Exact well locations can be found on **Figure 2** and associated data is in **Appendix D**.

16 Consecutive Days of Hydrology  
07/14/2023 - 07/30/2023
