**Bear Basin Restoration Site  
Monitoring Report MY01  
DMS Project # 95362  
DMS Contract # 004741**

**Construction Completed: February 2015**

**Data Collection: 2015**

**Submitted: January 2016**

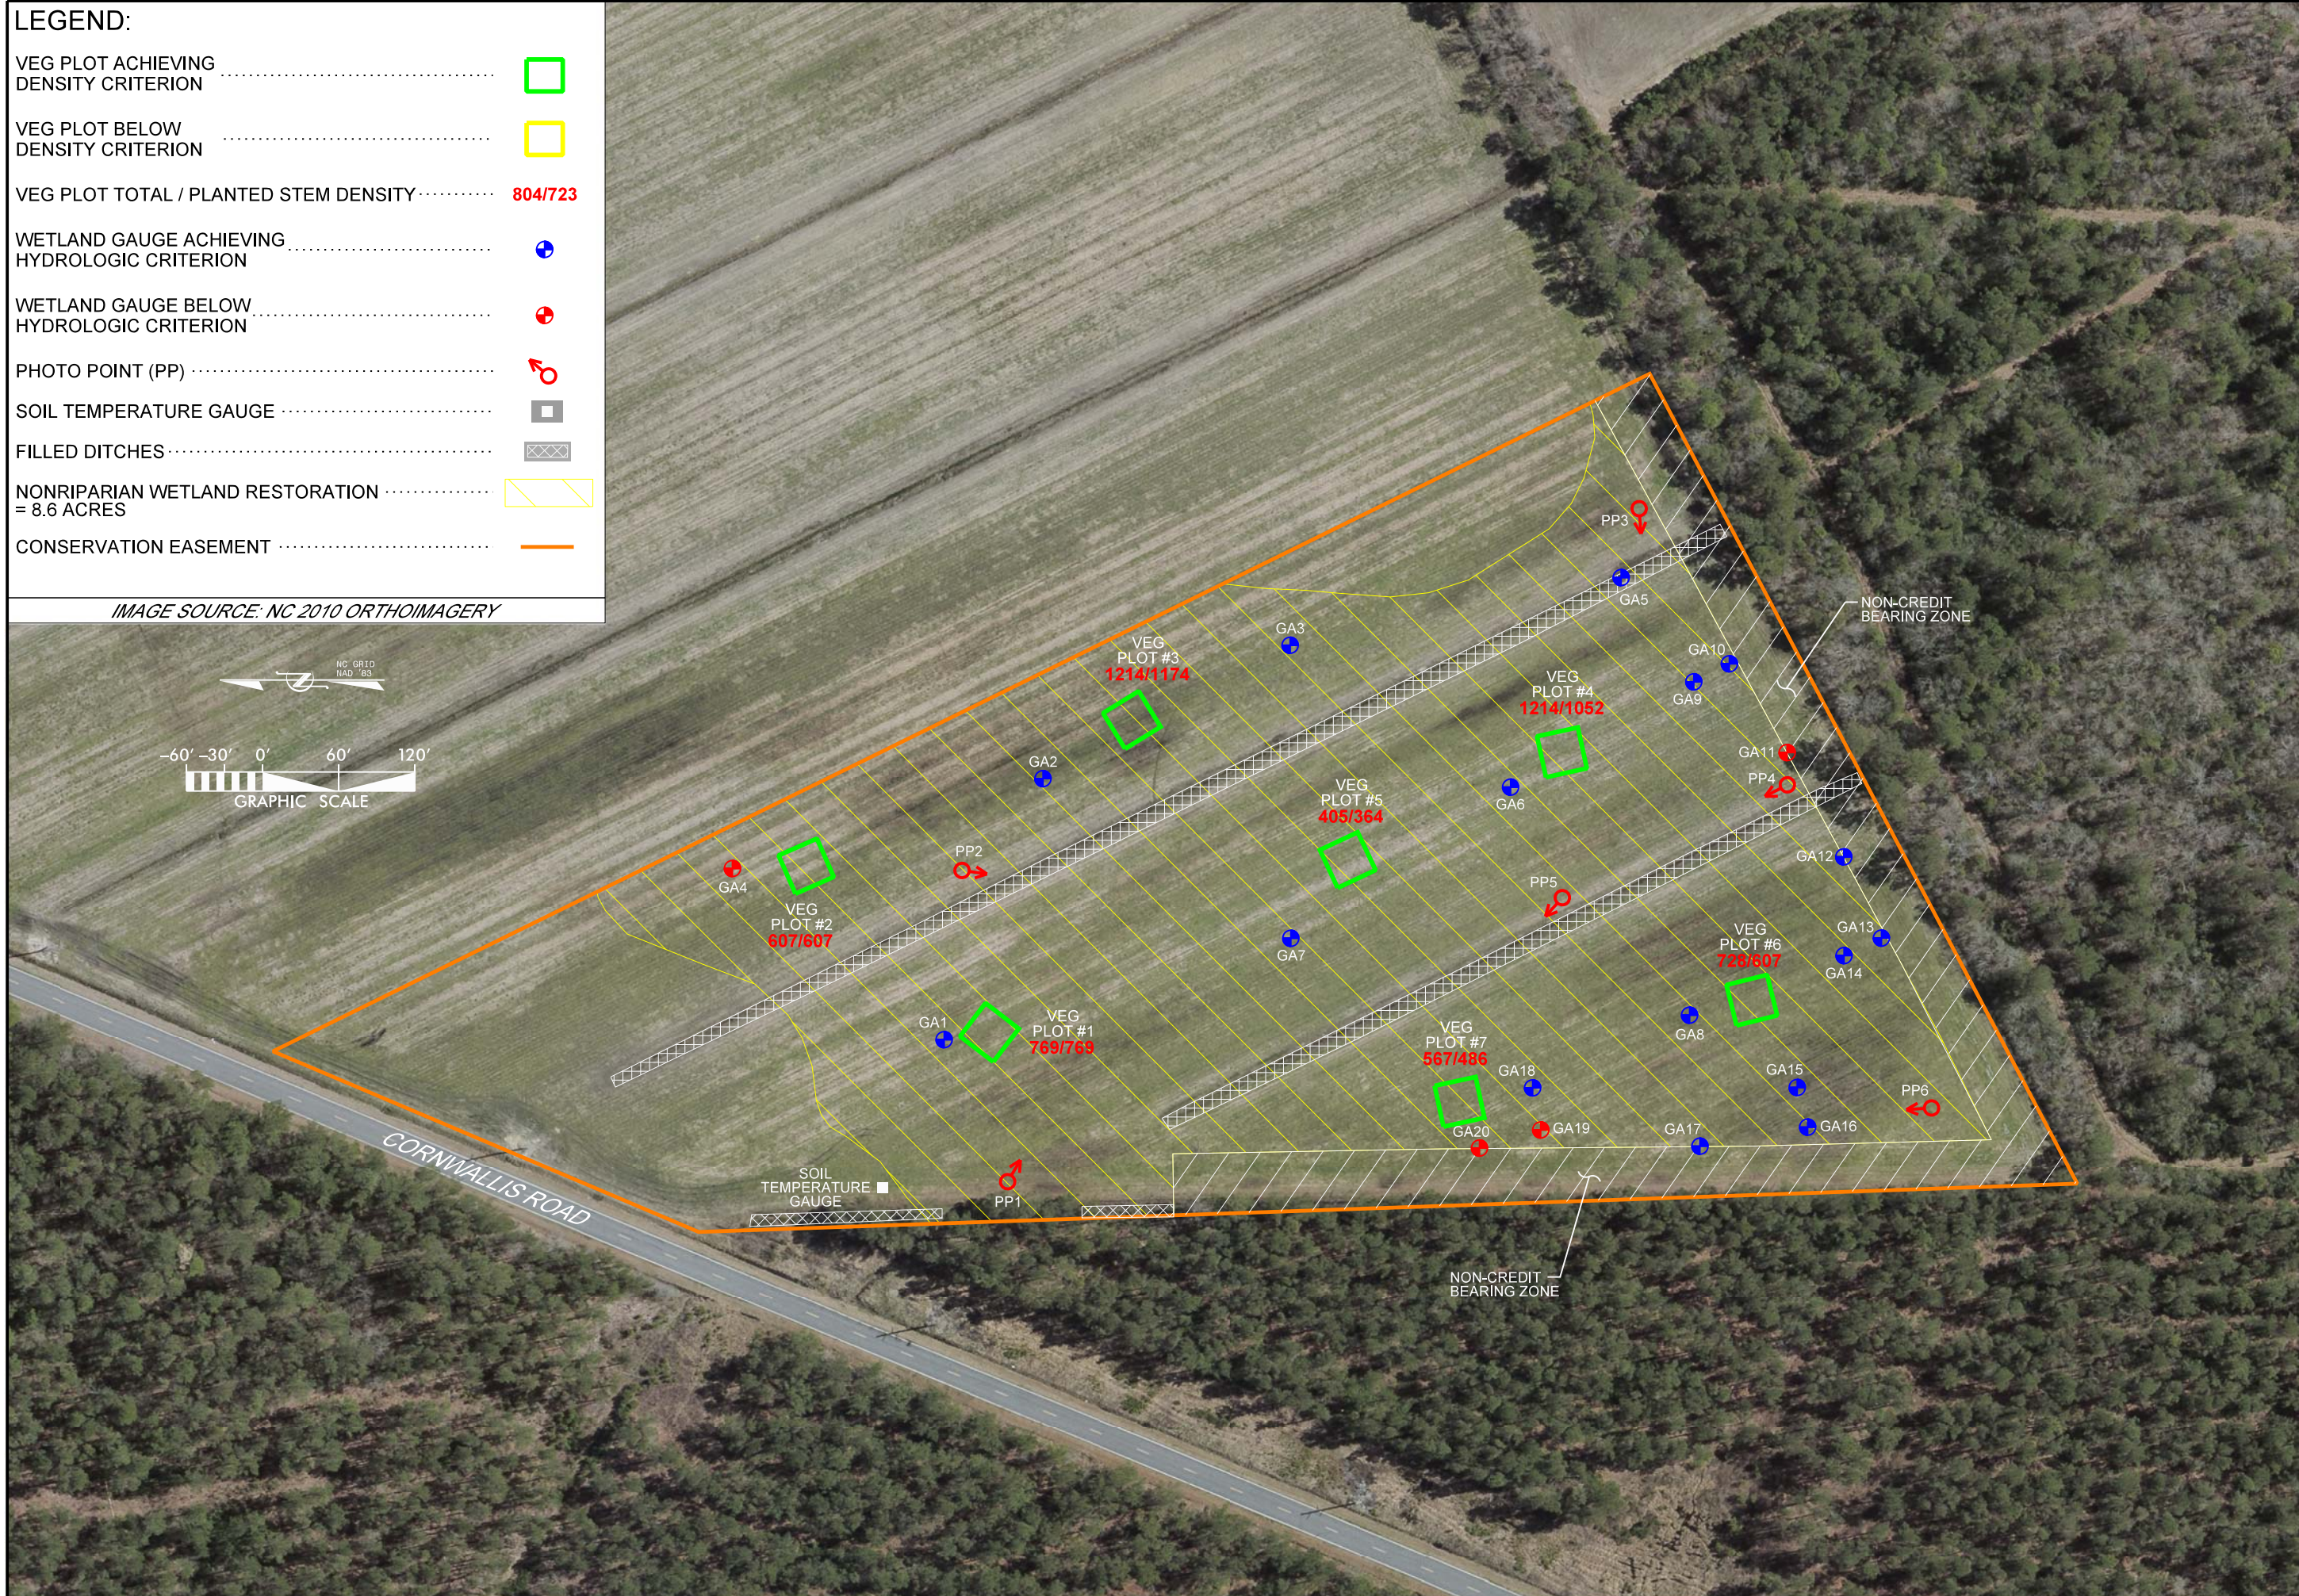
DATE
	SCALE
CURRENT CONDITION PLAN VIEW	
SHEET 1 OF 1	
FIGURE 3

- VEG PLOT ACHIEVING DENSITY CRITERION ..... □
- VEG PLOT BELOW DENSITY CRITERION ..... □
- VEG PLOT TOTAL / PLANTED STEM DENSITY ..... **804/723**
- WETLAND GAUGE ACHIEVING HYDROLOGIC CRITERION ..... ⊕
- WETLAND GAUGE BELOW HYDROLOGIC CRITERION ..... ⊕
- PHOTO POINT (PP) ..... ♂
- SOIL TEMPERATURE GAUGE ..... ■
- FILLED DITCHES .....
- NONRIPARIAN WETLAND RESTORATION = 8.6 ACRES .....
- CONSERVATION EASEMENT .....
