**Bear Basin Restoration Site
Monitoring Report MY03
DMS Project # 95362
DMS Contract # 004741**

**Onslow County, NC
CU# 03030001
DWR# 2013-0456
SAW# 2012-01391**

**Construction Completed: February 2015
Data Collection: 2017
Submitted: January 2018**

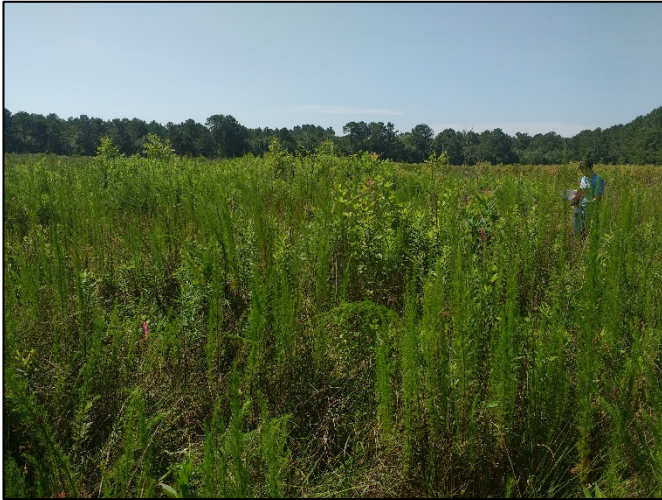
Vegetation Plot 1 – MY-03 – 7/5/17

Vegetation Plot ID	Vegetation Survival Threshold Met? (320 planted stems/acre)	Monitoring Year 03 Planted Stem Density (stems/acre)	Monitoring Year 03 Total Stem Density (stems/acre)
1	Yes	769	971
2	Yes	607	728
3	Yes	1,295	1,376
4	Yes	1,174	1,174
5	Yes	526	607
6	Yes	728	1012
7	Yes	607	890
