**Bear Basin Restoration Site  
Monitoring Report MY04  
DMS Project # 95362  
DMS Contract # 004741**

**Onslow County, NC  
CU# 03030001  
DWR# 2013-0456  
SAW# 2012-01391**

**Construction Completed: February 2015**

**Submitted: December 2018**

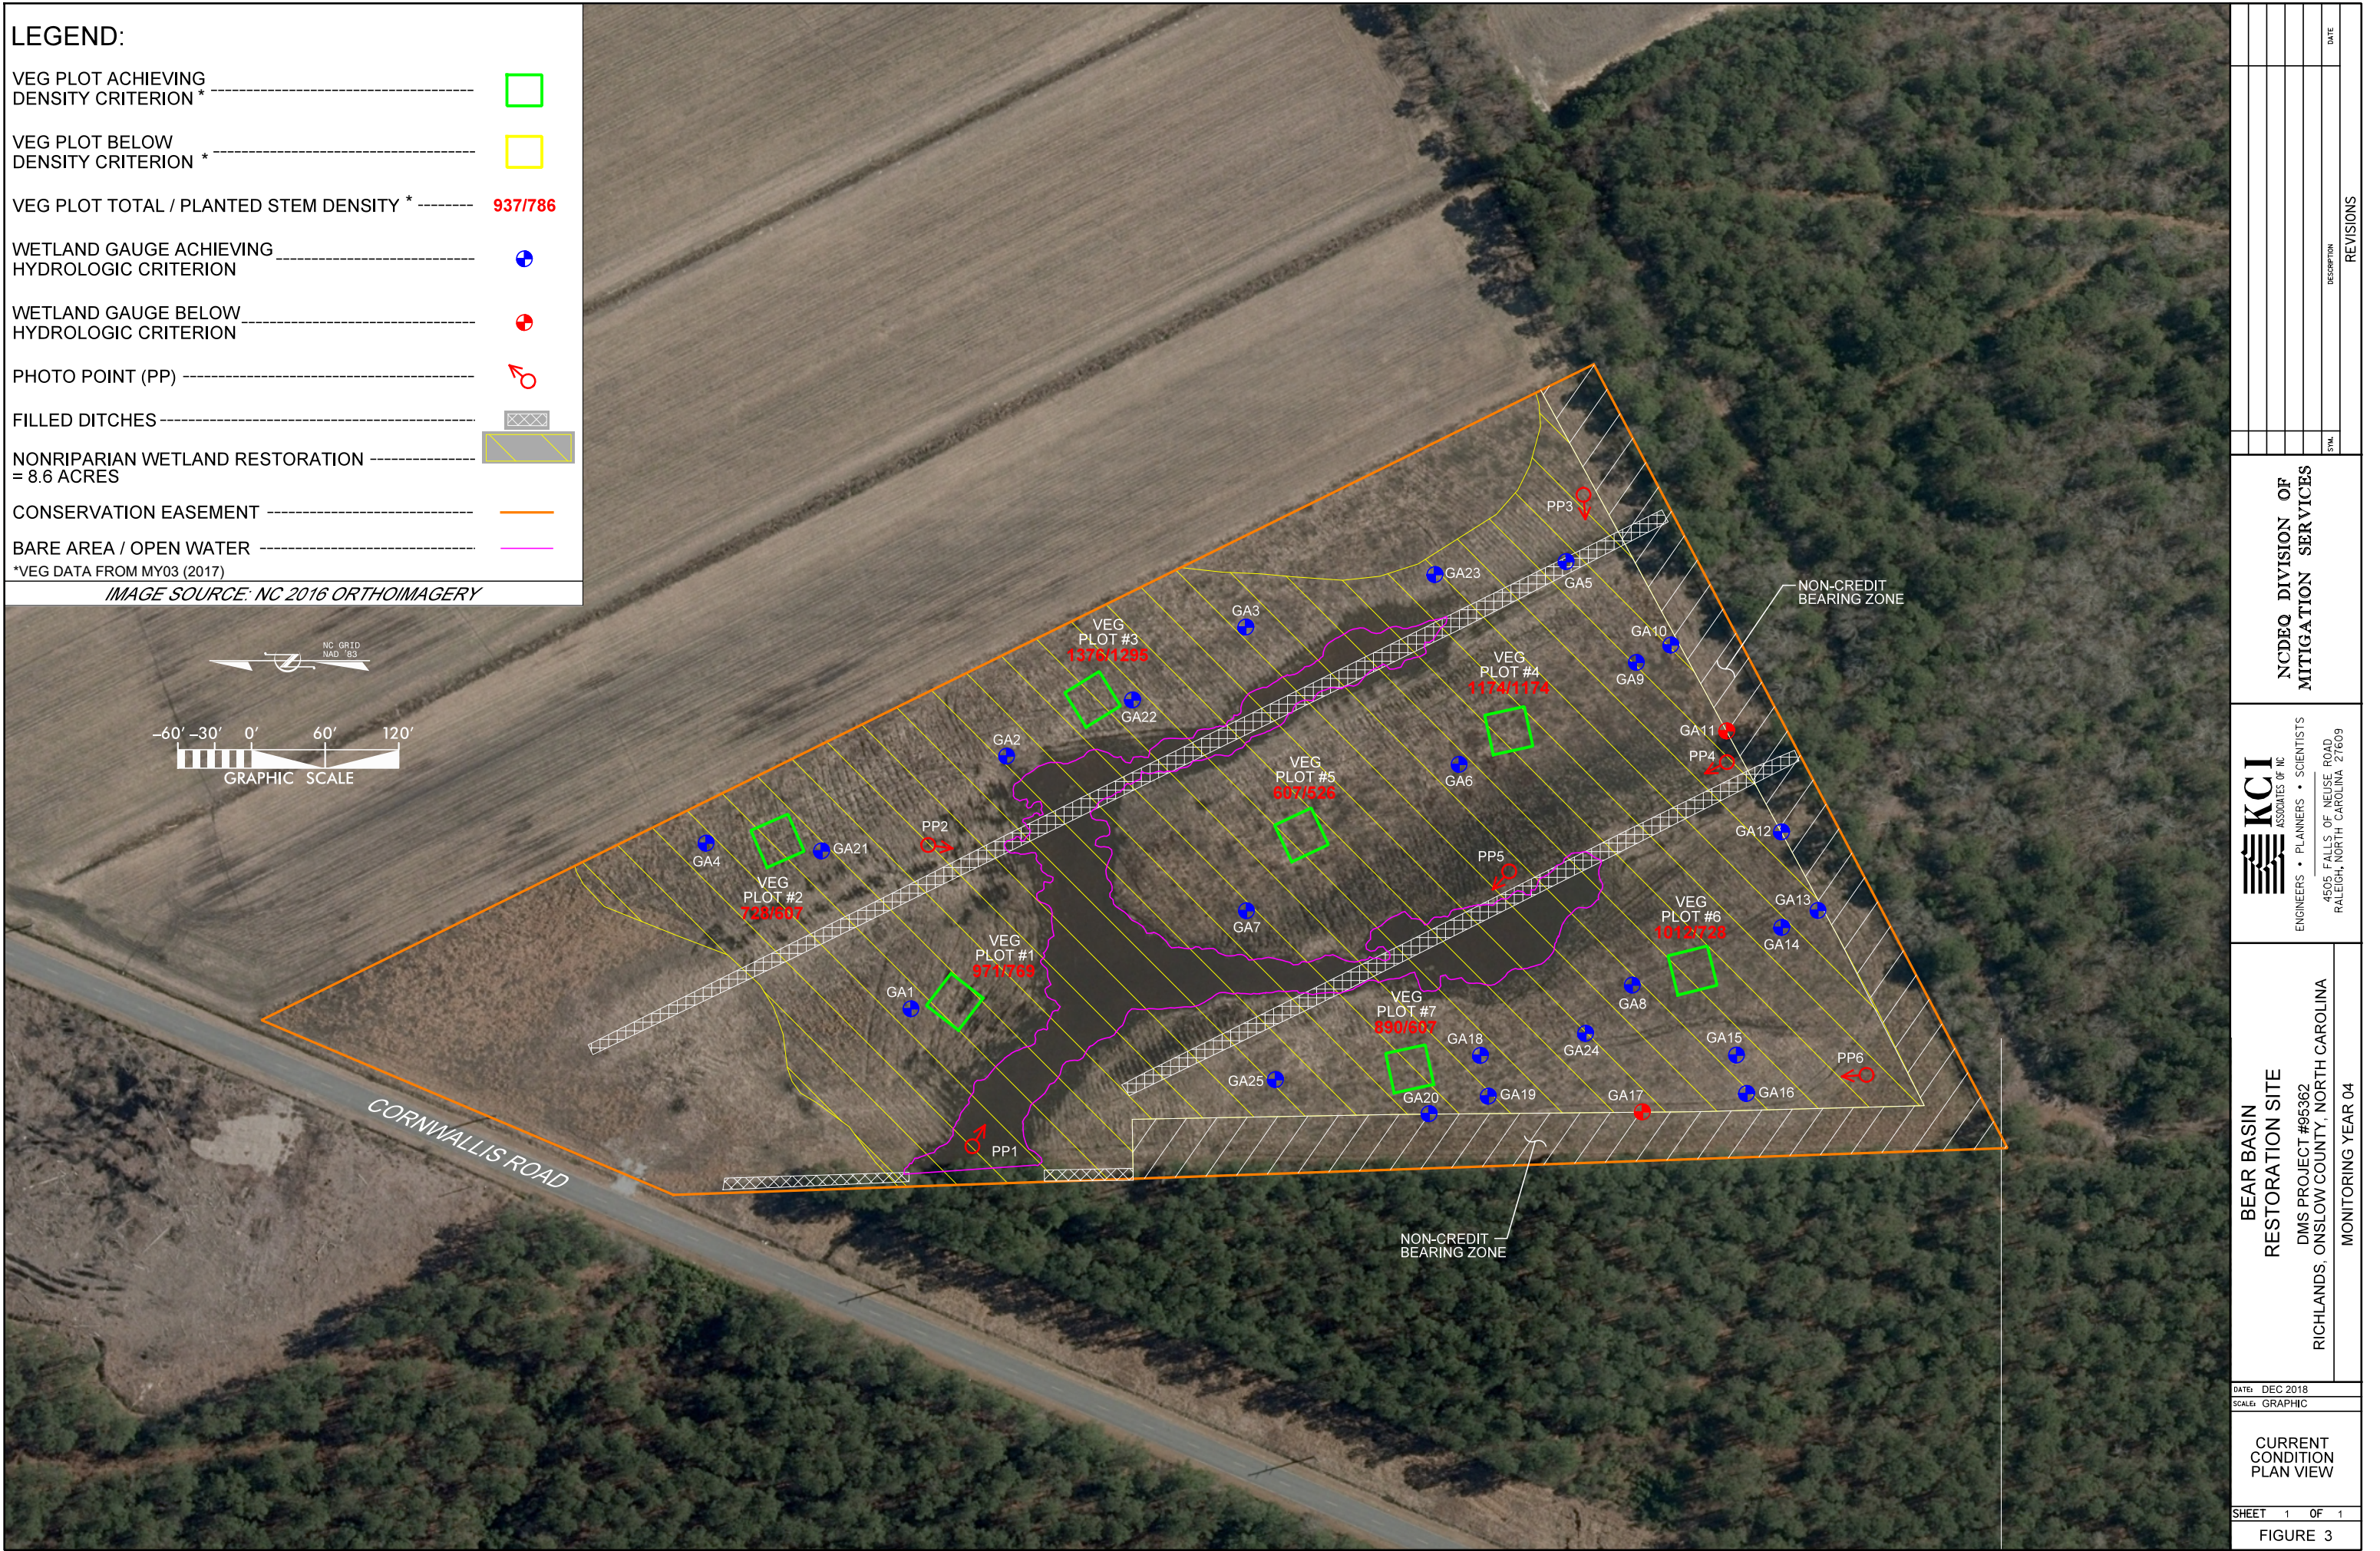
To make sure that there is no hydrologic trespass, there are some areas of open water on-site that connect to off-site ditches. This open water area has been brought up as a concern by the IRT during credit release meetings. In November 2018, KCI mapped this area (1.06 ac), which is shown in Figure 3, and will continue to monitor the extent of this area. It is expected that this area will decrease in size as vegetation continues to encroach on the open water. This will be documented in future monitoring reports.

\*=this polygon represents the area of open water discussed in Section 2.2
