**Bear Basin Restoration Site
Monitoring Report MY05
DMS Project # 95362
DMS Contract # 004741**

**Onslow County, NC
CU# 03030001
DWR# 2013-0456
SAW# 2012-01391**

**Construction Completed: February 2015
Data Collection: 2019
Submitted: December 2019**

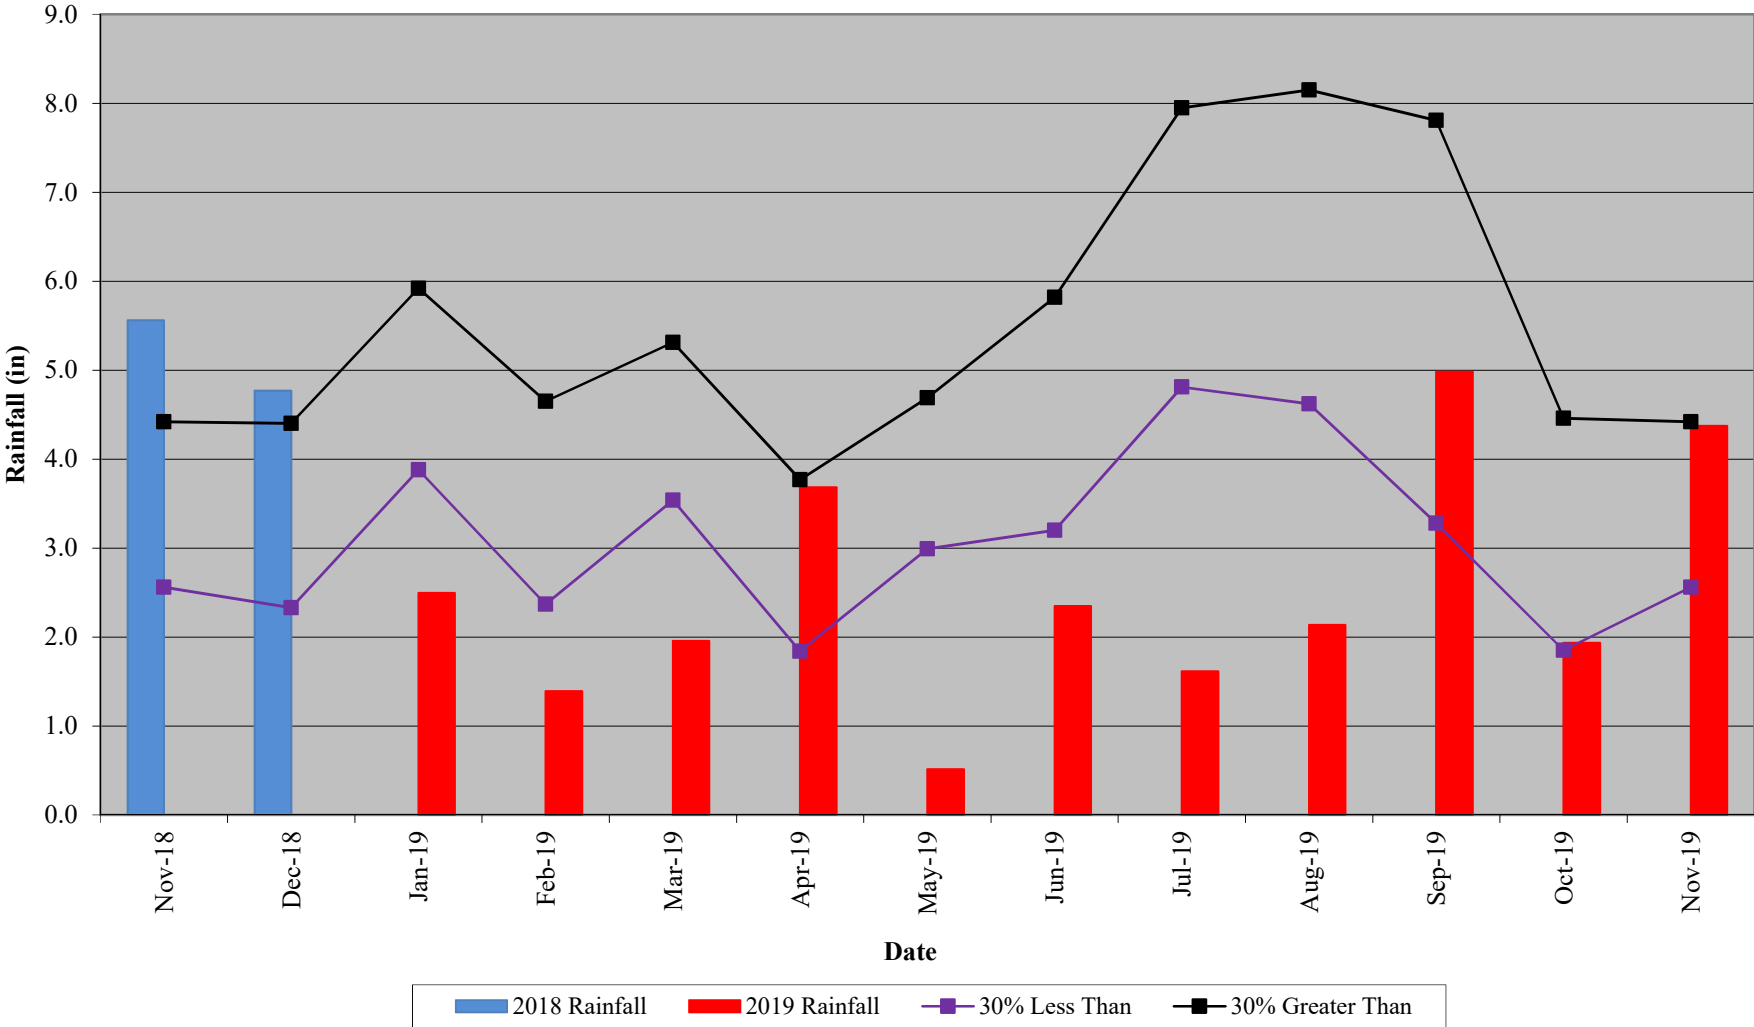
**Bear Basin Wetland Restoration Site
30-70 Percentile Graph
WETS Station Name: Maysville, NC**

The daily rainfall data was obtained from a local weather station in Jacksonville, NC; provided by the NC State Climate Office. For the 2019 year, the months of April, September, October and November experienced average rainfall, while January, February, March, May, June, July, and August, experienced below average rainfall. No months recorded above average rainfall for the site. Overall, the area experienced well below average rainfall during the 2019 growing season.
