MITIGATION PLAN

Bear Creek Restoration Project
(Phillips Site)
Chatham County, North Carolina
EEP ID #26
DENR Contract D09050S
SCO Project Number: 090772601

Bear Creek Restoration Project
(Phillips Site)
Chatham County, North Carolina
DENR Contract D09050S
SCO Project Number: 090772601

Wildlands Engineering, Inc.
1430 South Mint Street, Suite 104
Charlotte, NC 28203
Phone – 704-332-7754

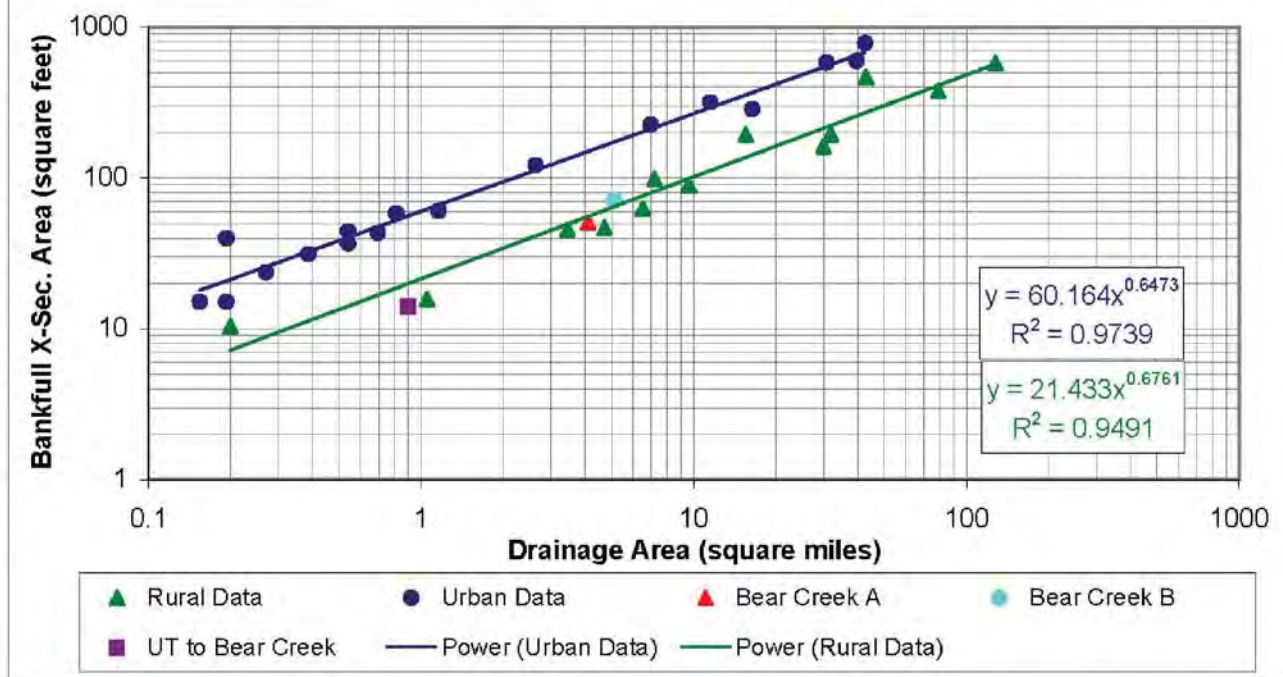
North Carolina Piedmont Regional Curve: Bankfull Area

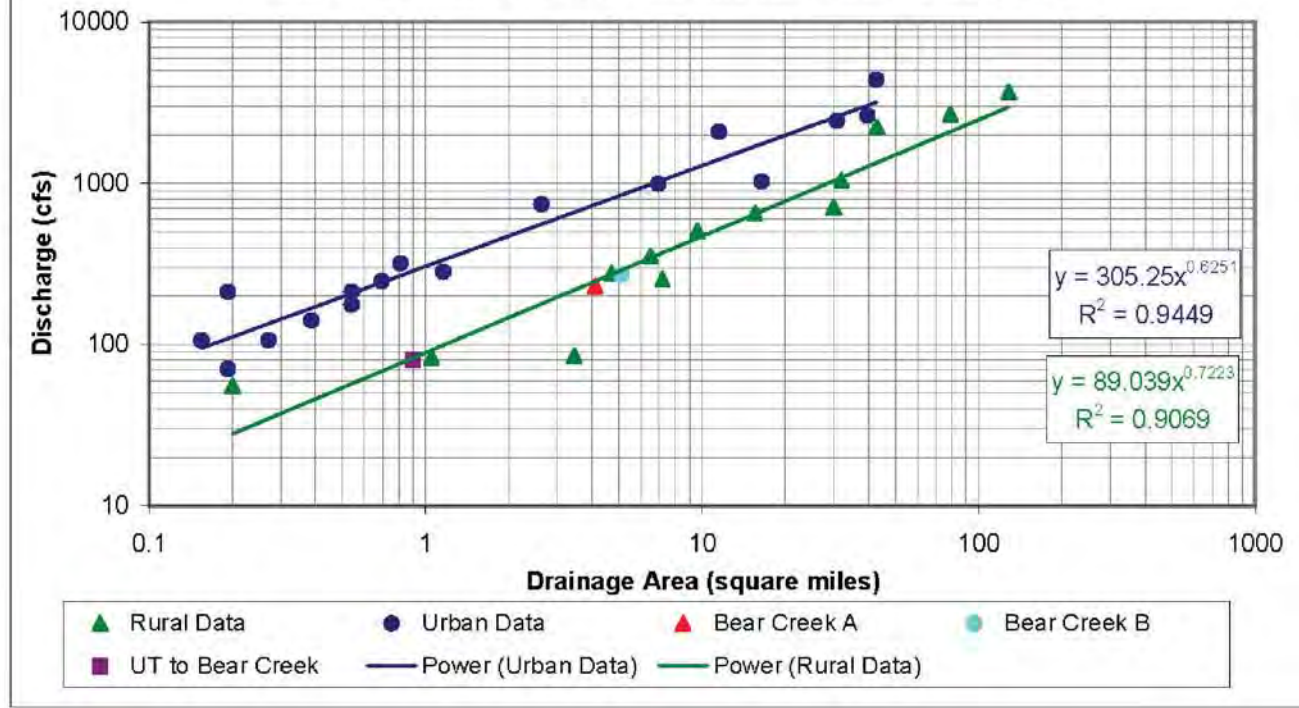
North Carolina Piedmont Regional Curve: Discharge

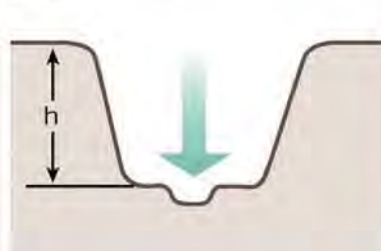
Channel Evolution Model Six Stages (Simon & Hupp, 1986)

Class III. Degradation
 $h < h_c$

Class IV. Degradation and Widening
 $h > h_c$

Bear Creek Reach A is currently in Stage IV of Simon's channel evolution model, illustrated in Figure 7. The channel is being widened by flow and cattle trampling of the banks. The channel has historically been straightened; this maintenance of a straight-line channel has steepened the channel such that sediment transport calculations indicate the existing condition slope is steeper than needed to move the sediment load. This indicates that the channel is continuing to degrade. There is no evidence that aggradation indicative of Stage V is starting to occur. Removal of cattle and restoration of a woody vegetated buffer will help to stabilize the channel. Construction of a stable cross-section and meandering pattern is needed to reduce channel slope and allow energy to be dissipated through meander bends.

UT to Bear Creek has been continuously trampled and disturbed, and is in Stage II to III of the Simon evolution model. The portion of the channel upstream of Siler City-Glendon Road is not extremely vertically incised, but lacks channel habitat diversity and bank-stabilizing vegetation. The downstream portion of the channel from Siler City-Glendon Road to the Bear Creek confluence is downcutting to meet the incised grade at Bear Creek. Due to its small size, these disturbances have not caused extensive stability problems but continuous and unlimited cattle trampling has not allowed the channel to stabilize itself.

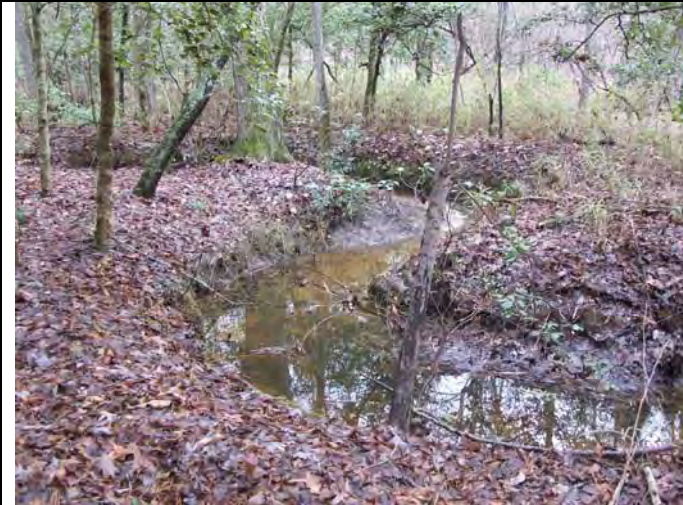
Photo 1-Spencer Creek meander pattern.
