Year 3 Monitoring Report
Bear Swamp Stream & Wetland Mitigation Project

Robeson County, North Carolina

Monitoring Year 3

Bear Swamp Stream and Wetland Mitigation Project
Year 3 Monitoring Report
DMS Project ID #100054
Robeson County, North Carolina

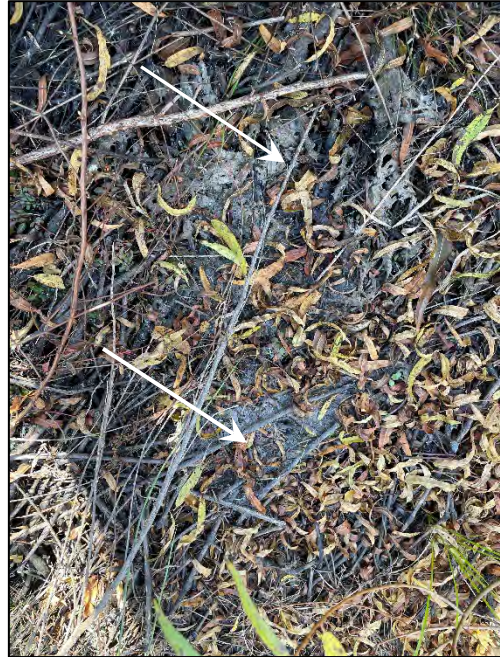
Headwater stream (or valley) restoration requires that evidence of channel formation be documented during each monitoring year. Applicable field indicators of channel formation are found in RGL 05-05 and outlined in the 2016 USACE Guidance; these indicators change based on monitoring year. The main channel formation indicators applicable to Monitoring Years 1-4 observed in MY3 are shown in Table 9 in Appendix C; this table will be updated in additional monitoring years. Representative photos of the observed indicators in MY3 are found in the photolog in Appendix A.

Evidence of channel formation: sediment deposition in
channel (11/20/2023)

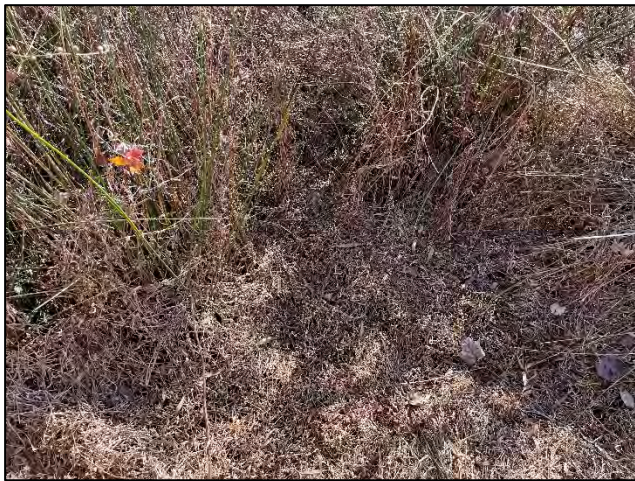
Evidence of channel formation: vegetation matted down
(11/20/2023)

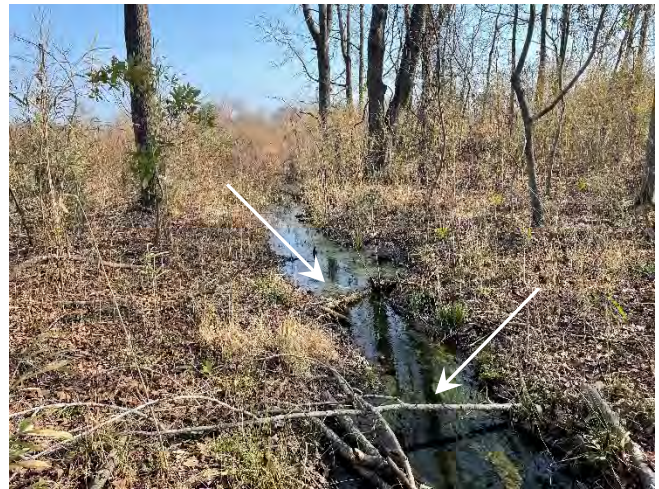
Evidence of channel formation: presence of litter and debris;
also note algae in channel (2/23/2023)

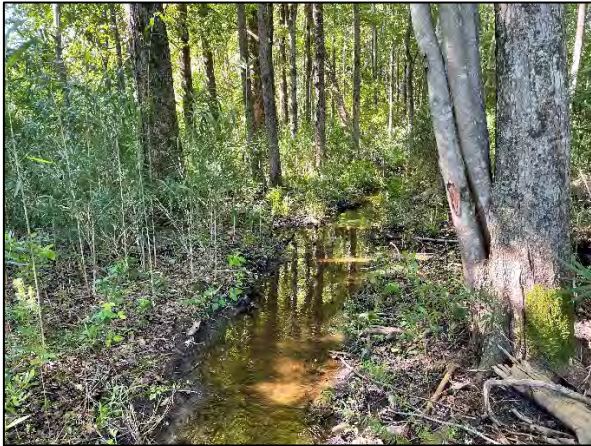
Evidence of channel formation: leaf litter washed away after Tropical Storm Idalia (9/2/2023)

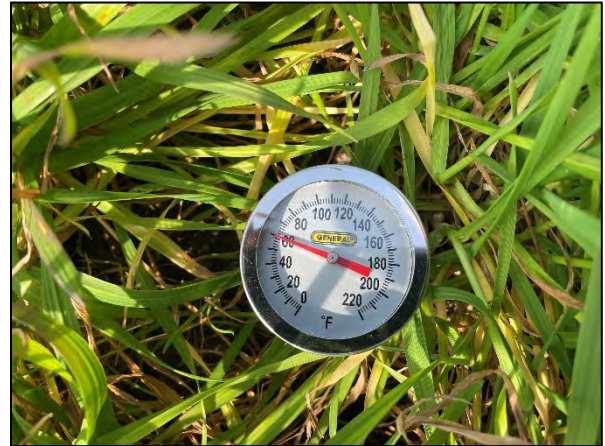
The growing season for this Project, based on WETS data tables for Robeson County, was given as March 15 – November 15 in the mitigation plan. However, based on readings of soil temperature at 20 inches (> 41° F) and observation of bud burst on March 1 (see photolog in Appendix A), it is proposed that the beginning growing season date be moved to March 1. Trees with dropped leaves were observed on November 20 (see photolog in Appendix A), so the end of the growing season was kept at November 15. Twelve (12) percent (target hydroperiod) of this duration (March 1 – November 15) is 31 days.

Soil temperature reading at 20 inches on 2/23/2023

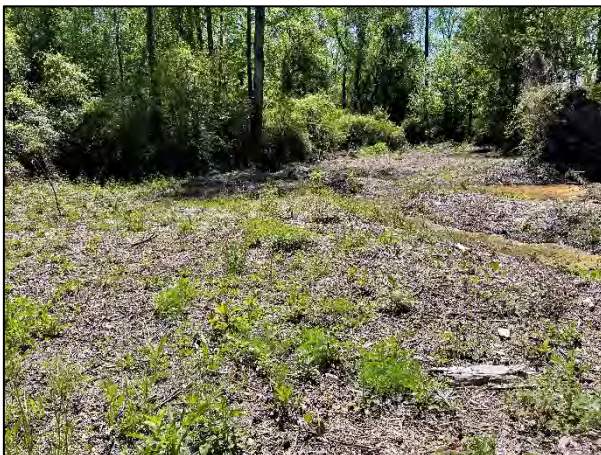
Chinese privet (*Ligustrum sinense*) was the most common non-native invasive species found within the forested section of the easement. Several other non-native invasive species were identified along the field edge of the forested section, including Japanese privet (*Ligustrum japonicum*) and Chinaberry (*Melia azedarach*); however, these species were not as prevalent as Chinese privet. During construction, most of the forested area was left intact; therefore, much of the privet remained, mostly along the southeast border of the easement, but also scattered throughout the southwest section, and totaled approximately 1.3 acre. All privet was either cut by hand and treated with Vastlan™ (Triclopyr choline) in 2021 or mechanically cut and mulched in 2022. The area treated in 2021 was planted in late winter 2022 with surplus stems taken from a nearby section of easement, which were planted originally for this purpose. The area that was mechanically cleared in 2022 was planted with species from the mitigation plan on January 2, 2024, at a density of 400 stems per acre (see Appendix B for details). Vegetation transects will be run in this area in MY4 at the request of the IRT.

Mechanically cleared privet area (4/24/2023)

Some re-sprouting of privet was observed in the easement in MY3—spot herbicide treatments occurred in June 2023 and January 2024.

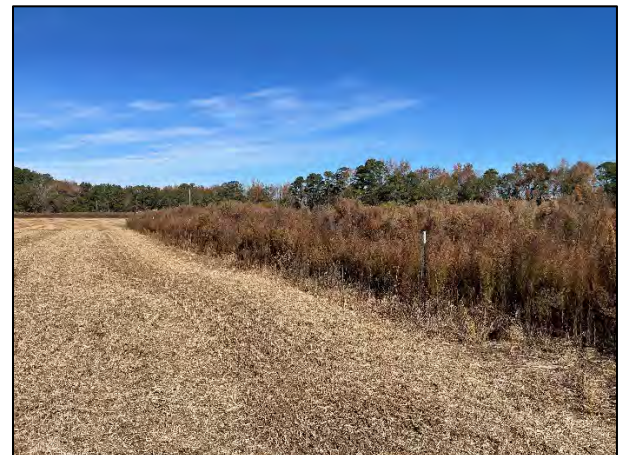
In MY2, mowing encroachment was observed in 3 areas along the western boundary of the easement. Two of these are adjacent to the active crop fields and were being mowed inadvertently. More t-posts were added to these areas in June 2023 to deter further mowing and supplemental planting occurred on January 2, 2024, with trees from the approved mitigation plan. Planting details are provided in Appendix B. The remaining mowing encroachment is the result of intentional mowing by an adjacent property renter along the southwest easement boundary and was not planted during the construction phase. After discussions with the property renter and landowner, this area was also planted with trees from the approved mitigation plan on January 2, 2024 (see Appendix B). While these areas were planted with large bare root stock, any unsuccessful specimens will be replaced with containerized trees.

Former encroachment area showing extra posts and grown-up vegetation (11/20/2023)

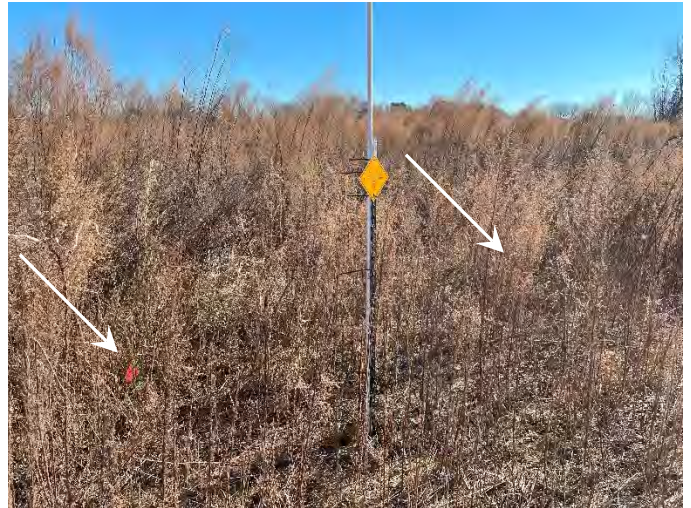
Supplemental planting (orange flags) in encroachment area along field (1/2/2024)

Encroachment Area 3 - Trees were planted a minimum of 8-feet away from the access path and the existing forest to allow for future growth. Fewer trees were needed as a result.

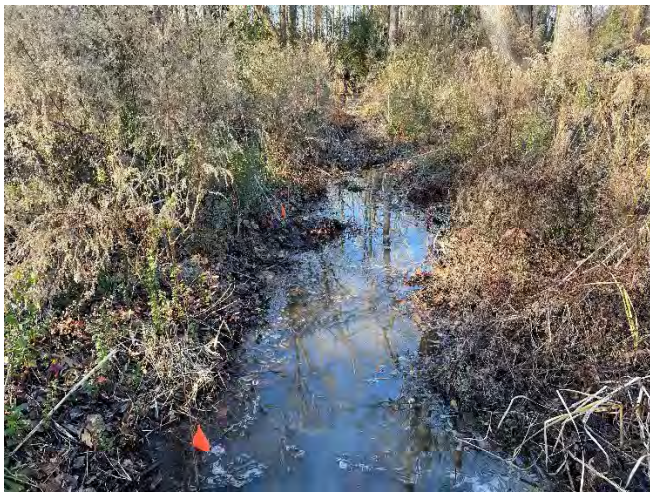
Planting in mechanically mulched Chinese privet area, along old channel (orange flags; 1/2/2024)

- **Planting occurred in the invasive area on 1/2/2024—details have been added to Appendix B. Taller bare-root specimens (many 3 ft.) were used, as this area only has one growing-season worth of vegetation growth due to being completely mulched in fall 2022. Planting density was also above MY3 stem density requirements to allow for some degree of mortality (400 stems per acre). The report has been updated, as well as the photolog.**

Invasive Removal 1 - Trees were planted at a slightly higher density in this area.

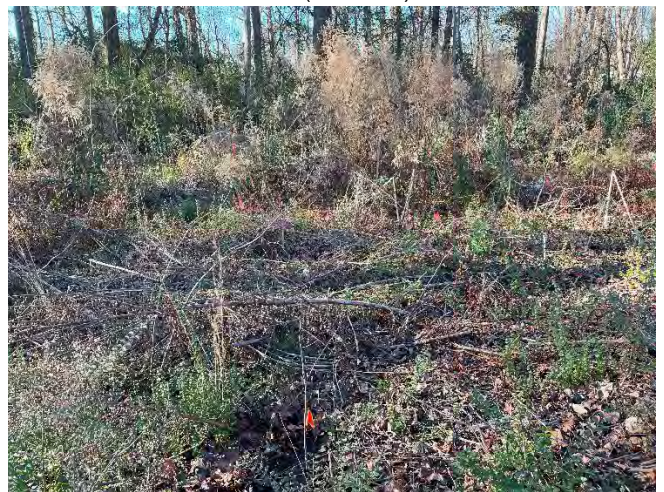
Planting in mechanically mulched Chinese privet area (orange flags; 1/2/2024)

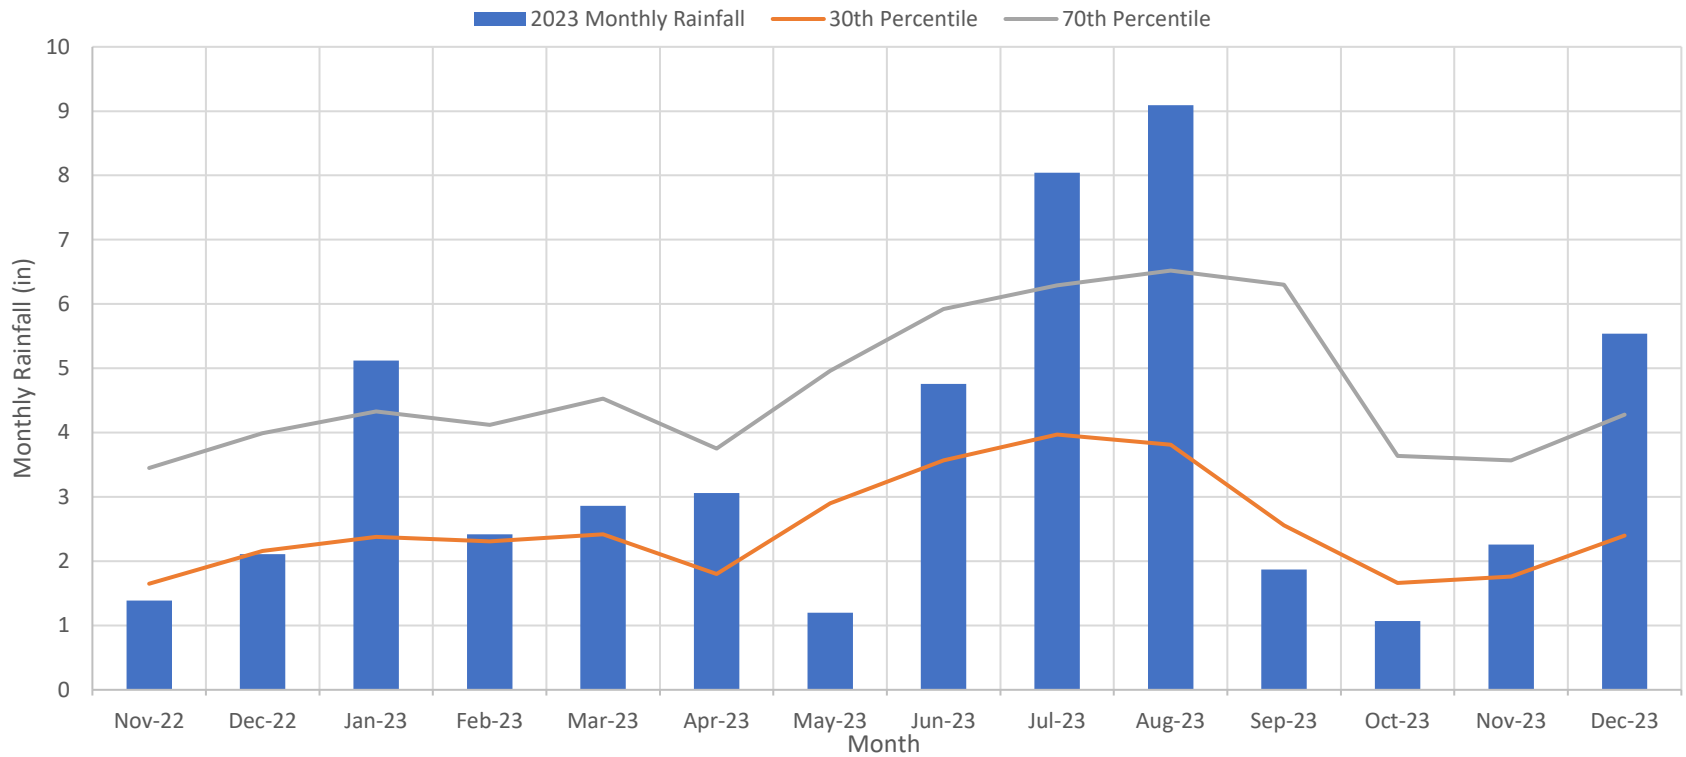
Bear Swamp Stream and Wetland Mitigation Project
Figure 3. Monthly Rainfall Data
Monitoring Year 3 - 2023

Monthly rainfall totals over the growing season are shown on Figure 3 (Appendix C), including an overlay of WETS-derived 30th and 70th percentile monthly rain totals. In MY1, the 30th and 70th percentiles were based on data from 1920-2019. Starting in MY2, the 30th and 70th percentiles are based on data from 1971-2022, to better reflect current conditions. In MY3, rainfall was in the normal or above normal range between January-April, June-August, and November-December, while the remaining months (May, September, and October) were below normal. The rain total for the year was in the normal range for the first time since monitoring began, largely due to above average rainfall in December. Between November 20 and December 31, it should be noted that rainfall data was obtained from the WCON7

Note: Percentiles calculated using historic rainfall data from WETS Station: Lumberton, NC, 1971-2022. Project rainfall data from HOBO Tipping Bucket Rain Gauge located on-site.

Rainfall Summary							
	2021*	2022^	2023+	2024	2025	2026	2027
Recorded Precip Total	28.26	36.20	47.29	-	-	-	-
WETS 30th Percentile	30.64	44.79	44.79	-	-	-	-
WETS 70th Percentile	56.69	52.96	52.96	-	-	-	-
Normal	N	N	Y	-	-	-	-

- **Figure 3 has been updated through December 2023 using totals from the WCON7 weather station in Lumberton, as there was a data collection error with the rain**

gage, likely resulting from debris in the funnel (cleared out 1/2/2024). A discussion of the rainfall data has also been updated in report Section 2.3.

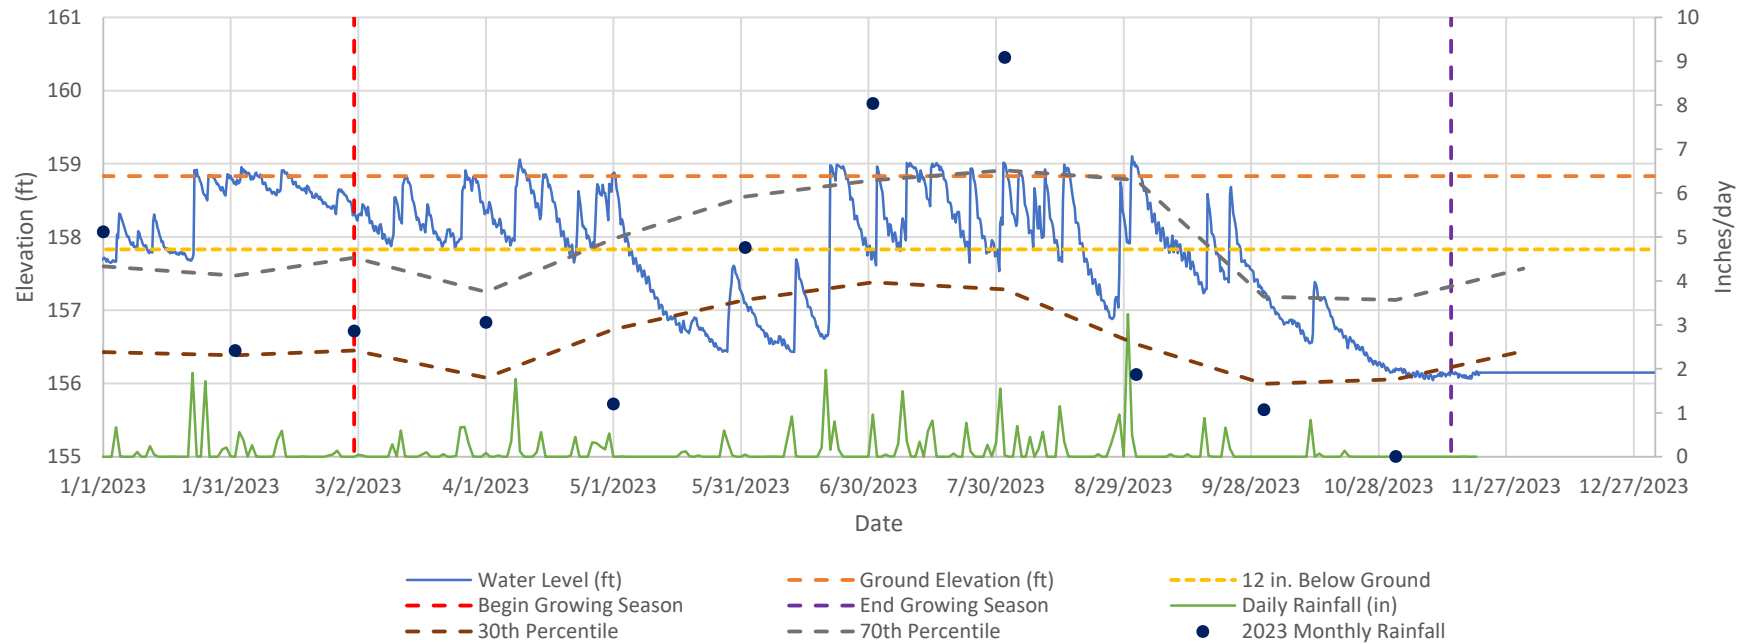
Site Info (Year 3)		Growing Season Information (Year 3 - 2023)	
Site	Bear Swamp	Site	Bear Swamp
Begin Date	1/1/2023	Gauge ID	BS3 - Groundwater
End Date	12/31/2023	Serial #	20452194
Total Days of Well Data	121	Growing Season Start Date	3/1/2023
-Rainfall data from HOBO Tipping Bucket Rain Gauge located at the Bear Swamp Stream and Wetland -Percentile lines in reference to WETS historic monthly Rainfall data for Lumberton, NC		Growing Season End Date	11/14/2023
		Total Growing Season Days	258
		NRCS Soil Series	Johnston
Success Criteria			
12.0%	Growing Season (Days)	31	
Most Consecutive Successful Days Within Growing Season		65	
Percent of Growing Season with Consecutive Successful Days		25.2%	
Average Water Level Elevation During Growing Season (ft)		157.69	
Total Cumulative Successful Days Within Growing Season		145

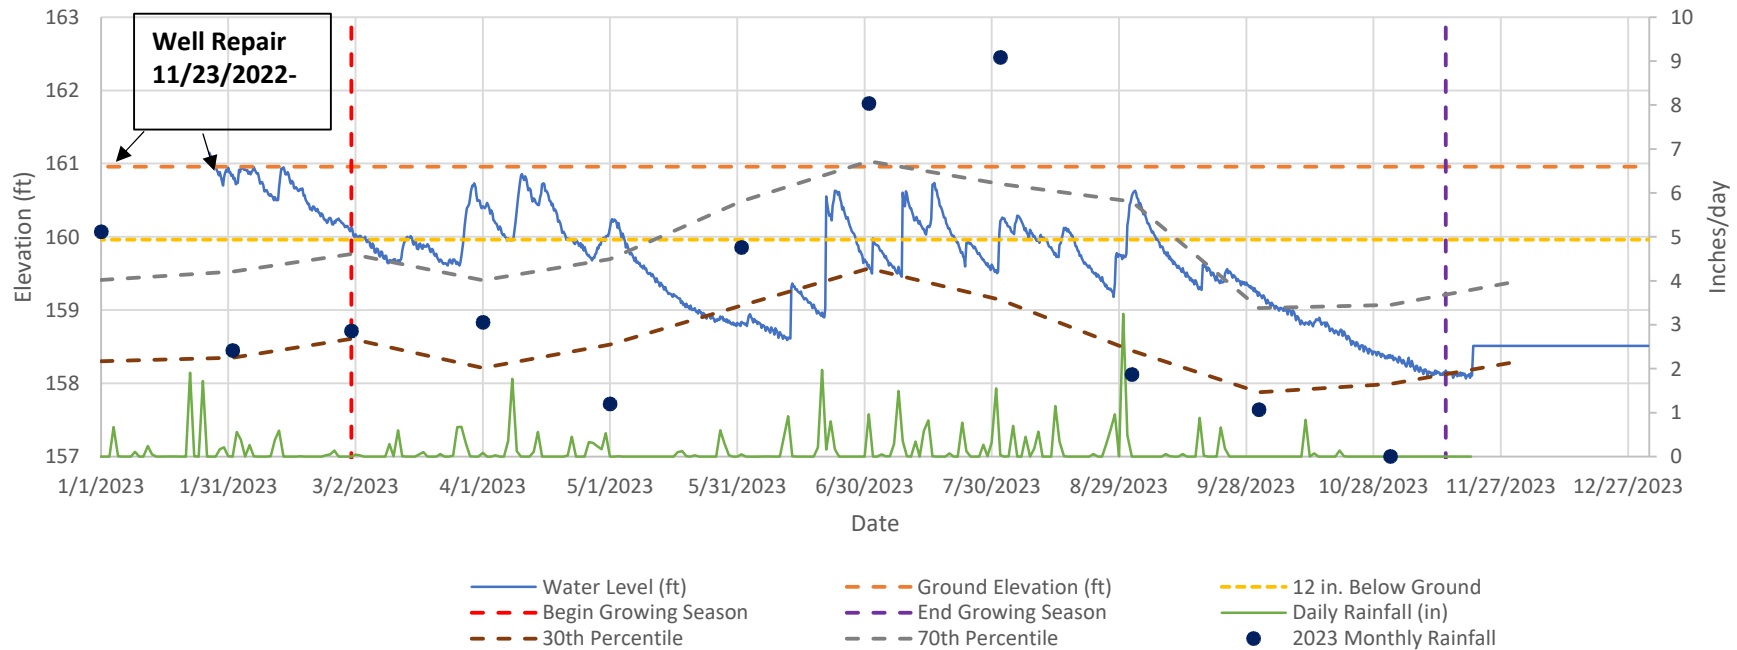
Of the four wells in restored wetland areas, all but one met or exceeded the 12% target hydroperiod during the growing season using the consecutive number of days where the water table was within 12 inches of the surface (Appendix C, Table 8). The maximum number of consecutive days were all in March and April, which is typical of this Site. It should be noted that, based on observation of well hydrographs during this time, EPR adjusted the sensor to ground measurements for BS2, BS3, and BS4 in the well spreadsheets (0.35 inches or less). These adjustments were undertaken to calibrate the well readings to onsite measurements of saturated/standing water conditions observed in the field. Potential reasons why well calibration was needed may include well subsidence and/or microtopographic variation introduced during construction. That is, the well may have been placed on slightly higher microtopographic relief than the average ground surface in the restored wetland area; therefore, while water in the wetland is reaching ground surface, the well may not be recording the reading accurately prior to calibration. The one well still not meeting hydroperiod was BS4, in the middle of Wetland B at the northern end of the easement. Per the IRT MY3 field visit, another well will be placed nearby before the growing season commences in MY4 to determine whether this outcome is an anomaly and to aid in credit release decisions.

Site Info (Year 3)		Growing Season Information (Year 3 - 2023)		
Site	Bear Swamp	Site	Bear Swamp	
Begin Date	1/1/2023	Gauge ID	BS4 - Groundwater	
End Date	12/31/2023	Serial #	20452199	
Total Days of Well Data	728	Growing Season Start Date	3/1/2023	
-Rainfall data from HOBO Tipping Bucket Rain Gauge located at the Bear Swamp Stream and Wetland Mitigation Project *Percentile lines in reference to WETS historic monthly rainfall data		Growing Season End Date	11/14/2023	
		Total Growing Season Days	258	
		NRCS Soil Series	Bibb	
		Success Criteria		
		12.0%	Growing Season (Days)	31
		Most Consecutive Successful Days Within Growing Season	26	
		Percent of Growing Season with Consecutive Successful Days	10.1%	
		Average Water Level Elevation During Growing Season (ft)	159.54	
		Total Cumulative Successful Days Within Growing Season	86

- **An additional gage will be installed near BS4 prior to the growing season in MY4. This request has been added to the report in Section 2.3.**
- ***Appendix C, Figure 3*** – *Please update rainfall data to include monthly rainfall through December 2023.*

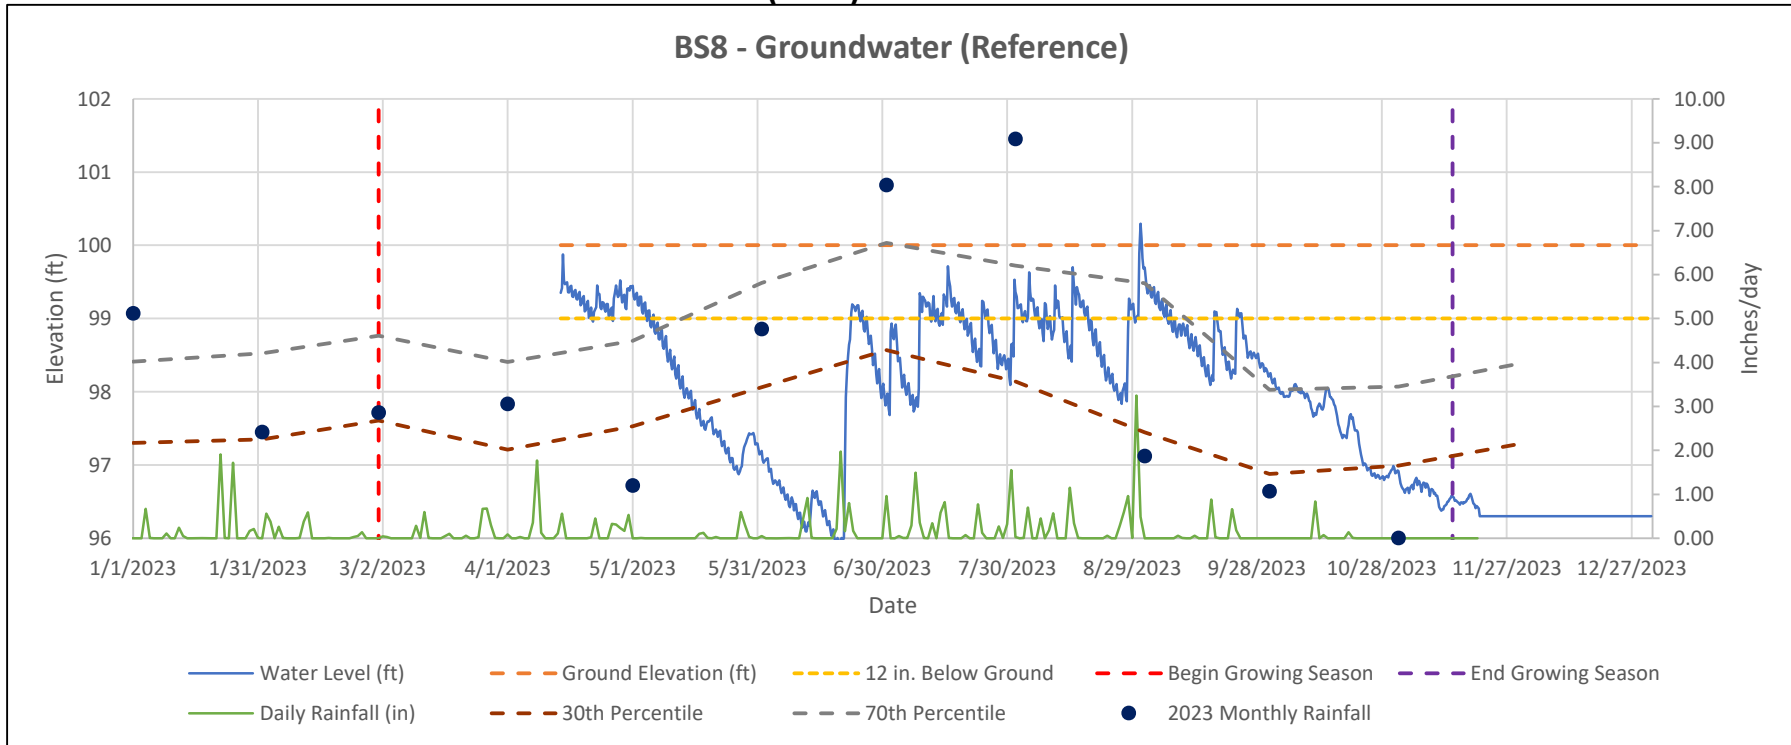
BS8 - Groundwater (Reference)

An additional reference well (BS8) was installed as a 'drier' reference comparison at the edge of the existing wetland in February 2023. Due to logger error, no data was collected between installation and April 13, missing the first 44 days of the growing season. Based on data collected, this well had a 9% hydroperiod; however, given conditions during March and April, it likely would have had a higher consecutive day total if the logger error did not occur.

Site Info (Year 3)		Growing Season Information (Year 3 - 2023)	
Site	Bear Swamp	Site	Bear Swamp
Begin Date	4/13/2023	Gauge ID	BS8 - Groundwater
End Date	12/31/2023	Serial #	20331489
Total Days of Well Data	523	Growing Season Start Date	3/1/2023
		Growing Season End Date	11/14/2023
		Total Growing Season Days	258
		NRCS Soil Series	Norfolk Loamy Sand
		Success Criteria	
		12.0%	Growing Season (Days)
			31
			Most Consecutive Successful Days Within Growing Season
			22
			Percent of Growing Season with Consecutive Successful Days
			8.5%
			Average Water Level Elevation During Growing Season (ft)
			98.16
			Total Cumulative Successful Days Within Growing Season
			73

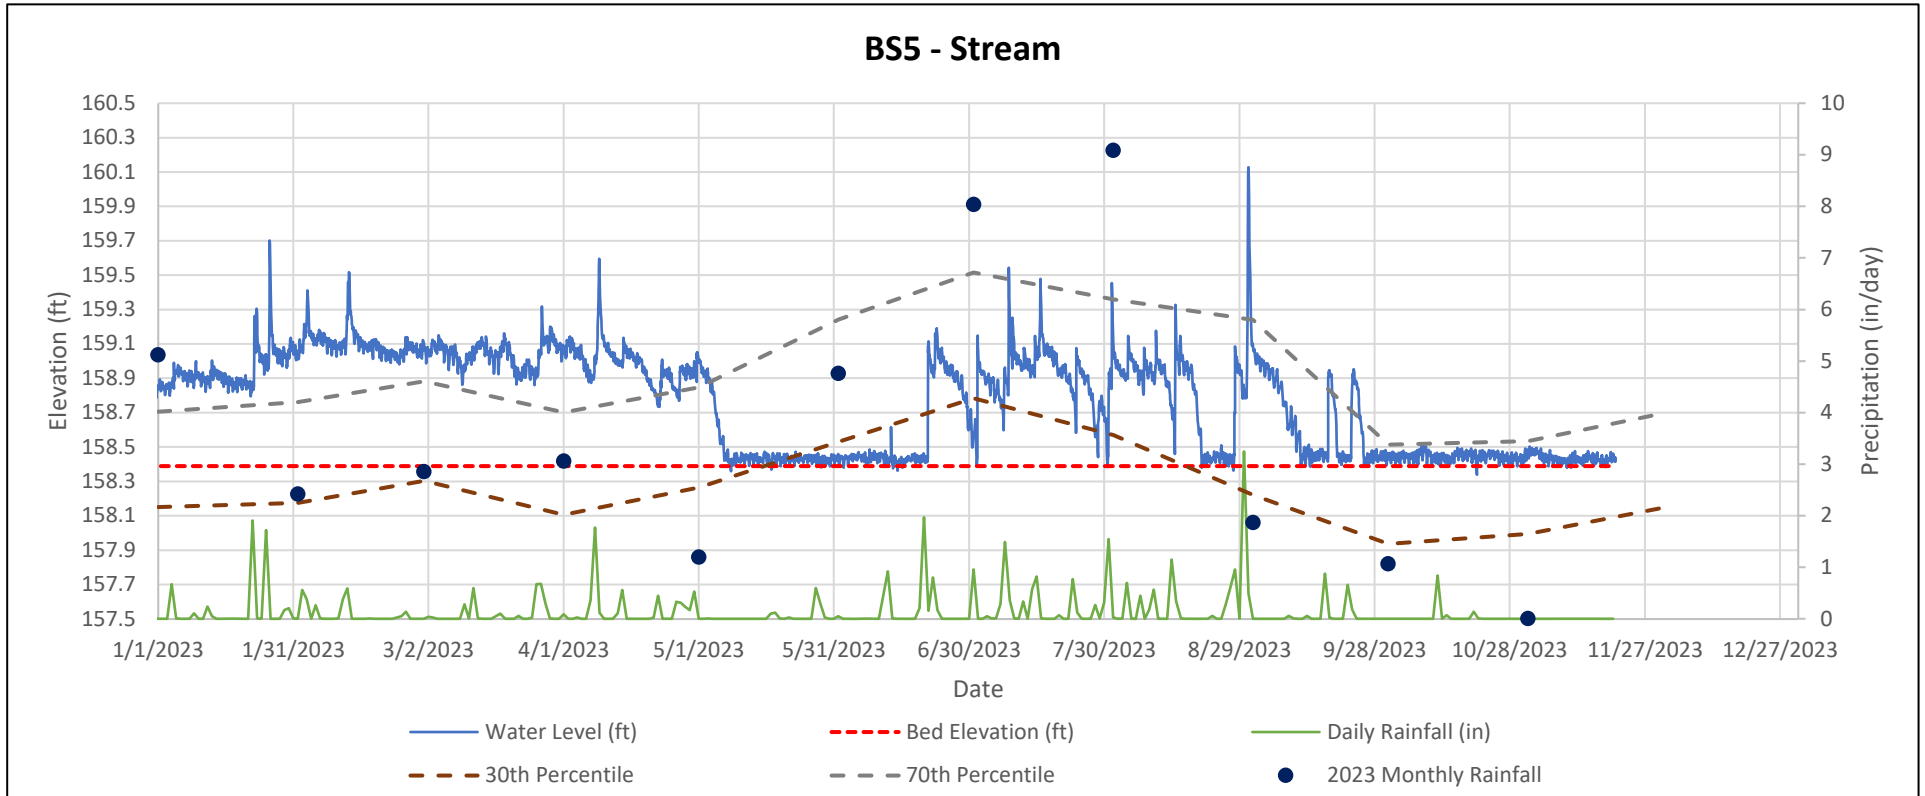
Bear Swamp Year 3 (2023) Streamflow Data

Site Info	
Stream	Bear Swamp
Reach	Bear Swamp
Date Installed	11/9/2020
Serial Number	20452196
Reach Type	Intermittent

-Rainfall data from HOBO Tipping Bucket Rain Gauge located at the Bear Swamp Stream and Wetland Mitigation Project

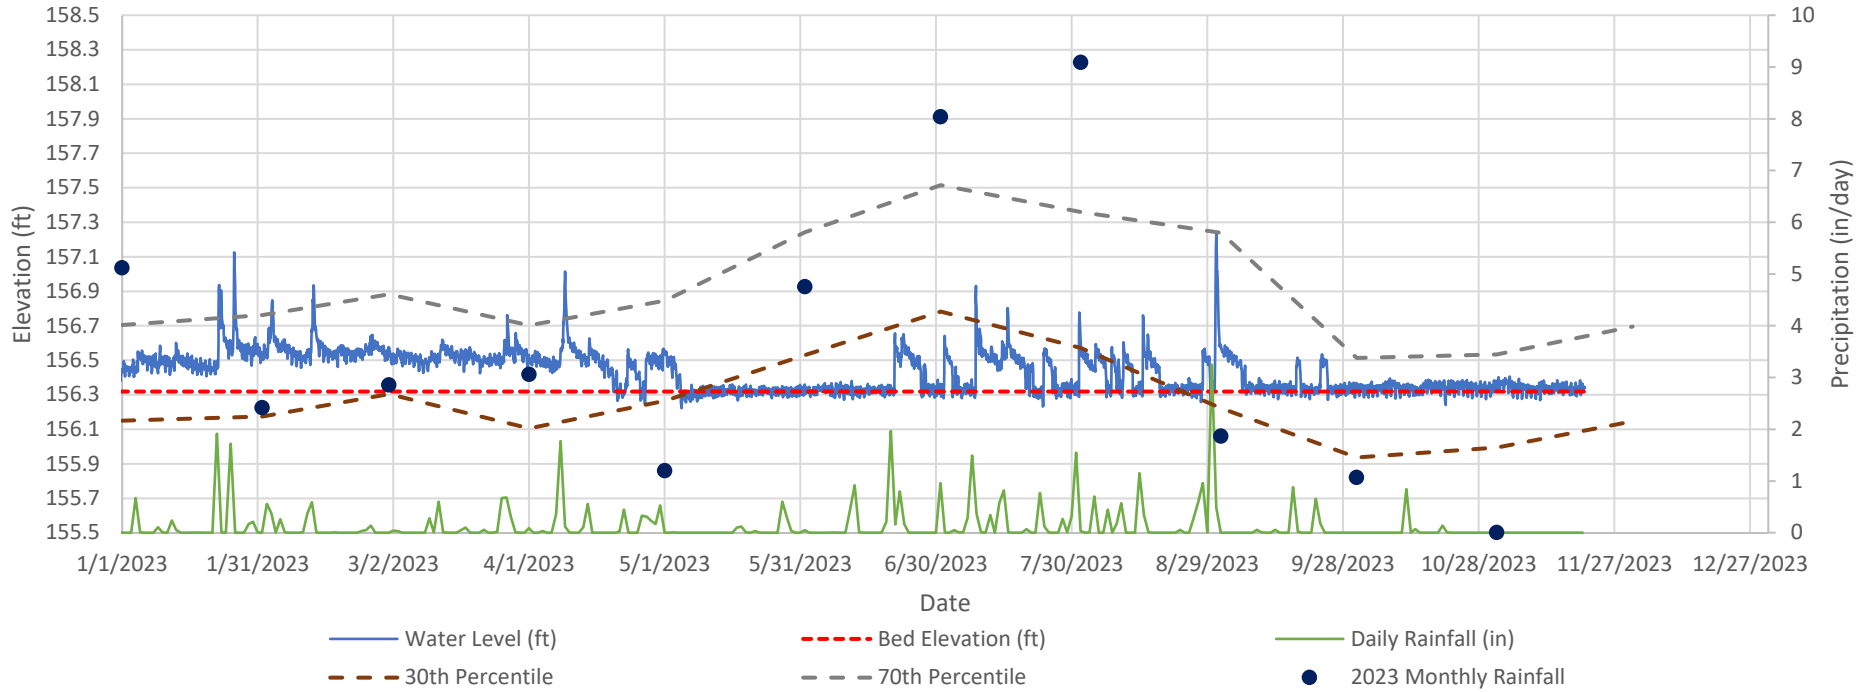
BS6 - Stream

Site Info	
Stream	Bear Swamp
Reach	0
Date Installed	11/9/2020
Serial Number	20452197
Reach Type	Intermittent

-Rainfall data from HOBO Tipping Bucket Rain Gauge located at the Bear Swamp Stream and Wetland Mitigation Project.
 -Percentile lines in reference to WETS historic monthly rainfall data for Lumberton, NC
