**BENSON GROVE MITIGATION SITE**  
**2005 Annual Monitoring Report (Year 4)**

Johnson County  
EEP Project No. 32  
Design Firm: Rummel, Klepper & Kahl, LLP

**February 2006**

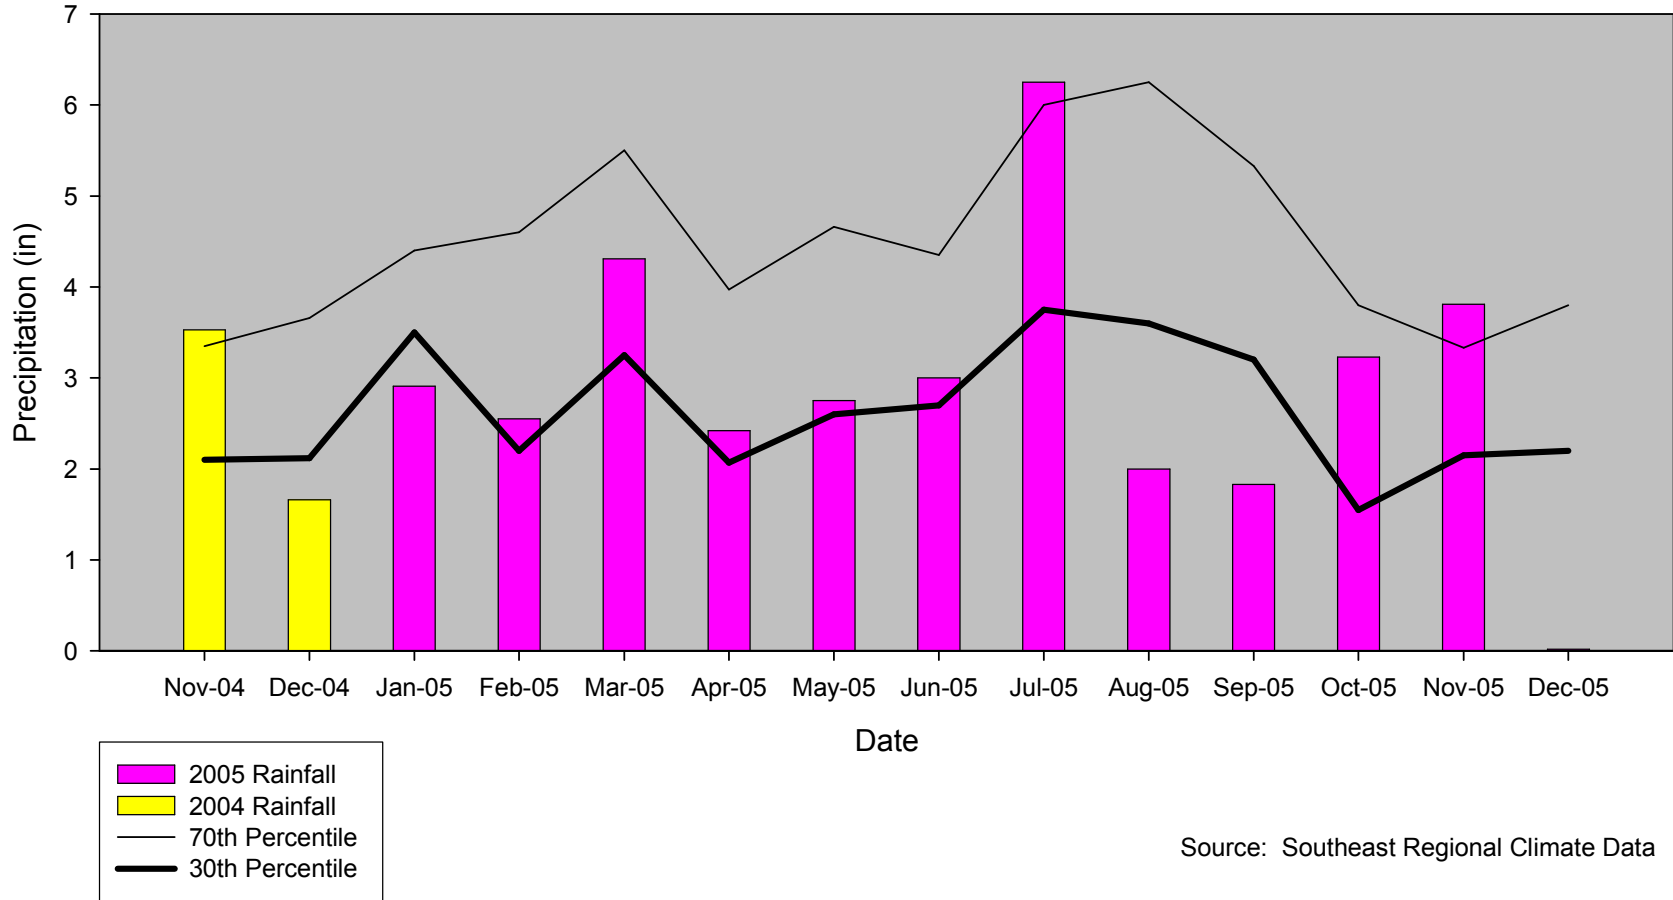
**Figure 3. Monthly Rainfall and 30-70 Percentile Graph for Smithfield, NC Benson Grove Mitigation Site**

Figure 3 provides an evaluation of the local climate in comparison with historical data in order to determine whether 2005 was a year with “average” rainfall. The bars are the monthly rainfall totals for the 2005 hydrologic year. Also represented are the 30<sup>th</sup> and 70<sup>th</sup> percentiles of monthly precipitation for Smithfield located approximately 10 miles east of the Site. The historical data and monthly data were collected from the Southeast Regional Climate Data.

Months with below average rainfall include: January, August, and September. The months of February, March, May, June, and November (in the latter part of November) experienced average rainfall. July received above average rainfall. Through the end of November, the region has experienced a rain deficit of approximately eight inches. A normal yearly rainfall in the area is approximately 47.3 inches.

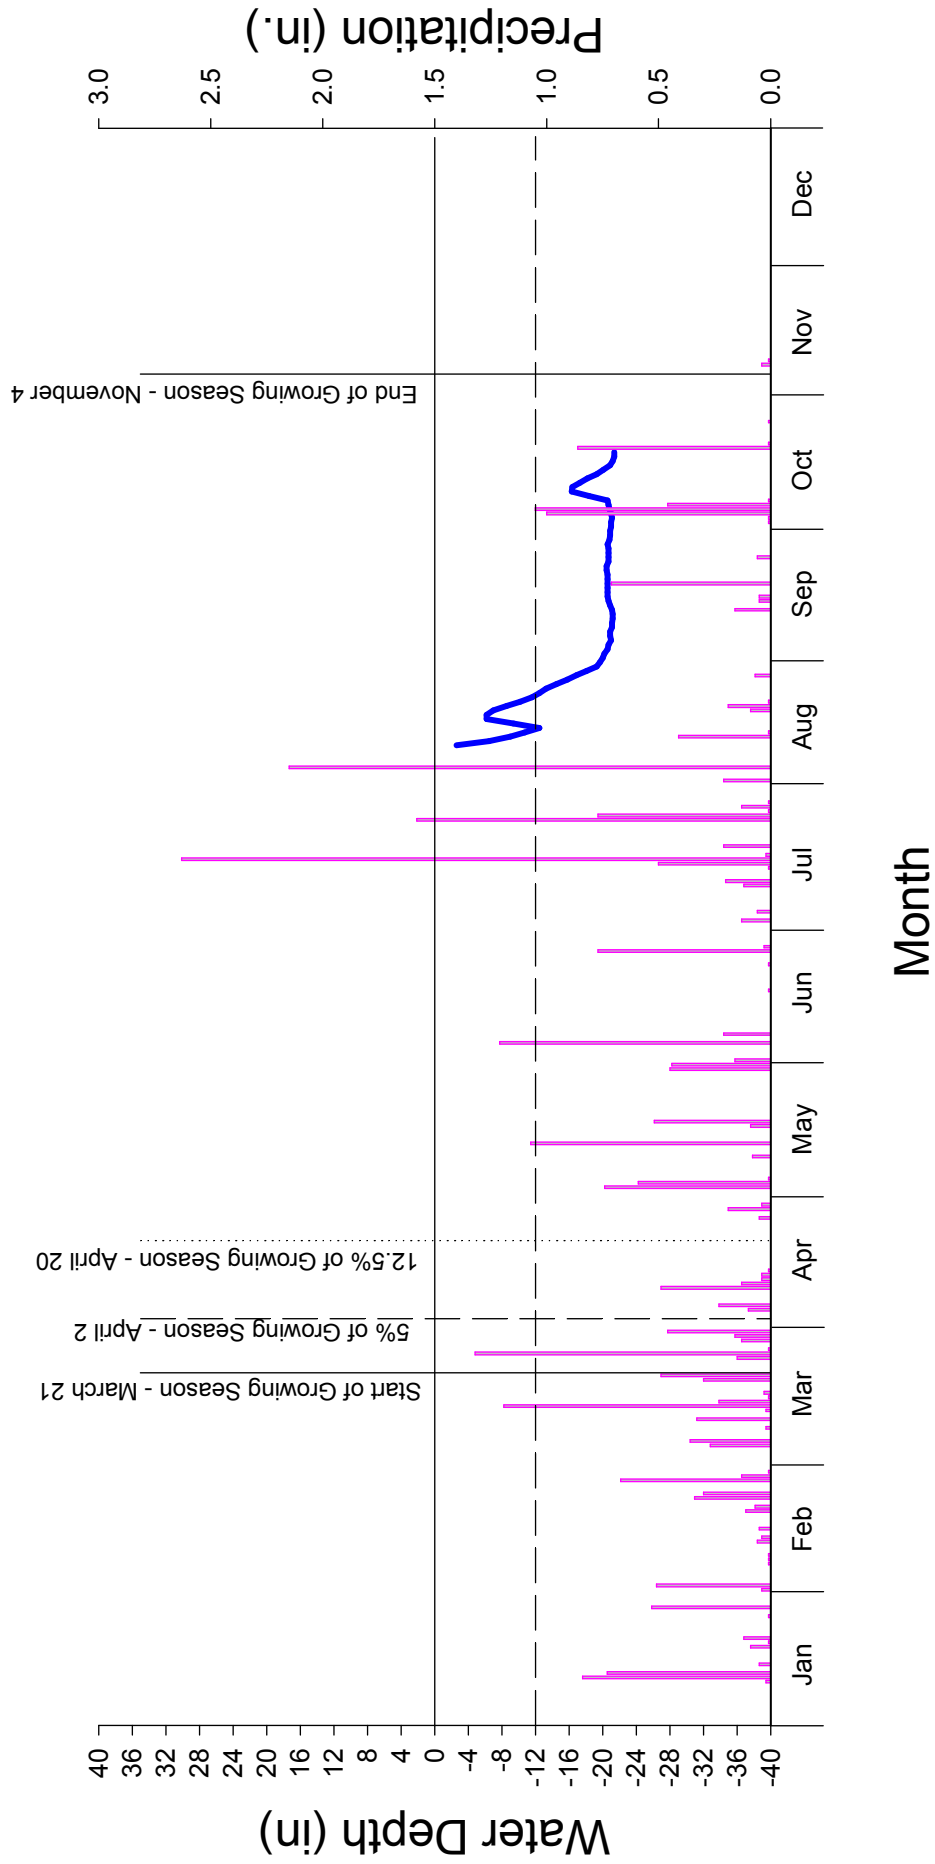
## Monitoring Gauge 1 - B6513E9

\*Gauge was found to be non-functioning during first site visit in July 2005. Gauge was replaced in August 2005.

Wells 1, 9, and 10 were not functional for a majority of the growing season. They were replaced with new gauges on August 11th, 2005. Well 11 was non-functional for the entire growing season and will be replaced prior to the 2006 growing season. All other groundwater gauges met the success criteria for 12.5% for the growing season.

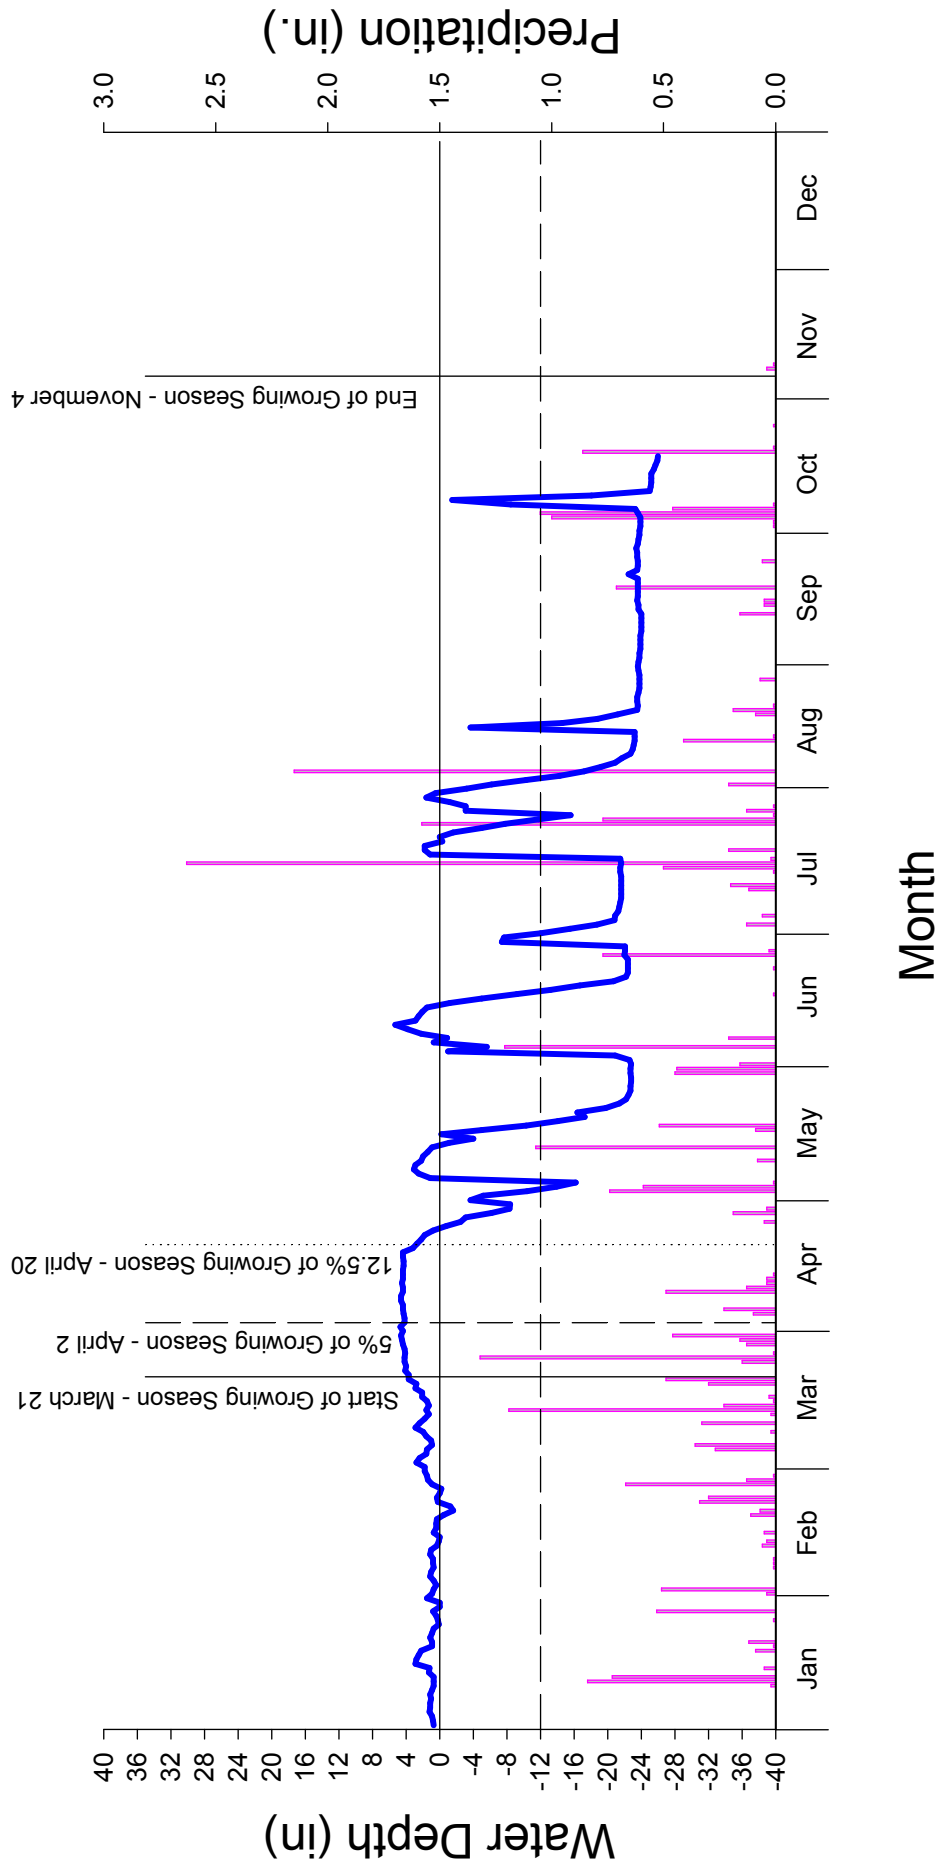
# Benson Grove 2005 Monitoring Gauge 2 - 9BEBE69

Appendix B contains the hydrographs for each monitoring gauge for the current monitoring year. The corresponding rain data collected from the on-site rain gauge is also provided on each hydrograph.

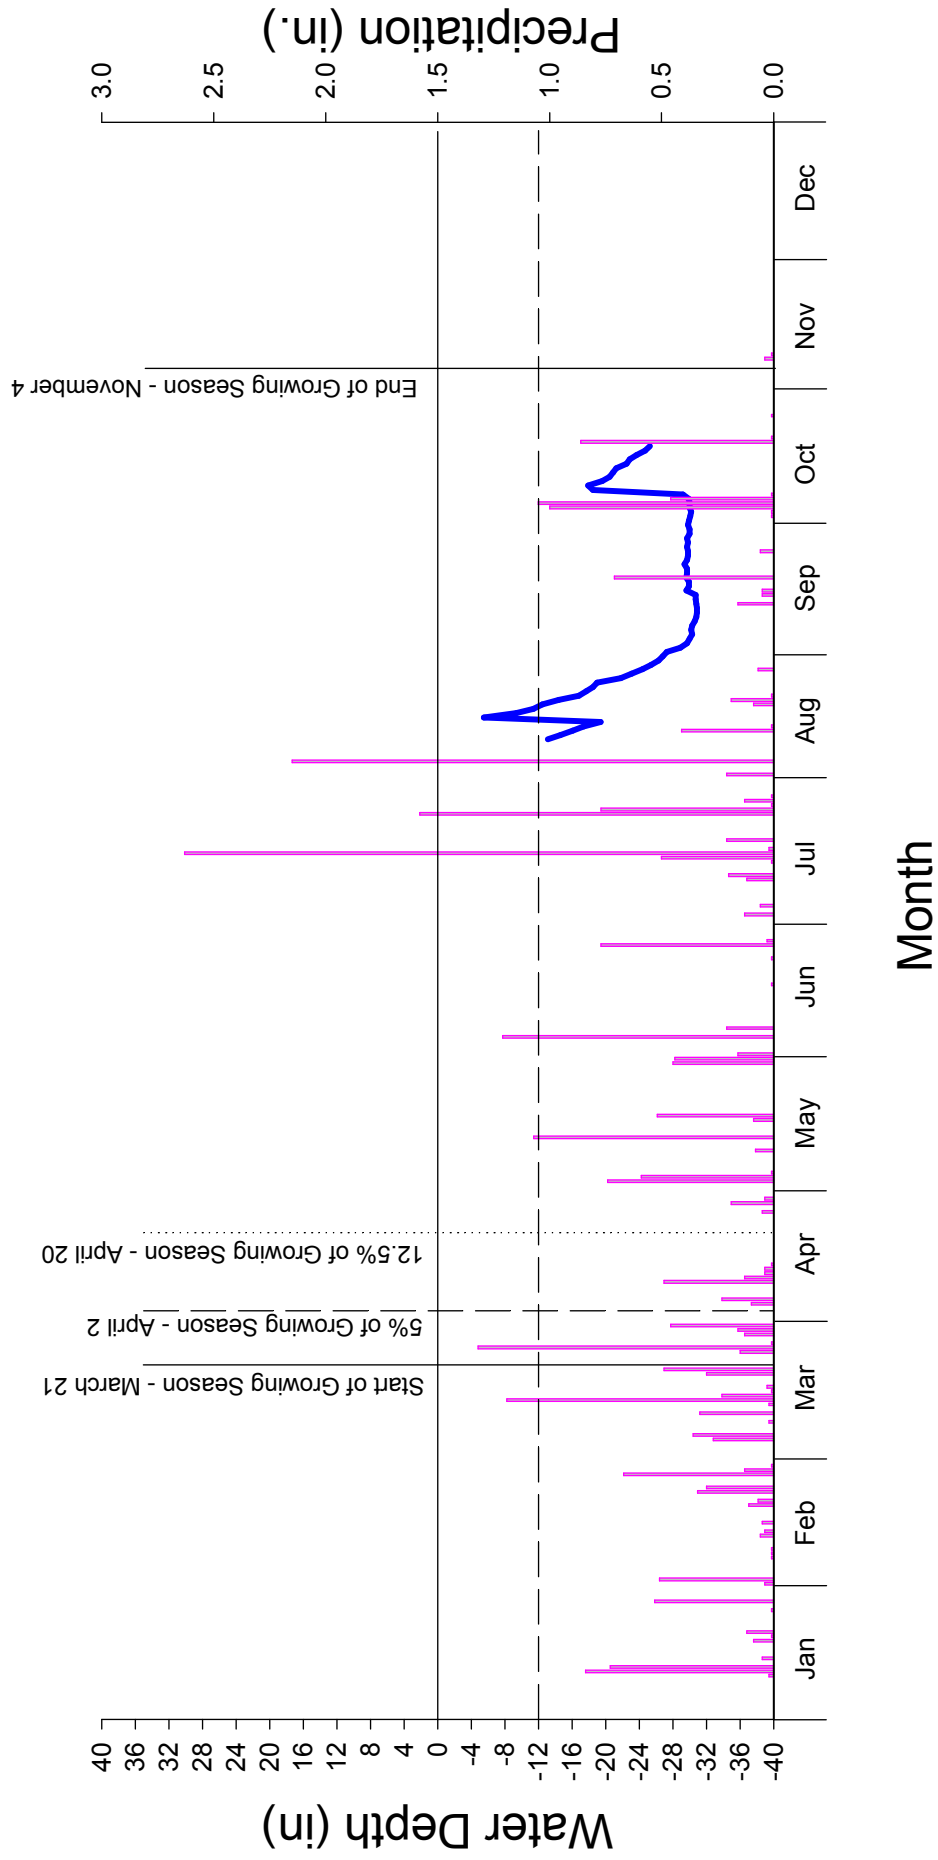
## Monitoring Gauge 9 - B6B8E7D

\*Gauge was found to be non-functioning during first site visit in July 2005. Gauge was replaced in August 2005.

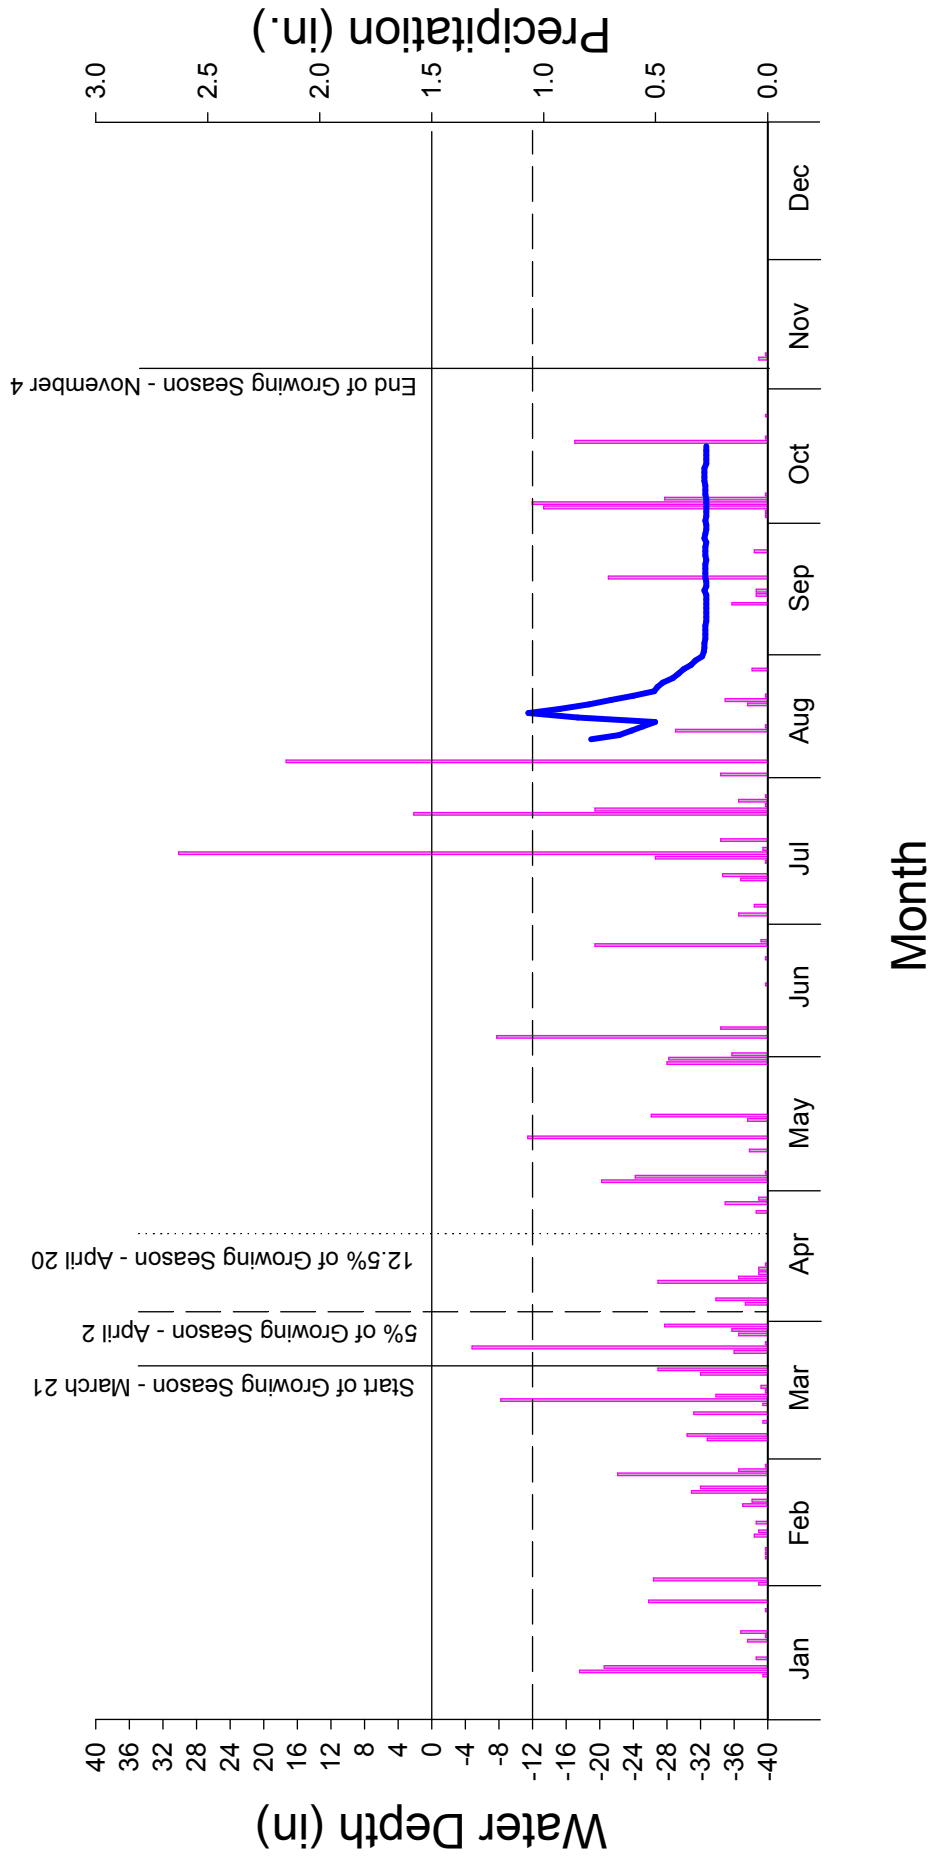
# Benson Grove 2005 Monitoring Gauge 10 - B6B4A4B

\*Gauge was found to be non-functioning during first site visit in July 2005. Gauge was replaced in August 2005.

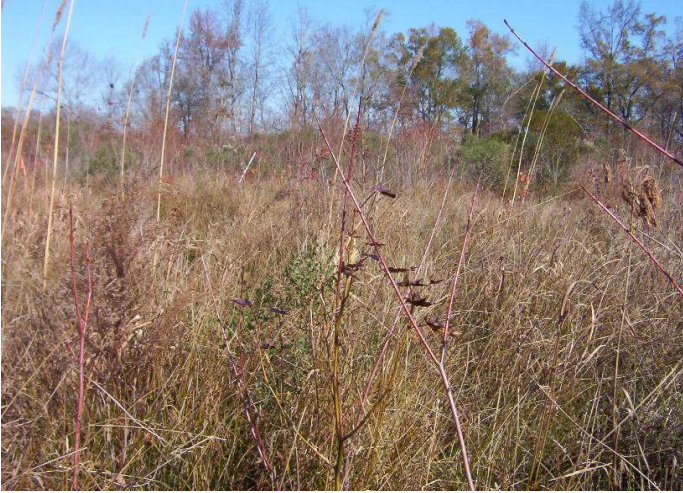
Plot 1

Nuisance trees such as red maple and sweetgum occur in significant amounts in some areas of the site, as seen in Plots 1, 2, 3, and 8. The increase in stem counts of these species is likely due to site characteristics and proximity to seed sources. However, these occurrences do not appear to have a direct effect on the survivability of planted species on the plots.

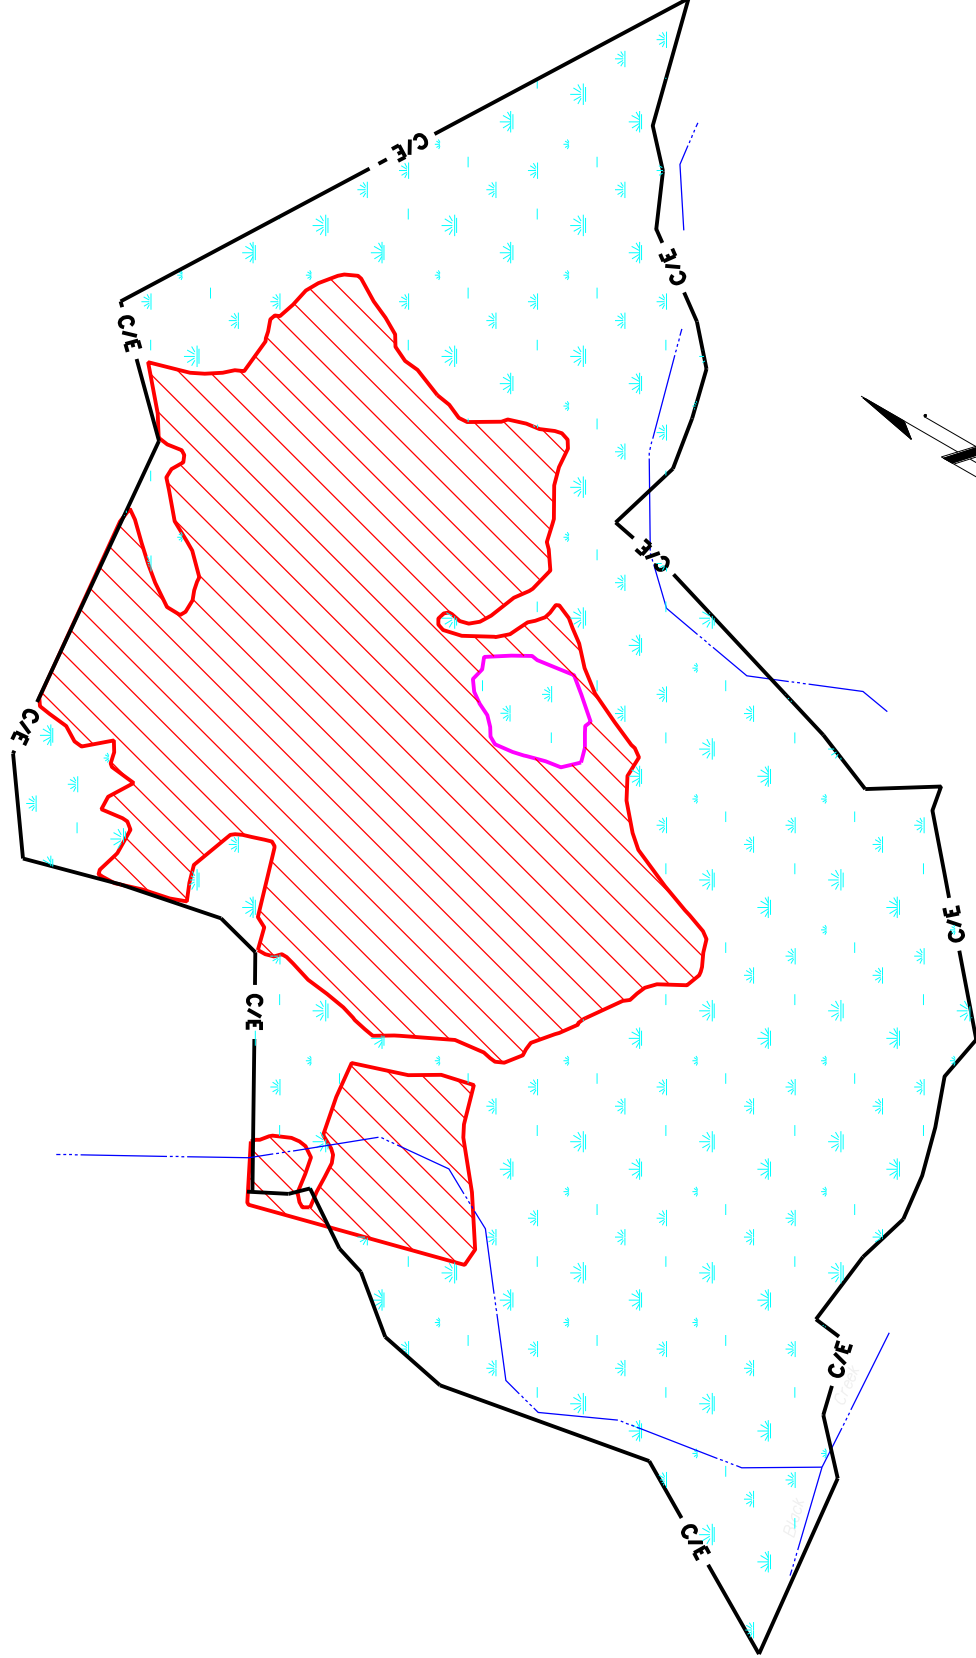
FIGURE **D**

WETLAND PRESERVATION	50.7 ± ac.
 	WETLAND RESTORATION	31.5 ± ac.
	Total	82.2 ± ac.

Client: **WETLAND RESTORATION AREA  
Benson Grove Mitigation Site**
