BENSON GROVE MITIGATION SITE

2006 Annual Monitoring Report (Year 5)

EEP Project No. 32

January 2007

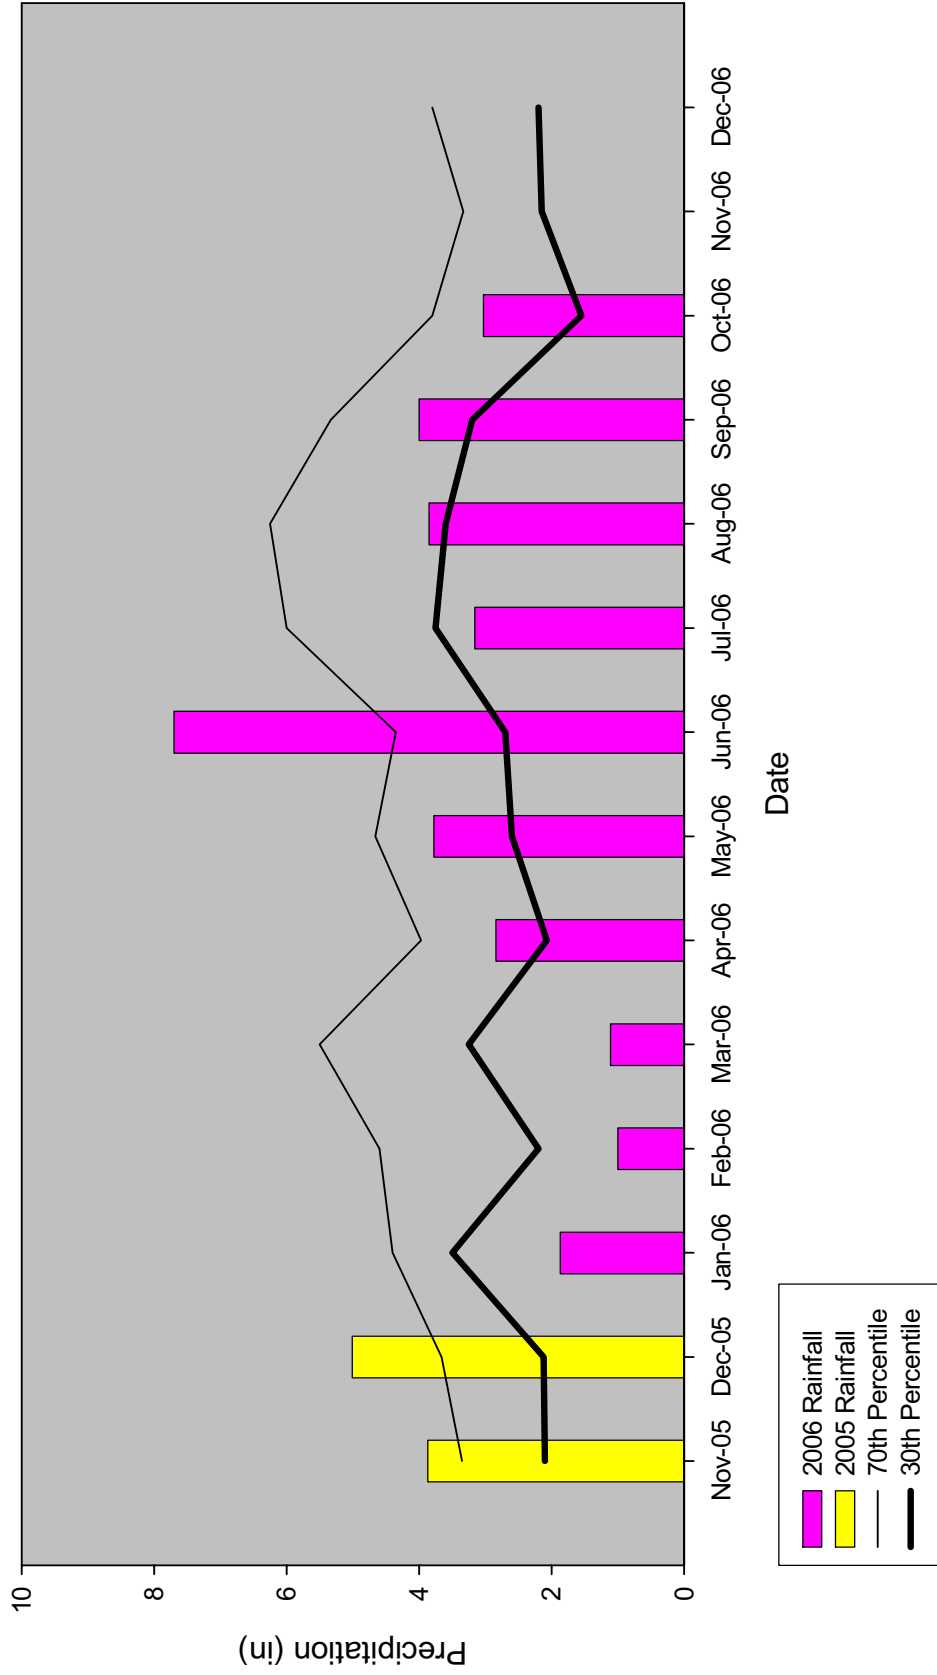
**Fig 3. Benson Grove 30-70 Percentile Graph 2006
Smithfield, NC**

Figure 3 provides an evaluation of the local climate in comparison with historical data in order to determine whether 2006 was a year with “average” rainfall. The bars are the monthly rainfall totals for the 2006 hydrologic year. Also represented are the 30th and 70th percentiles of monthly precipitation for Smithfield located approximately 10 miles east of the Site. The historical data and monthly data were collected from the Southeast Regional Climate Data.

Months with below average rainfall include: January, February, March, and July. The months of April, May, August, September, and October experienced average rainfall. June received above average rainfall. A normal yearly rainfall in the area is approximately 47.3 inches.

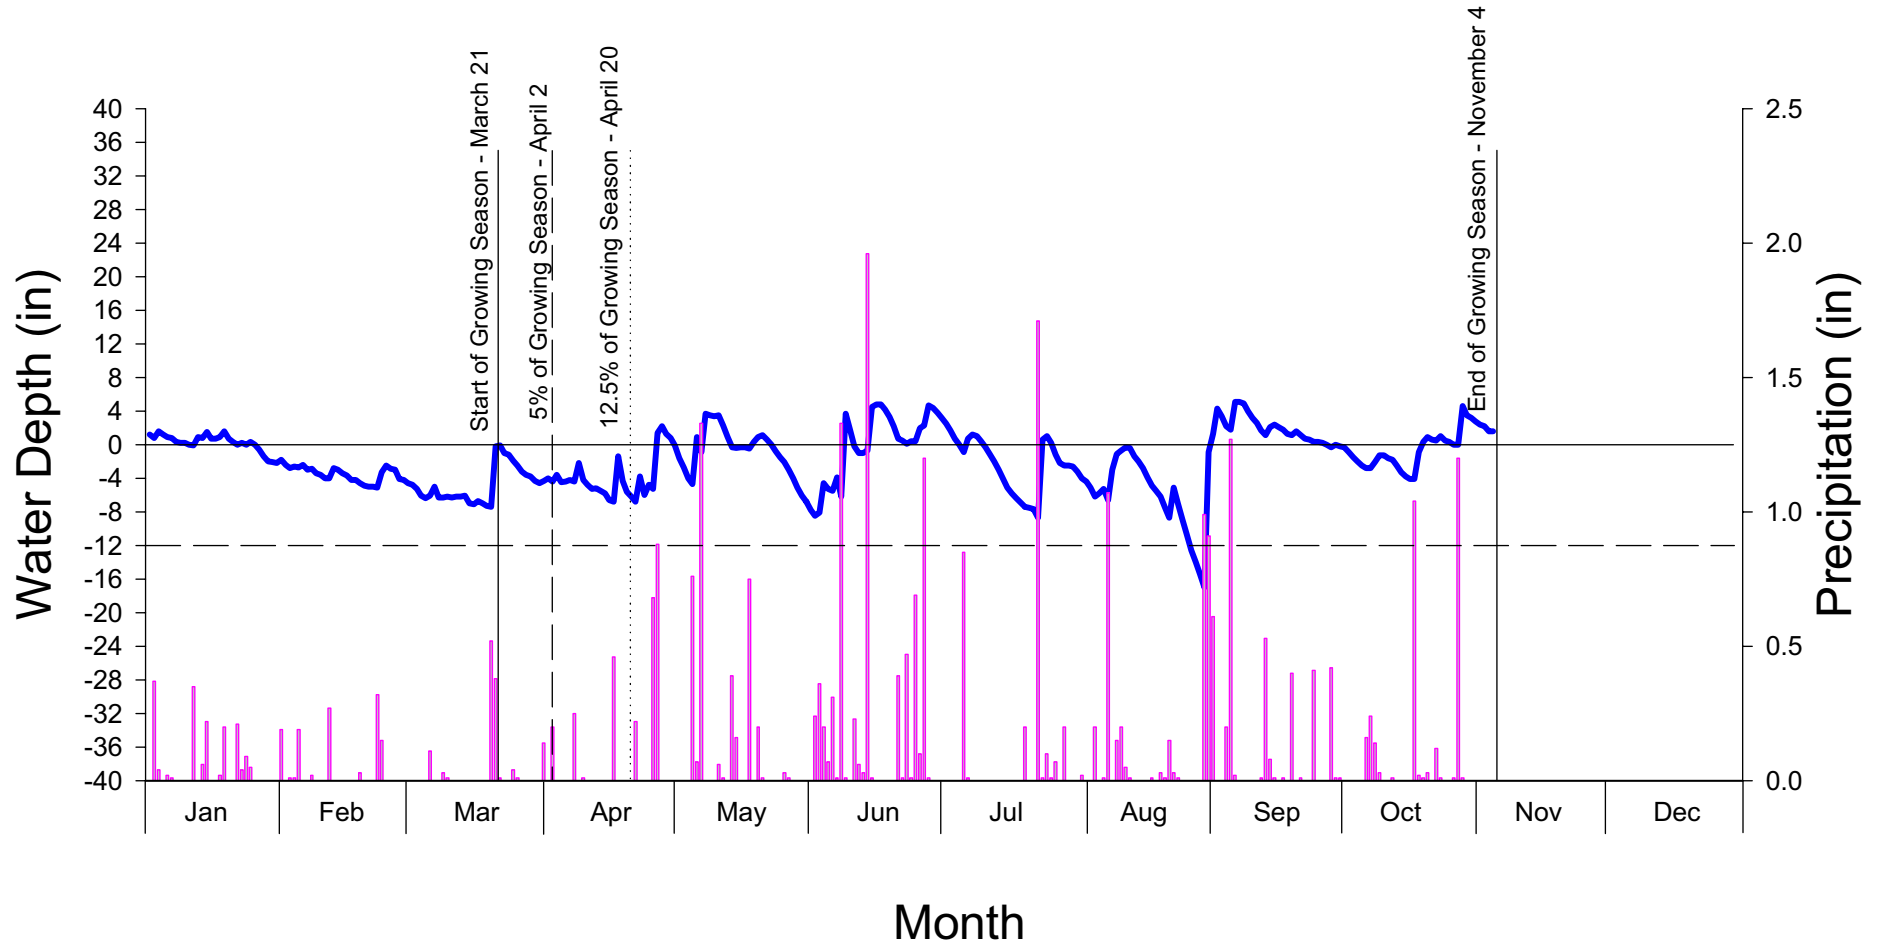
Benson Grove 2006 Monitoring Gauge 1 - B6513E9

Monitoring Gauge	<5%	5-12.5%	>12.5%	Actual %	Success Date
BGGW-1			✓	70	March 21 – August 26
BGGW-2			✓	18	June 4 – July 15
BGGW-3			✓	14	April 30 – June 1
BGGW-4			✓	15	March 21 – April 25
BGGW-5			✓	30	March 21 – May 30
BGGW-6			✓	30	March 21 – May 30
BGGW-7			✓	53	March 21 – July 19
BGGW-8			✓	30	March 21 – May 30
BGGW-9			✓	30	March 21 – May 31
BGGW-10			✓	18	April 18 – May 26
BGGW-11			✓	29	March 21 – May 27
