# Big Cedar Creek Stream Restoration Plan

## Stanly County, North Carolina

EEP Project Number D06054-D

Final Plans

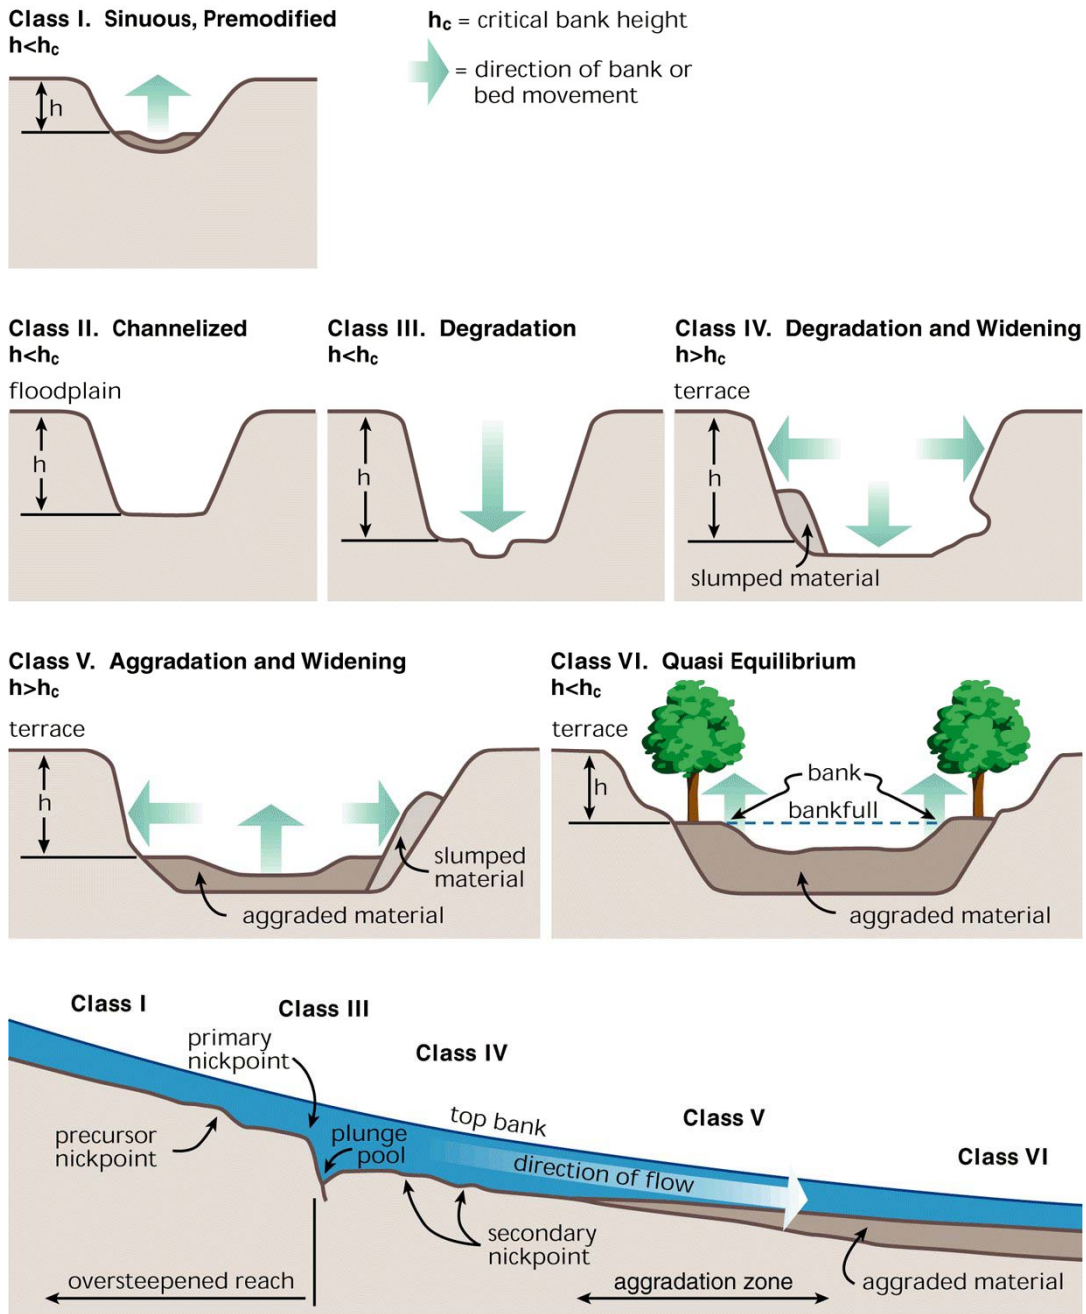
**Figure 3.3 Simon Channel Evolution Model**  
**Big Cedar Creek Stream Restoration Project**  
**Stanly County**  
**September 2007**  
**EEP Project # D06054-D**

Source: Simon, 1989; US Army Corps of Engineers, 1990.  
 Fig. 7.14 -- Channel evolution model.  
 In Stream Corridor Restoration: Principles, Processes, and Practices, 10/98.  
 Interagency Stream Restoration Working Group (FISRWG)(15 Federal agencies of the US).

A common sequence of physical adjustments has been observed in many streams following disturbance. This adjustment process is often referred to as channel evolution. Disturbance can result from channelization, increase in runoff due to build-out in the watershed, removal of streamside vegetation, and other changes that negatively affect stream stability. All of these disturbances occur in both urban and rural environments. Several models have been used to describe this process of physical adjustment for a stream. The Simon (1989) Channel Evolution Model characterizes evolution in six steps, including:

1. Sinuous, pre-modified
2. Channelized
3. Degradation
4. Degradation and widening
5. Aggradation and widening
6. Quasi-equilibrium.

The channel evolution process is initiated once a stable, well-vegetated stream that interacts frequently with its floodplain is disturbed. Disturbance commonly results in an increase in stream power that causes degradation, often referred to as channel incision (Lane, 1955). Incision eventually leads to over-steepening of the banks, and when critical bank heights are exceeded, the banks begin to fail, and mass wasting of soil and rock leads to channel widening. Incision and widening continue moving upstream in the form of a head-cut. Eventually the mass wasting slows, and the stream begins to aggrade. A new, low-flow channel begins to form in the sediment deposits. By the end of the evolutionary process, a stable stream with dimension, pattern, and profile similar to those of undisturbed channels forms in the deposited alluvium. The new channel is at a lower elevation than its original form, with a new floodplain constructed of alluvial material (FISRWG, 1998).

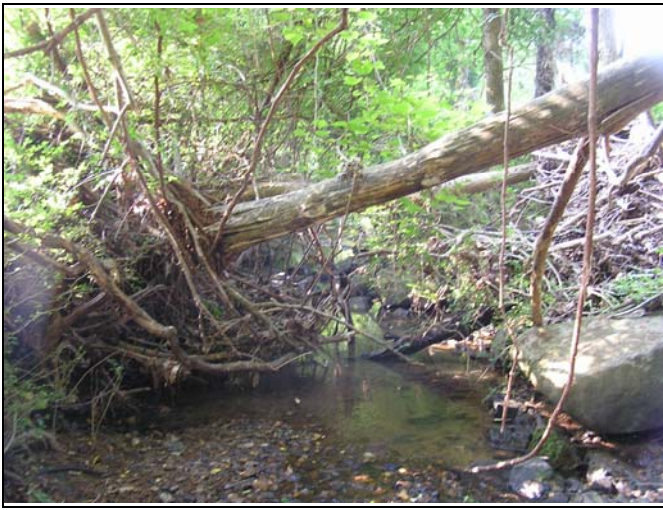
Big Cedar Creek – near top of project. High shear stress forces cause bank instability, resulting in loss of bank vegetation.

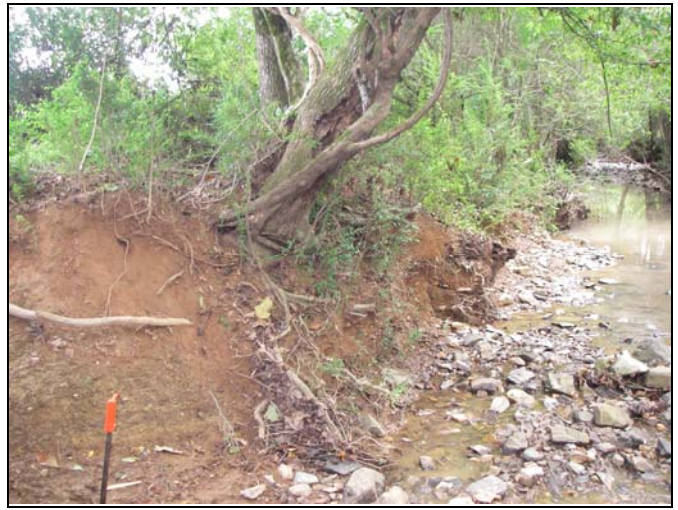
Big Cedar Creek – near center of project. High erodibility and lack of surface protection results in shear, unstable banks.

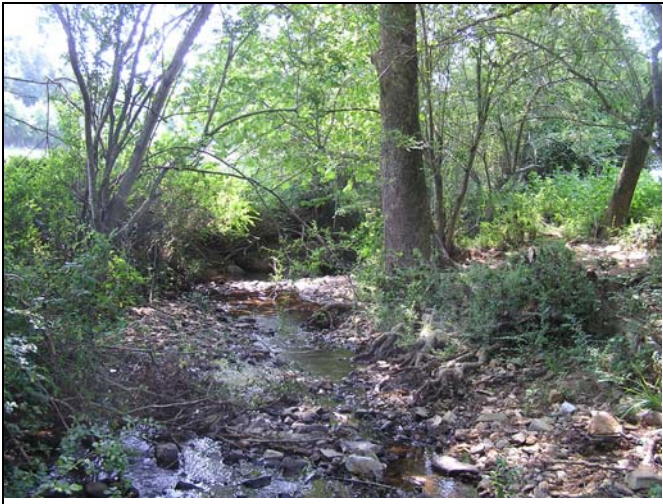
Big Cedar Creek – cattle access point. Continuous bed and bank disturbance causes fine sediments to enter the channel. Note invasive vegetation on right bank.

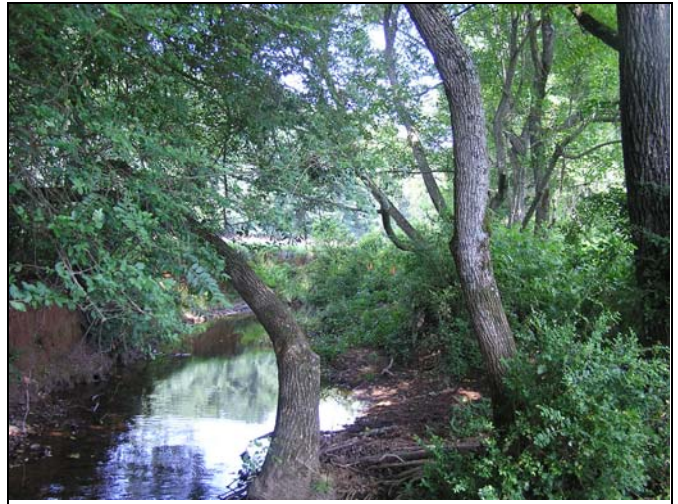
Big Cedar Creek – near center of project. High near bank stress results in shear, unstable left bank.

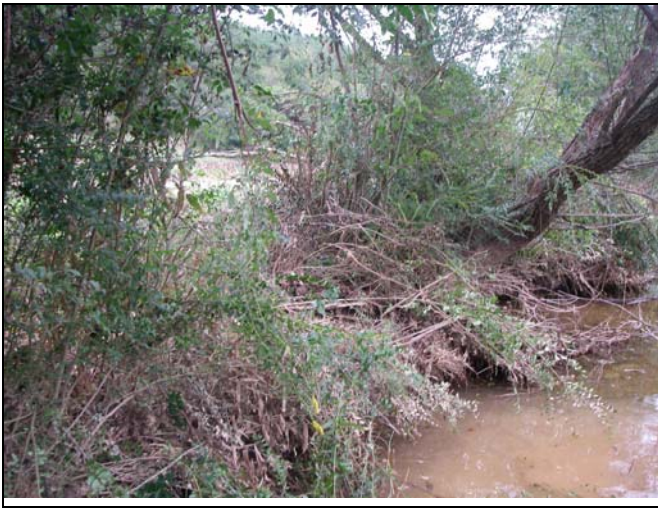
UT1. High shear stress forces cause bank instability, resulting in loss of bank vegetation.

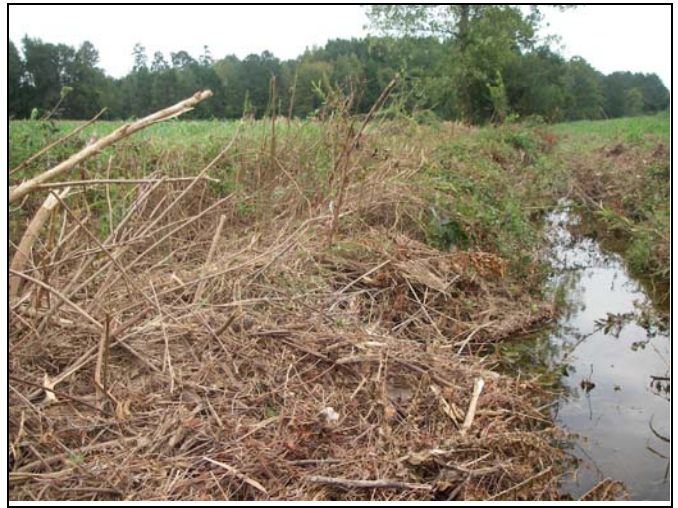
UT1 - typical. Historic agricultural manipulation resulted in a straight channel lacking bedform diversity. Agricultural activities today come within feet of the channel.

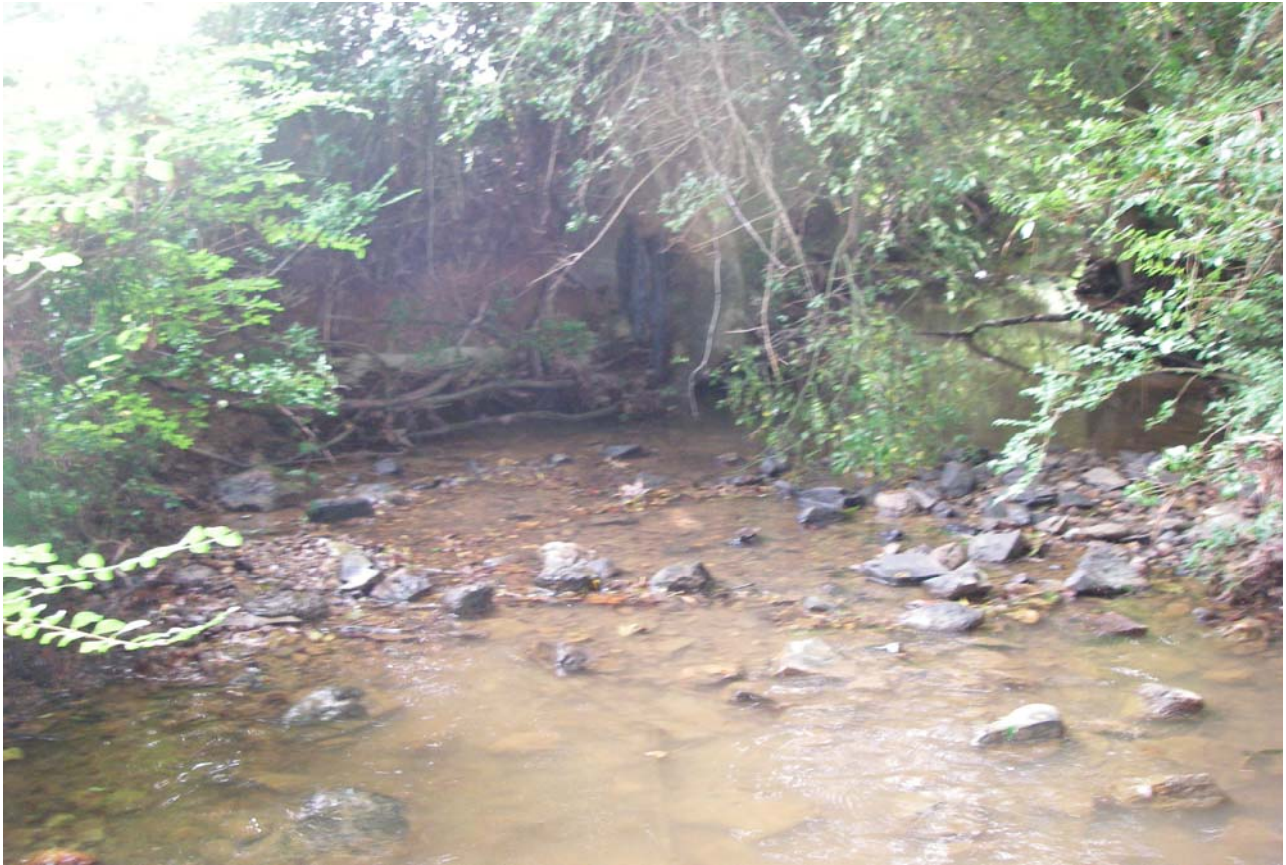
### Cross-section Data: BCC Reach 1 X1

Feature	Stream Type	BKF Area	BKF Width	BKF Depth	Max BKF Depth	W/D	BH Ratio	ER	BKF Elev	TOB Elev
Riffle	E4/1	36.7	16.3	2.3	2.8	7.1	1.8	>7.8	240.6	242.7

The head of Reach 1 is defined by a wood line and marks the upstream extent of the project area. Reach 1 ends approximately 60 LF below the confluence of Big Cedar Creek and UT2. Reach 1 is horizontally confined, and its bank height ratio of 1.8 indicates that the reach does not have access to a floodplain at the bankfull stage. Existing conditions sediment competence analyses confirmed high shear stresses. Further detail on these analyses is given in Section 6.4. The reach has a low width to depth ratio of 7.1 and an overall channel slope of 0.008 ft/ft. As a result of the low width to depth ratio, no depositional areas, such as point bars, lateral bars, or side bars are present throughout this reach.

Bedform diversity ranges from sorted gravels and cobbles in riffles to finer particles in pools. Bedrock was most frequently observed in the pools and controls the maximum pool depth. The reach is classified as an E4/1 to indicate that while the d50 particle size corresponds to the gravel classification (4), the reach exhibits bedrock control (1).

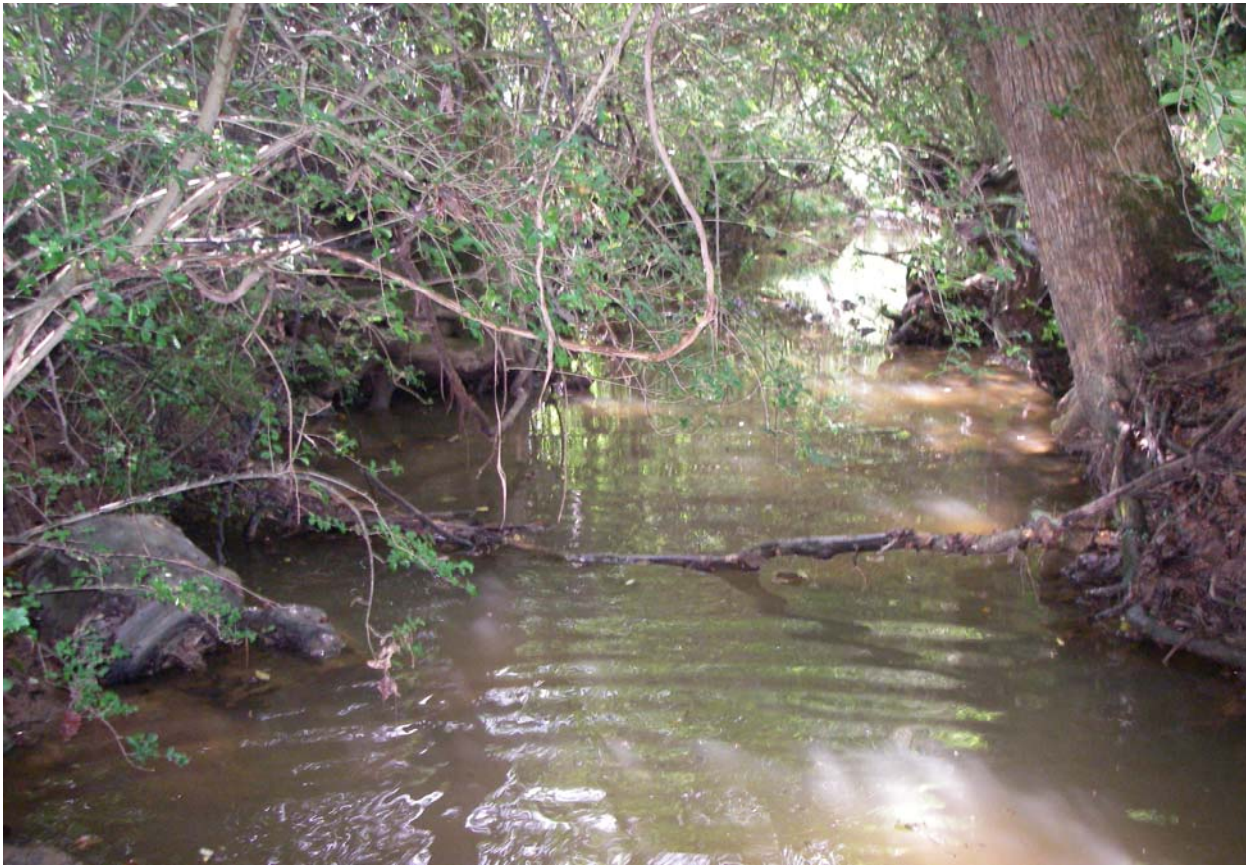
### Cross-section Data: BCC Reach 1 X2

Feature	Stream Type	BKF Area	BKF Width	BKF Depth	Max BKF Depth	W/D	BH Ratio	ER	BKF Elev	TOB Elev
Pool		43.0	13.5	3.2	3.8	4.2	1.3		240.6	241.9

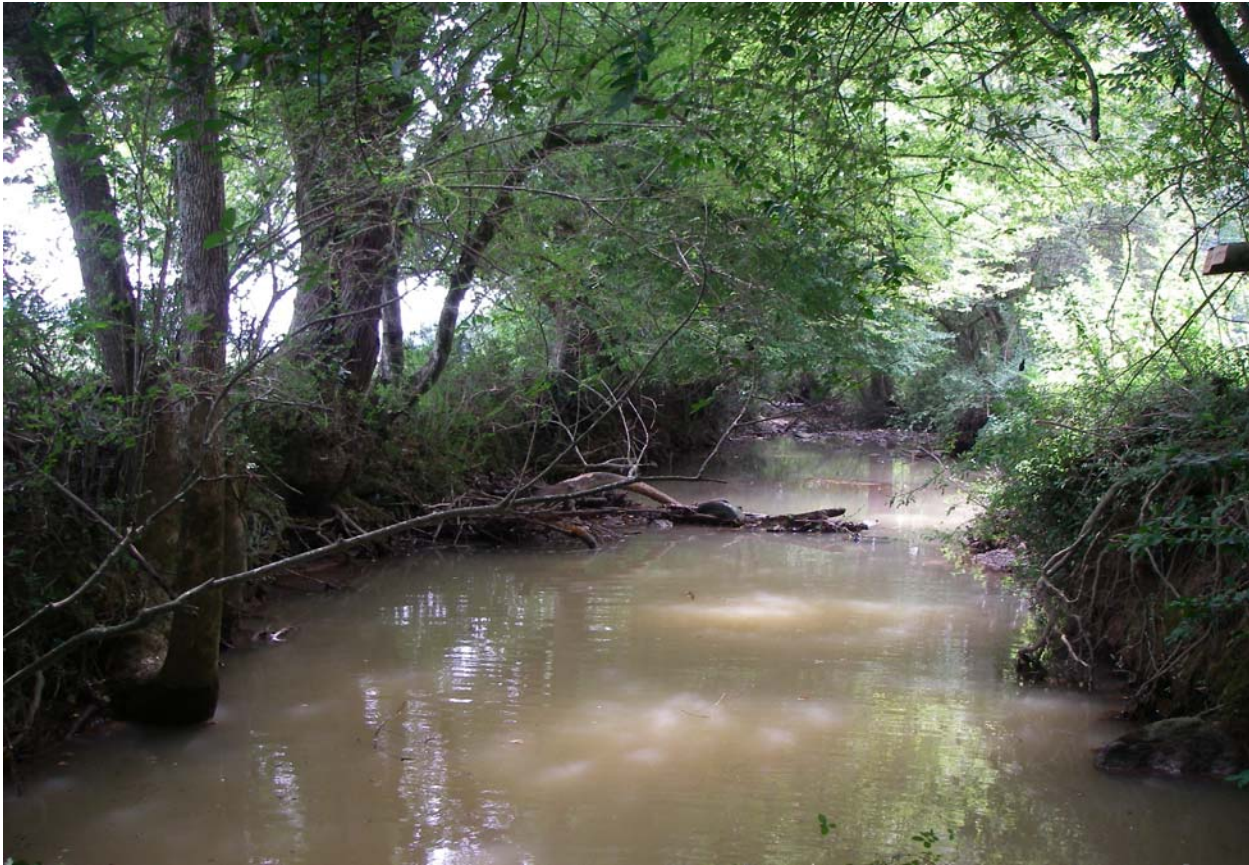
### Cross-section Data: BCC Reach 2 X3

Feature	Stream Type	BKF Area	BKF Width	BKF Depth	Max BKF Depth	W/D	BH Ratio	ER	BKF Elev	TOB Elev
Pool		63.2	19.9	3.2	4.2	6.2	1.5		235.8	238.0

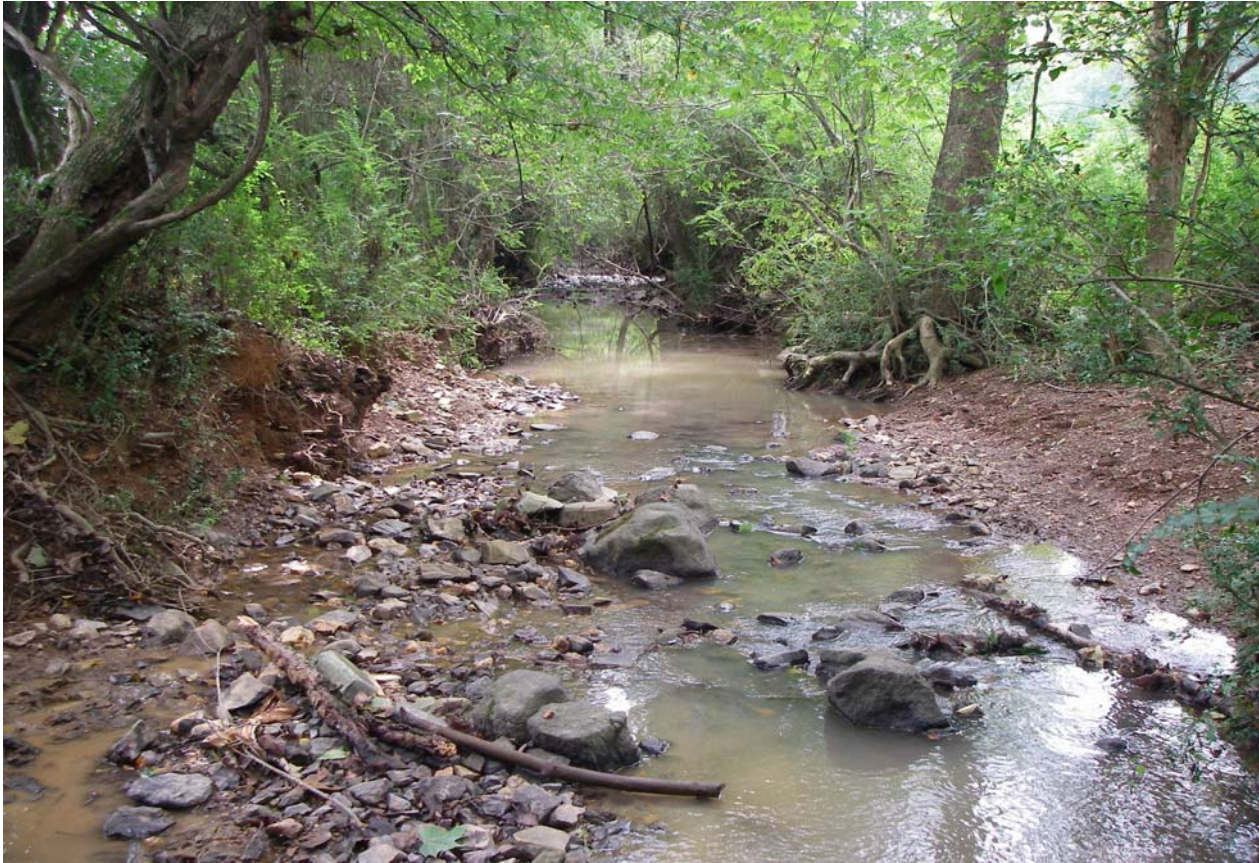
### Cross-section Data: BCC Reach 2 X4

Feature	Stream Type	BKF Area	BKF Width	BKF Depth	Max BKF Depth	W/D	BH Ratio	ER	BKF Elev	TOB Elev
Riffle	B4/1c	39.7	22.0	1.8	2.6	12.2	1.9	1.5	234.6	236.9

Bedform diversity ranges from well sorted gravels and cobbles in riffles to finer particles in pools. Bedrock was observed in pools and controls the maximum pool depth. The reach is classified as a Rosgen B4/1c channel due to the presence of both gravel and bedrock.

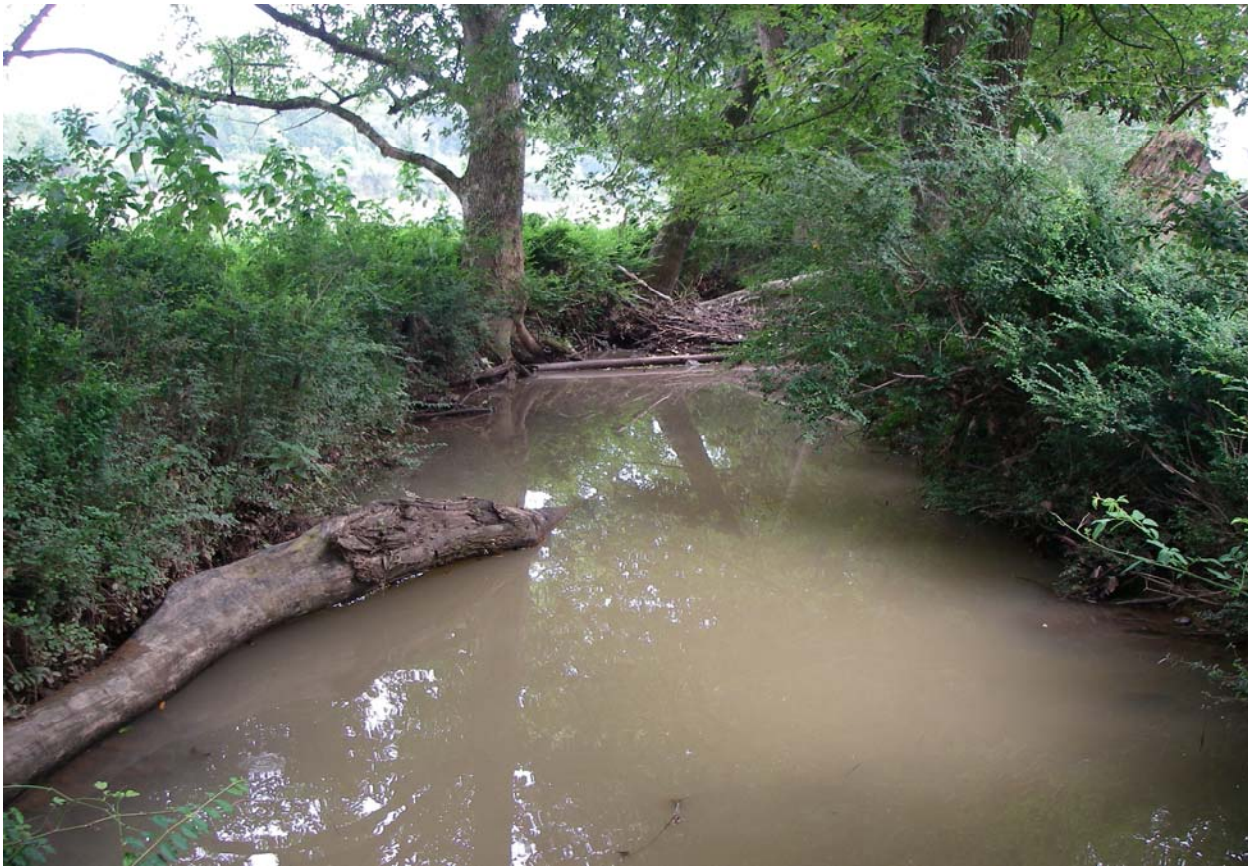
### Cross-section Data: BCC Reach 3 X5

Feature	Stream Type	BKF Area	BKF Width	BKF Depth	Max BKF Depth	W/D	BH Ratio	ER	BKF Elev	TOB Elev
Pool		47.6	20.4	2.3	3.3	8.9	1.4		229.0	230.2

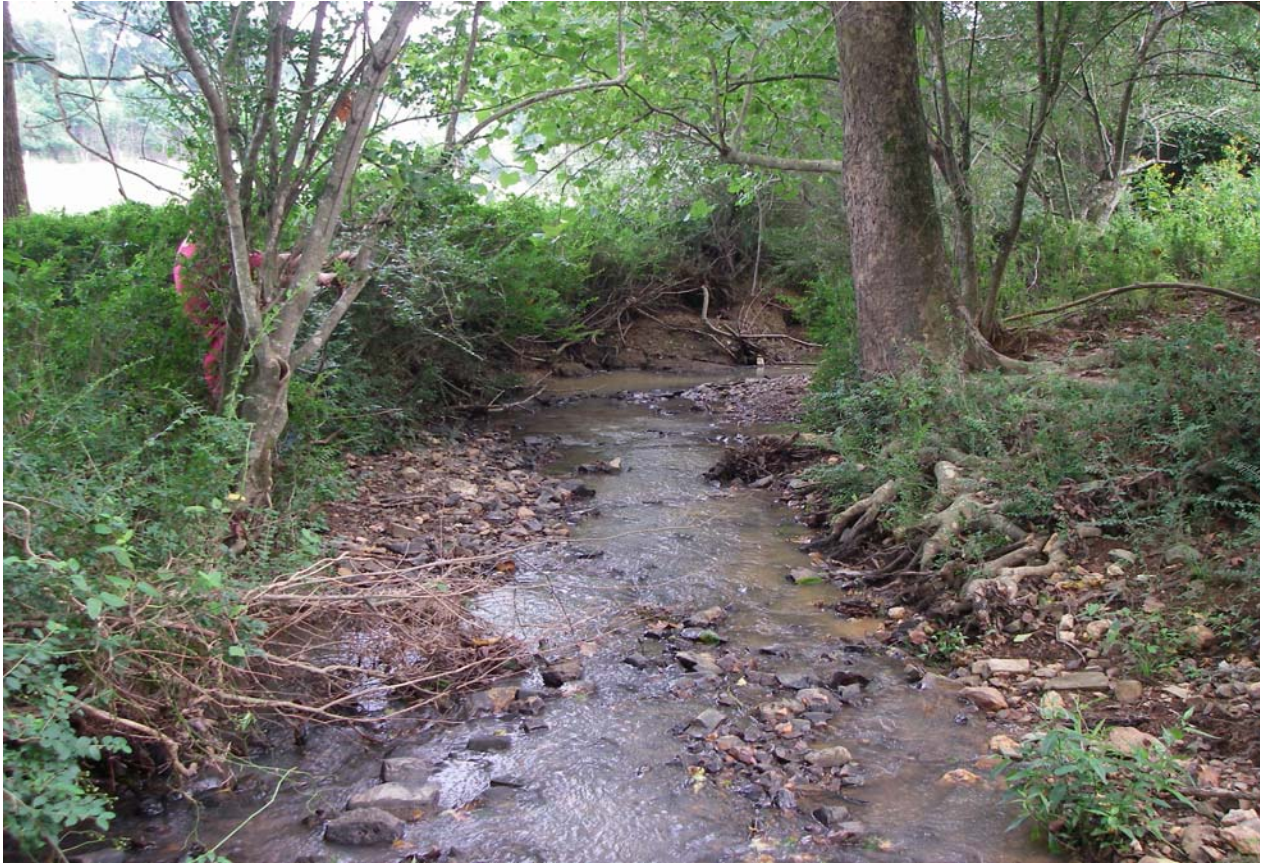
### Cross-section Data: BCC Reach 3 X6

Feature	Stream Type	BKF Area	BKF Width	BKF Depth	Max BKF Depth	W/D	BH Ratio	ER	BKF Elev	TOB Elev
Riffle	C4/1	32.8	19.5	1.7	2.7	11.5	1.6	>5.7	226.7	228.3

Reach 3 extends 2,046 LF downstream of Reach 2 and is defined by a decrease in channel slope. The overall channel slope for this reach is 0.0045 ft/ft. The channel has an entrenchment ratio of  $>5.7$  and a width to depth ratio of 11.5. However, the reach is moderately incised as indicated by a bank height ratio of 1.6. Reach 3 exhibits well sorted gravel and cobble riffles. Point bars and lateral bars are observed throughout this reach. A bedrock riffle 100 LF in length is located at the base of Reach 3. This feature acts as grade control for the entire reach. This reach is classified as a C4/1, although sinuosity is much lower than expected for a C channel due to past channelization. If left alone, this channel would continue to laterally erode to increase sinuosity. A small ephemeral tributary joins Big Cedar on the left bank approximately two thirds of the way down the reach. This area

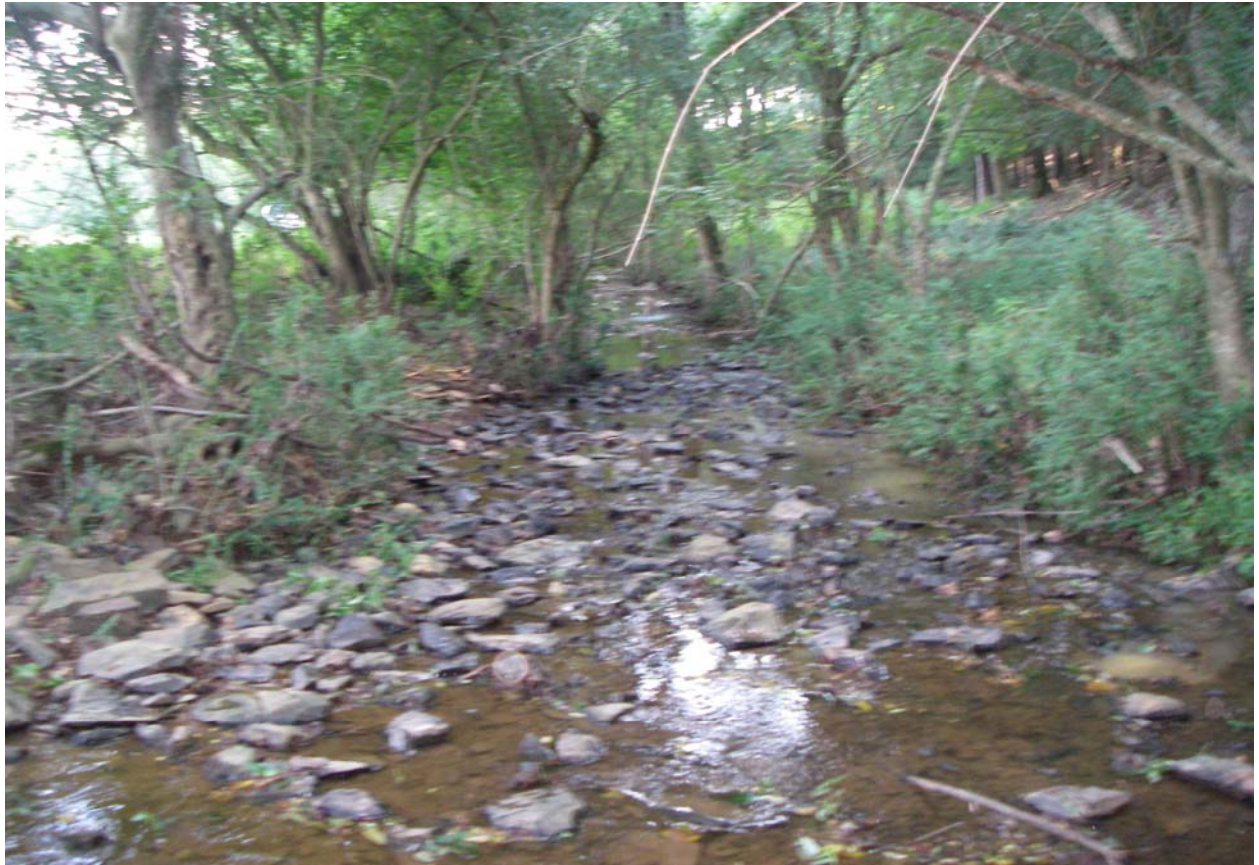
### Cross-section Data: BCC Reach 4 X7

Feature	Stream Type	BKF Area	BKF Width	BKF Depth	Max BKF Depth	W/D	BH Ratio	ER	BKF Elev	TOB Elev
Riffle	C4/1	47.1	29.6	1.6	2.3	18.5	1.6	>3.7	220.0	221.5

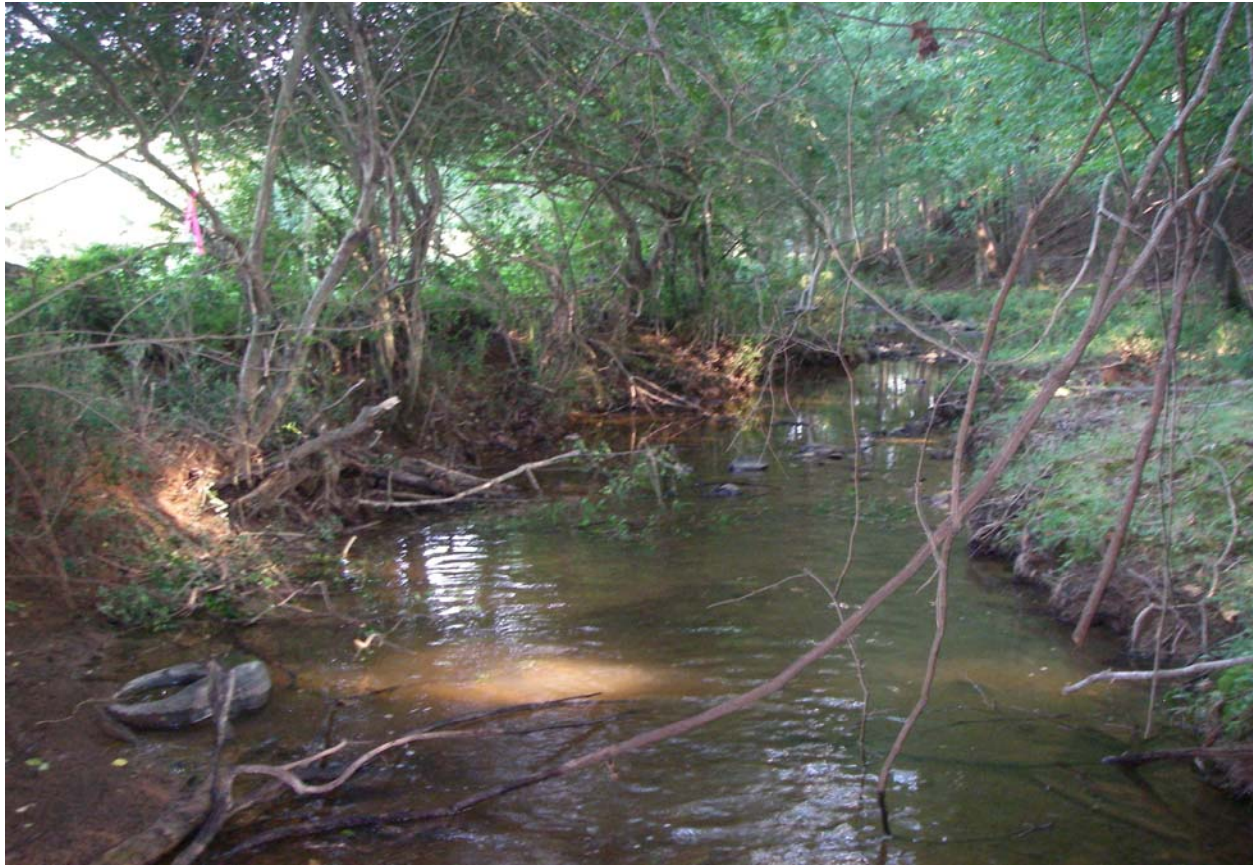
### Cross-section Data: BCC Reach 4 X8

Feature	Stream Type	BKF Area	BKF Width	BKF Depth	Max BKF Depth	W/D	BH Ratio	ER	BKF Elev	TOB Elev
Pool		50.1	25.5	2.0	3.4	12.8	1.4		215.8	217.2

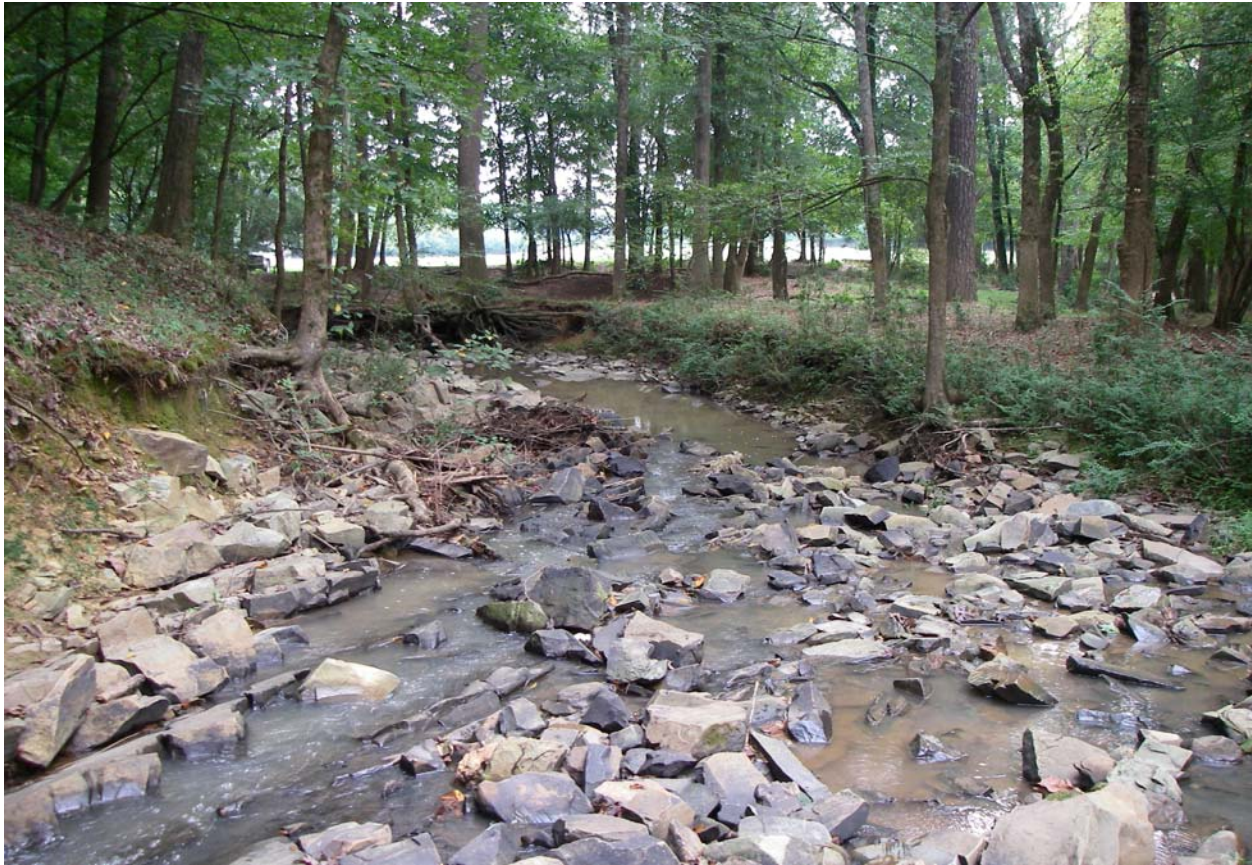
### Cross-section Data: BCC Reach 5 X9

Feature	Stream Type	BKF Area	BKF Width	BKF Depth	Max BKF Depth	W/D	BH Ratio	ER	BKF Elev	TOB Elev
Riffle	B3/1c	41.5	26.3	1.6	2.3	16.4	1.5	>2.0	208.0	209.3

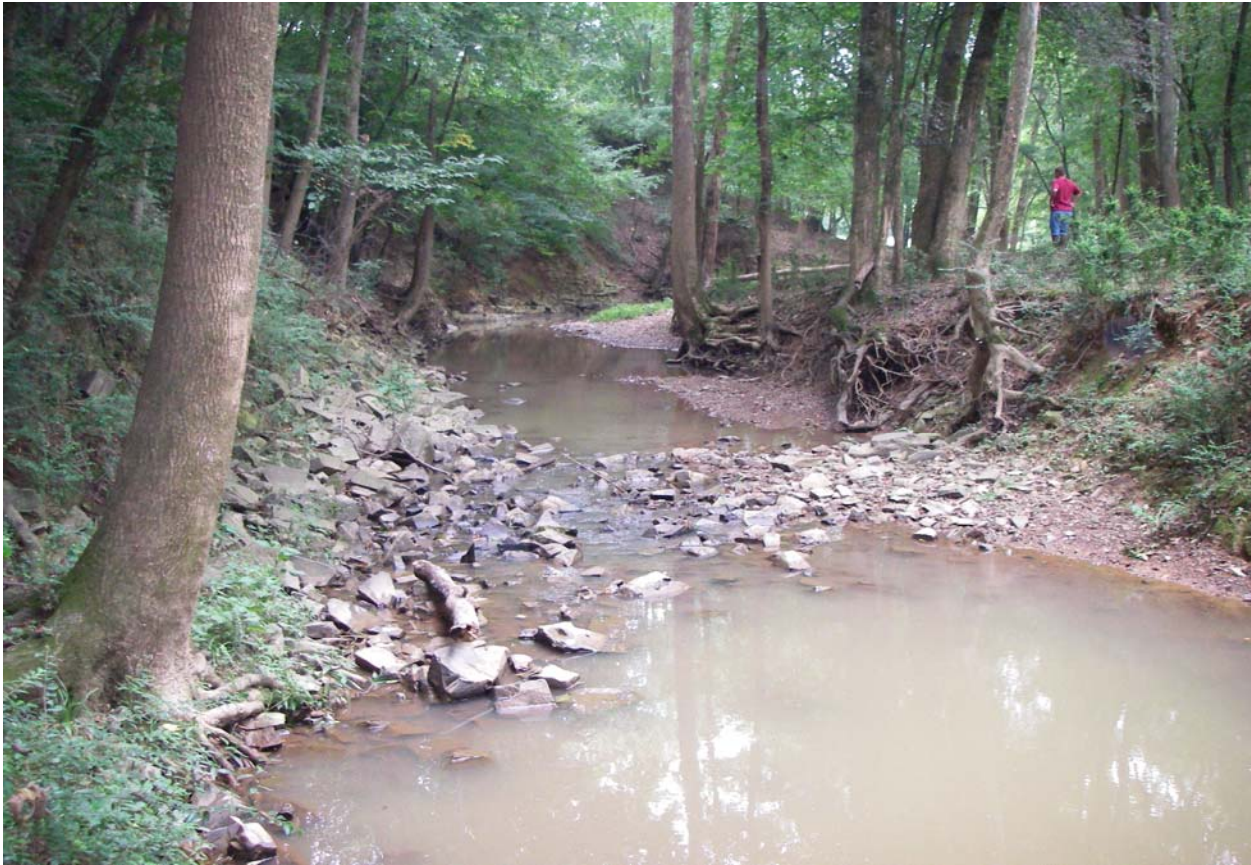
### Cross-section Data: BCC Reach 6 X10

Feature	Stream Type	BKF Area	BKF Width	BKF Depth	Max BKF Depth	W/D	BH Ratio	ER	BKF Elev	TOB Elev
Riffle	F3/1	60.9	25.6	2.4	3.1	10.7	2.2	1.2	202.3	206.1

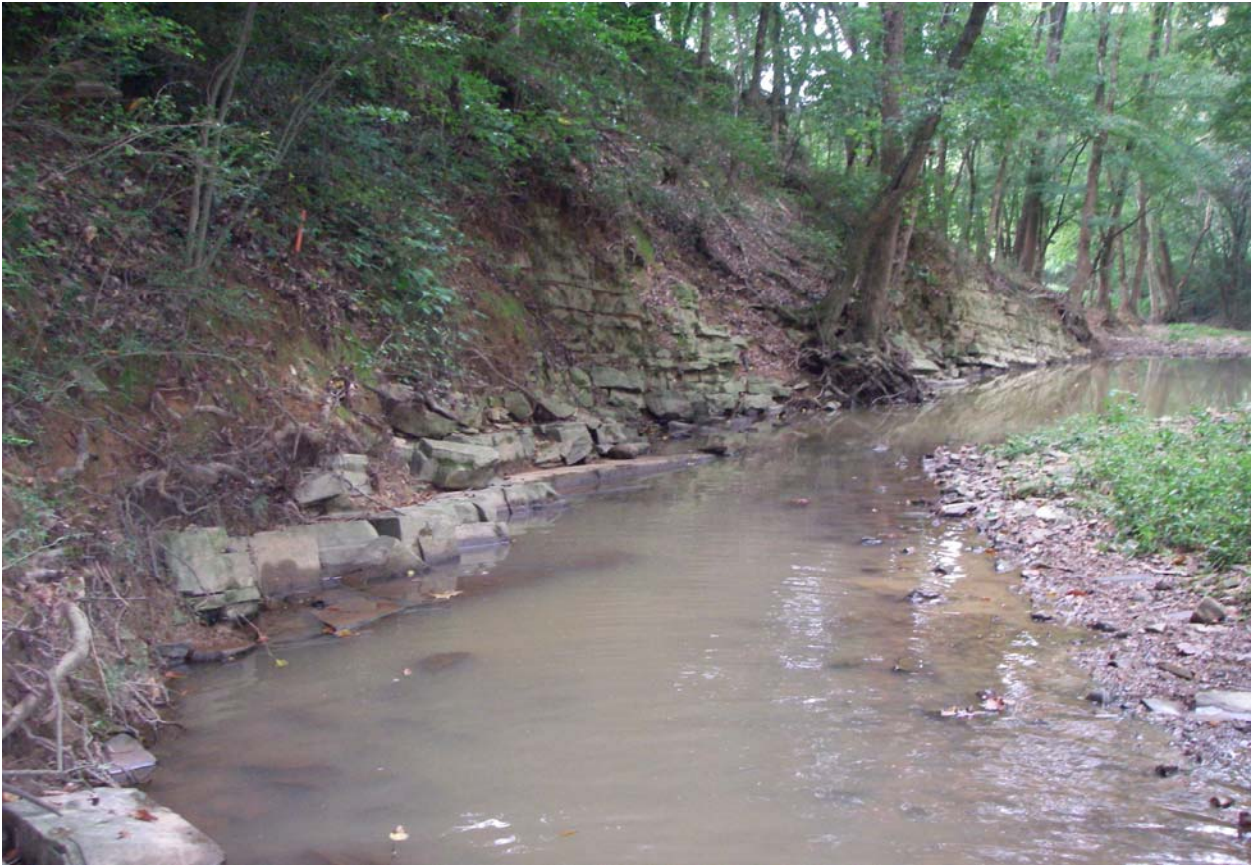
### Cross-section Data: BCC Reach 6 X11

Feature	Stream Type	BKF Area	BKF Width	BKF Depth	Max BKF Depth	W/D	BH Ratio	ER	BKF Elev	TOB Elev
Pool		54.3	31.2	1.7	3.2	18.4	1.9		201.8	204.6

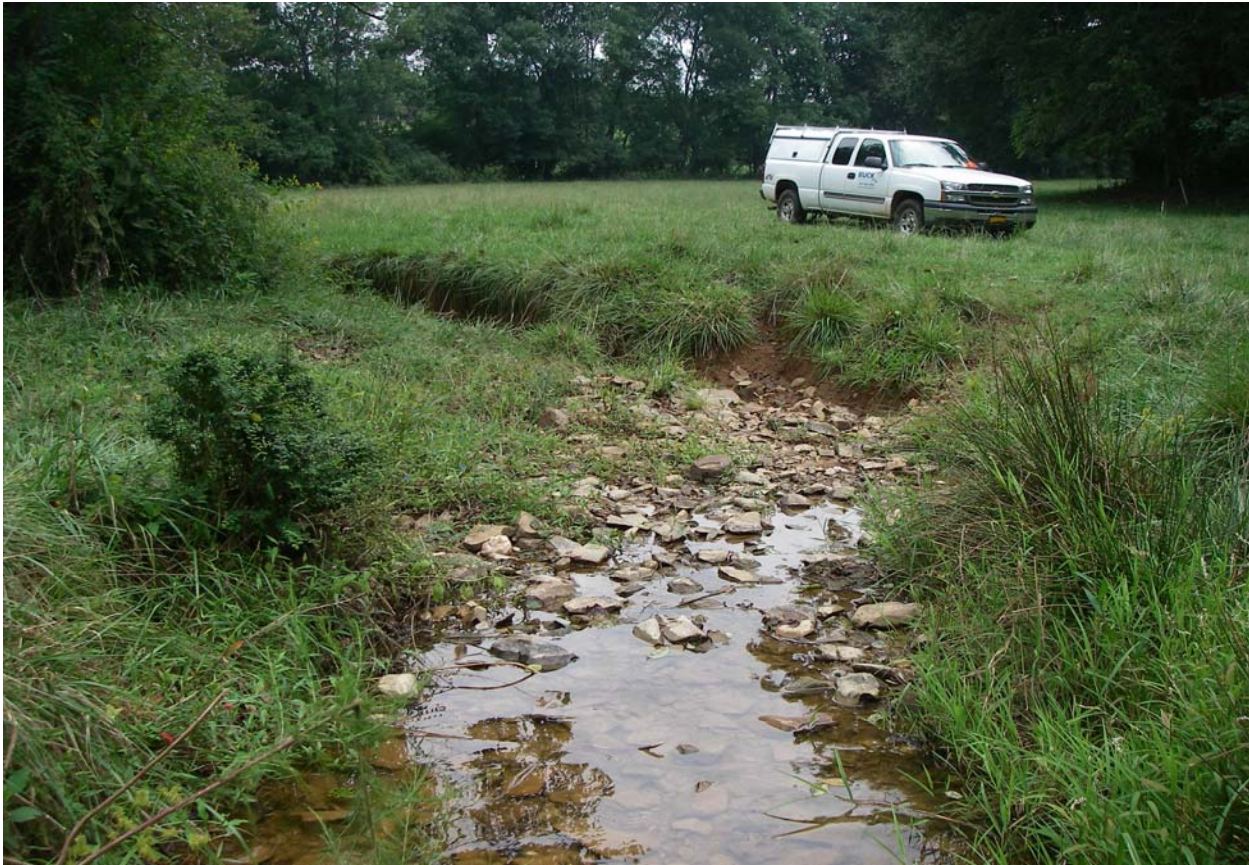
### Cross-section Data: UT2 Reach 1 X1

Feature	Stream Type	BKF Area	BKF Width	BKF Depth	Max BKF Depth	W/D	BH Ratio	ER	BKF Elev	TOB Elev
Riffle	G4	10.8	9.2	1.2	1.6	7.7	1.3	>15.5	246.3	246.8

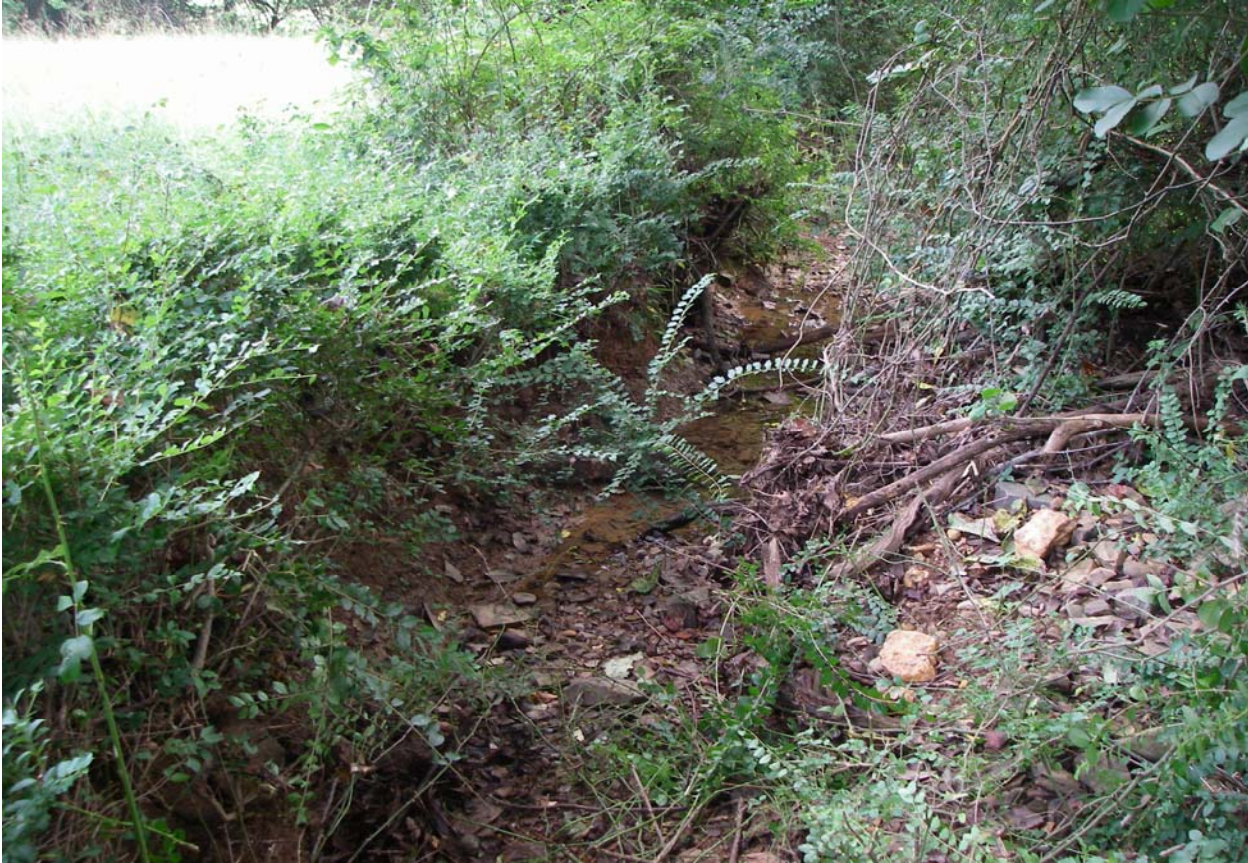
### Cross-section Data: UT2 Reach 1 X2

Feature	Stream Type	BKF Area	BKF Width	BKF Depth	Max BKF Depth	W/D	BH Ratio	ER	BKF Elev	TOB Elev
Pool		11.5	11.4	1.0	2.2	11.4	1.4		242.8	243.7

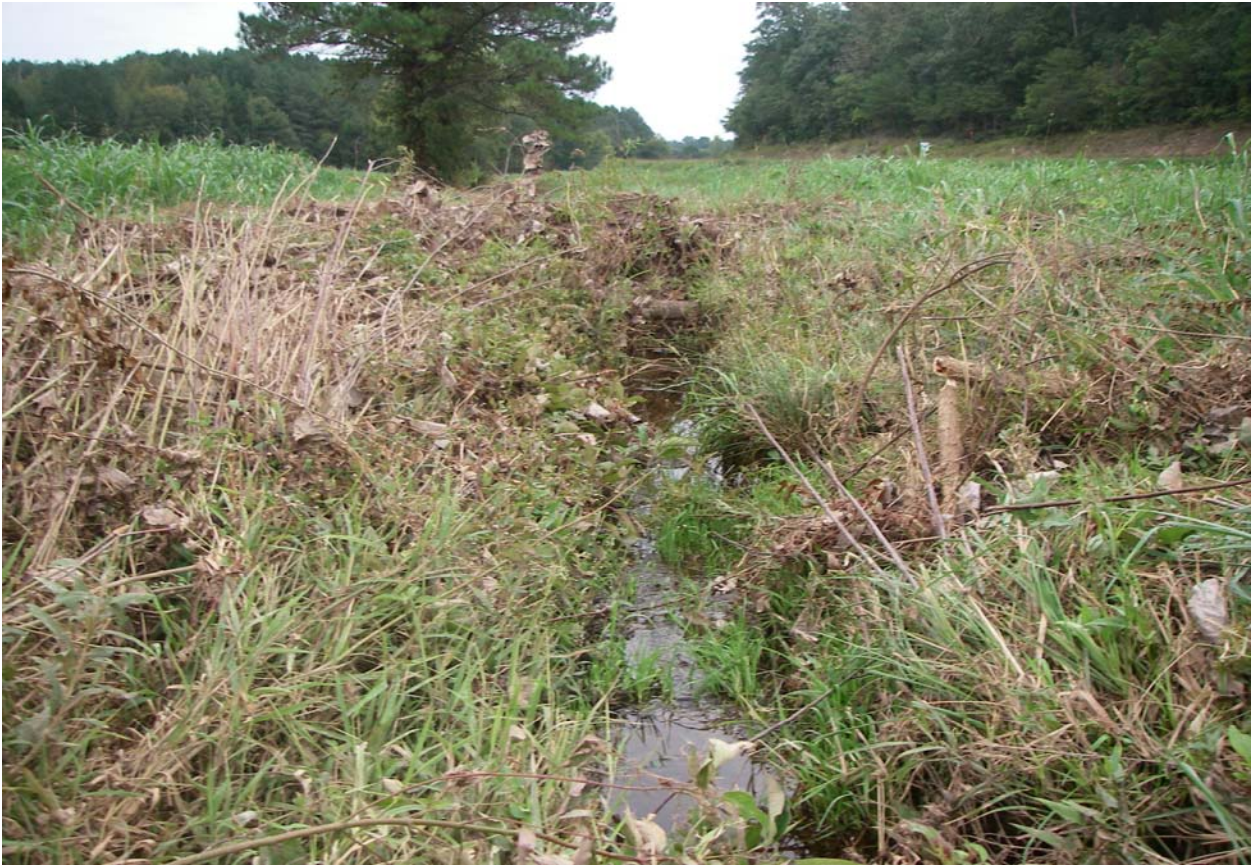
### Cross-section Data: UT1 Reach 1 X3

Feature	Stream Type	BKF Area	BKF Width	BKF Depth	Max BKF Depth	W/D	BH Ratio	ER	BKF Elev	TOB Elev
Riffle	C4/1	14.4	18.9	0.8	1.8	23.6	1.6	>7.2	263.6	264.64

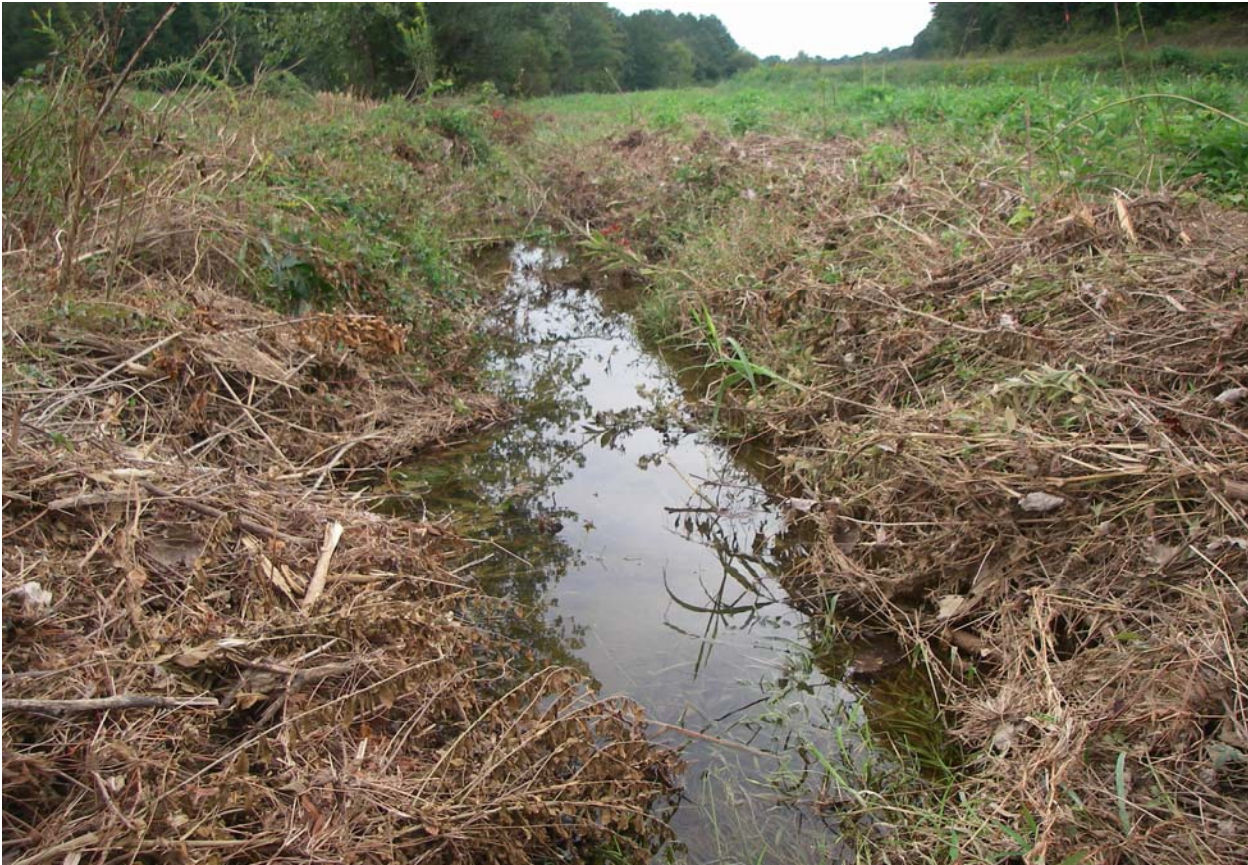
### Cross-section Data: UT1 Reach 1 X4

Feature	Stream Type	BKF Area	BKF Width	BKF Depth	Max BKF Depth	W/D	BH Ratio	ER	BKF Elev	TOB Elev
Pool	C4/1	15.3	9.3	1.6	2.2	5.8	2.2		259.8	262.28

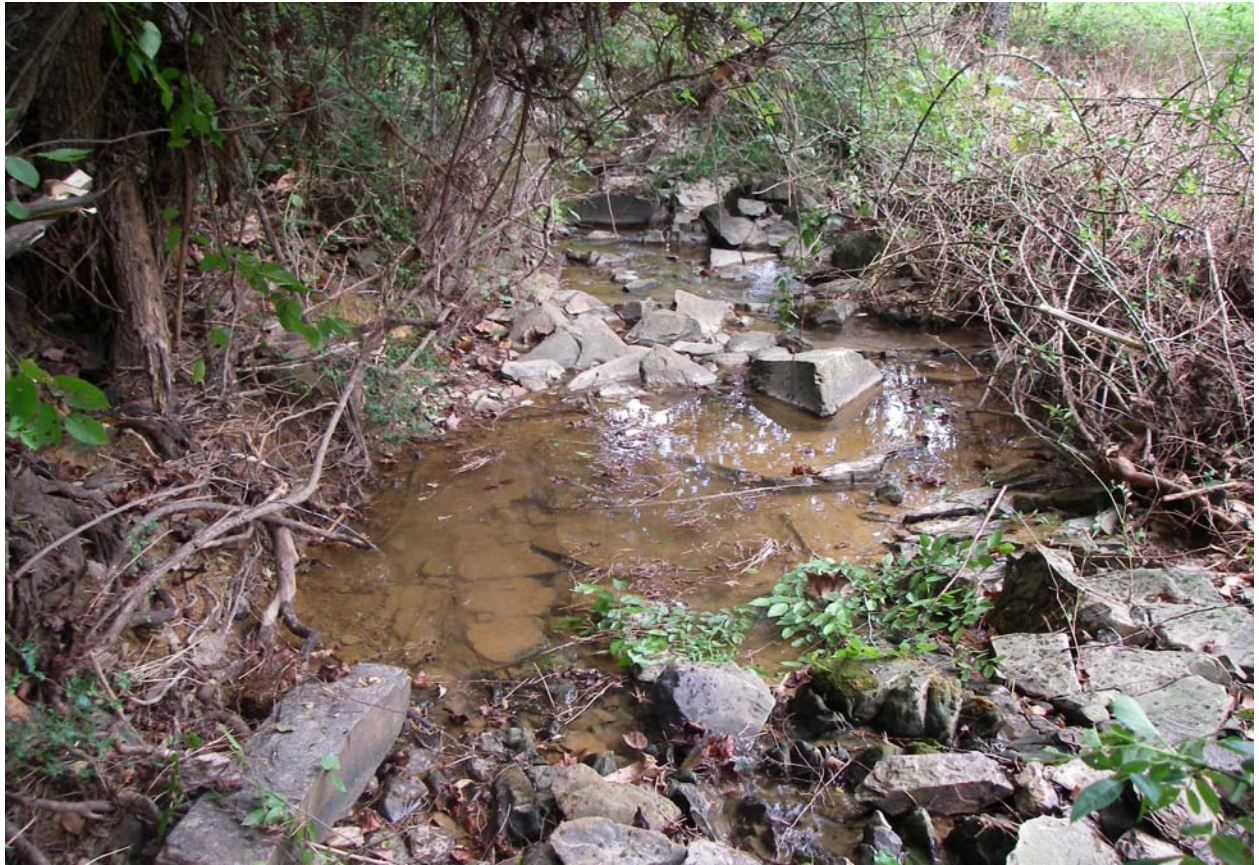
### Cross-section Data: UT1 Reach 2 X5

Feature	Stream Type	BKF Area	BKF Width	BKF Depth	Max BKF Depth	W/D	BH Ratio	ER	BKF Elev	TOB Elev
Pool	E4/1	16.6	10	1.7	2.1	6.0	2.2		248.7	251.36

Bed substrate material ranges in size from bedrock to silt and clay found in the pools. Maximum pool depths for this reach are a function of the bedrock outcrops. These outcrops provide vertical stability and prevent channel incision. Reach 2 is classified as a Rosgen E4/1 channel.
