# Big Cedar Creek Stream Restoration Plan

## Stanly County, North Carolina

EEP Project Number D06054-D

Final Plans

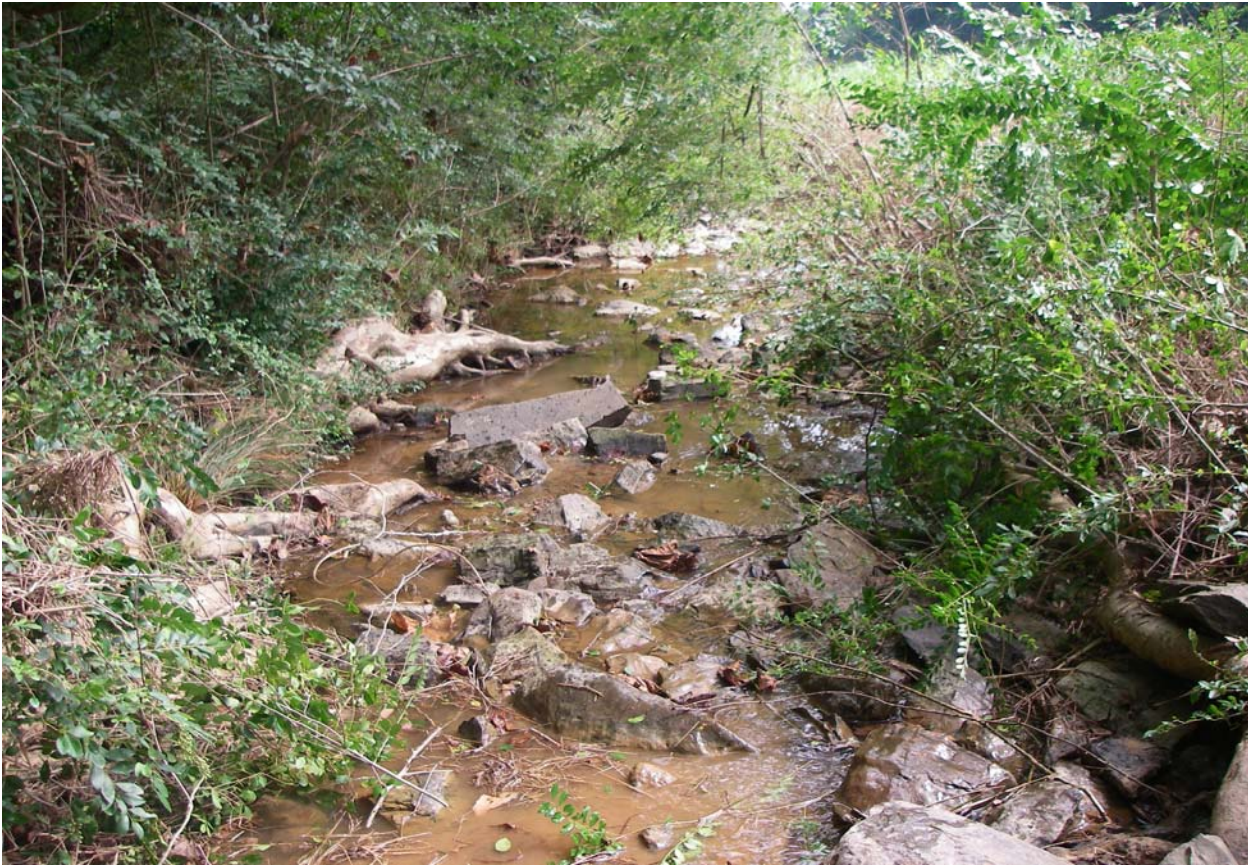
### Cross-section Data: UT1 Reach 2 X6

Feature	Stream Type	BKF Area	BKF Width	BKF Depth	Max BKF Depth	W/D	BH Ratio	ER	BKF Elev	TOB Elev
Riffle	E4/1	18.5	13.1	1.4	2.2	9.4	2.1	3.7	248.1	250.57

Bed substrate material ranges in size from bedrock to silt and clay found in the pools. Maximum pool depths for this reach are a function of the bedrock outcrops. These outcrops provide vertical stability and prevent channel incision. Reach 2 is classified as a Rosgen E4/1 channel.

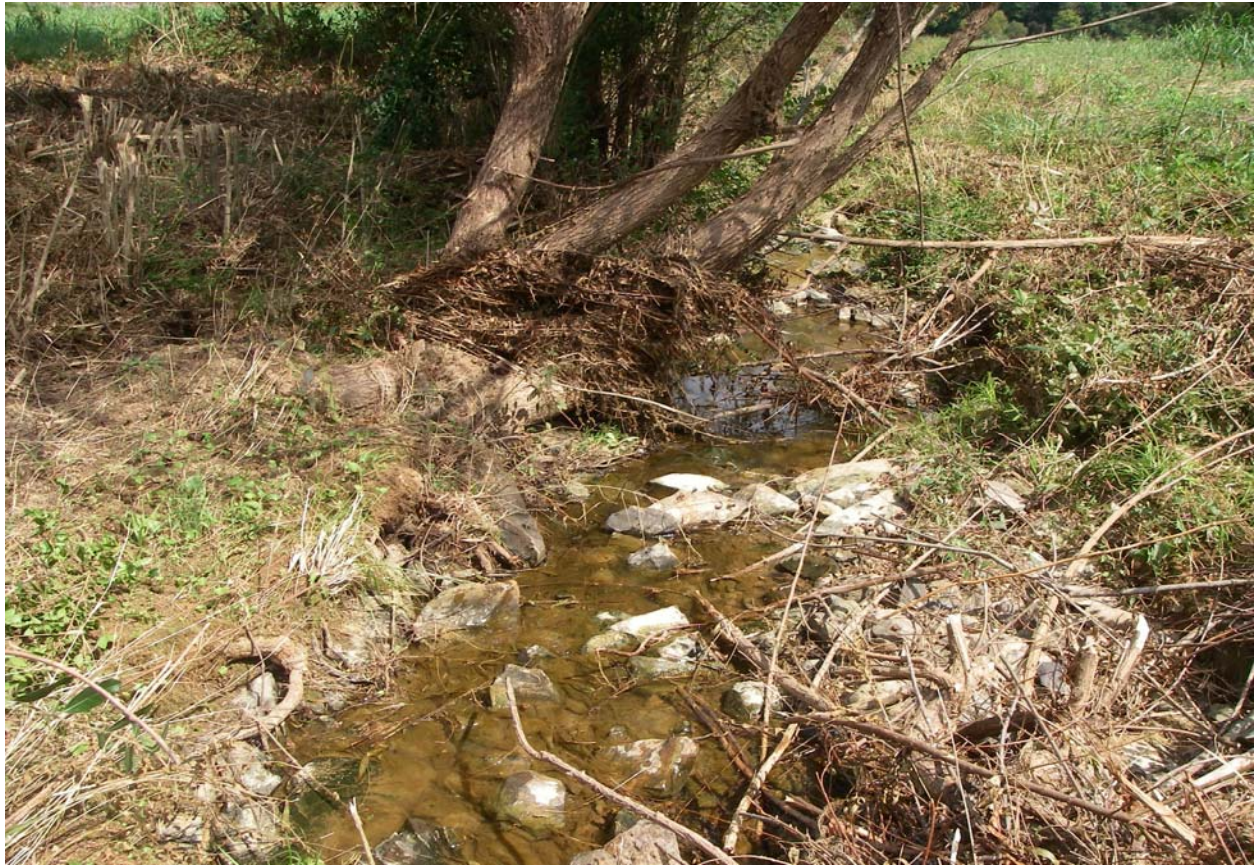
### Cross-section Data: UT1 Reach 3 X7

Feature	Stream Type	BKF Area	BKF Width	BKF Depth	Max BKF Depth	W/D	BH Ratio	ER	BKF Elev	TOB Elev
Riffle	C4/1	20.9	17.6	1.2	2.4	14.7	1.4	>6.5	236.6	237.45

Bed substrate material ranges in size from bedrock to silt and clay found in the pools. Maximum pool depths for this reach are a function of the bedrock outcrops. These outcrops provide vertical stability and prevent channel incision. Reach 3 is classified as a Rosgen C4/1 channel.

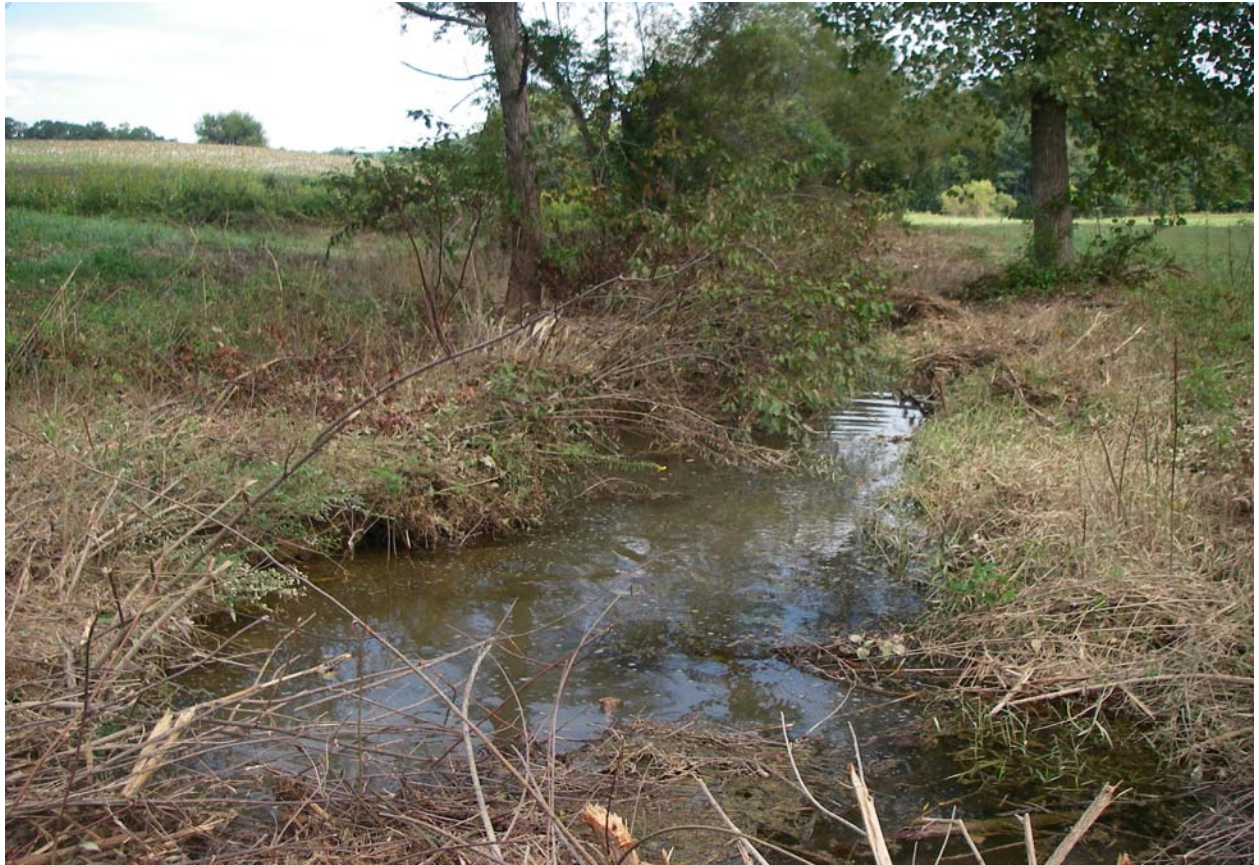
### Cross-section Data: UT1 Reach 3 X9

Feature	Stream Type	BKF Area	BKF Width	BKF Depth	Max BKF Depth	W/D	BH Ratio	ER	BKF Elev	TOB Elev
Pool	C4/1	21.6	14.5	1.5	2.1	9.7	1.9		233	234.95

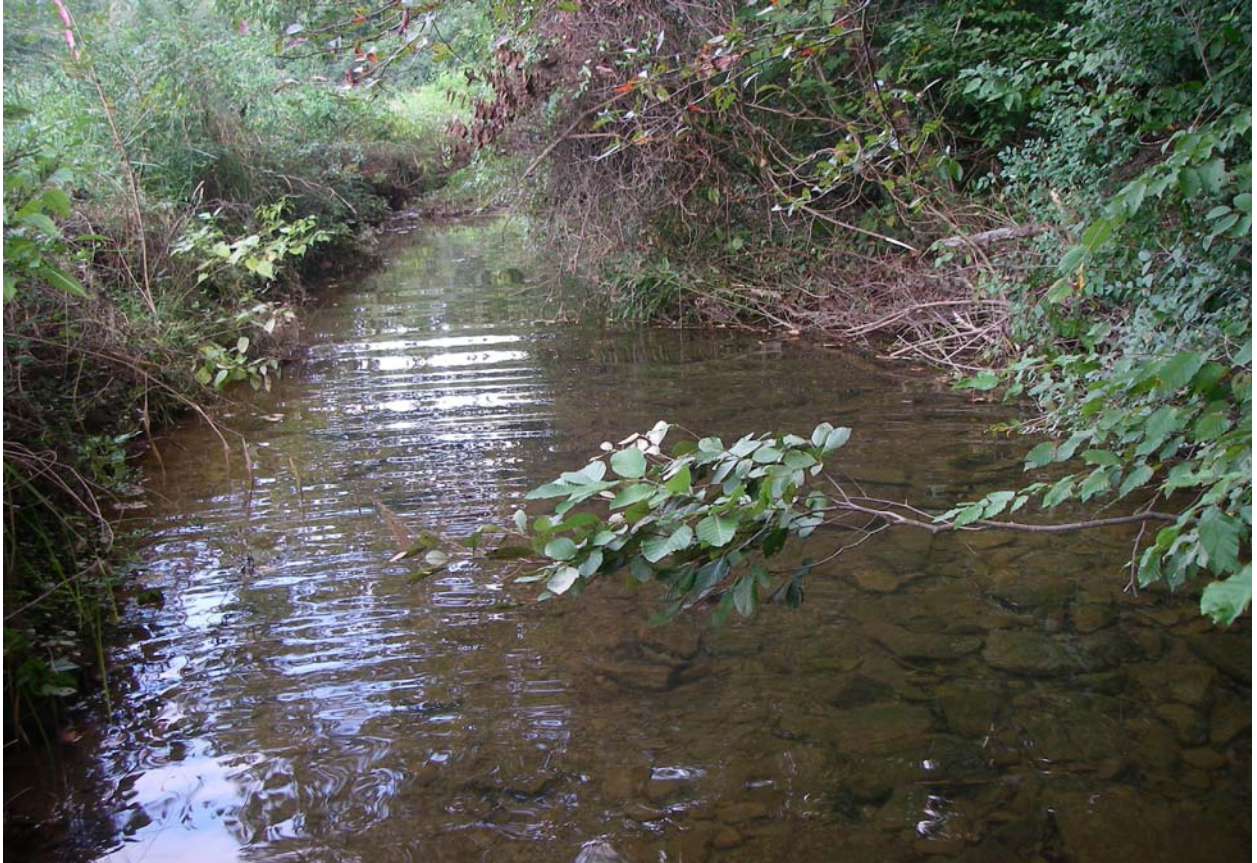
### Cross-section Data: UT1 Reach 4 X12

Feature	Stream Type	BKF Area	BKF Width	BKF Depth	Max BKF Depth	W/D	BH Ratio	ER	BKF Elev	TOB Elev
Pool	C4/1	39.5	21.0	1.9	3.0	11.1	1.4	3.9	216.1	217.21

Bed substrate material ranges in size from bedrock to silt and clay found in the pools. Maximum pool depths for this reach are a function of the bedrock outcrops. These outcrops provide vertical stability and prevent channel incision. Reach 4 is classified as a Rosgen C4/1 channel.

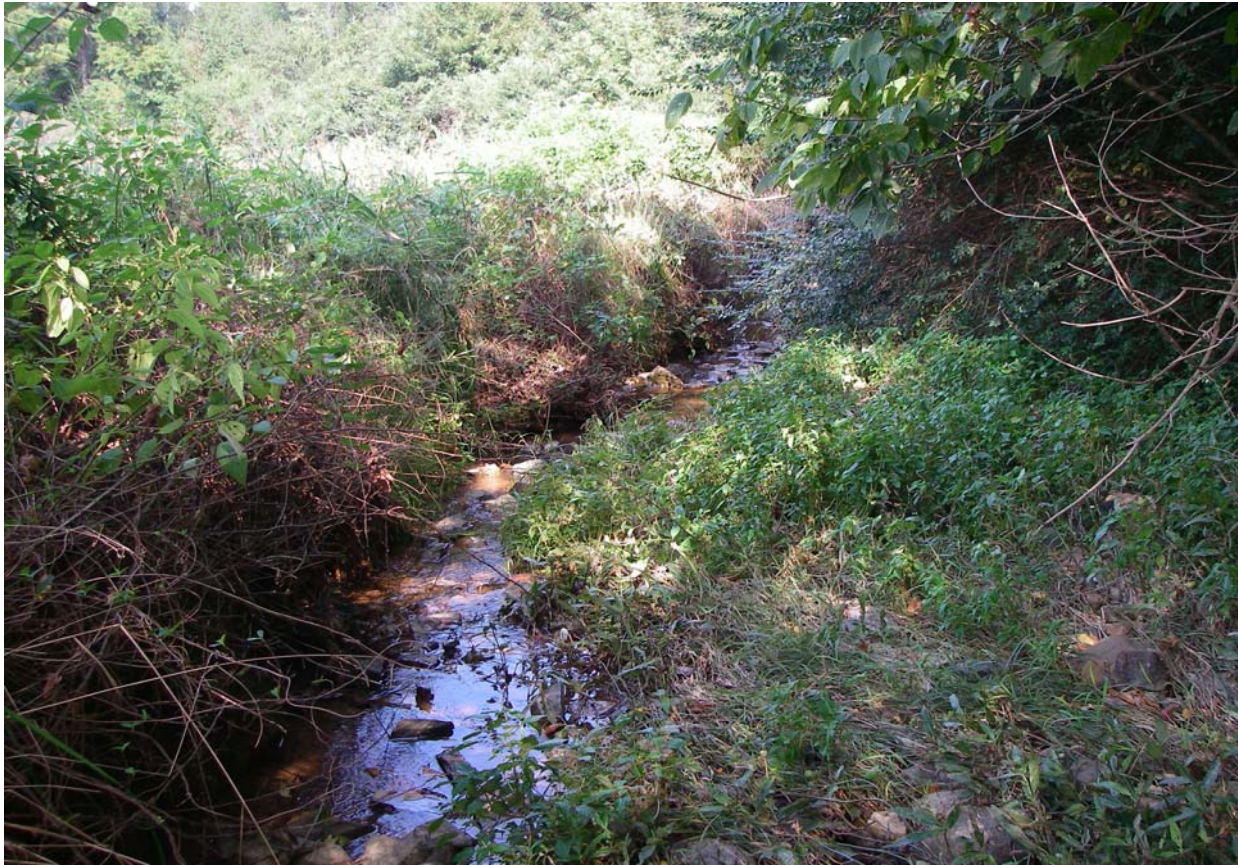
### Cross-section Data: UT1 Reach 4 X13

Feature	Stream Type	BKF Area	BKF Width	BKF Depth	Max BKF Depth	W/D	BH Ratio	ER	BKF Elev	TOB Elev
Riffle	C4/1	22.6	23.1	1.0	1.8	23.1	1.8	3.0	215.4	216.85

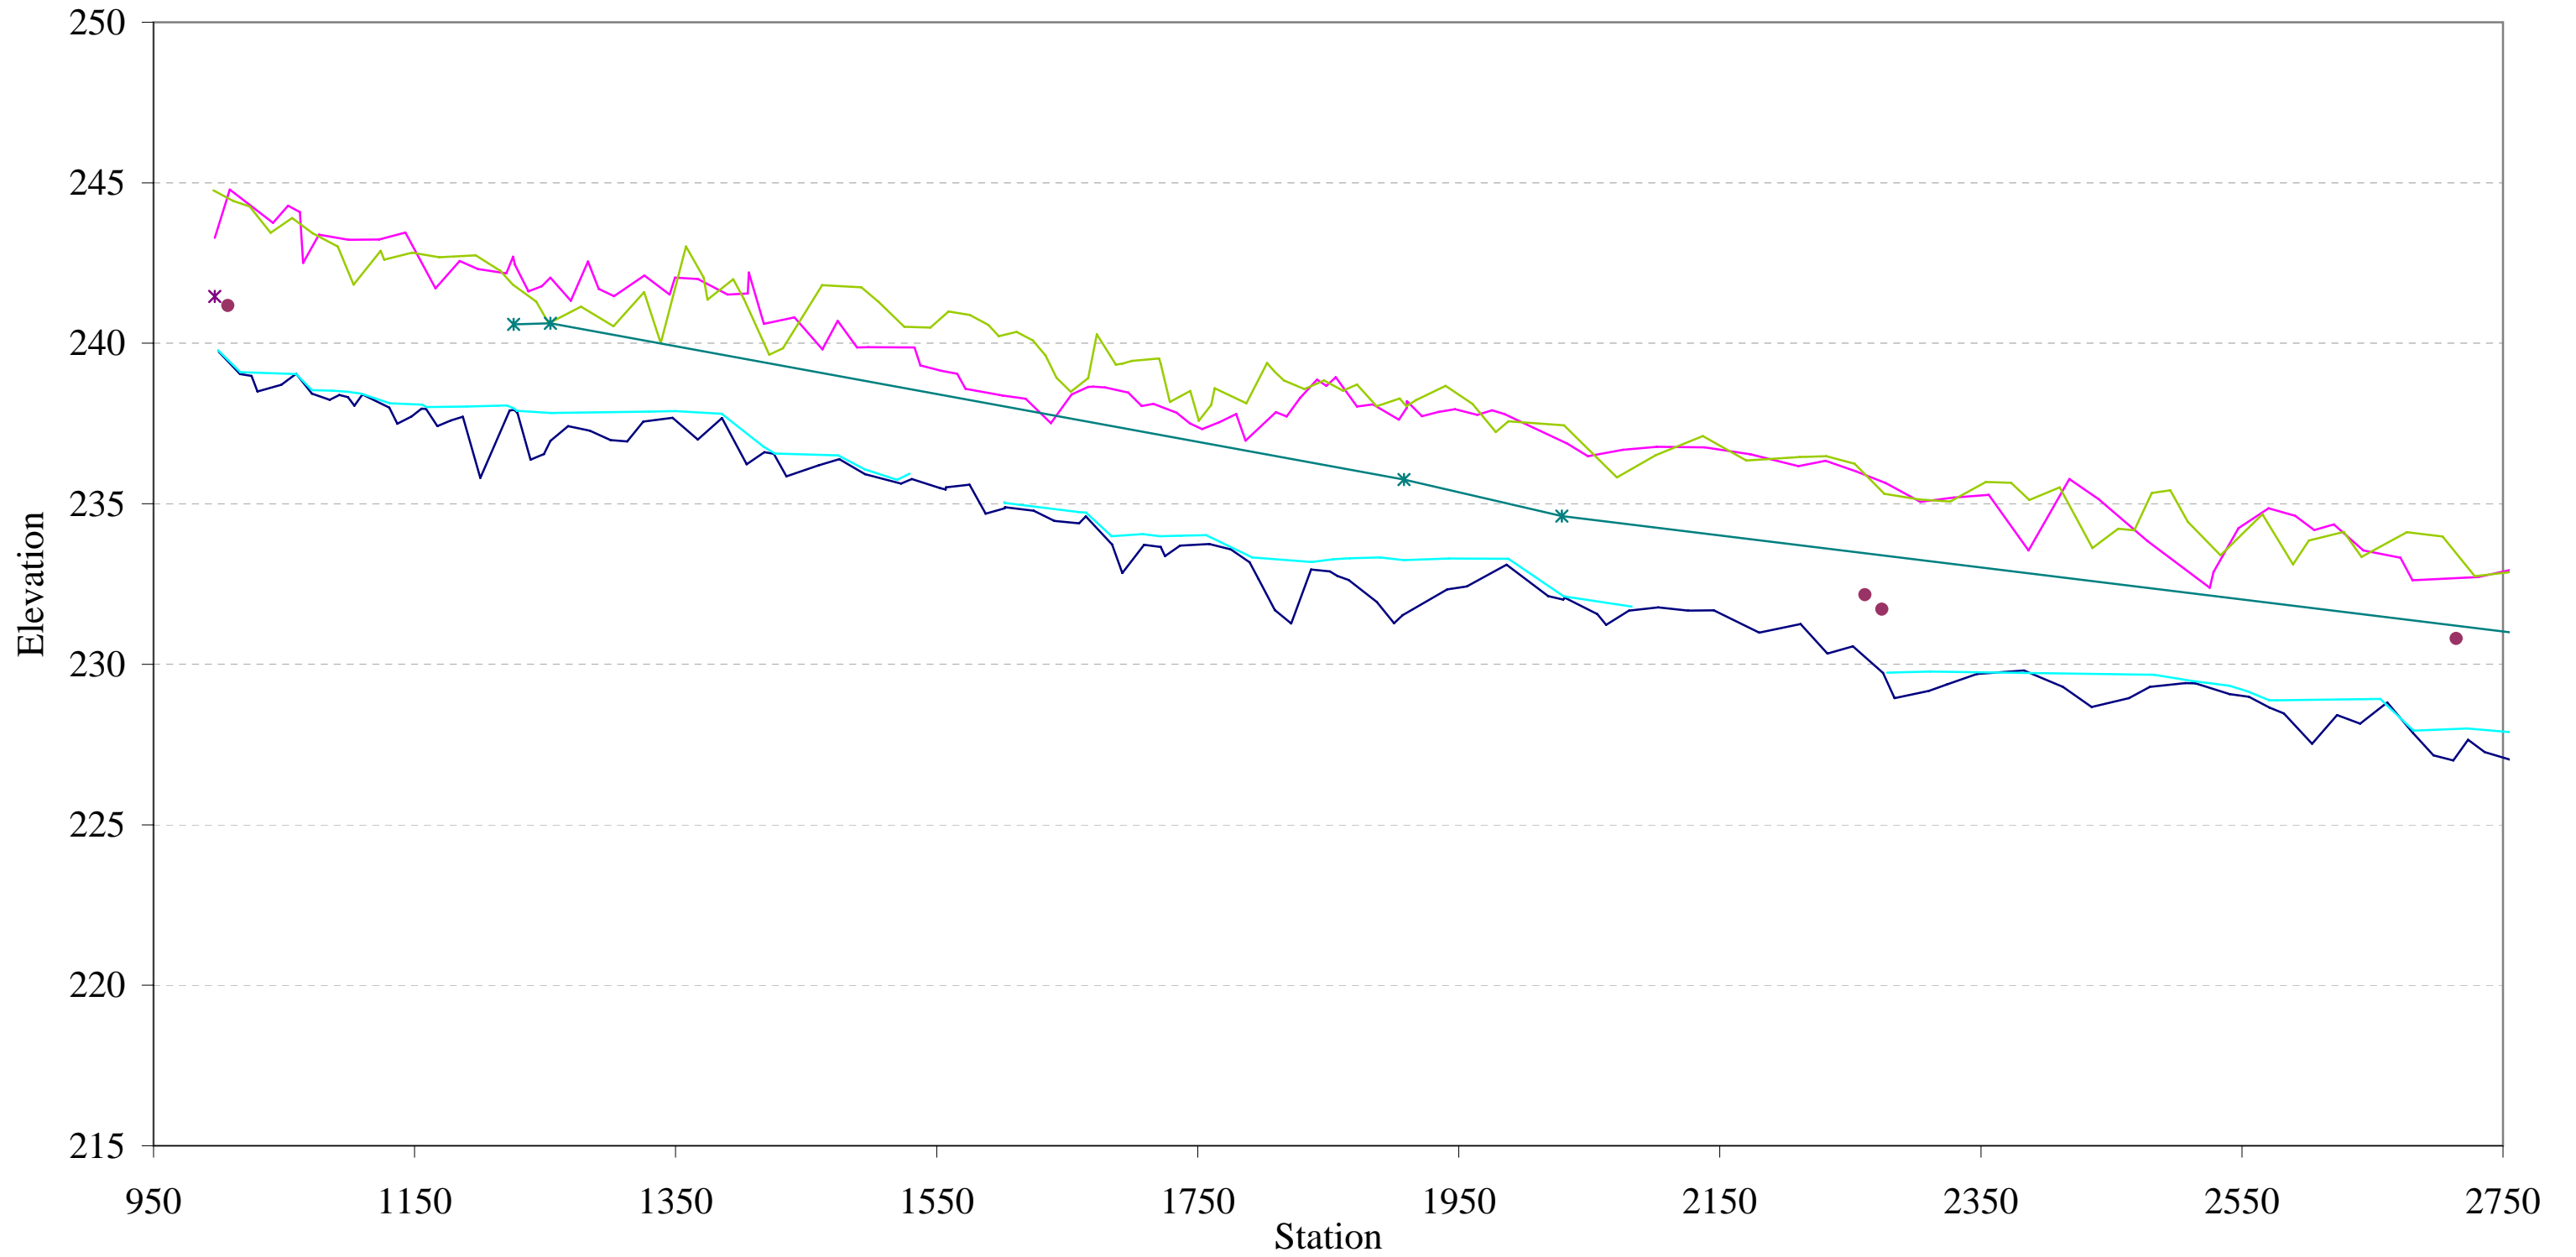
# Big Cedar Creek Longitudinal Profile Chart -Part 1

— TWG — LTB — RTB — WSF \* RBF • LBF \* Determined BF

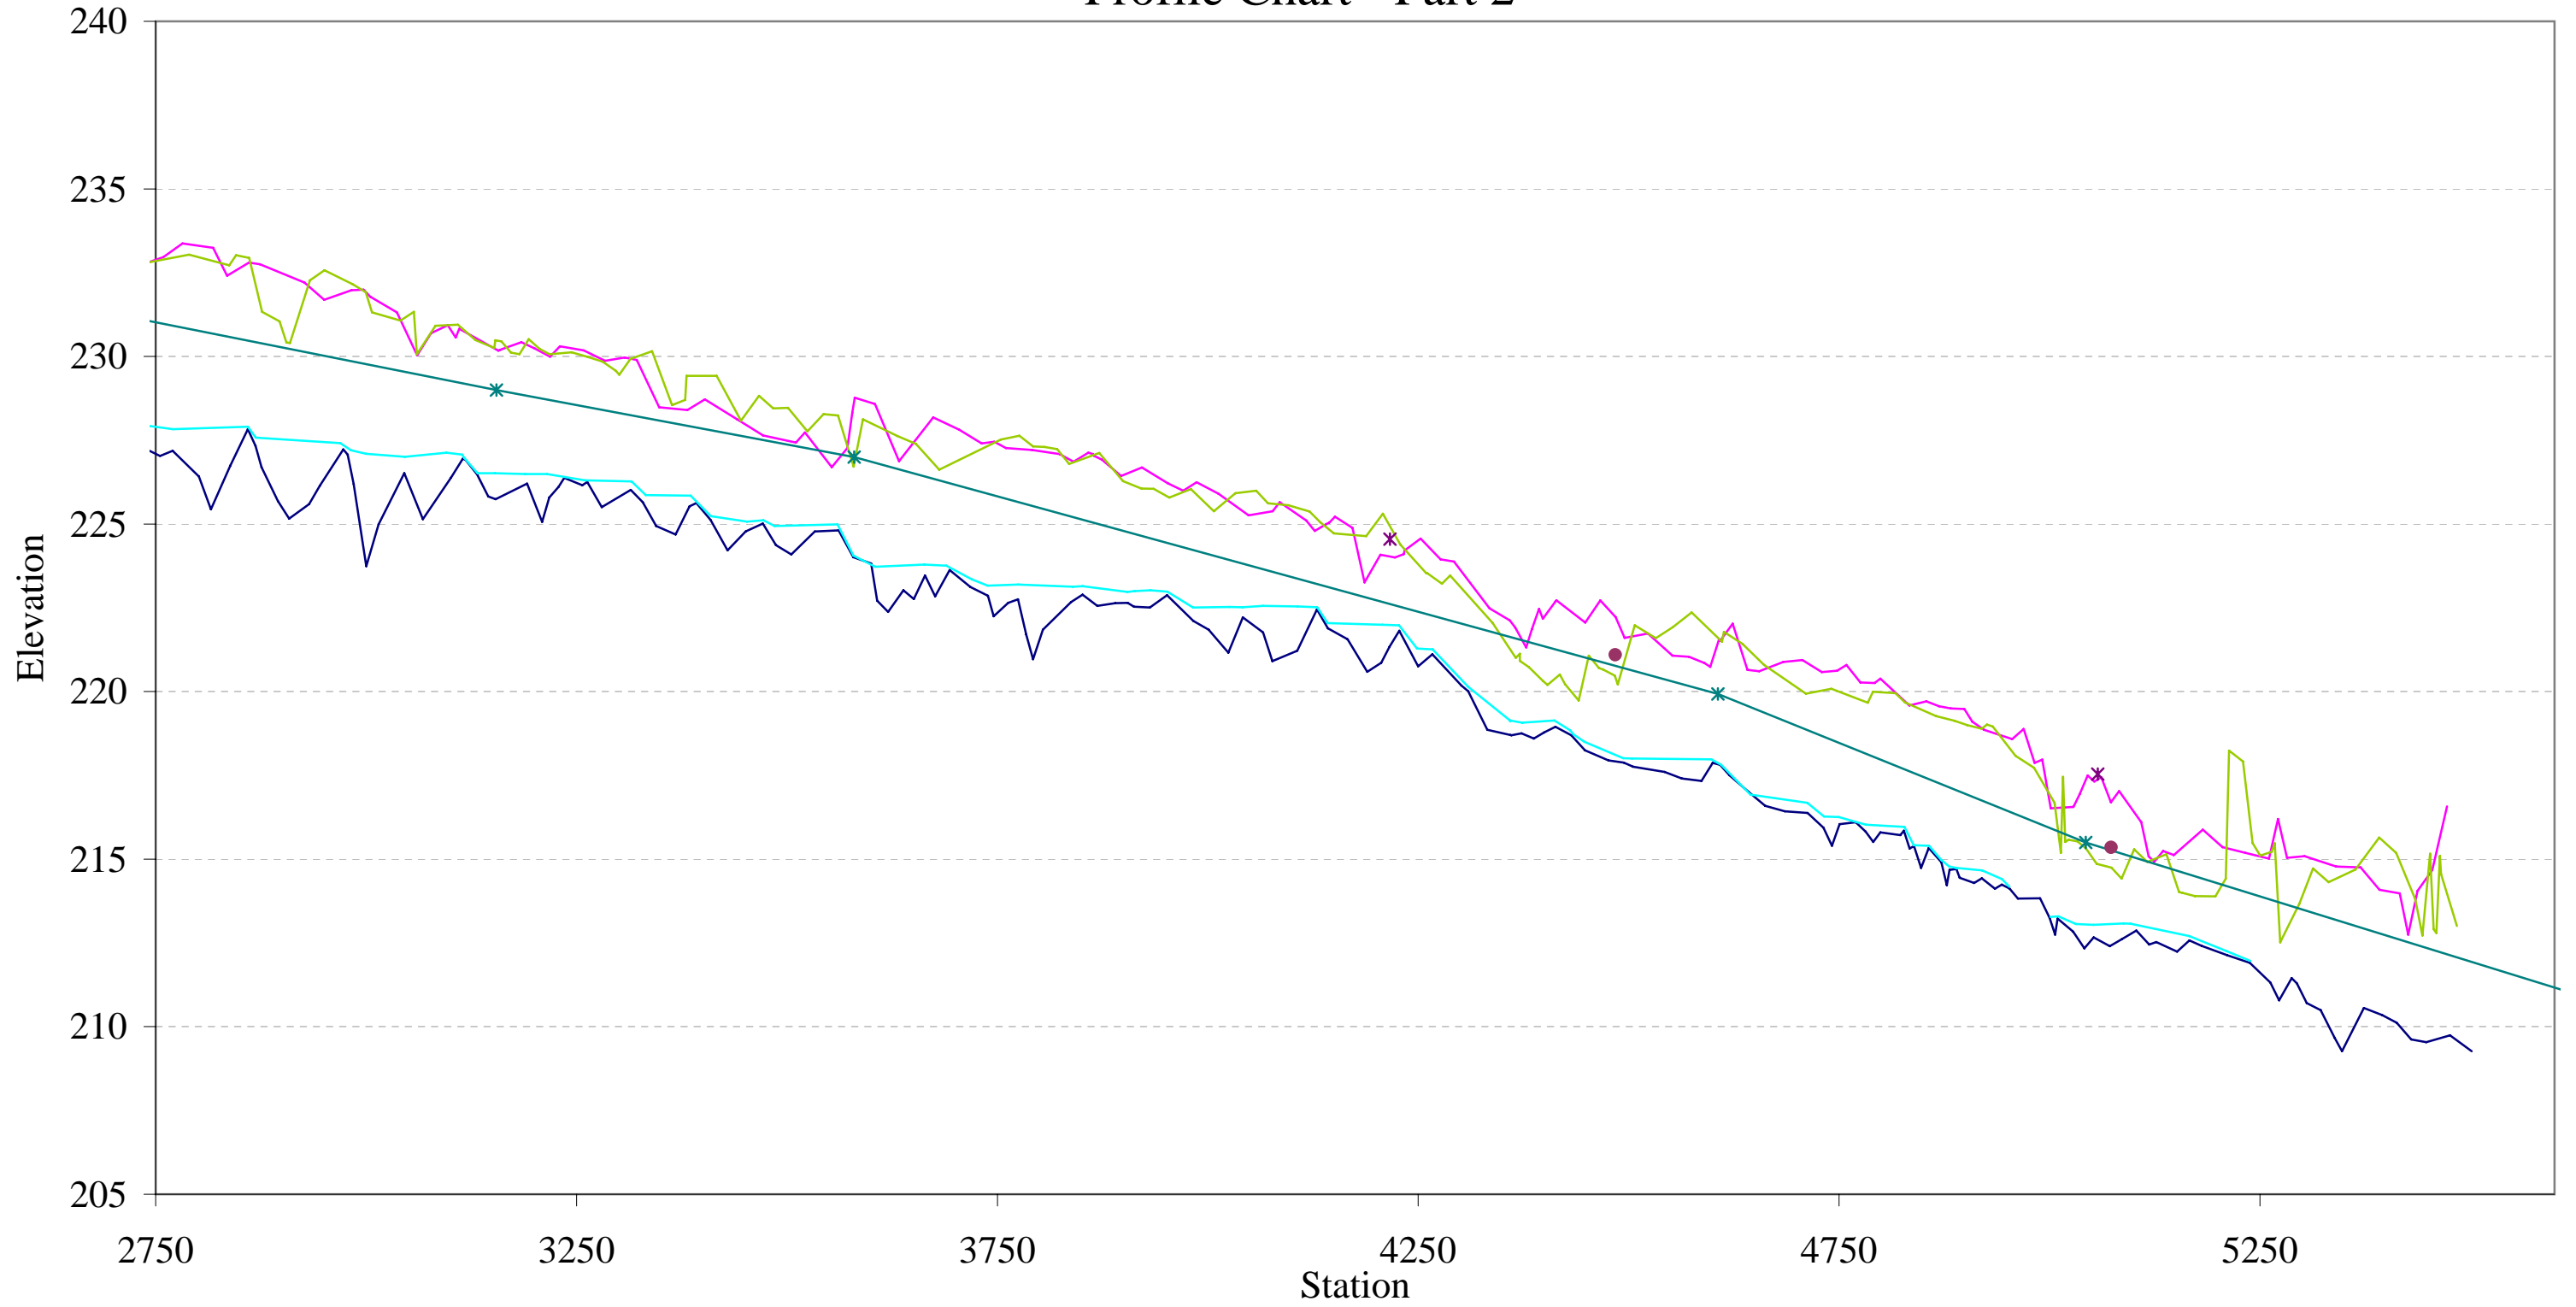
# Big Cedar Creek Longitudinal Profile Chart - Part 2

— TWG — LTB — RTB — WSF \* RBF ● LBF \* Determined BF

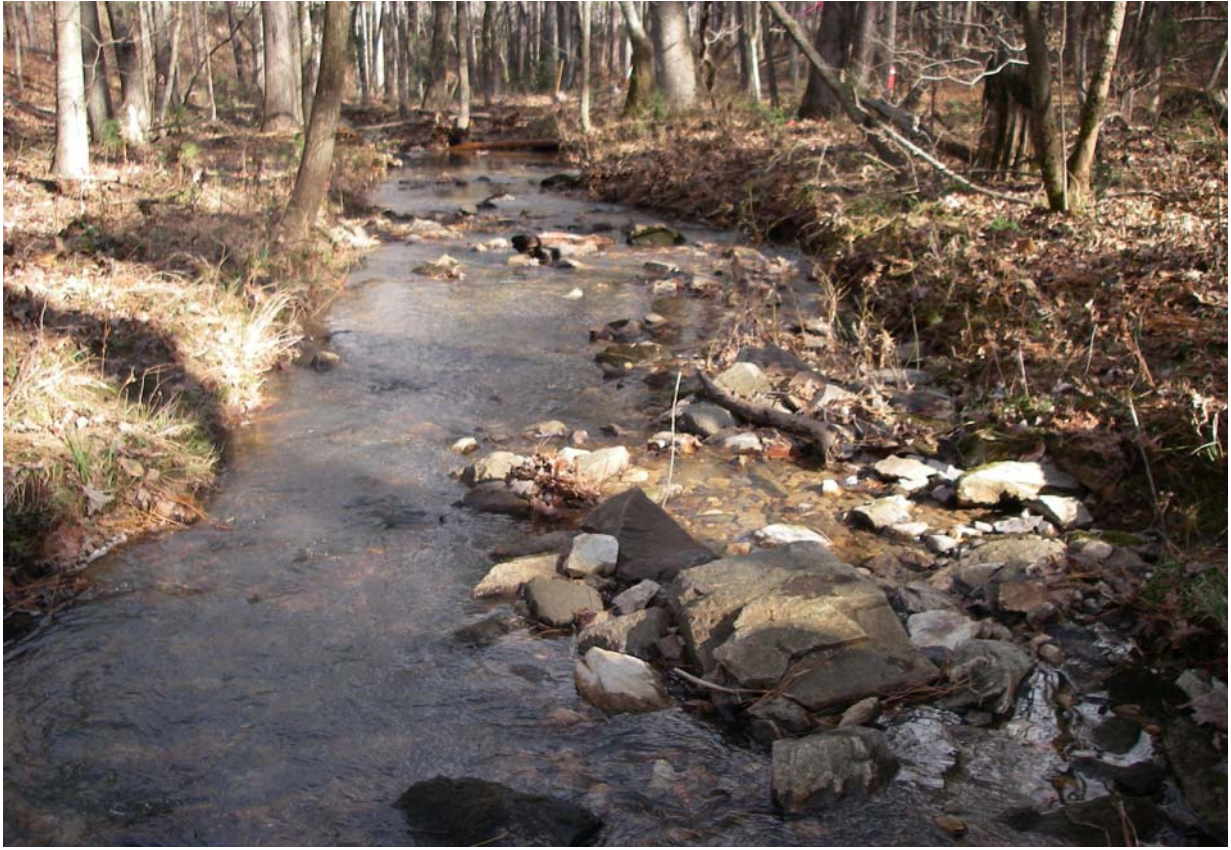
### Cross-section Data: UT to Rocky Creek - Riffle

Feature	Stream Type	BKF Area	BKF Width	BKF Depth	Max BKF Depth	W/D	BH Ratio	ER	BKF Elev	TOB Elev
Riffle	E4b	16.3	12.2	1.3	1.8	9.1	1.0	5.9	1000.3	1000.3

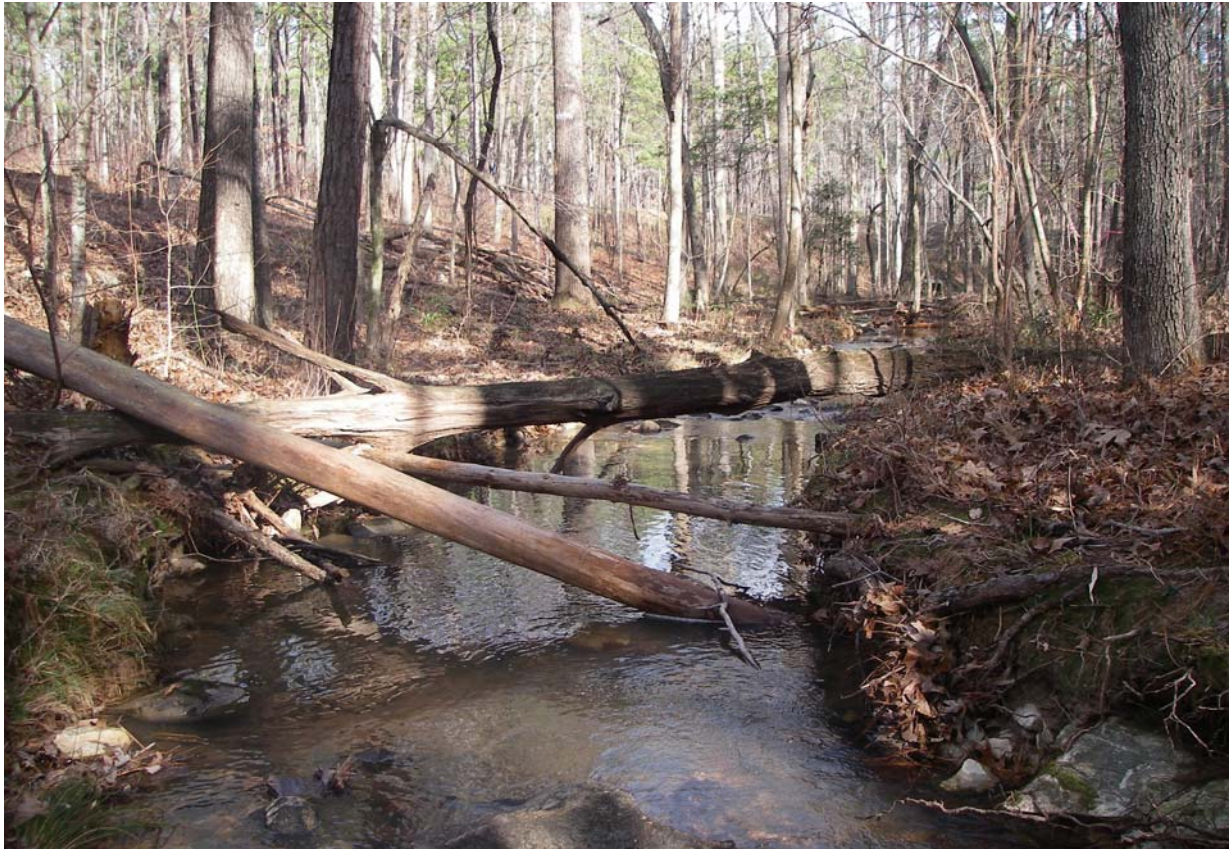
### Cross-section Data: UT to Rocky Creek - Pool

Feature	Stream Type	BKF Area	BKF Width	BKF Depth	Max BKF Depth	W/D	BH Ratio	ER	BKF Elev	TOB Elev
Pool		19.3	10.9	1.8	2.2	6.1	1.0		998.5	998.5
