# **ANNUAL MONITORING REPORT YEAR 1 (2006)**

**(Contract Number D05015-2)  
BIG BULL CREEK BUFFER RESTORATION SITE  
JOHNSTON COUNTY, NORTH CAROLINA**

**September 2006**

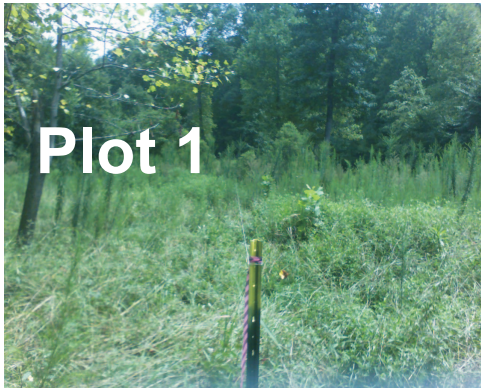
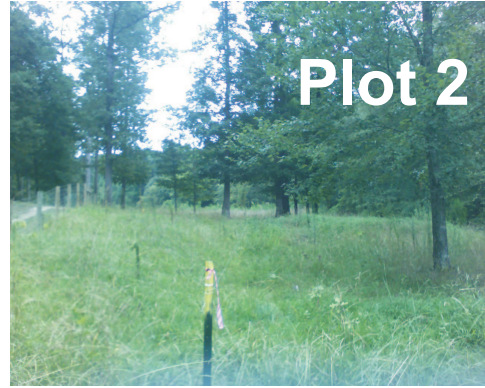
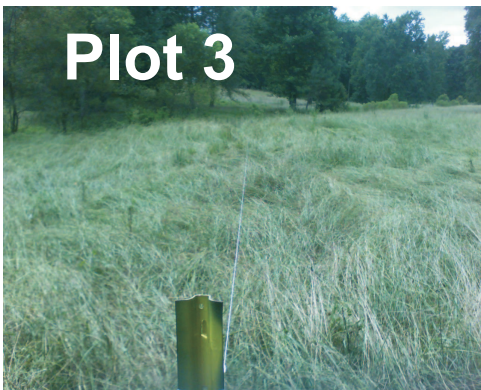
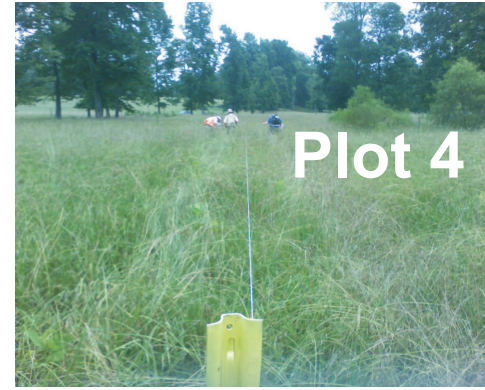
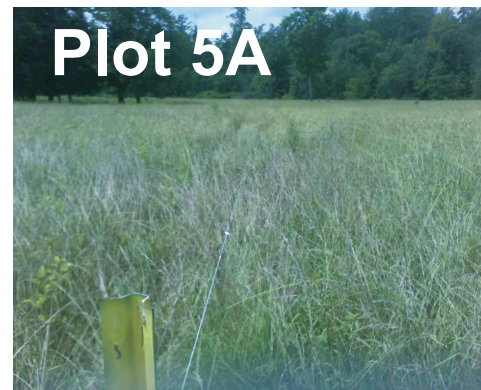
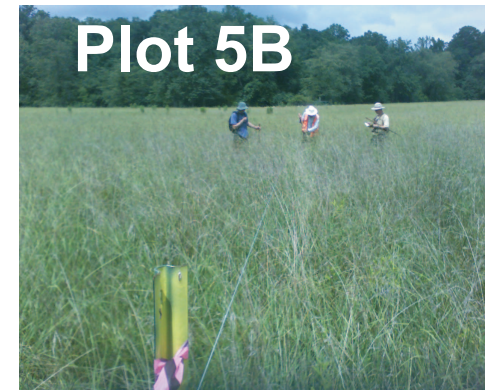
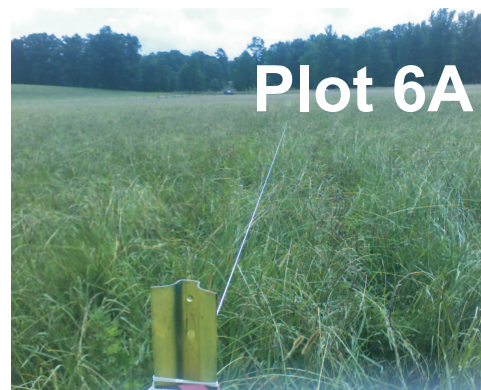
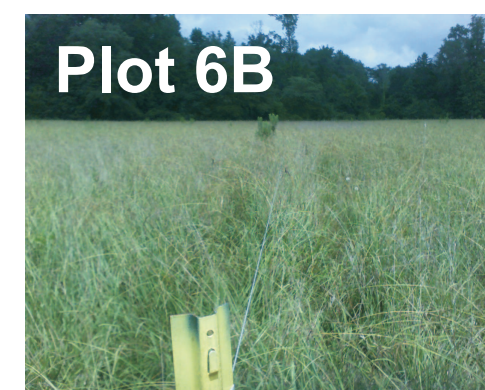
**Big Bull Creek Buffer Restoration Site  
Year 1 (2006) Annual Monitoring Report  
Vegetation Plot Photographs Taken August 2006**

Quantitative sampling of vegetation was conducted in August 2006. Results are provided in Table 2. Vegetation success criteria for year 1 (320 stems per acre) were exceeded for the 2006 annual monitoring year with 1645 tree stems per acre across the Site. Each individual vegetation plot met success criteria and had good species diversity with 10 to 15 Character Tree Species present within each plot.
