**ANNUAL MONITORING REPORT
YEAR 3 (2008)
BIG BULL CREEK BUFFER RESTORATION SITE
JOHNSTON COUNTY, NORTH CAROLINA
(Contract Number D05015-2)**

**BIG BULL CREEK BUFFER RESTORATION SITE
ANNUAL MONITORING REPORT
YEAR 3 (2008)
JOHNSTON COUNTY, NORTH CAROLINA**

**Big Bull Creek Buffer Restoration Site Year 3 (2008) Annual Monitoring
Vegetation Plot Pictures Taken June 2008**

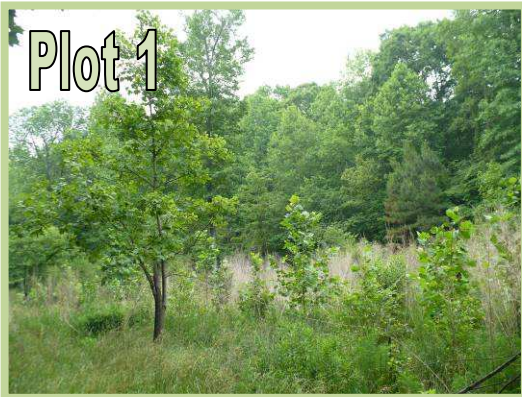
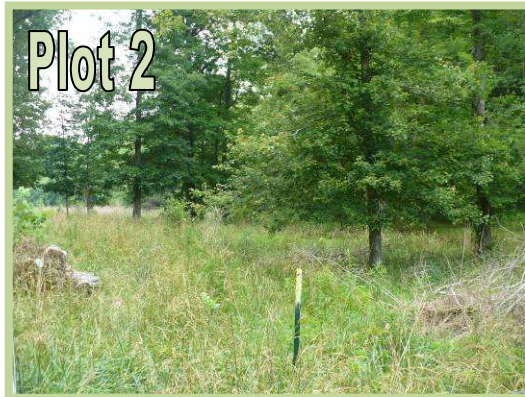
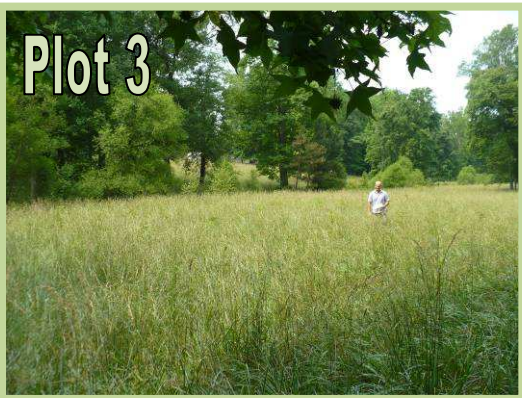
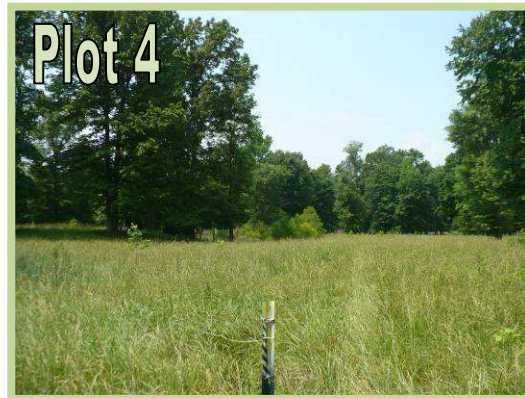
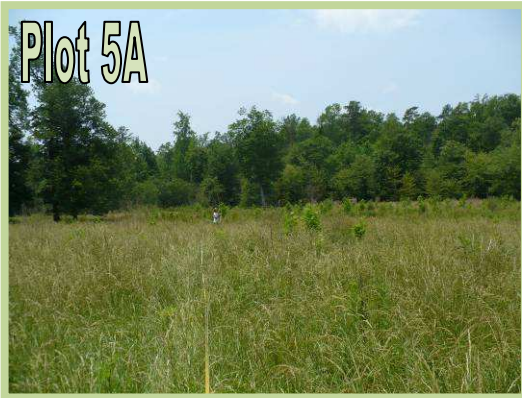
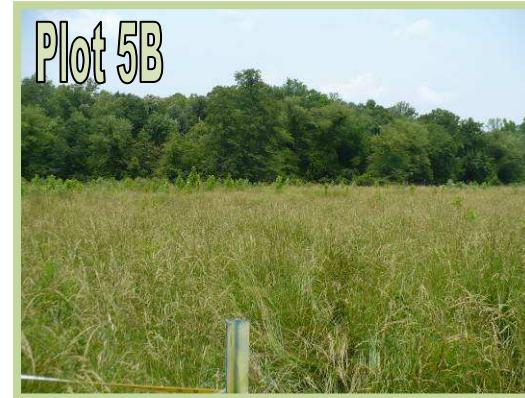
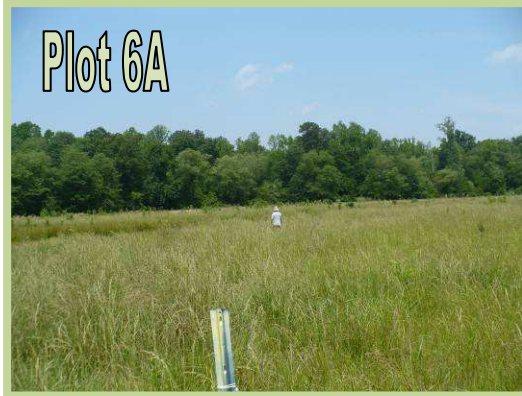
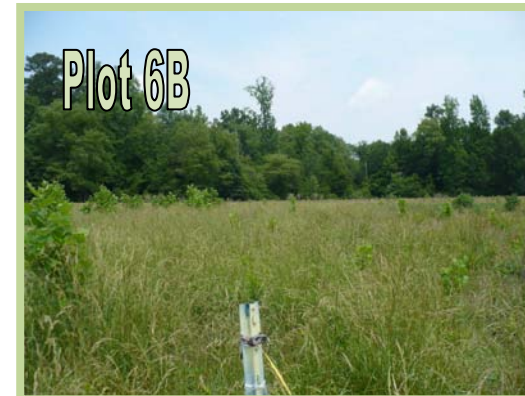
Quantitative sampling of vegetation was conducted in June 2008. Results are provided in Table 2. Vegetation success criteria for year 3 (320 stems per acre) were exceeded for the 2008 annual monitoring year with 1895 tree stems per acre across the Site. Each individual vegetation plot met success criteria and had good species diversity with 8 to 15 Character Tree Species present within each plot.
