**ANNUAL MONITORING REPORT
YEAR 4 (2009)
BIG BULL CREEK BUFFER RESTORATION SITE
JOHNSTON COUNTY, NORTH CAROLINA
(Contract Number D05015-2)**

June 2009

**BIG BULL CREEK BUFFER RESTORATION SITE
ANNUAL MONITORING REPORT
YEAR 4 (2009)
JOHNSTON COUNTY, NORTH CAROLINA**

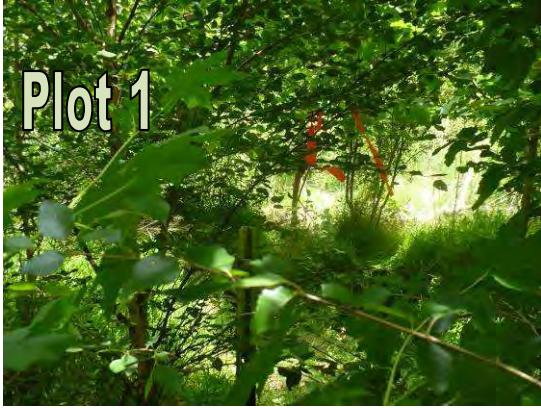
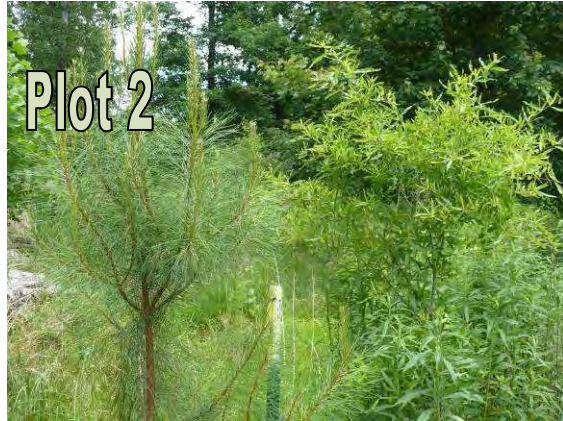
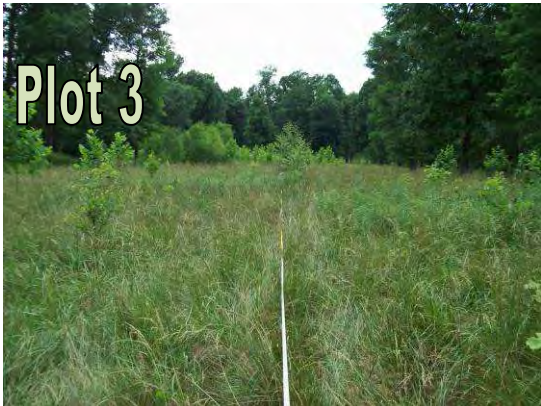
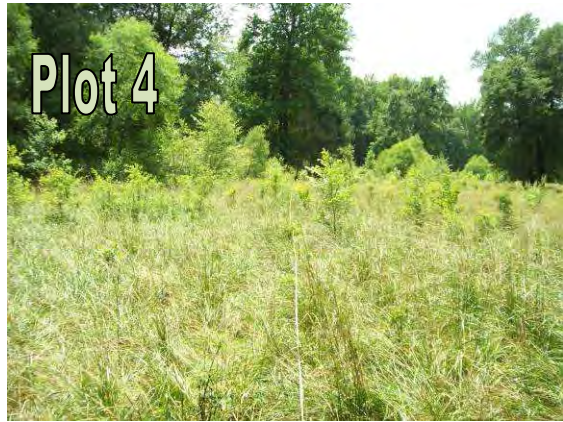
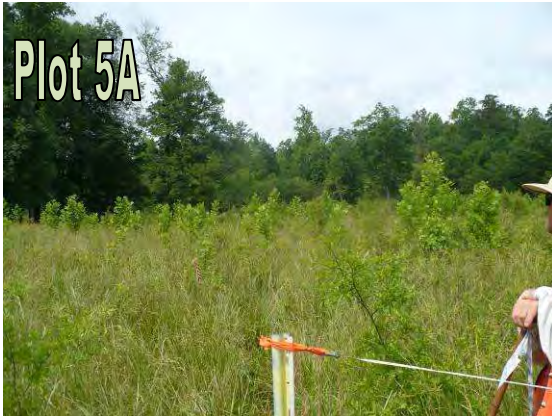
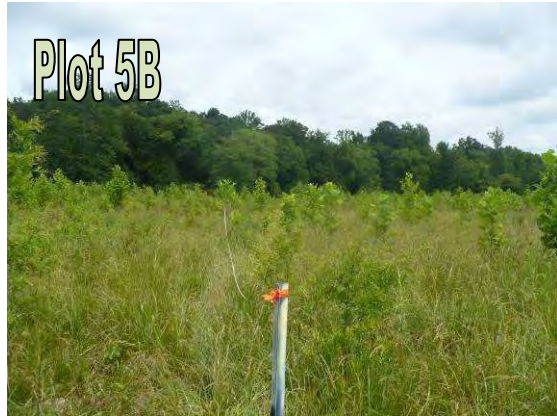
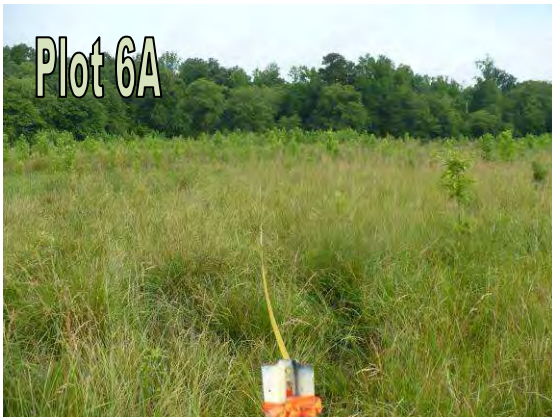
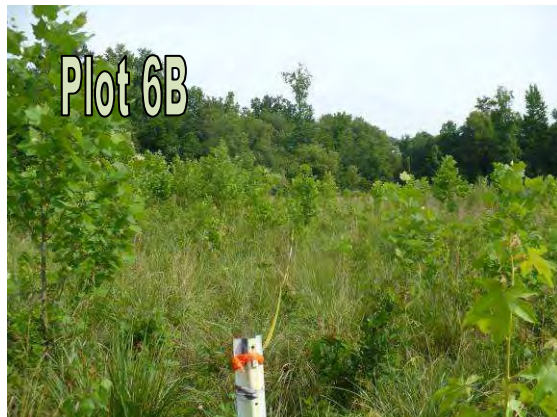
**Big Bull Creek Buffer Restoration Site Year 4 (2009) Annual Monitoring
Vegetation Plot Pictures Taken June 2009**

Quantitative sampling of vegetation was conducted in June 2009. Results are provided in Table 2. Vegetation success criteria for year 4 (320 stems per acre) were exceeded for the 2009 annual monitoring year with 5443 tree stems per acre across the Site. Each individual vegetation plot met success criteria and had good species diversity with 8 to 15 Character Tree Species present within each plot.
