**ANNUAL MONITORING REPORT
YEAR 5 (2010)
BIG BULL CREEK BUFFER RESTORATION SITE
JOHNSTON COUNTY, NORTH CAROLINA
(Contract Number D05015-2)**

October 2010

**BIG BULL CREEK BUFFER RESTORATION SITE
ANNUAL MONITORING REPORT
YEAR 5 (2010)
JOHNSTON COUNTY, NORTH CAROLINA**

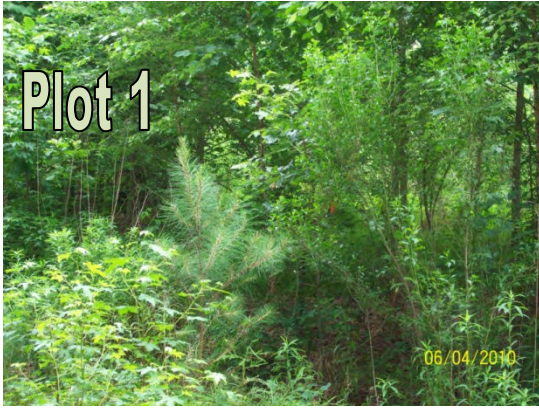
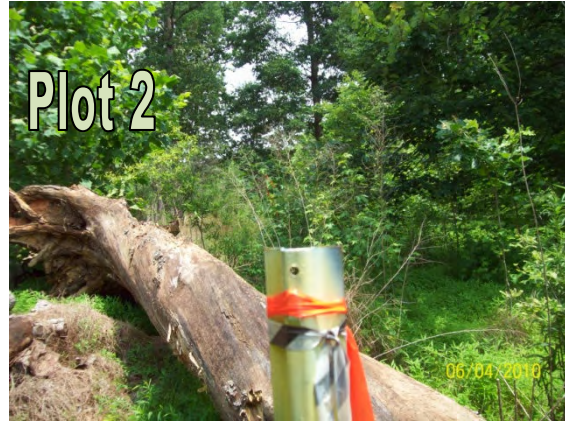
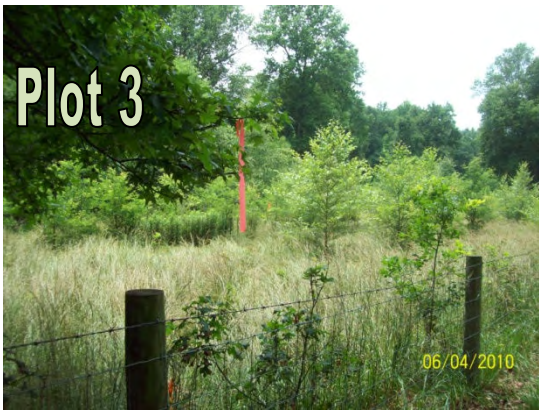
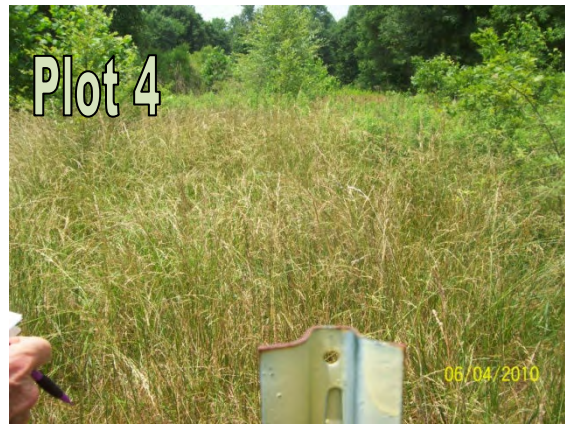
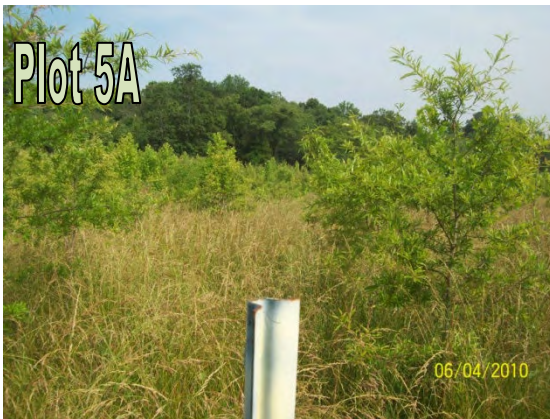
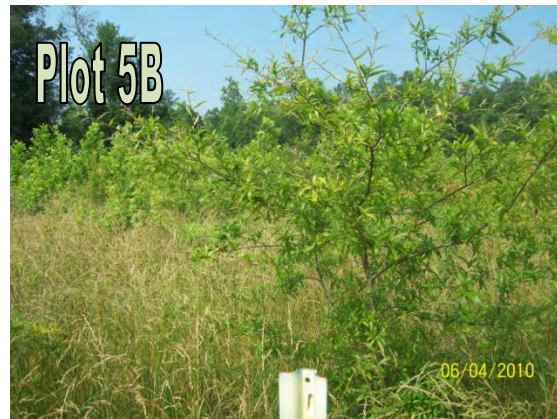
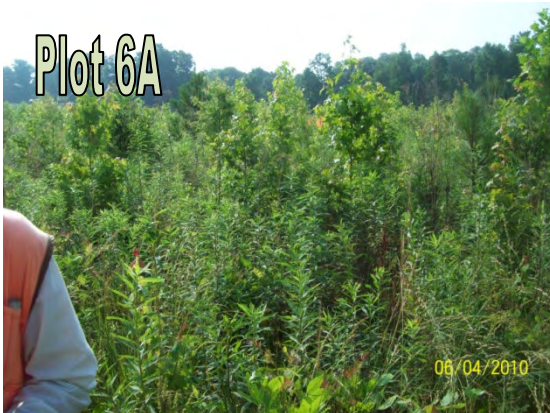
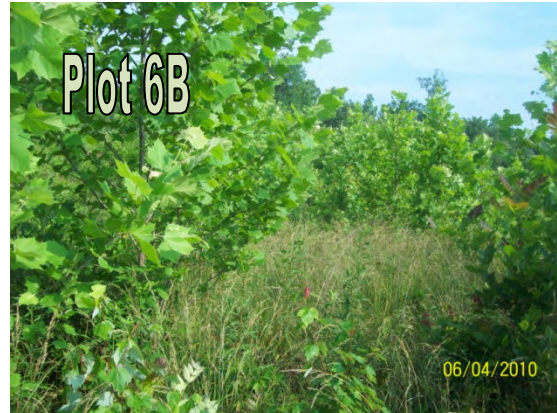
**Big Bull Creek Buffer Restoration Site Year 5 (2010) Annual Monitoring
Vegetation Plot Pictures Taken June 2010**

Quantitative sampling of vegetation was conducted in June 2010. Results are provided in Table 2. Vegetation success criteria for year 5 (320 stems per acre) were exceeded for the 2010 annual monitoring year with 6500 tree stems per acre across the Site. Each individual vegetation plot met success criteria and had good species diversity with 11 to 18 Character Tree Species present within each plot.
