Big Cedar Creek Stream Restoration Final Mitigation Plan and As-built Baseline Report Stanly County, North Carolina

EEP Project Number D06054-D

Submission Date: July 2009

Final Mitigation Plan and As-built Baseline Report

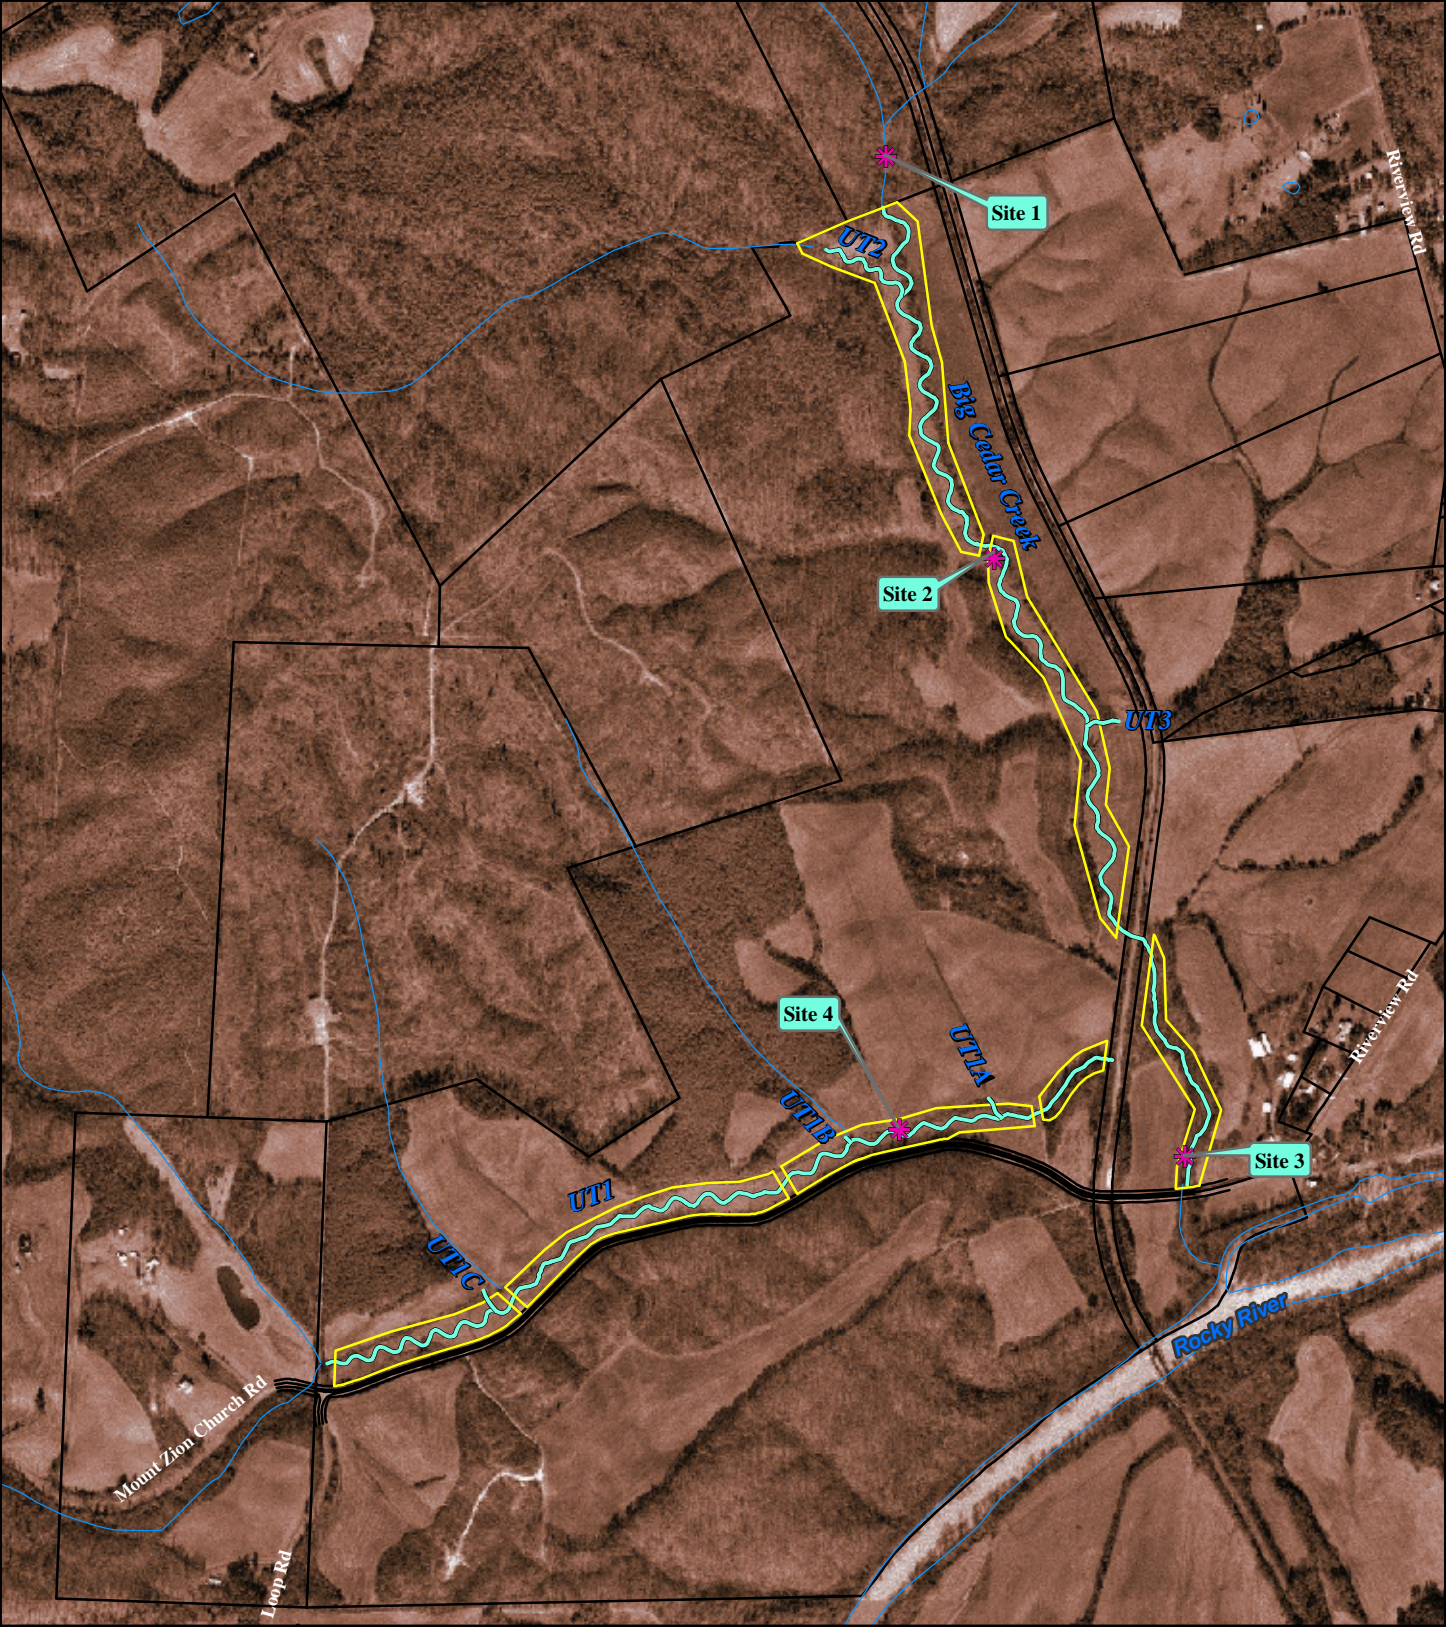
Pre-construction monitoring was conducted at three sites within the project limits and at one upstream reference site in September 2006 (Figure 3). The results of this sampling event will be used as a baseline for comparison of post restoration monitoring results. Post restoration monitoring sites shall be located in the same general vicinity as the pre restoration monitoring sites. In general, post restoration monitoring results should show trends towards biological distributions similar to that observed at the reference site.
