Re: NCIRT Review and USACE Approval of the Big Harris Draft Mitigation Plan; SAW-2009-00475; DMS Project #739

RE: Big Harris Creek Mitigation Site
Cleveland County, NC
Broad River Basin 06010105
Response to Mitigation Plan Comments

Figure 2a Site Map - Area A
 Big Harris Creek Mitigation Site
 Broad River Basin (03050105)
 Cleveland County, NC

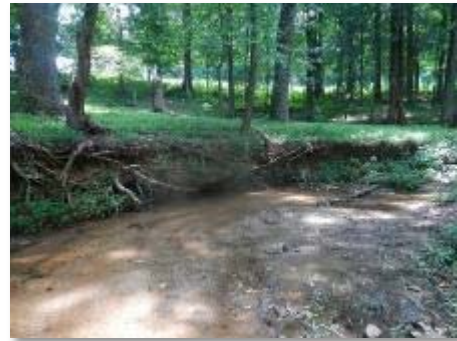
Lower Stick Elliott Creek

LSEC receives drainage from USEC in Project Area B. No impoundments are present in the watershed, and drainage to the system includes mostly forest and pastureland with some agricultural lots and some light public/institutional land use at the Union Elementary School. Hydrology to these reaches appears undisturbed but is likely impacted by the variety of land uses in the watershed. The channel is incised and overwidened and exhibits bedrock outcrops and good bedform diversity. The riparian buffer consists of mature woods. Cattle were observed throughout the reach. The approved Categorical Exclusion for the project notes that the federally threatened Dwarf-flowered heartleaf (*Hexastylis naniflora*) may be present within the buffer of this reach. A bedrock slide is present mid-reach and the creek flows through a large meander bend to join UBHC. LSEC exhibits active lateral erosion undermining mature tree roots and threatening the trees' overall stability. The reach includes undercut banks, some woody debris, root mats, bedrock outcrops, and some fine-grained riffles. While available aquatic habitats are varied, they are subject to fine sediment deposition from the actively eroding stream banks; depositional bars are present throughout the reach. LSEC appears to be in Simon Stage V (widening and depositing). The buffer through this section of the project consists of a mature, hardwood canopy with a sparse understory that is impacted by grazing.

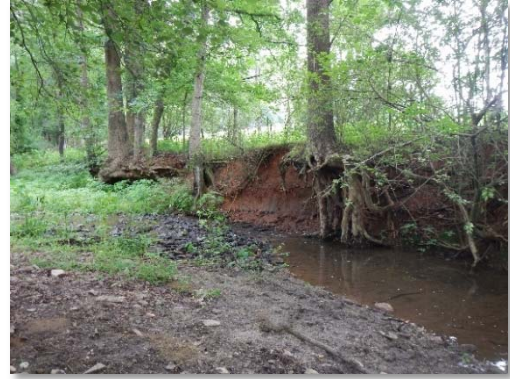
UBHC Reach 4 begins at an easement break between Stick Elliott Road and the confluence with Scism Creek just upstream of a bedrock slide on UBHC. The buffer along this reach is similar to UBHC Reach 3. There are mature trees throughout the buffer but there is a complete lack of understory due to livestock access. There are cattle pathways in and out of the channel throughout the reach that have caused additional bank failure and sedimentation of the stream bed.

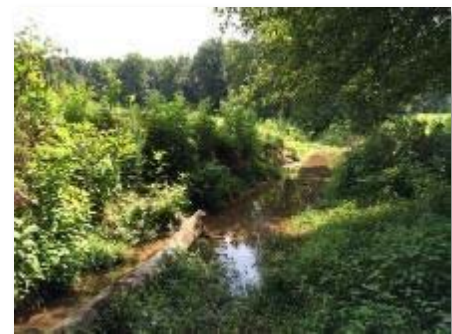
LFC Reach 1 flows through a cattle pasture with a 5 to 10-foot strip of large trees along both stream banks. LFC Reach 1 begins as a highly incised (BHR = 5.1) and overly wide channel. The stream was obviously channelized in the past and has subsequently widened (Simon Stage IV/V). Numerous livestock paths along the zone are contributing sediment, bacteria, and nutrients directly to the stream system. Many of the stream bank sections along Reach 1 are vertical or near vertical, with some undercutting of the trees along the banks. The reach bed material is composed of sand, gravel, and

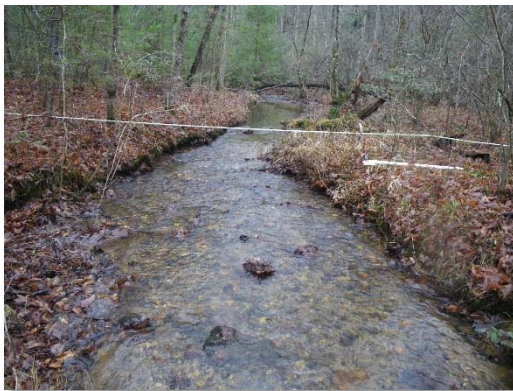
Consistent bankfull indicators on both banks through riffle section

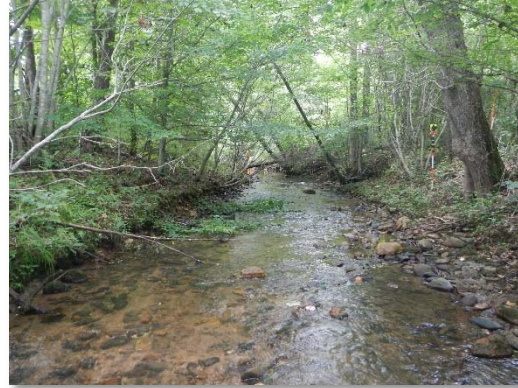
Consistent bankfull indicators on both banks of riffle section (looking downstream)
