**YEAR 2 MONITORING REPORT
for the
BIG WARRIOR AND LITTLE WARRIOR CREEKS
MITIGATION SITE**

Wilkes County, North Carolina
EEP Project Number: 92715

North Carolina Wildlife Resources Commission
Watershed Enhancement Group

November 2008

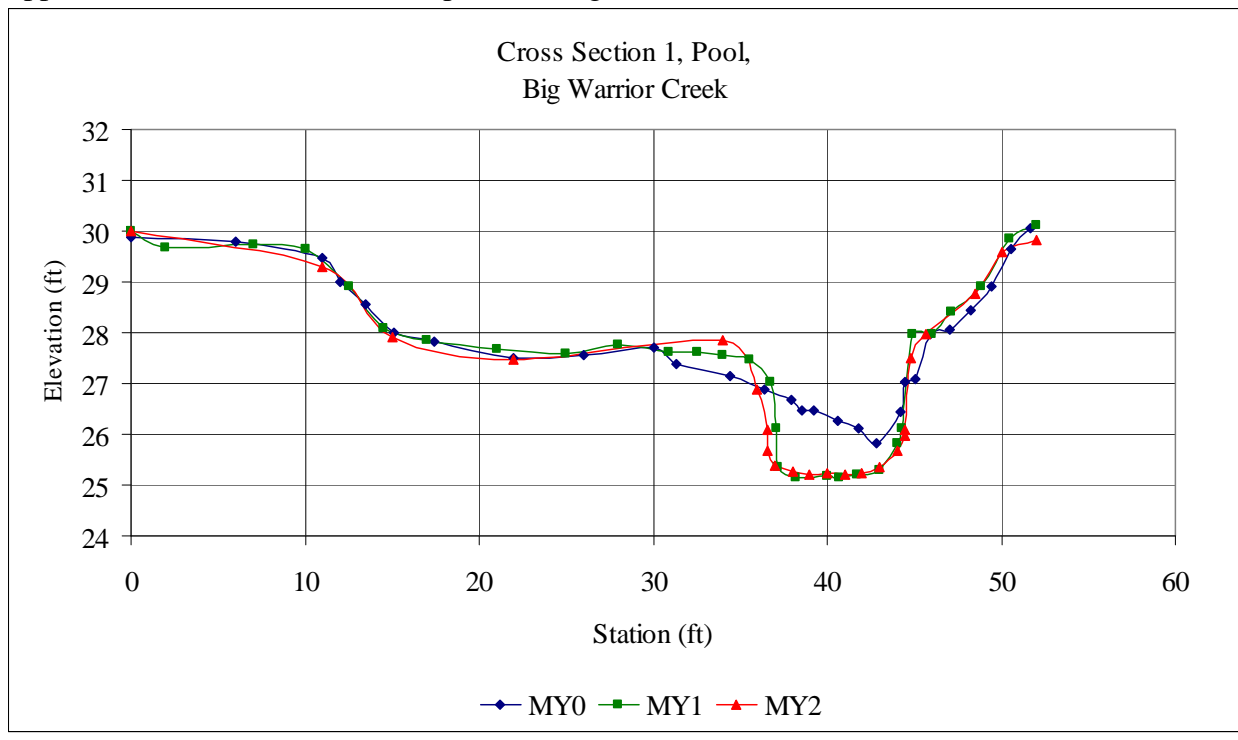
Appendix A.1. Cross-section comparisons Big Warrior Creek, MY0-MY2.

Cross-section 1 (Appendix A.1.): This cross-section transects a pool. The thalweg has degraded by 0.5 ft since the MY0. However both banks are stable and vegetated.

Cross-Section 1 Abbreviated Morphological Summary			
	MY0	MY1	MY2
Bankfull Cross Sectional Area (ft ²)	15.3	31.0	29.0
Maximum Bankfull Depth (ft)	1.9	3.0	2.7
Bankfull Mean Depth (ft)	1.0	1.0	0.9
Width/Depth Ratio	15.7		35.1
Entrenchment Ratio	2.6		1.6
Bankfull Width (ft)	15.5	31.8	31.9

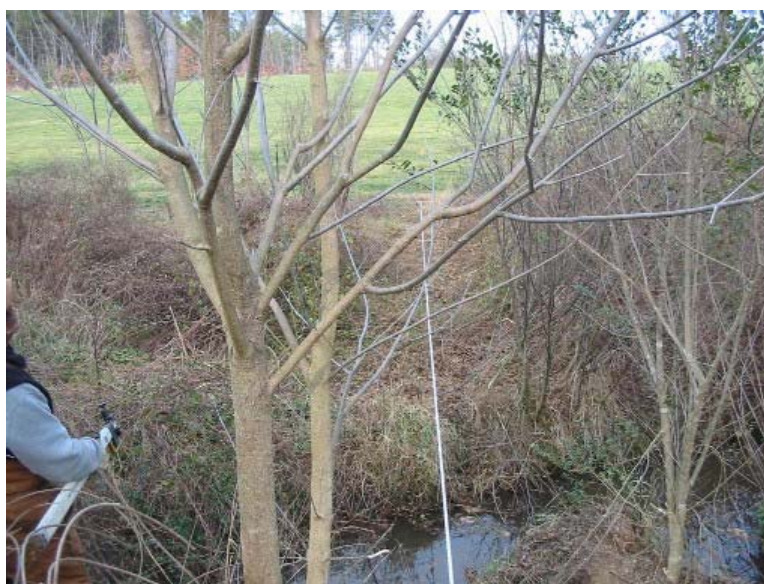
Cross-Section 2 Abbreviated Morphological Summary			
	MY0	MY1	MY2
Bankfull Cross Sectional Area (ft ²)	20.3	43.1	34.9
Maximum Bankfull Depth (ft)	2.8	3.8	3.4
Bankfull Mean Depth (ft)	1.6	1.3	1.1
Width/Depth Ratio	7.9	27.4	29.1
Entrenchment Ratio	5.3	2.9	1.7
Bankfull Width (ft)	12.7	34.4	31.9

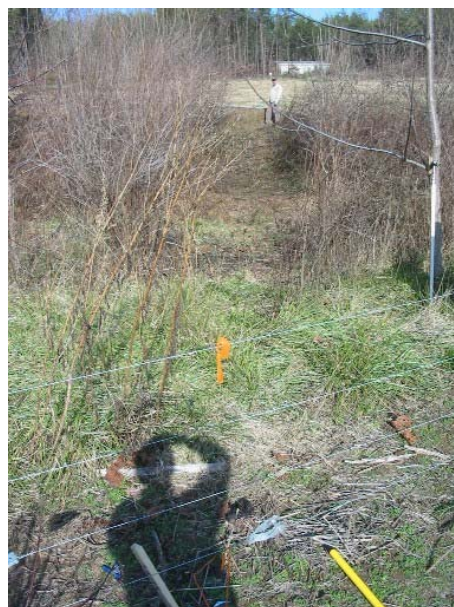
Cross-Section 3 Abbreviated Morphological Summary			
	MY0	MY1	MY2
Bankfull Cross Sectional Area (ft ²)	12.8	10.1	17.8
Maximum Bankfull Depth (ft)	2.1	1.9	2.1
Bankfull Mean Depth (ft)	1.0	1.0	1.0
Width/Depth Ratio	11.6	10.9	18.0
Entrenchment Ratio	6.9	6.5	3.7
Bankfull Width (ft)	12.2	10.5	17.9

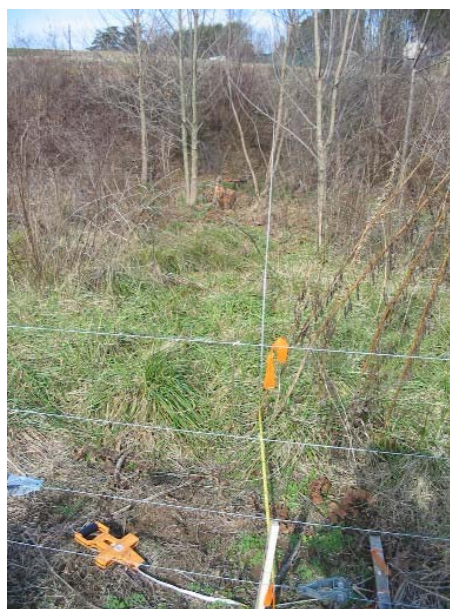
Cross-Section 4 Abbreviated Morphological Summary			
	MY0	MY1	MY2
Bankfull Cross Sectional Area (ft ²)	19.5	11.8	21.6
Maximum Bankfull Depth (ft)	2.6	2.2	2.9
Bankfull Mean Depth (ft)	1.1	1.5	1.4
Width/Depth Ratio			10.4
Entrenchment Ratio			4.2
Bankfull Width (ft)	17.5	8.0	15.0

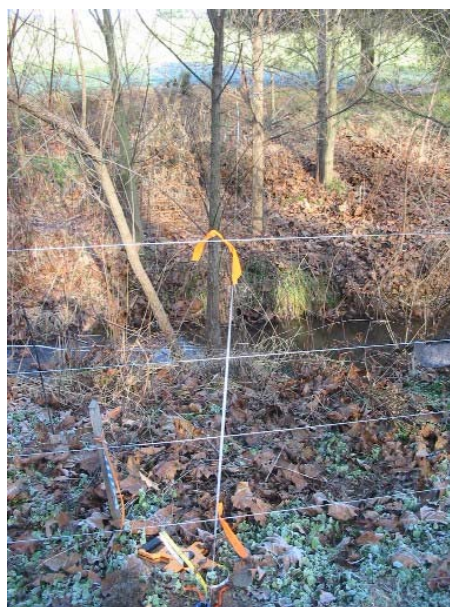
Cross-Section 5 Abbreviated Morphological Summary			
	MY0	MY1	MY2
Bankfull Cross Sectional Area (ft ²)	20.3	35.4	19.8
Maximum Bankfull Depth (ft)	1.9	2.5	2.1
Bankfull Mean Depth (ft)	1.0	1.3	0.8
Width/Depth Ratio	22.3	20.8	27.6
Entrenchment Ratio	1.5	2.4	1.6
Bankfull Width (ft)	21.3	27.2	23.4

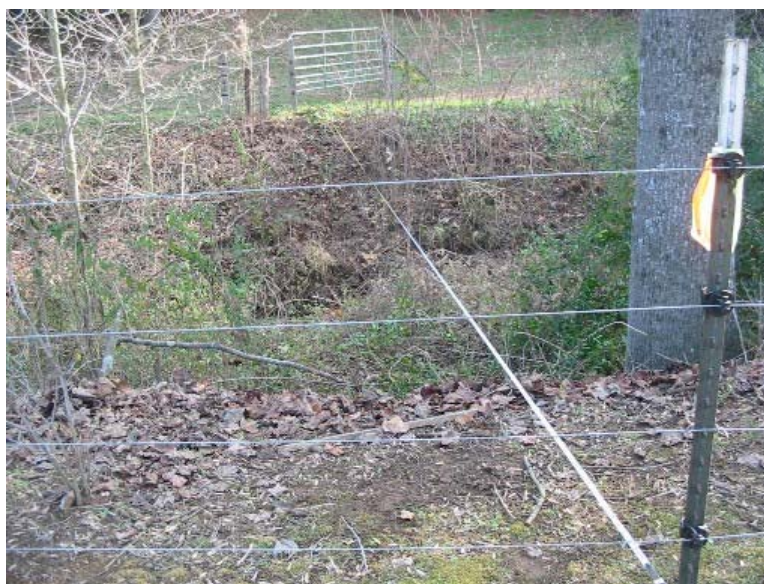
Cross-Section 6 Abbreviated Morphological Summary			
	MY0	MY1	MY2
Bankfull Cross Sectional Area (ft ²)	22.3	10.0	14.3
Maximum Bankfull Depth (ft)	2.2	1.5	1.8
Bankfull Mean Depth (ft)	1.4	1.1	1.0
Width/Depth Ratio	10.9	8.3	15.3
Entrenchment Ratio	2.3	3.9	2.2
Bankfull Width (ft)	15.6	9.1	14.8

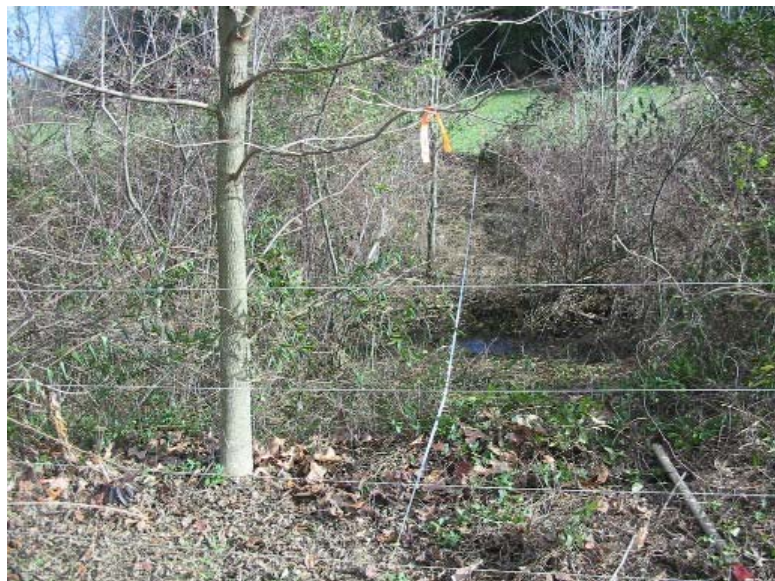
Cross-Section 7 Abbreviated Morphological Summary			
	MY0	MY1	MY2
Bankfull Cross Sectional Area (ft ²)	16.4	27.2	23.1
Maximum Bankfull Depth (ft)	2.3	2.6	2.4
Bankfull Mean Depth (ft)	1.1	1.1	1.0
Width/Depth Ratio	14.1	24.6	23.2
Entrenchment Ratio	2.3	1.5	1.6
Bankfull Width (ft)	15.2	25.8	23.2

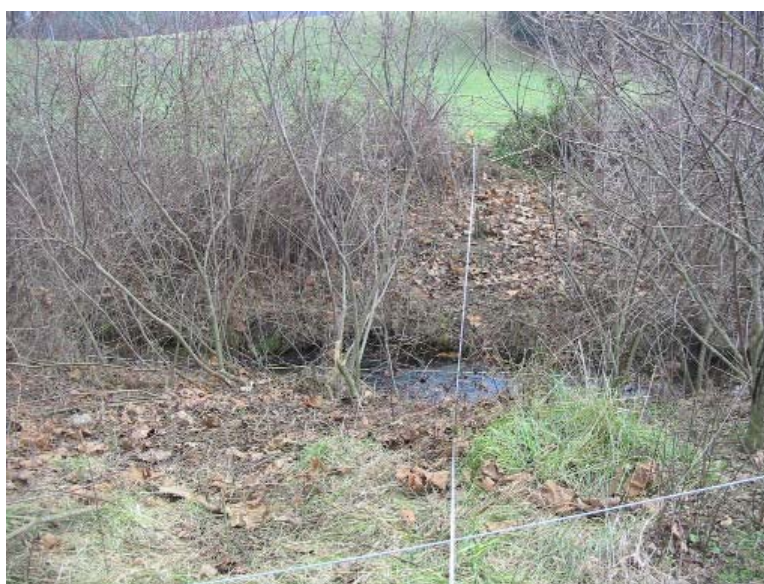
Cross-Section 8 Abbreviated Morphological Summary			
	MY0	MY1	MY2
Bankfull Cross Sectional Area (ft ²)	15.3	5.8	11.3
Maximum Bankfull Depth (ft)	2.4	1.3	1.5
Bankfull Mean Depth (ft)	1.1	0.9	0.8
Width/Depth Ratio	12.8	6.5	17.1
Entrenchment Ratio	3.5	3.3	2.0
Bankfull Width (ft)	14.0	6.1	13.9

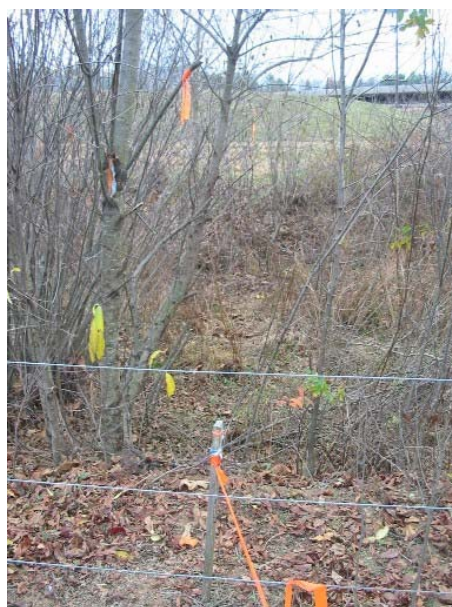
Cross-Section 9 Abbreviated Morphological Summary			
	MY0	MY1	MY2
Bankfull Cross Sectional Area (ft ²)	16.0	13.2	14.5
Maximum Bankfull Depth (ft)	1.7	1.8	1.9
Bankfull Mean Depth (ft)	0.5	0.4	0.5
Width/Depth Ratio	64.1	70.7	63.2
Entrenchment Ratio	1.2	1.3	1.2
Bankfull Width (ft)	32.0	30.6	31.6

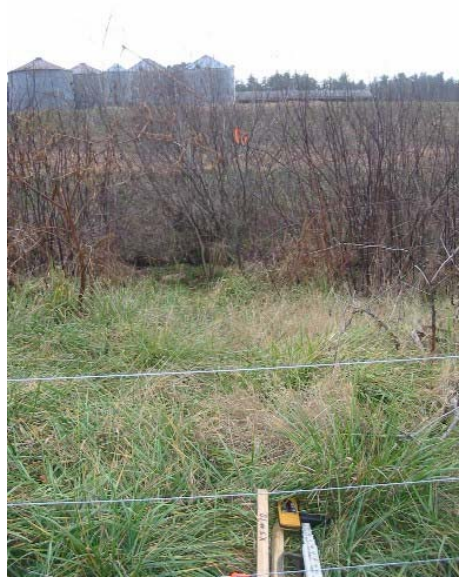
Cross-Section 10 Abbreviated Morphological Summary			
	MY0	MY1	MY2
Bankfull Cross Sectional Area (ft ²)	13.9	10.3	9.1
Maximum Bankfull Depth (ft)	1.2	1.5	1.4
Bankfull Mean Depth (ft)	0.7	0.5	0.5
Width/Depth Ratio	32.1	35.7	43.1
Entrenchment Ratio	1.6	1.7	1.8
Bankfull Width (ft)	21.1	19.2	19.8

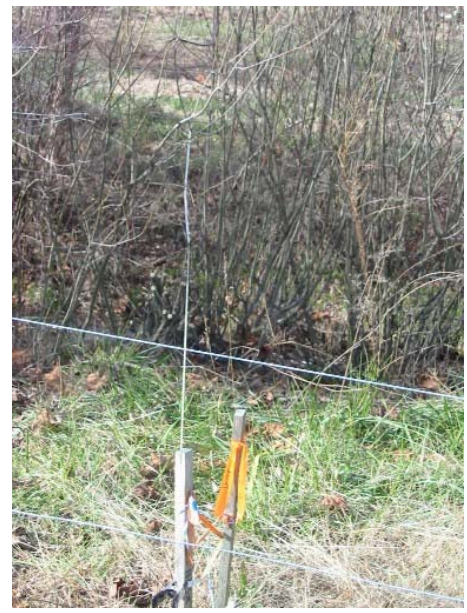
Cross-Section 11 Abbreviated Morphological Summary			
	MY0	MY1	MY2
Bankfull Cross Sectional Area (ft ²)	20.2	7.6	9.9
Maximum Bankfull Depth (ft)	2.1	1.3	1.3
Bankfull Mean Depth (ft)	1.3	0.9	0.9
Width/Depth Ratio	11.7	9.2	13.1
Entrenchment Ratio	2.5	2.4	1.8
Bankfull Width (ft)	15.4	8.4	11.4

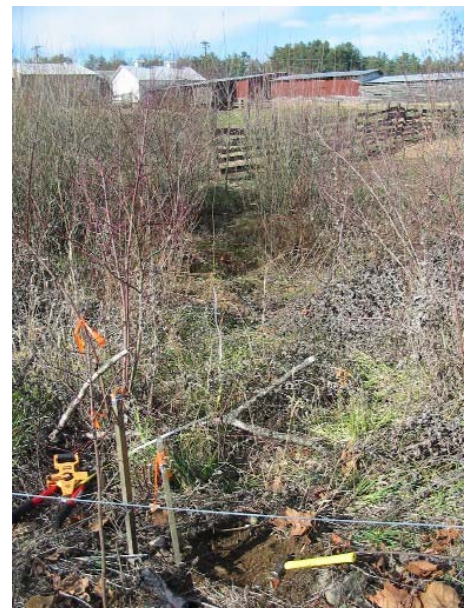
Cross-Section 12 Abbreviated Morphological Summary			
	MY0	MY1	MY2
Bankfull Cross Sectional Area (ft ²)	20.4	10.8	13.6
Maximum Bankfull Depth (ft)	2.0	1.5	1.7
Bankfull Mean Depth (ft)	1.3	0.8	0.8
Width/Depth Ratio	11.6	18.1	18.9
Entrenchment Ratio	2.7	2.9	2.8
Bankfull Width (ft)	15.4	14.0	16.0

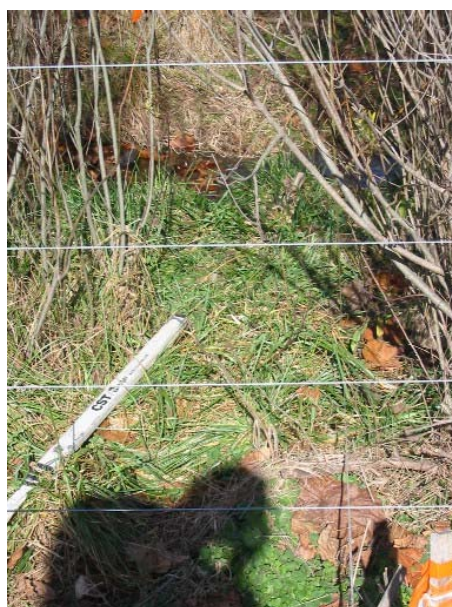
Cross-Section 13 Abbreviated Morphological Summary			
	MY0	MY1	MY2
Bankfull Cross Sectional Area (ft ²)	20.5	8.0	9.8
Maximum Bankfull Depth (ft)	1.6	1.0	1.2
Bankfull Mean Depth (ft)	1.6	0.3	0.3
Width/Depth Ratio	8.2	66.1	86.8
Entrenchment Ratio	3.4	2.6	1.8
Bankfull Width (ft)	13.0	23.0	29.2

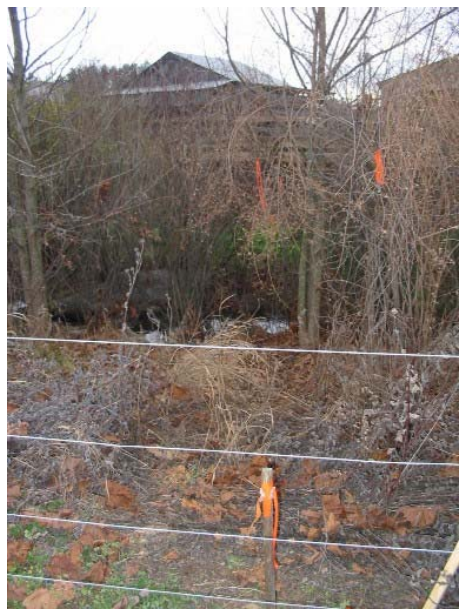
Cross-Section 14 Abbreviated Morphological Summary			
	MY0	MY1	MY2
Bankfull Cross Sectional Area (ft ²)	24.7	8.3	14.9
Maximum Bankfull Depth (ft)	2.7	1.5	1.7
Bankfull Mean Depth (ft)	1.9	0.7	0.9
Width/Depth Ratio			18.9
Entrenchment Ratio			2.0
Bankfull Width (ft)	13.3	11.6	16.8

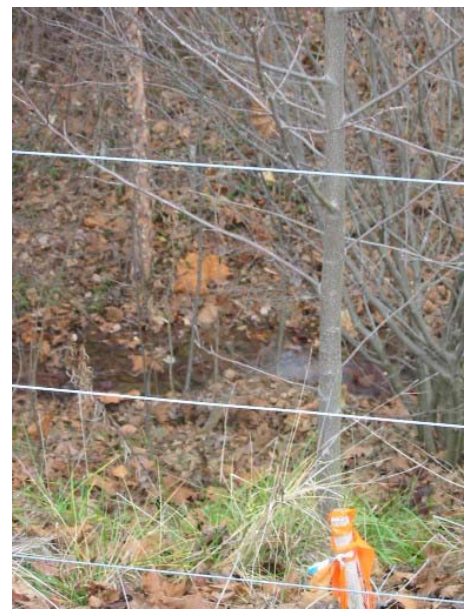
Cross-Section 15 Abbreviated Morphological Summary			
	MY0	MY1	MY2
Bankfull Cross Sectional Area (ft ²)	17.3	10.5	10.9
Maximum Bankfull Depth (ft)	2.1	1.5	1.5
Bankfull Mean Depth (ft)	1.2	1.1	1.1
Width/Depth Ratio	11.4	8.4	9.1
Entrenchment Ratio	2.5	2.6	2.1
Bankfull Width (ft)	14.0	9.4	10.0

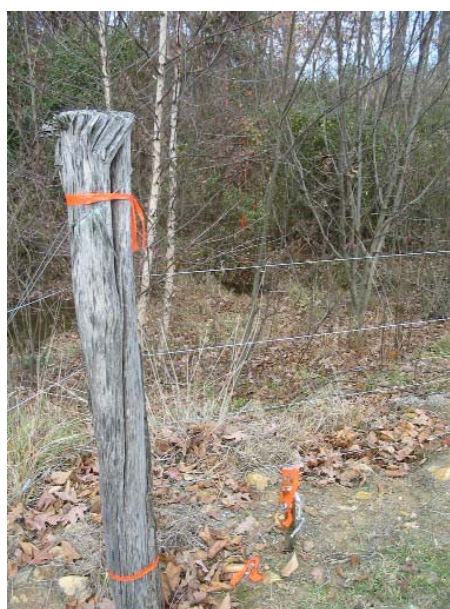
Cross-Section 16 Abbreviated Morphological Summary			
	MY0	MY1	MY2
Bankfull Cross Sectional Area (ft ²)	40.7	15.3	18.9
Maximum Bankfull Depth (ft)	3.0	1.7	2.0
Bankfull Mean Depth (ft)	2.9	0.9	0.9
Width/Depth Ratio	72.6	17.3	22.0
Entrenchment Ratio	2.5	3.4	1.2
Bankfull Width (ft)	14.0	16.3	20.4

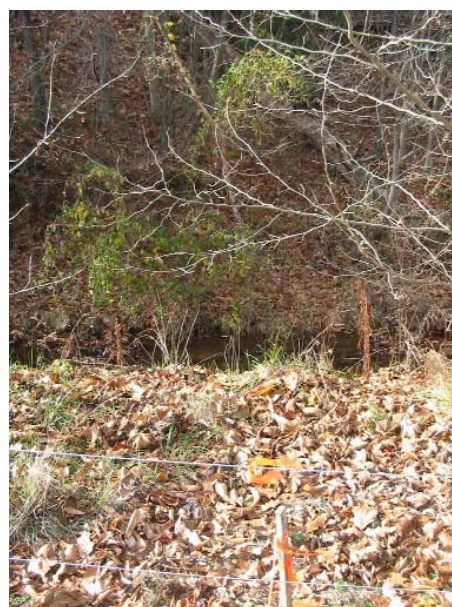
Cross-Section 18 Abbreviated Morphological Summary			
	MY0	MY1	MY2
Bankfull Cross Sectional Area (ft ²)	10.5	12.5	11.5
Maximum Bankfull Depth (ft)	1.5	1.5	1.5
Bankfull Mean Depth (ft)	0.8	0.8	0.7
Width/Depth Ratio	18.6	19.9	22.3
Entrenchment Ratio	2.5	1.9	1.7
Bankfull Width (ft)	14.0	15.7	16.1

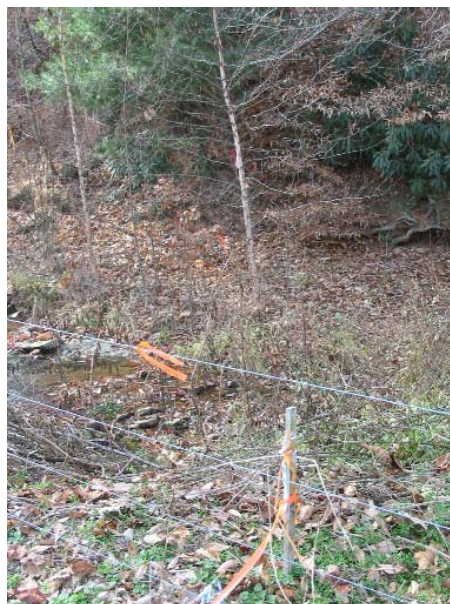
Cross-Section 19 Abbreviated Morphological Summary			
	MY0	MY1	MY2
Bankfull Cross Sectional Area (ft ²)	16.0	9.8	10.7
Maximum Bankfull Depth (ft)	1.5	1.1	1.3
Bankfull Mean Depth (ft)	0.9	0.8	0.8
Width/Depth Ratio	18.5	16.7	16.8
Entrenchment Ratio	1.7	1.8	1.9
Bankfull Width (ft)	17.2	12.8	13.4

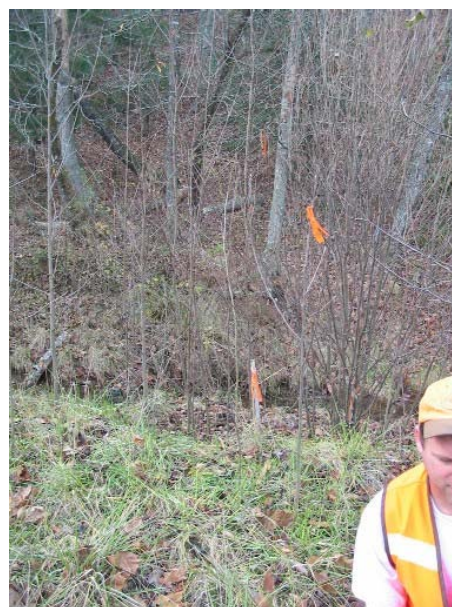
Cross-Section 20 Abbreviated Morphological Summary			
	MY0	MY1	MY2
Bankfull Cross Sectional Area (ft ²)	14.8	5.4	8.6
Maximum Bankfull Depth (ft)	1.6	1.0	1.3
Bankfull Mean Depth (ft)	0.9	0.6	0.7
Width/Depth Ratio	17.3	15.5	18.1
Entrenchment Ratio	1.6	1.9	1.5
Bankfull Width (ft)	16.0	9.1	12.5

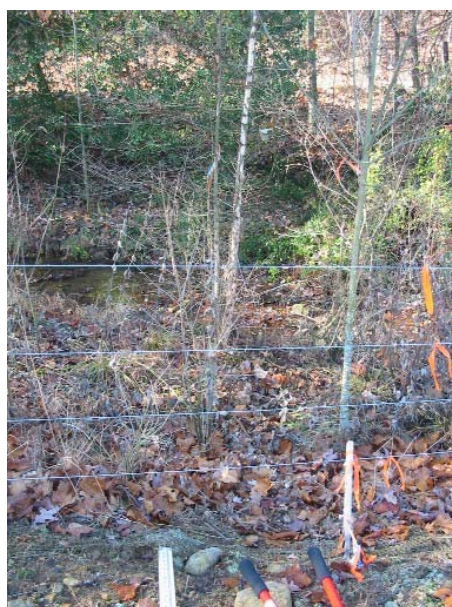
Cross-Section 21 Abbreviated Morphological Summary			
	MY0	MY1	MY2
Bankfull Cross Sectional Area (ft ²)	12.3	18.8	14.7
Maximum Bankfull Depth (ft)	1.4	1.5	1.3
Bankfull Mean Depth (ft)	0.9	0.8	0.9
Width/Depth Ratio			17.2
Entrenchment Ratio			2.2
Bankfull Width (ft)	14.0	23.6	15.9

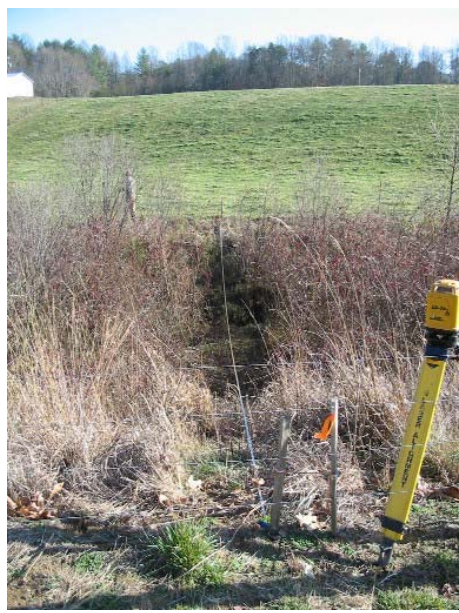
Cross-Section 1 Abbreviated Morphological Summary			
	MY0	MY1	MY2
Bankfull Cross Sectional Area (ft ²)	18.7	12.0	15.2
Maximum Bankfull Depth (ft)	2.8	2.0	2.7
Bankfull Mean Depth (ft)	1.0	1.4	1.4
Width/Depth Ratio	19.8		7.6
Entrenchment Ratio	1.9		3.6
Bankfull Width (ft)	19.2	8.9	10.7

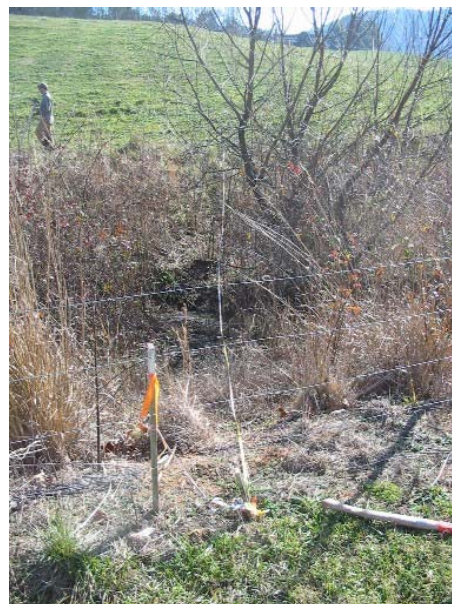
Cross-Section 2 Abbreviated Morphological Summary			
	MY0	MY1	MY2
Bankfull Cross Sectional Area (ft ²)	16.1	10.0	13.8
Maximum Bankfull Depth (ft)	2.2	1.8	2.2
Bankfull Mean Depth (ft)	1.5	1.1	0.9
Width/Depth Ratio	7.5	8.7	16.6
Entrenchment Ratio	1.8	3.3	2.3
Bankfull Width (ft)	11.0	9.4	15.1

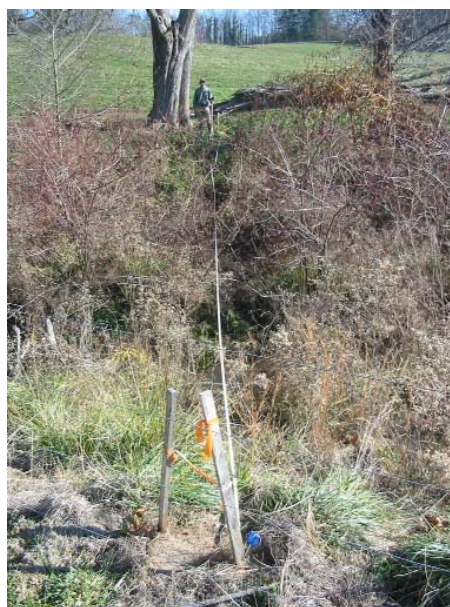
Cross-Section 3 Abbreviated Morphological Summary			
	MY0	MY1	MY2
Bankfull Cross Sectional Area (ft ²)	23.8	10.9	20.1
Maximum Bankfull Depth (ft)	2.8	1.9	2.7
Bankfull Mean Depth (ft)	2.2	1.2	1.5
Width/Depth Ratio	5.1		9
Entrenchment Ratio	1.8		2.9
Bankfull Width (ft)	11.0	9.4	13.5

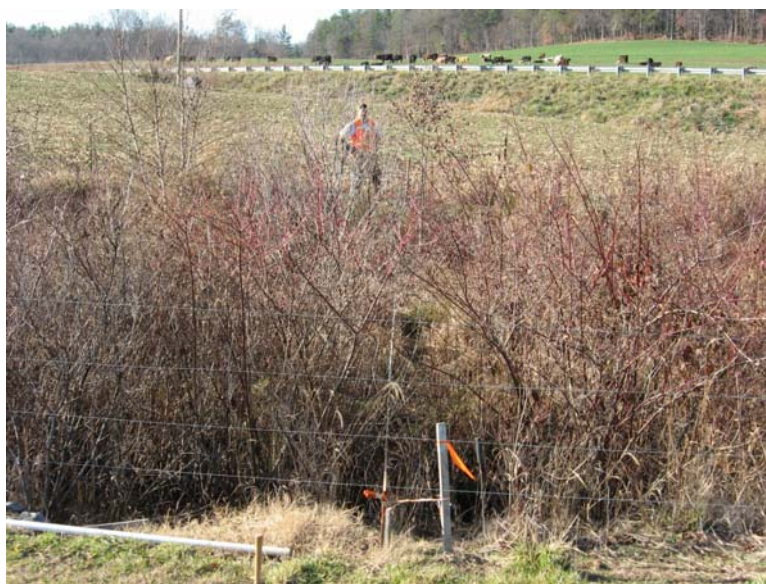
Cross-Section 4 Abbreviated Morphological Summary			
	MY0	MY1	MY2
Bankfull Cross Sectional Area (ft ²)	15.5	6.5	11.3
Maximum Bankfull Depth (ft)	1.7	1.2	2.0
Bankfull Mean Depth (ft)	1.4	0.9	1.1
Width/Depth Ratio	7.8	8.9	9.6
Entrenchment Ratio	1.8	4.5	3.8
Bankfull Width (ft)	11.0	7.6	10.4

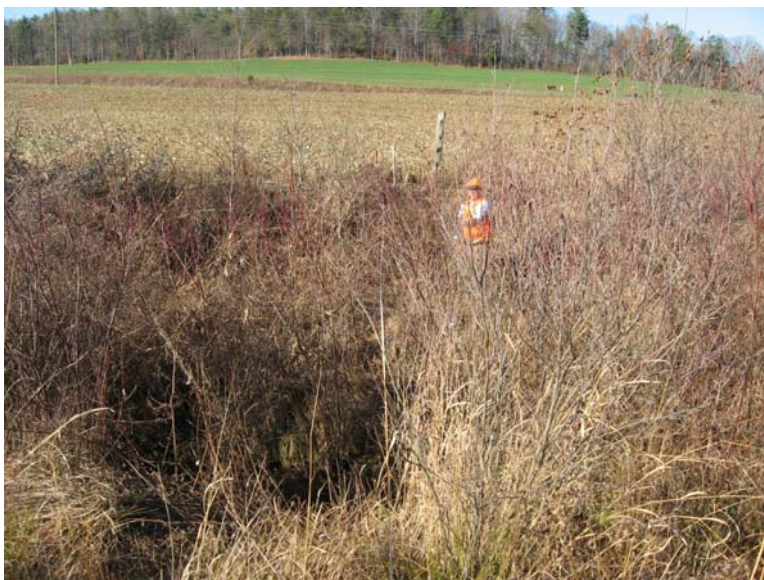
Cross-Section 5 Abbreviated Morphological Summary			
	MY0	MY1	MY2
Bankfull Cross Sectional Area (ft ²)	16.5	10.0	14.3
Maximum Bankfull Depth (ft)	2.7	1.5	2.1
Bankfull Mean Depth (ft)	1.5	1.1	1.2
Width/Depth Ratio	7.3	8.1	9.4
Entrenchment Ratio	1.8	3.0	2.8
Bankfull Width (ft)	11.0	9.0	11.6

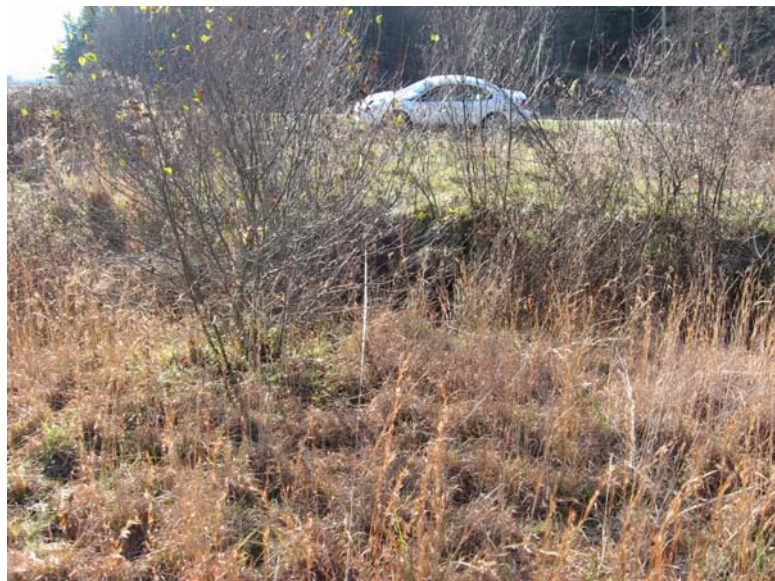
Cross-Section 6 Abbreviated Morphological Summary			
	MY0	MY1	MY2
Bankfull Cross Sectional Area (ft ²)	10.2	5.8	6.0
Maximum Bankfull Depth (ft)	2.0	1.7	1.6
Bankfull Mean Depth (ft)	0.9	1.3	1.1
Width/Depth Ratio	11.8	3.6	5.3
Entrenchment Ratio	1.8	8.7	2.2
Bankfull Width (ft)	11.0	4.6	5.6

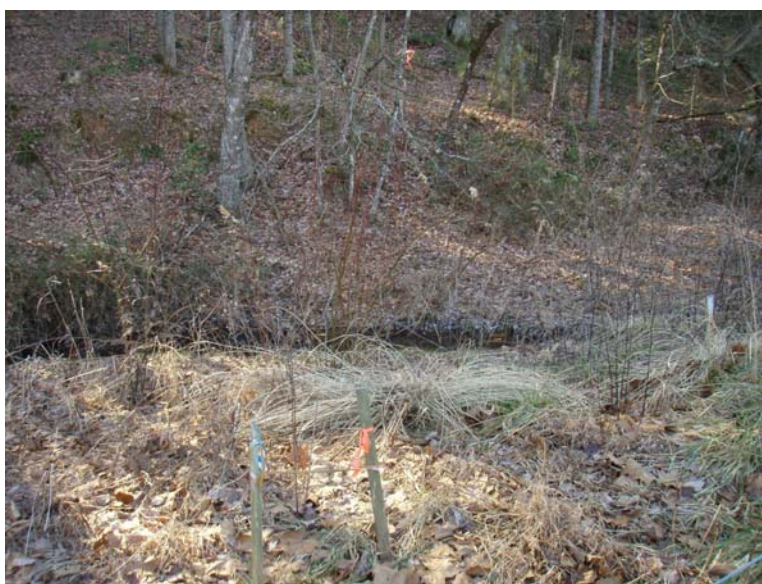
Cross-Section 7 Abbreviated Morphological Summary			
	MY0	MY1	MY2
Bankfull Cross Sectional Area (ft ²)	10.6	2.2	11.5
Maximum Bankfull Depth (ft)	1.3	0.6	1.6
Bankfull Mean Depth (ft)	1.0	0.4	0.8
Width/Depth Ratio	11.4	12.5	20.4
Entrenchment Ratio	1.8	3.0	2.1
Bankfull Width (ft)	11.0	5.3	15.3

Cross-section 7 (Appendix A.2.): This cross-section transects a riffle. During post-processing the MY2 data was adjusted 3.5 ft to the left to align the cross-section points with the previous years' data. This adjustment was necessary because the left end pin had been disturbed. This cross-section did not exhibit any signs of instability. The right bank does appear to have degraded somewhat between MY1 and MY2. The channel thalweg and both banks are stable and the banks are well vegetated.

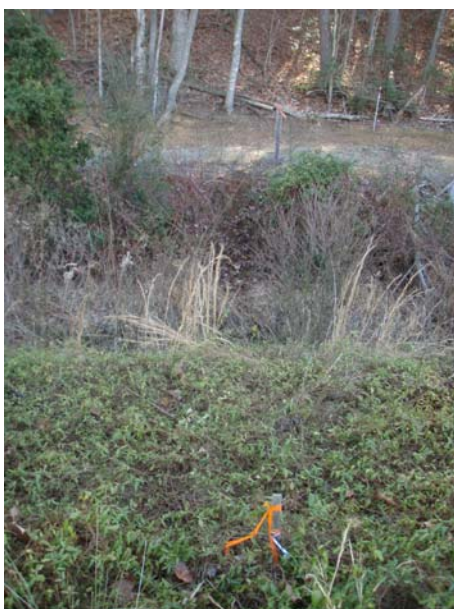
Cross-Section 8 Abbreviated Morphological Summary			
	MY0	MY1	MY2
Bankfull Cross Sectional Area (ft ²)	7.0	3.5	8.2
Maximum Bankfull Depth (ft)	1.2	1.1	1.7
Bankfull Mean Depth (ft)	0.6	0.8	0.6
Width/Depth Ratio	17.2		22.6
Entrenchment Ratio	1.8		1.4
Width/Depth Ratio	11.0	4.2	13.6

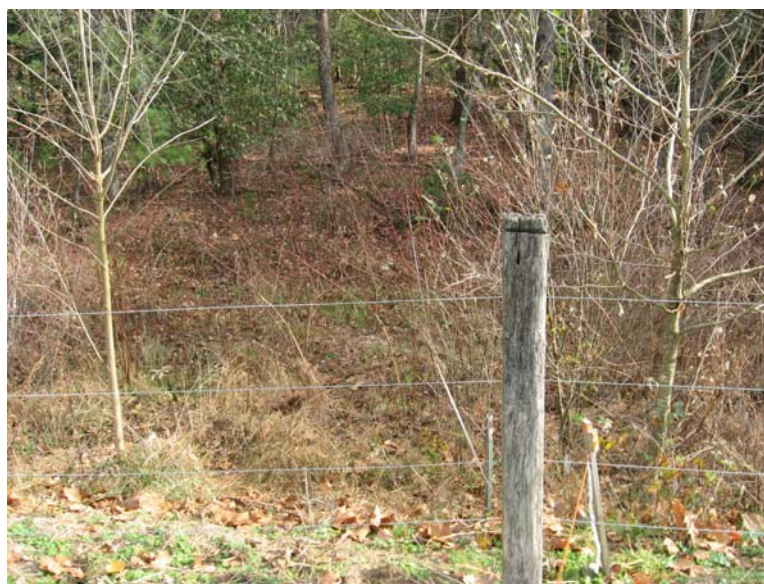
Cross-Section 9 Abbreviated Morphological Summary			
	MY0	MY1	MY2
Bankfull Cross Sectional Area (ft ²)	5.4	5.7	5.9
Maximum Bankfull Depth (ft)	1.1	1.4	1.5
Bankfull Mean Depth (ft)	0.5	0.5	0.4
Width/Depth Ratio	22.5		42.8
Entrenchment Ratio	1.8		1.7
Bankfull Width (ft)	11.0	12.0	15.8

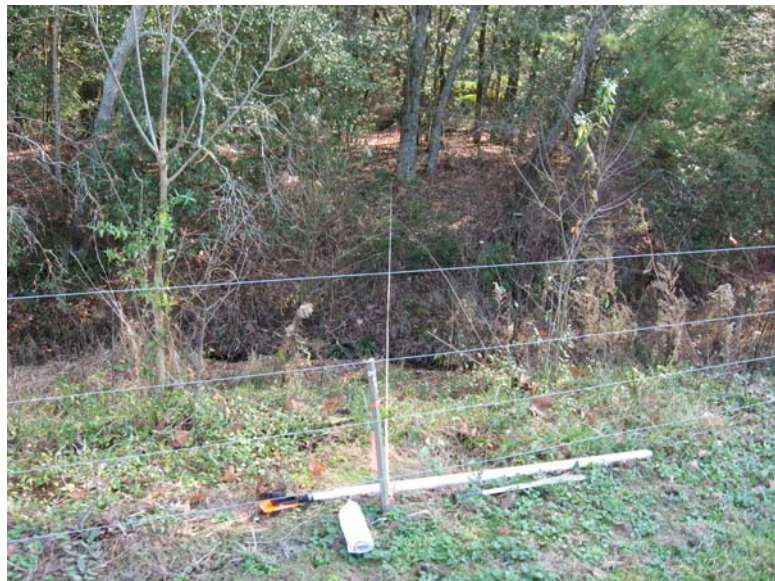
Cross-Section 10 Abbreviated Morphological Summary			
	MY0	MY1	MY2
Bankfull Cross Sectional Area (ft ²)	7.2	1.8	4.2
Maximum Bankfull Depth (ft)	1.2	0.7	1.3
Bankfull Mean Depth (ft)	0.7	0.5	0.7
Width/Depth Ratio	16.9	7.3	8.3
Entrenchment Ratio	1.8	2.7	2.6
Bankfull Width (ft)	11.0	3.7	5.9

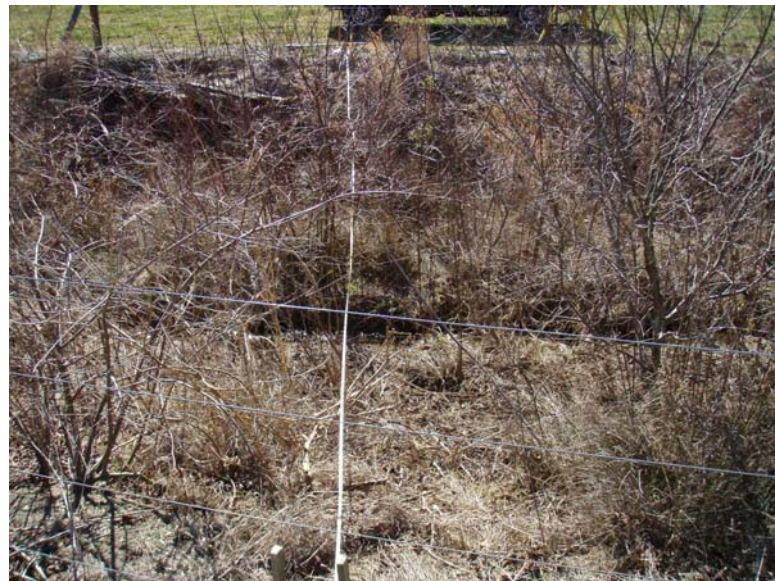
Cross-Section 11 Abbreviated Morphological Summary			
	MY0	MY1	MY2
Bankfull Cross Sectional Area (ft ²)	3.8	1.4	4.1
Maximum Bankfull Depth (ft)	0.8	0.9	1.2
Bankfull Mean Depth (ft)	0.4	0.6	0.6
Width/Depth Ratio	21.3	4.2	12.3
Entrenchment Ratio	1.9	7.0	2.9
Bankfull Width (ft)	9.0	2.4	7.1

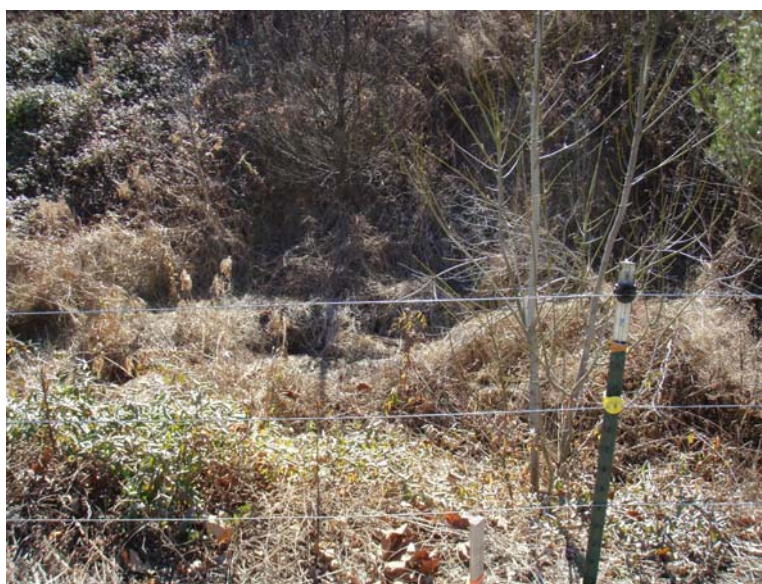
Cross-Section 13 Abbreviated Morphological Summary			
	MY0	MY1	MY2
Bankfull Cross Sectional Area (ft ²)	3.6	13.1	1.6
Maximum Bankfull Depth (ft)	1.1	1.8	0.4
Bankfull Mean Depth (ft)	0.4	0.8	0.2
Width/Depth Ratio	20.3	21.2	48.3
Entrenchment Ratio	2.1	1.4	2.0
Bankfull Width (ft)	8.5	16.7	8.8

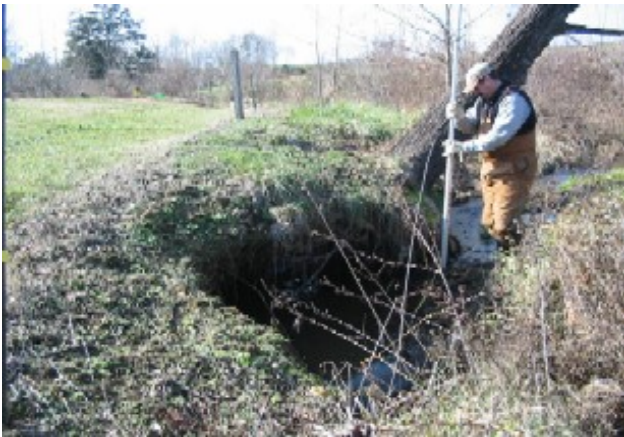
The first problem area is near longitudinal profile station 4+66 (lower pasture) on Big Warrior Creek. A large walnut tree, on the right bank, is leaning over the stream and the flow of water is directed toward it (Appendix C.1.3.). The water's flow has scoured under the tree's root system causing the tree and right bank to collapse. The easement boundary fence and stream channel will be compromised should the walnut tree fall. This could cause the stream to encroach into the adjacent pasture.

Area below cross-section 4. Note: large walnut tree leaning.

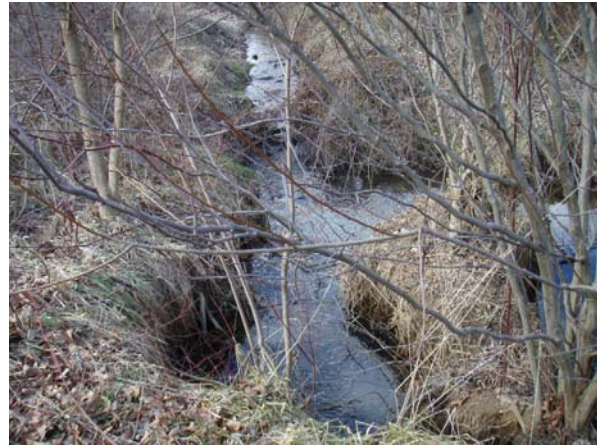
Area below cross-section 2.

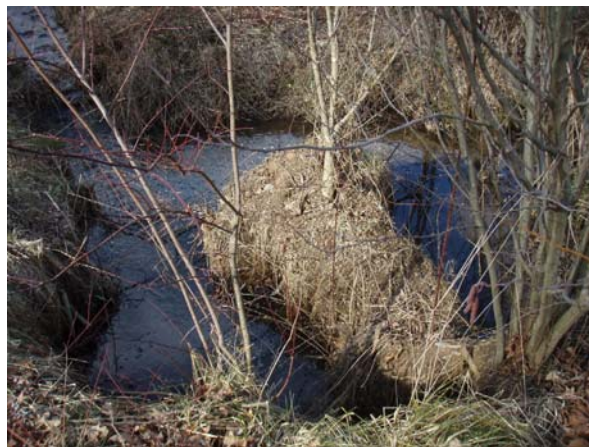
Area below cross-section 2.

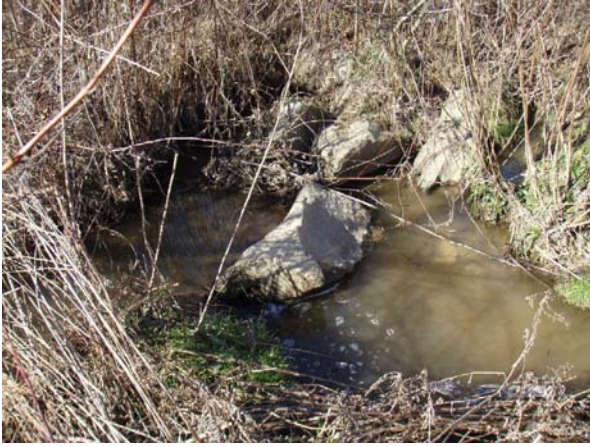
Area in the vicinity of cross-section 2. Water is piping through the boulders.

Downstream of the culvert on Andrews Road (SR 1256) water was piping through a constructed rock structure. The NCWRC used a combination of geotextile fabric and repositioned boulders to eliminate the flow of water through this structure. This repair was found to be functioning properly during the MY2 survey.

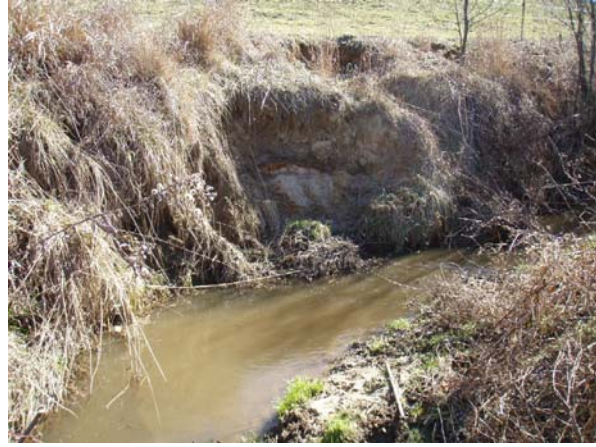
Area between cross-sections 1 and 2, LUS. Banks are sloughing due to overland flow.

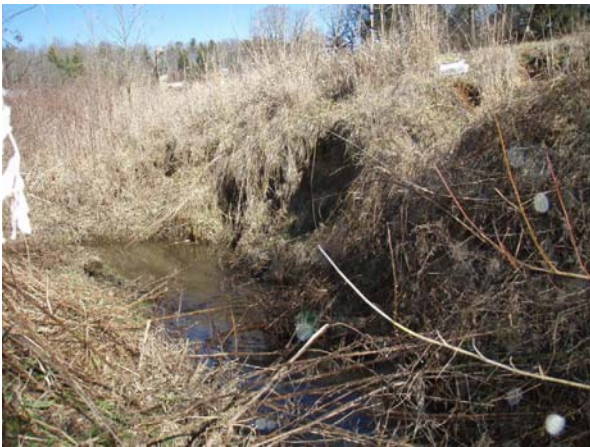
Area between cross-sections 1 and 2, LDS.

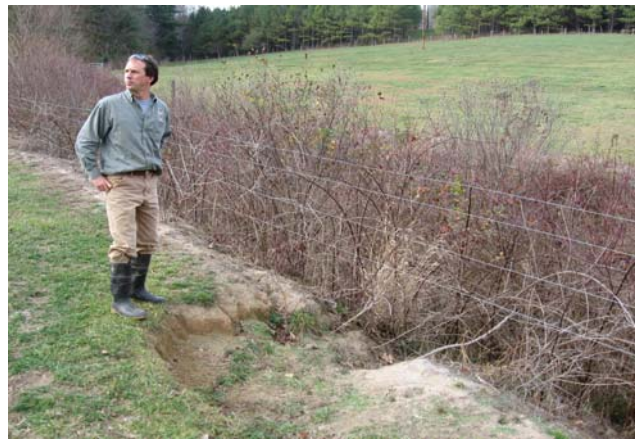
Area located on an unnamed tributary to Little Warrior Creek.

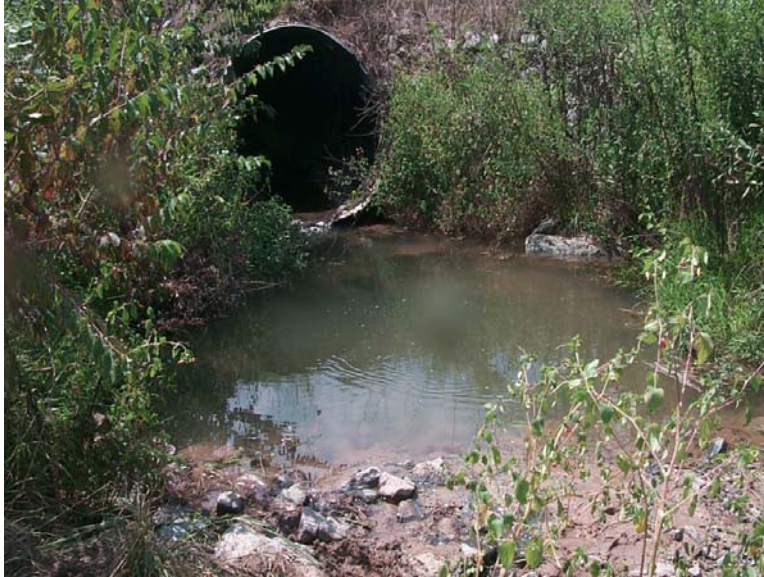
Appendix C.3. 2005 Little Warrior Creek stream repair photographs.

Repositioned boulders and added geotextile fabric to the rock sill in front of the culvert, September 2005.

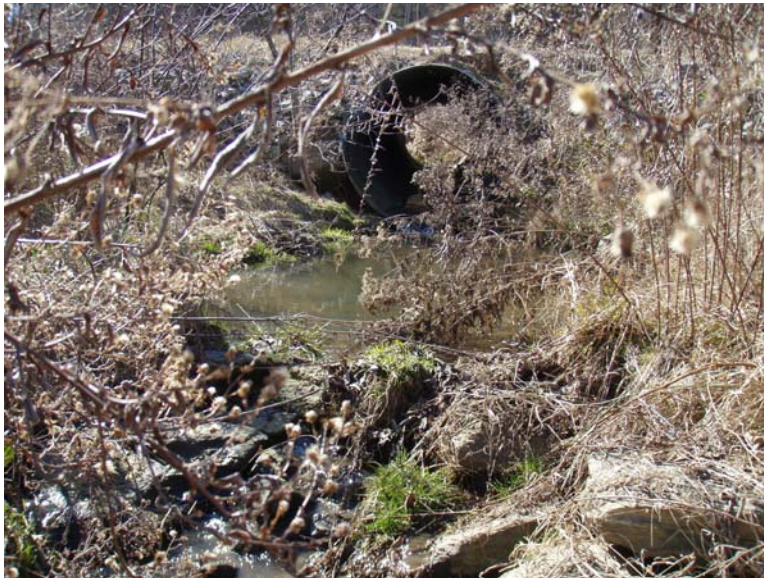
Photograph looking upstream at the culvert, December 2007.

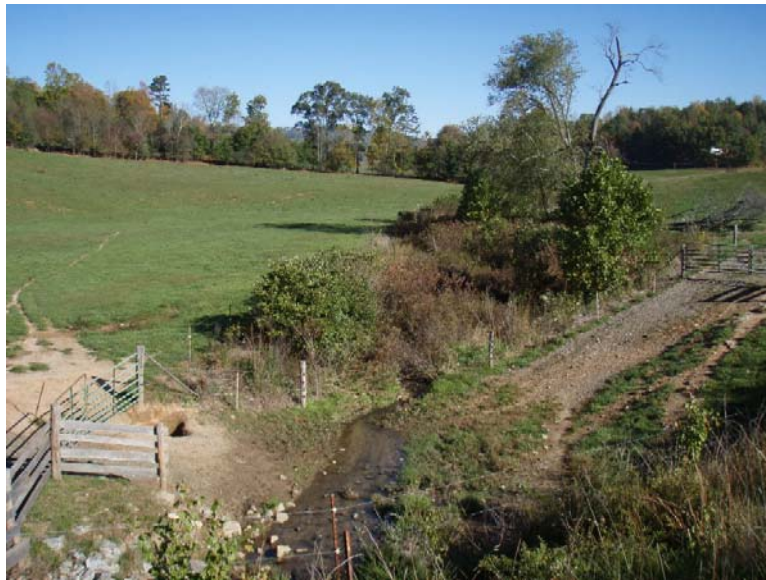
September 2007.

An area above the enhanced stream crossing, north of NC 18, had become devoid of vegetation because the cattle were allowed to access to this area to drink water from the stream. Discussions with the landowner revealed that the drinking water system on that side of the stream had not worked since the project was completed. The drinking water system was repaired and the bare ground sowed with brown top millet and the area mulched with straw. The landowner continues to leave the gates open to this ford and others around the farm. This area may require reseeding.

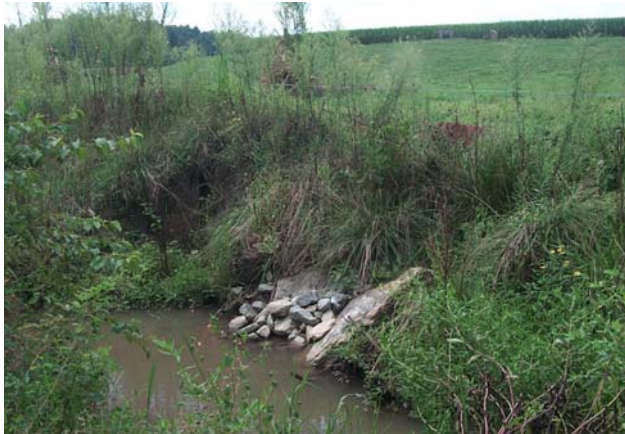
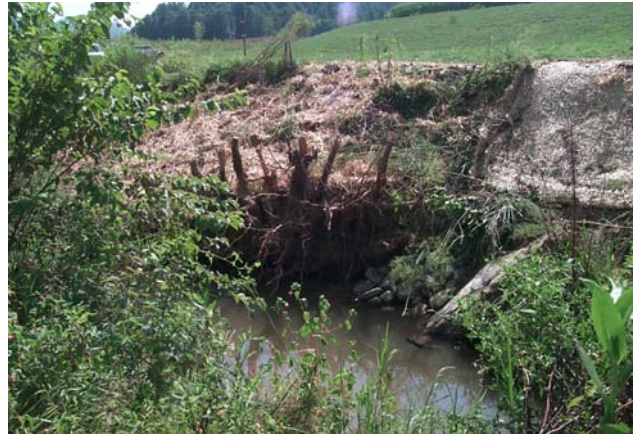
Before stream bank repairs to the left bank above cross-section 3, September 2005.

After stream bank repairs to the left bank above cross-section 3, September 2005.

A portion of the left bank near cross-section 3 on Little Warrior creek had sloughed due to overland flow. A root wad was positioned in the left bank to protect this area during periods of high flows and to provide a bench. A berm was created at the top of the bank to redirect the overland flow away from this location. This preventive measure has failed because the cattle had access to the berm, which prevented the pasture grass from becoming reestablished.

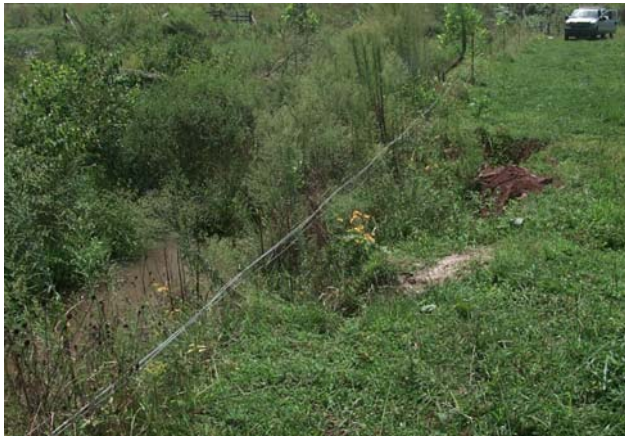
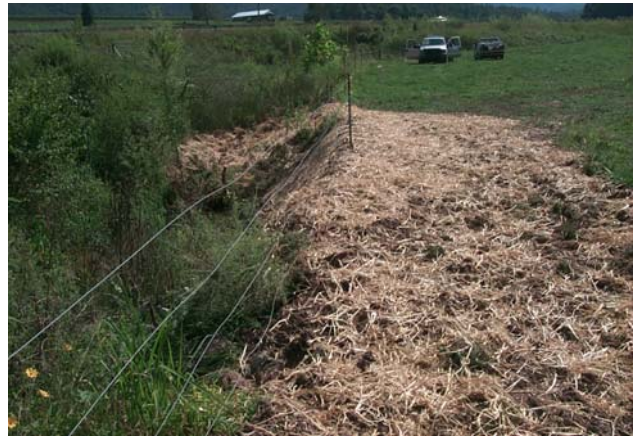
Before stream bank repairs to the left bank around cross-section 3, September 2005.

After stream bank repairs to the left bank around cross-section 3, September 2005.

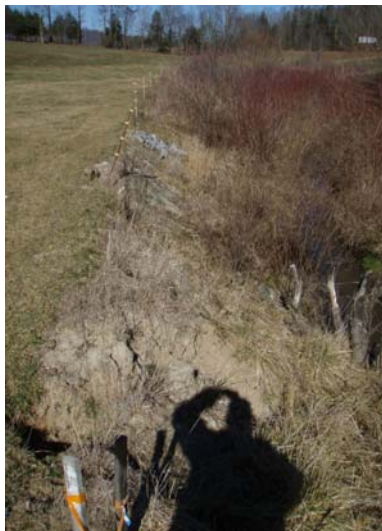
January 2008.
