YEAR 3 MONITORING AND CLOSEOUT REPORT
BIG WARRIOR AND LITTLE WARRIOR CREEKS
MITIGATION SITE

Wilkes County, North Carolina

EEP Project Number: 92715
Contract Number D06082; Task Order Number 07MON01-(6)

Period Covered: October 2007 – October 2008

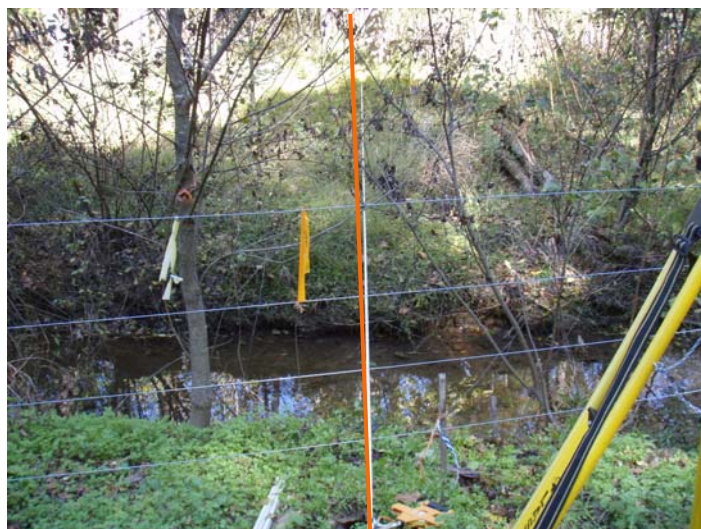
Cross-Section 1 Abbreviated Morphological Summary				
	MY0	MY1	MY2	MY3
Bankfull Cross Sectional Area (ft ²)	15.3	31.0	29.0	29.1
Maximum Bankfull Depth (ft)	1.9	3.0	2.7	3.0
Bankfull Mean Depth (ft)	1.0	1.0	0.9	0.9
Width/Depth Ratio	15.7		35.1	34.9
Entrenchment Ratio	2.6		1.6	1.6
Bankfull Width (ft)	15.5	31.8	31.9	31.8

Cross-section 1 (Appendix A.1.): This cross-section transects a pool. The thalweg has degraded by 0.8 ft since MY0. The cross-sectional area and mean bankfull depth have remained stable at 29.1 to 31.0 ft² and 0.9 to 1.0 ft since MY1. The right bank is in poor condition due to repeated herbicide application by the landowner. The left bank is stable and vegetated.

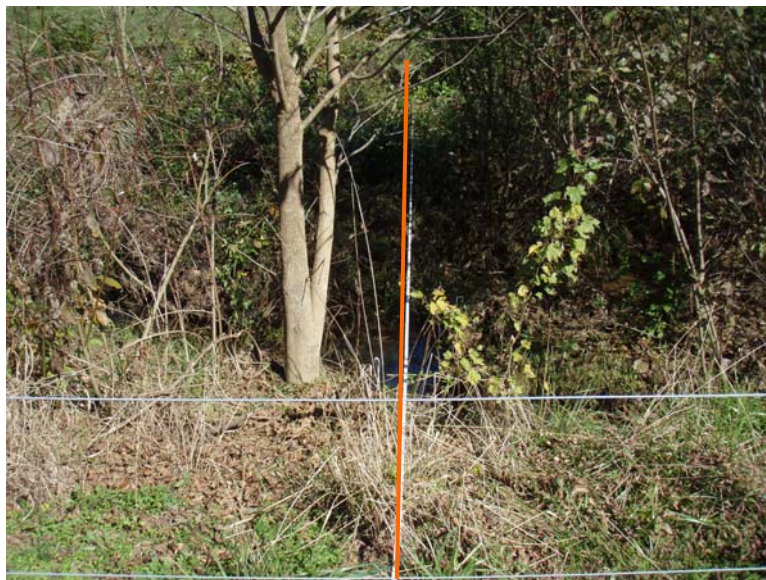
Cross-Section 2 Abbreviated Morphological Summary				
	MY0	MY1	MY2	MY3
Bankfull Cross Sectional Area (ft ²)	20.3	43.1	34.9	34.8
Maximum Bankfull Depth (ft)	2.8	3.8	3.4	3.4
Bankfull Mean Depth (ft)	1.6	1.3	1.1	1.0
Width/Depth Ratio	7.9	27.4	29.1	31.7
Entrenchment Ratio	5.3	2.9	1.7	1.7
Bankfull Width (ft)	12.7	34.4	31.9	33.2

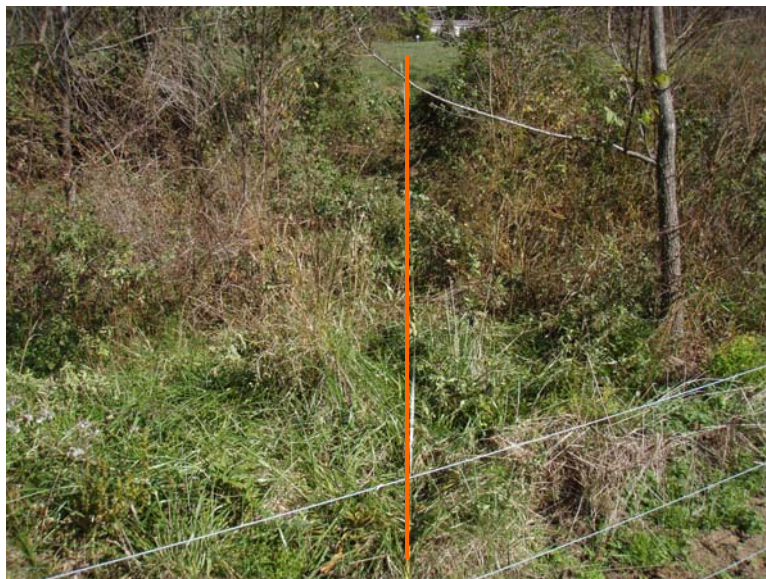
Cross-Section 3 Abbreviated Morphological Summary				
	MY0	MY1	MY2	MY3
Bankfull Cross Sectional Area (ft ²)	12.8	10.1	17.8	8.8
Maximum Bankfull Depth (ft)	2.1	1.9	2.1	1.8
Bankfull Mean Depth (ft)	1.0	1.0	1.0	1.0
Width/Depth Ratio	11.6	10.9	18.0	9.0
Entrenchment Ratio	6.9	6.5	3.7	7.1
Bankfull Width (ft)	12.2	10.5	17.9	8.9

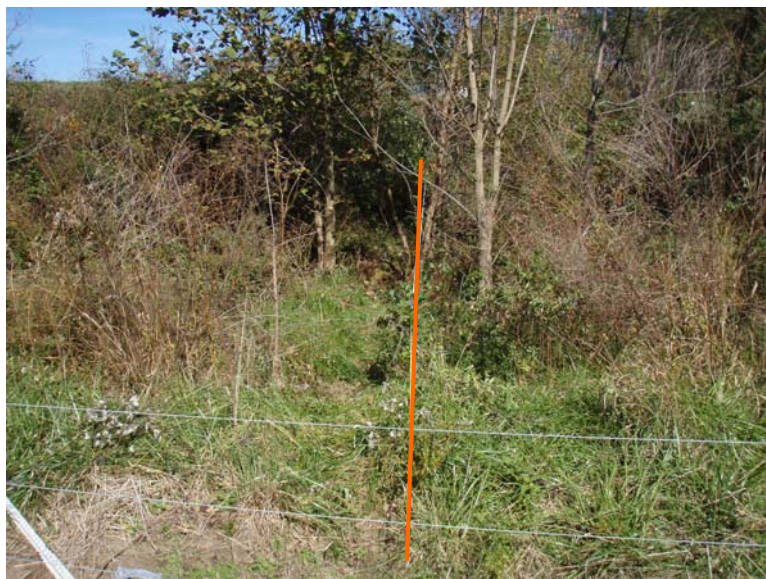
Cross-Section 4 Abbreviated Morphological Summary				
	MY0	MY1	MY2	MY3
Bankfull Cross Sectional Area (ft ²)	19.5	11.8	21.6	21.5
Maximum Bankfull Depth (ft)	2.6	2.2	2.9	2.7
Bankfull Mean Depth (ft)	1.1	1.5	1.4	1.4
Width/Depth Ratio			10.4	10.8
Entrenchment Ratio			4.2	4.0
Bankfull Width (ft)	17.5	8.0	15.0	15.3

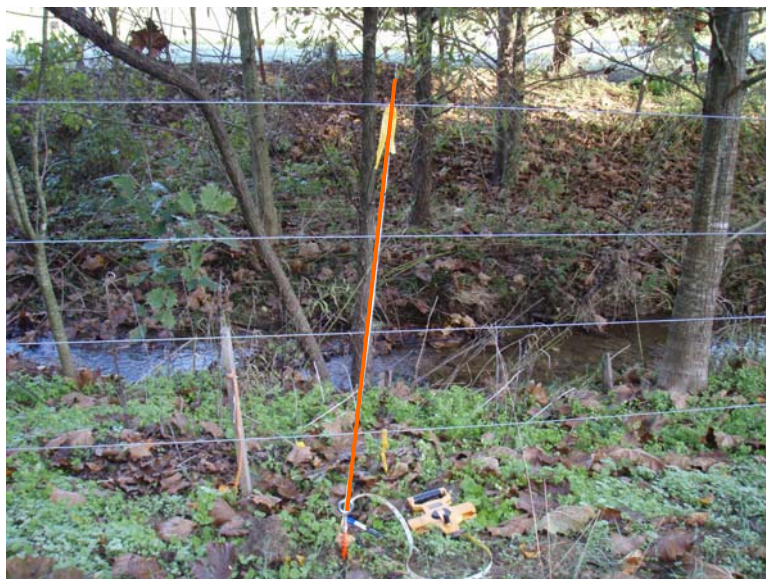
Cross-Section 5 Abbreviated Morphological Summary				
	MY0	MY1	MY2	MY3
Bankfull Cross Sectional Area (ft ²)	20.3	35.4	19.8	20.0
Maximum Bankfull Depth (ft)	1.9	2.5	2.1	2.3
Bankfull Mean Depth (ft)	1.0	1.3	0.8	0.9
Width/Depth Ratio	22.3	20.8	27.6	26.3
Entrenchment Ratio	1.5	2.4	1.6	1.6
Bankfull Width (ft)	21.3	27.2	23.4	23.0

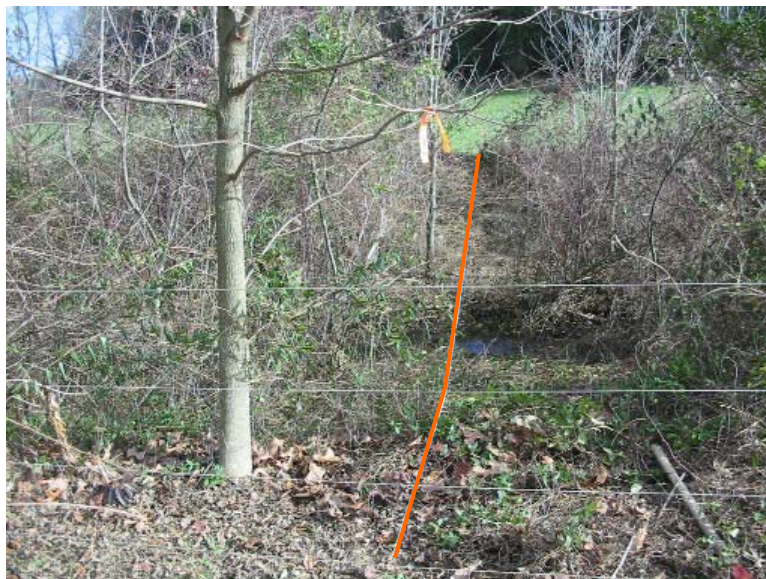
Cross-Section 7 Abbreviated Morphological Summary				
	MY0	MY1	MY2	MY3
Bankfull Cross Sectional Area (ft ²)	16.4	27.2	23.1	23.2
Maximum Bankfull Depth (ft)	2.3	2.6	2.4	2.3
Bankfull Mean Depth (ft)	1.1	1.1	1.0	1.0
Width/Depth Ratio	14.1	24.6	23.2	25.5
Entrenchment Ratio	2.3	1.5	1.6	1.5
Bankfull Width (ft)	15.2	25.8	23.2	24.3

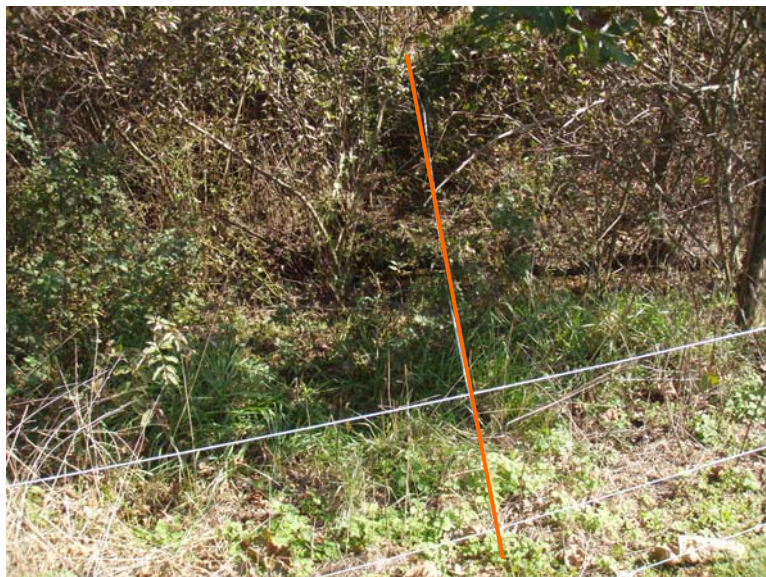
Cross-Section 8 Abbreviated Morphological Summary				
	MY0	MY1	MY2	MY3
Bankfull Cross Sectional Area (ft ²)	15.3	5.8	11.3	13.9
Maximum Bankfull Depth (ft)	2.4	1.3	1.5	1.7
Bankfull Mean Depth (ft)	1.1	0.9	0.8	0.9
Width/Depth Ratio	12.8	6.5	17.1	16.1
Entrenchment Ratio	3.5	3.3	2.0	1.8
Bankfull Width (ft)	14.0	6.1	13.9	15.0

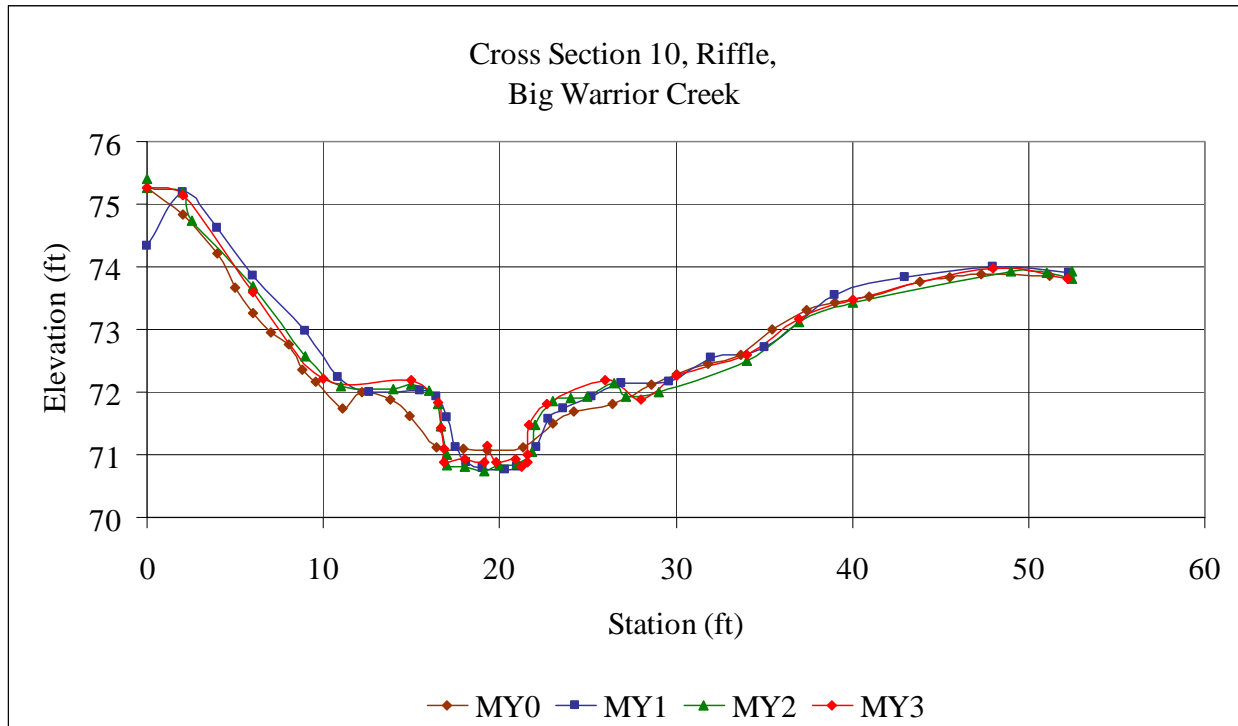
Cross-Section 10 Abbreviated Morphological Summary				
	MY0	MY1	MY2	MY3
Bankfull Cross Sectional Area (ft ²)	13.9	10.3	9.1	9.7
Maximum Bankfull Depth (ft)	1.2	1.5	1.4	1.5
Bankfull Mean Depth (ft)	0.7	0.5	0.5	0.5
Width/Depth Ratio	32.1	35.7	43.1	41.7
Entrenchment Ratio	1.6	1.7	1.8	1.9
Bankfull Width (ft)	21.1	19.2	19.8	20.1

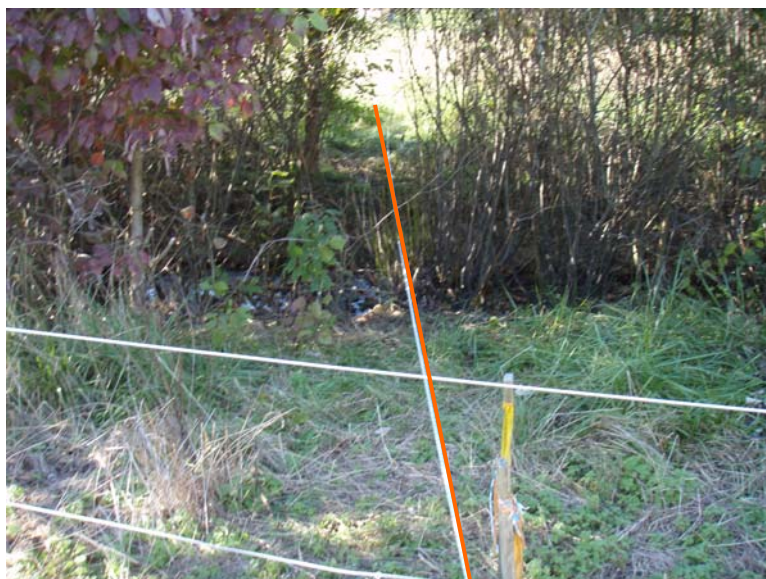
Cross-Section 11 Abbreviated Morphological Summary				
	MY0	MY1	MY2	MY3
Bankfull Cross Sectional Area (ft ²)	20.2	7.6	9.9	10.0
Maximum Bankfull Depth (ft)	2.1	1.3	1.3	1.3
Bankfull Mean Depth (ft)	1.3	0.9	0.9	0.9
Width/Depth Ratio	11.7	9.2	13.1	12.6
Entrenchment Ratio	2.5	2.4	1.8	1.8
Bankfull Width (ft)	15.4	8.4	11.4	11.2

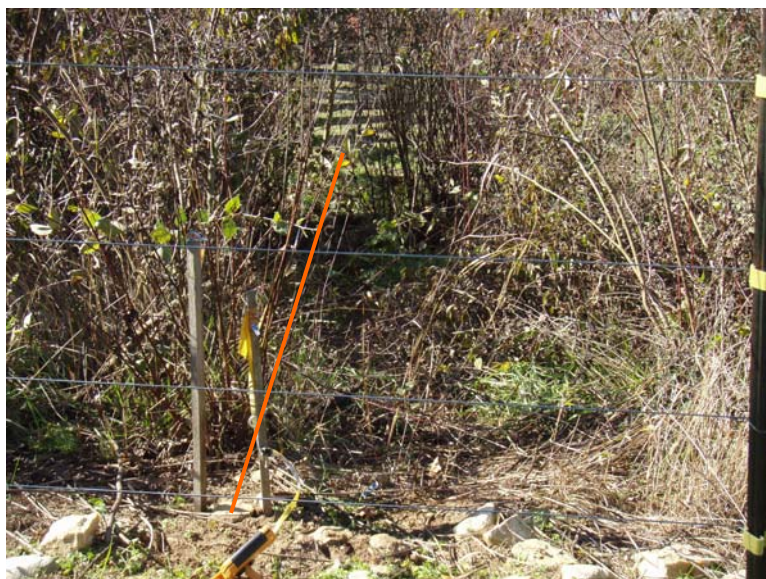
Cross-Section 12 Abbreviated Morphological Summary				
	MY0	MY1	MY2	MY3
Bankfull Cross Sectional Area (ft ²)	20.4	10.8	13.6	13.8
Maximum Bankfull Depth (ft)	2.0	1.5	1.7	1.7
Bankfull Mean Depth (ft)	1.3	0.8	0.8	0.8
Width/Depth Ratio	11.6	18.1	18.9	20.1
Entrenchment Ratio	2.7	2.9	2.8	2.7
Bankfull Width (ft)	15.4	14.0	16.0	16.6

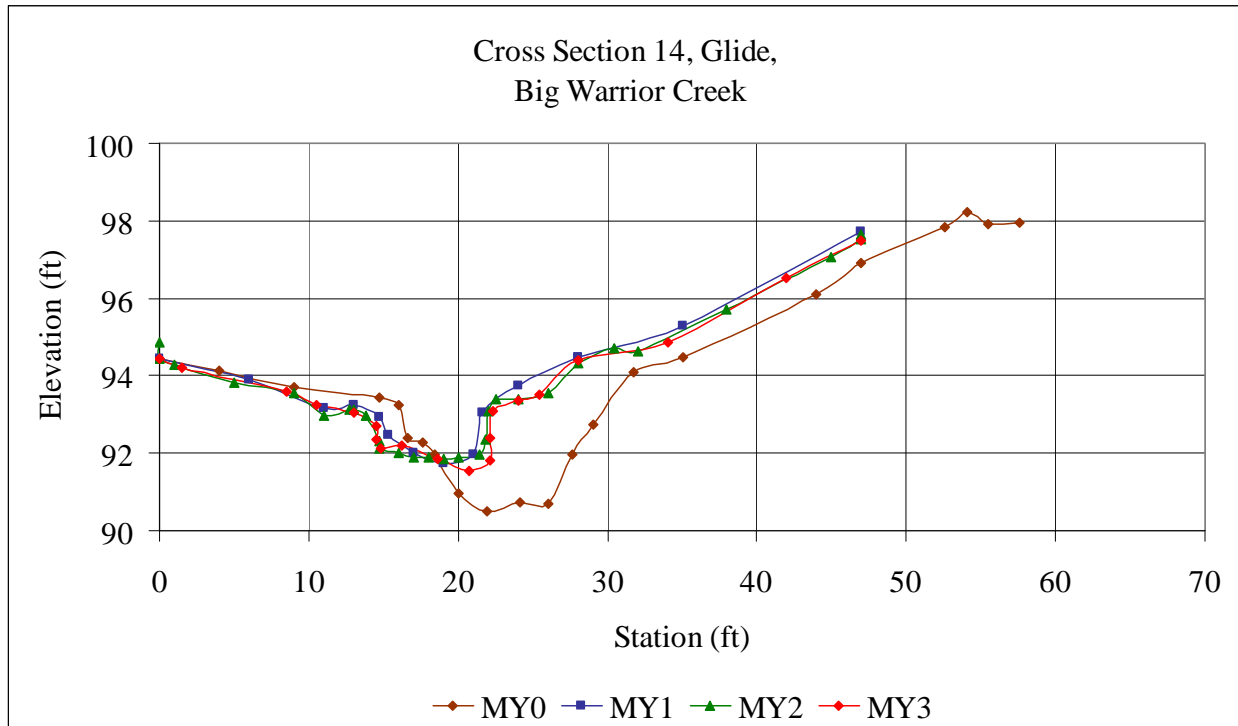
Cross-Section 14 Abbreviated Morphological Summary				
	MY0	MY1	MY2	MY3
Bankfull Cross Sectional Area (ft ²)	24.7	8.3	14.9	14.9
Maximum Bankfull Depth (ft)	2.7	1.5	1.7	2.0
Bankfull Mean Depth (ft)	1.9	0.7	0.9	0.9
Width/Depth Ratio			18.9	17.9
Entrenchment Ratio			2.0	2.1
Bankfull Width (ft)	13.3	11.6	16.8	16.3

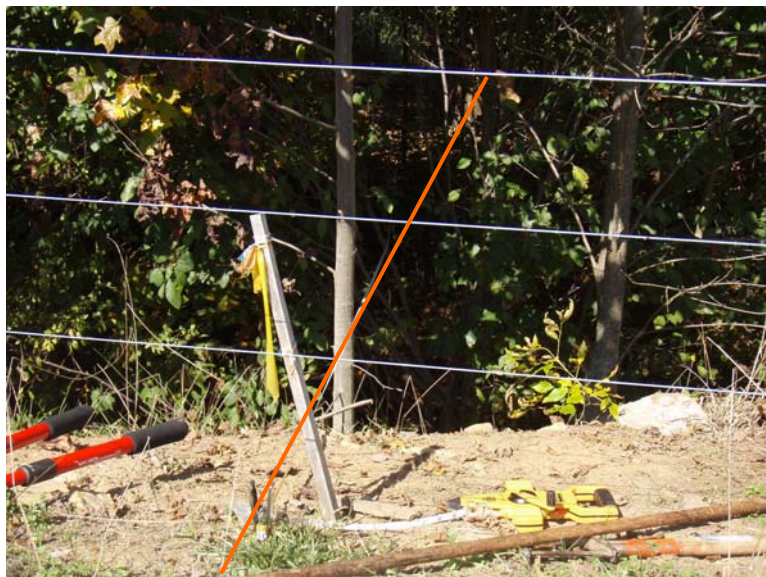
Cross-Section 15 Abbreviated Morphological Summary				
	MY0	MY1	MY2	MY3
Bankfull Cross Sectional Area (ft ²)	17.3	10.5	10.9	11.2
Maximum Bankfull Depth (ft)	2.1	1.5	1.5	1.5
Bankfull Mean Depth (ft)	1.2	1.1	1.1	1.2
Width/Depth Ratio	11.4	8.4	9.1	8.2
Entrenchment Ratio	2.5	2.6	2.1	2.3
Bankfull Width (ft)	14.0	9.4	10.0	9.6

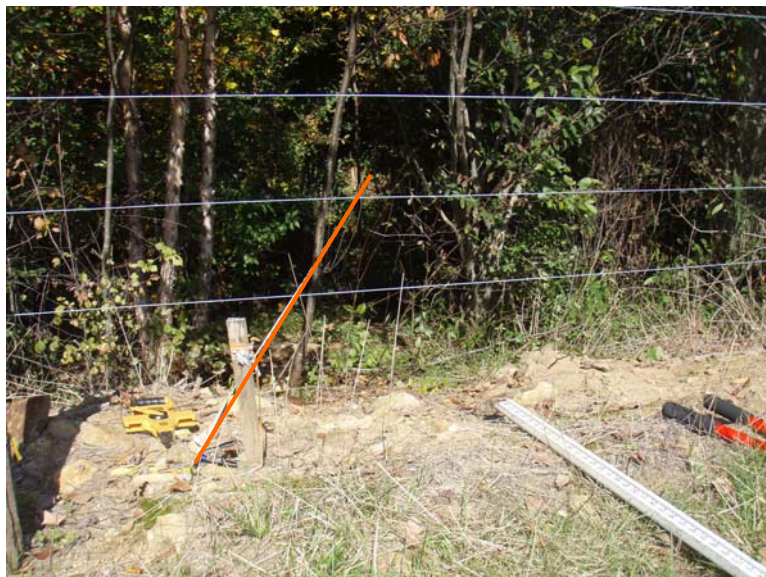
Cross-Section 16 Abbreviated Morphological Summary				
	MY0	MY1	MY2	MY3
Bankfull Cross Sectional Area (ft ²)	40.7	15.3	18.9	18.8
Maximum Bankfull Depth (ft)	3.0	1.7	2.0	2.6
Bankfull Mean Depth (ft)	2.9	0.9	0.9	0.7
Width/Depth Ratio	72.6	17.3	22.0	43.7
Entrenchment Ratio	2.5	3.4	1.2	1.7
Bankfull Width (ft)	14.0	16.3	20.4	28.6

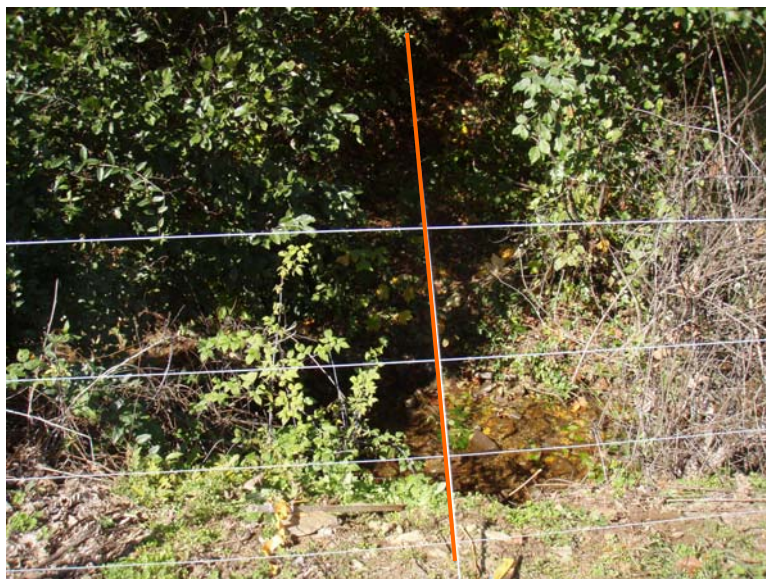
Cross-Section 17 Abbreviated Morphological Summary				
	MY0	MY1	MY2	MY3
Bankfull Cross Sectional Area (ft ²)	13.3	7.7	13.1	14.3
Maximum Bankfull Depth (ft)	2.0	1.2	1.7	1.7
Bankfull Mean Depth (ft)	1.0	1.0	1.3	1.2
Width/Depth Ratio			8.3	9.2
Entrenchment Ratio			2.5	2.3
Bankfull Width (ft)	14.0	7.9	10.4	11.5

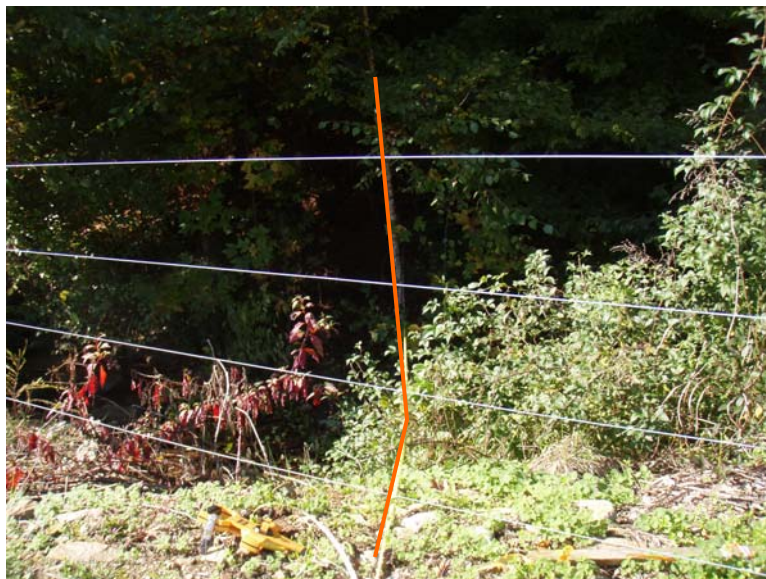
Cross-Section 19 Abbreviated Morphological Summary				
	MY0	MY1	MY2	MY3
Bankfull Cross Sectional Area (ft ²)	16.0	9.8	10.7	10.9
Maximum Bankfull Depth (ft)	1.5	1.1	1.3	1.3
Bankfull Mean Depth (ft)	0.9	0.8	0.8	0.8
Width/Depth Ratio	18.5	16.7	16.8	18.3
Entrenchment Ratio	1.7	1.8	1.9	1.9
Bankfull Width (ft)	17.2	12.8	13.4	14.2

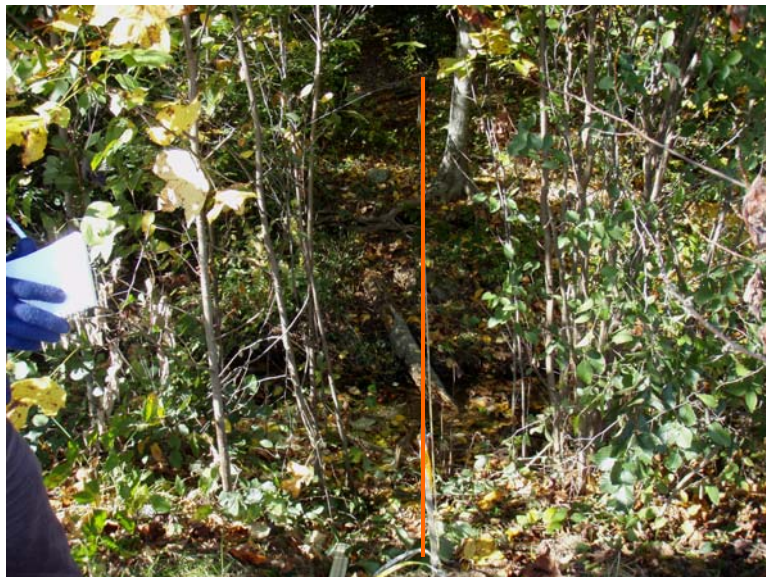
Cross-Section 20 Abbreviated Morphological Summary				
	MY0	MY1	MY2	MY3
Bankfull Cross Sectional Area (ft ²)	14.8	5.4	8.6	9.3
Maximum Bankfull Depth (ft)	1.6	1.0	1.3	1.7
Bankfull Mean Depth (ft)	0.9	0.6	0.7	0.8
Width/Depth Ratio	17.3	15.5	18.1	15.8
Entrenchment Ratio	1.6	1.9	1.5	1.8
Bankfull Width (ft)	16.0	9.1	12.5	12.1

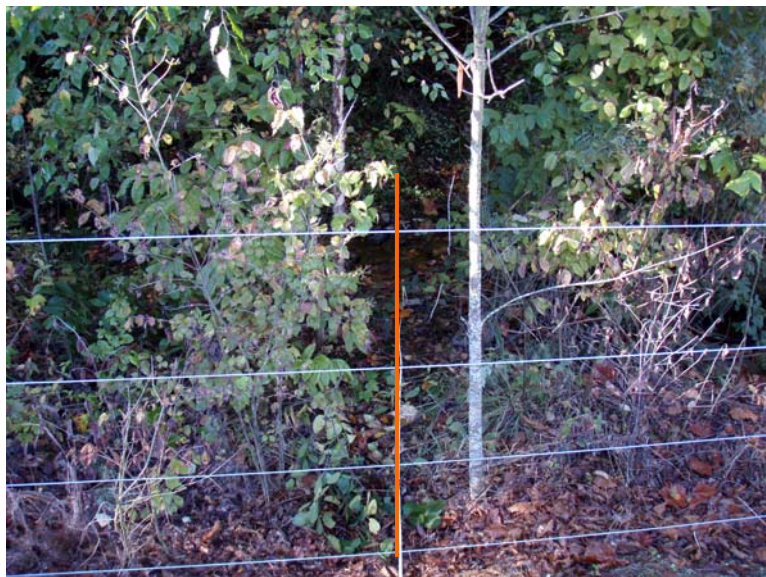
Cross-Section 21 Abbreviated Morphological Summary				
	MY0	MY1	MY2	MY3
Bankfull Cross Sectional Area (ft ²)	12.3	18.8	14.7	18.0
Maximum Bankfull Depth (ft)	1.4	1.5	1.3	1.7
Bankfull Mean Depth (ft)	0.9	0.8	0.9	1.0
Width/Depth Ratio			17.2	19.3
Entrenchment Ratio			2.2	1.9
Bankfull Width (ft)	14.0	23.6	15.9	18.7

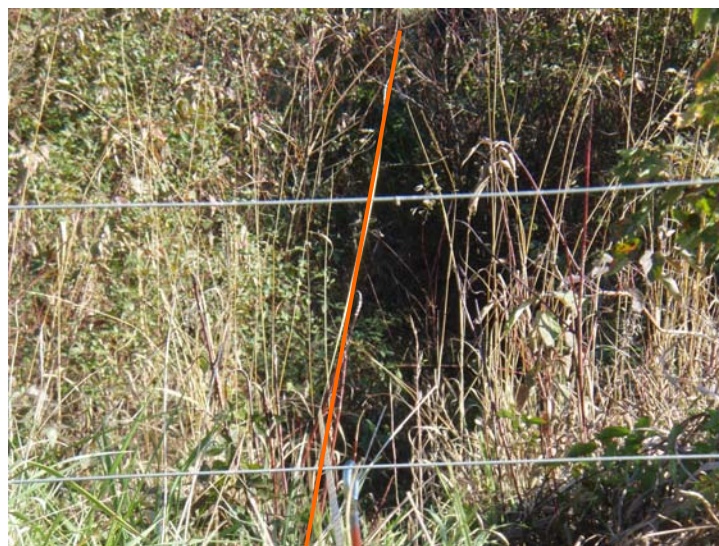
Cross-Section 1 Abbreviated Morphological Summary				
	MY0	MY1	MY2	MY3
Bankfull Cross Sectional Area (ft ²)	18.7	12.0	15.2	15.6
Maximum Bankfull Depth (ft)	2.8	2.0	2.7	2.6
Bankfull Mean Depth (ft)	1.0	1.4	1.4	1.3
Width/Depth Ratio	19.8	12.6	7.6	9
Entrenchment Ratio	1.9	1.2	3.6	3.2
Bankfull Width (ft)	19.2	8.9	10.7	11.9

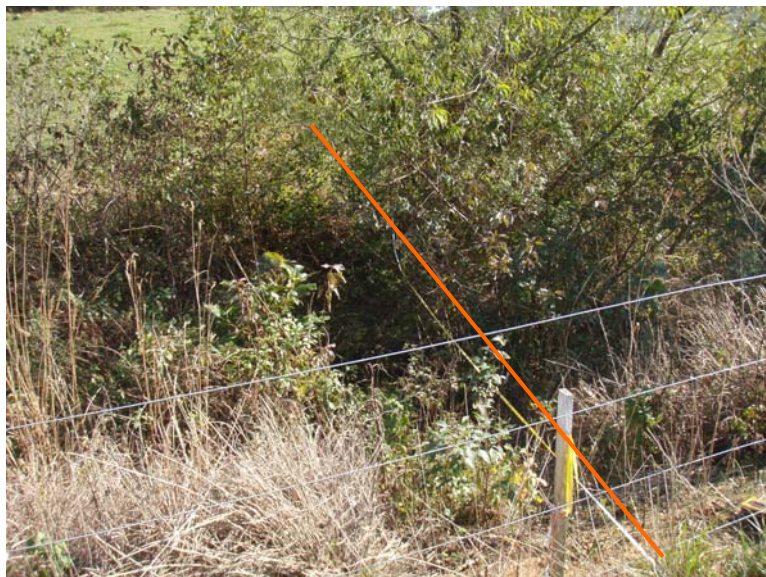
Cross-Section 2 Abbreviated Morphological Summary				
	MY0	MY1	MY2	MY3
Bankfull Cross Sectional Area (ft ²)	16.1	10.0	13.8	14.8
Maximum Bankfull Depth (ft)	2.2	1.8	2.2	2.3
Bankfull Mean Depth (ft)	1.5	1.1	0.9	1.0
Width/Depth Ratio	7.5	8.7	16.6	13.8
Entrenchment Ratio	1.8	3.3	2.3	2.6
Bankfull Width (ft)	11.0	9.4	15.1	14.3

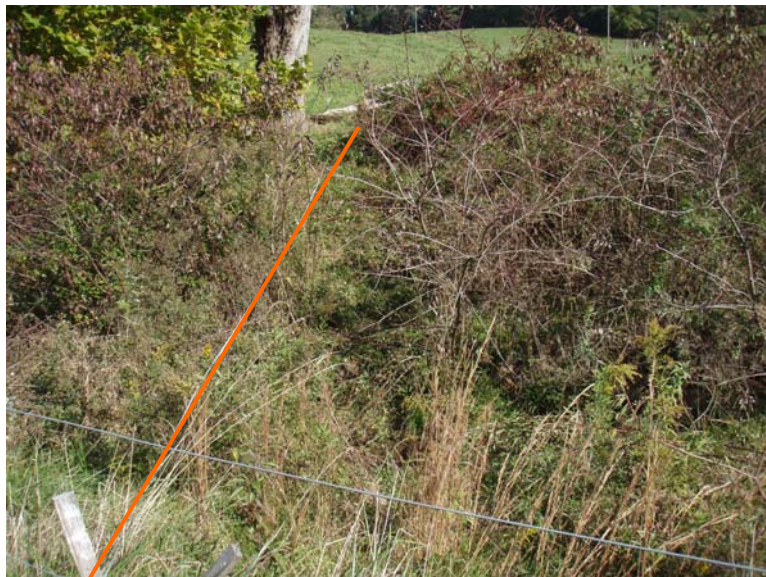
Cross-Section 3 Abbreviated Morphological Summary				
	MY0	MY1	MY2	MY3
Bankfull Cross Sectional Area (ft ²)	23.8	10.9	20.1	20.1
Maximum Bankfull Depth (ft)	2.8	1.9	2.7	2.8
Bankfull Mean Depth (ft)	2.2	1.2	1.5	1.4
Width/Depth Ratio	5.1		9	9.6
Entrenchment Ratio	1.8		2.9	3
Bankfull Width (ft)	11.0	9.4	13.5	13.9

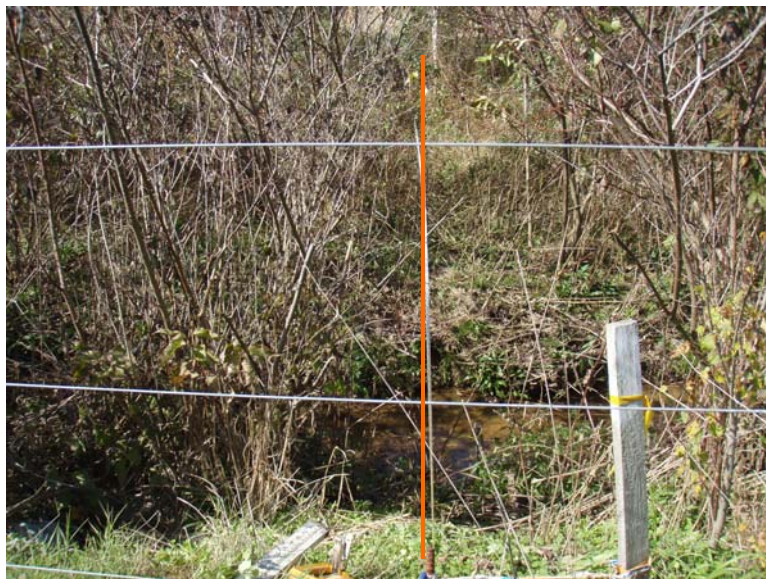
Cross-Section 4 Abbreviated Morphological Summary				
	MY0	MY1	MY2	MY3
Bankfull Cross Sectional Area (ft ²)	15.5	6.5	11.3	11.8
Maximum Bankfull Depth (ft)	1.7	1.2	2.0	1.9
Bankfull Mean Depth (ft)	1.4	0.9	1.1	0.6
Width/Depth Ratio	7.8	8.9	9.6	35.0
Entrenchment Ratio	1.8	4.5	3.8	1.8
Bankfull Width (ft)	11.0	7.6	10.4	20.3

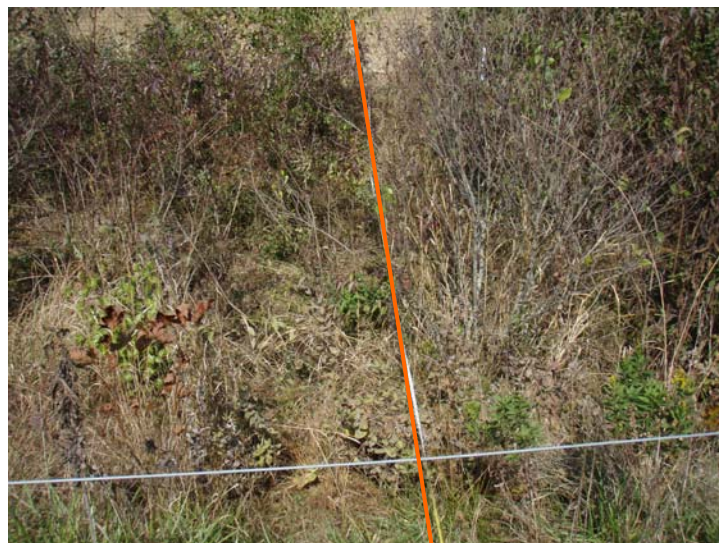
Cross-Section 5 Abbreviated Morphological Summary				
	MY0	MY1	MY2	MY3
Bankfull Cross Sectional Area (ft ²)	16.5	10.0	14.3	13.0
Maximum Bankfull Depth (ft)	2.7	1.5	2.1	2.4
Bankfull Mean Depth (ft)	1.5	1.1	1.2	1.3
Width/Depth Ratio	7.3	8.1	9.4	7.6
Entrenchment Ratio	1.8	3.0	2.8	3.3
Bankfull Width (ft)	11.0	9.0	11.6	10.0

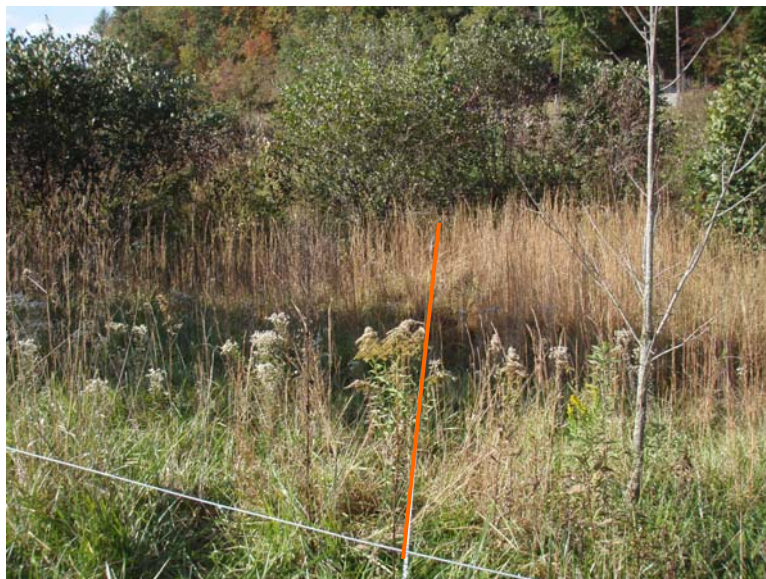
Cross-Section 6 Abbreviated Morphological Summary				
	MY0	MY1	MY2	MY3
Bankfull Cross Sectional Area (ft ²)	10.2	5.8	6.0	6.0
Maximum Bankfull Depth (ft)	2.0	1.7	1.6	1.6
Bankfull Mean Depth (ft)	0.9	1.3	1.1	1.1
Width/Depth Ratio	11.8	3.6	5.3	5.0
Entrenchment Ratio	1.8	8.7	2.2	2.0
Bankfull Width (ft)	11.0	4.6	5.6	5.4

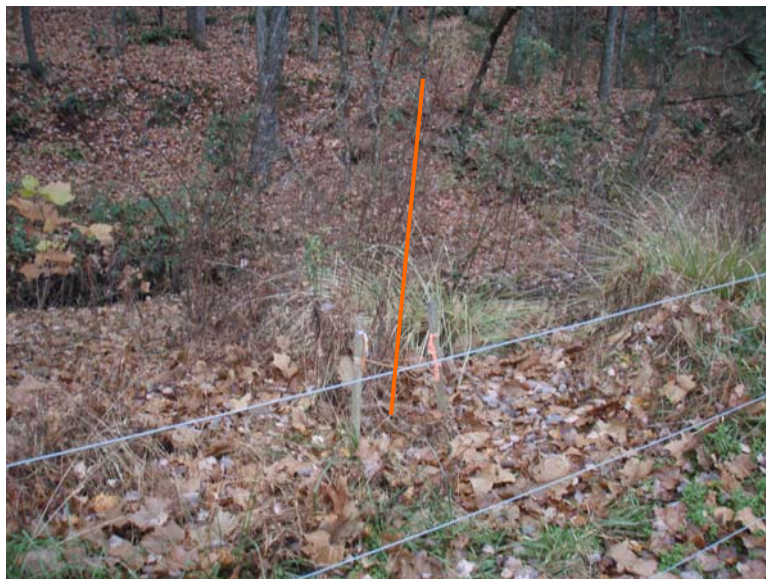
Cross-Section 7 Abbreviated Morphological Summary				
	MY0	MY1	MY2	MY3
Bankfull Cross Sectional Area (ft ²)	10.6	2.2	11.5	11.6
Maximum Bankfull Depth (ft)	1.3	0.6	1.6	1.5
Bankfull Mean Depth (ft)	1.0	0.4	0.8	0.7
Width/Depth Ratio	11.4	12.5	20.4	23.1
Entrenchment Ratio	1.8	3.0	2.1	2.2
Bankfull Width (ft)	11.0	5.3	15.3	16.4

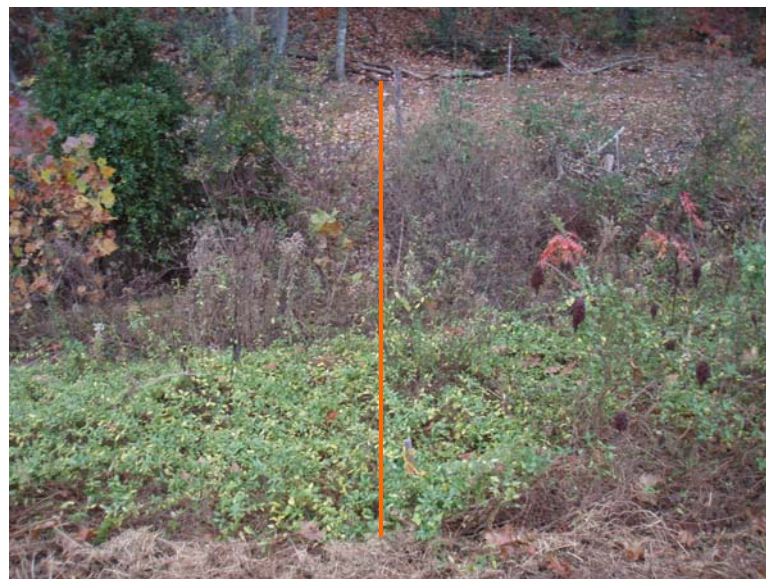
Cross-Section 8 Abbreviated Morphological Summary				
	MY0	MY1	MY2	MY3
Bankfull Cross Sectional Area (ft ²)	7.0	3.5	8.2	8.6
Maximum Bankfull Depth (ft)	1.2	1.1	1.7	2.0
Bankfull Mean Depth (ft)	0.6	0.8	0.6	0.7
Width/Depth Ratio	17.2		22.6	19.7
Entrenchment Ratio	1.8		1.4	1.5
Bankfull Width (ft)	11.0	4.2	13.6	13.0

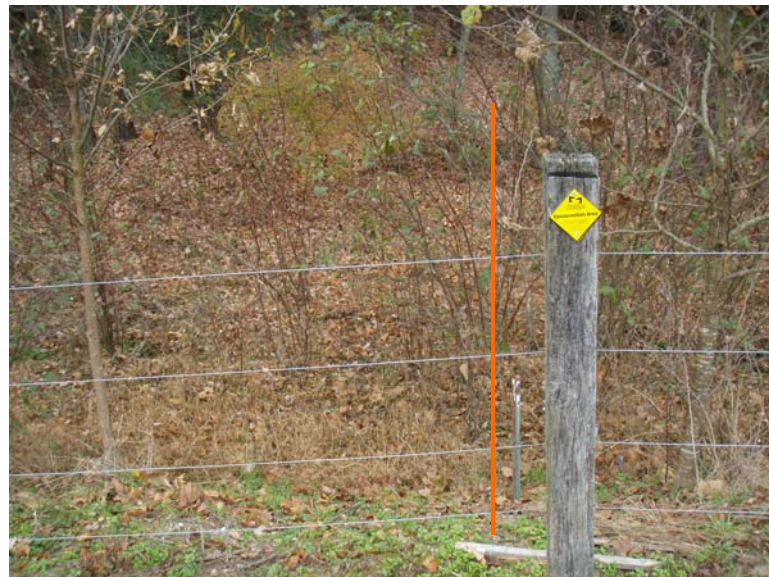
Cross-Section 9 Abbreviated Morphological Summary				
	MY0	MY1	MY2	MY3
Bankfull Cross Sectional Area (ft ²)	5.4	5.7	5.9	4.9
Maximum Bankfull Depth (ft)	1.1	1.4	1.5	1.5
Bankfull Mean Depth (ft)	0.5	0.5	0.4	0.3
Width/Depth Ratio	22.5		42.8	44.8
Entrenchment Ratio	1.8		1.7	1.8
Bankfull Width (ft)	11.0	12.0	15.8	14.8

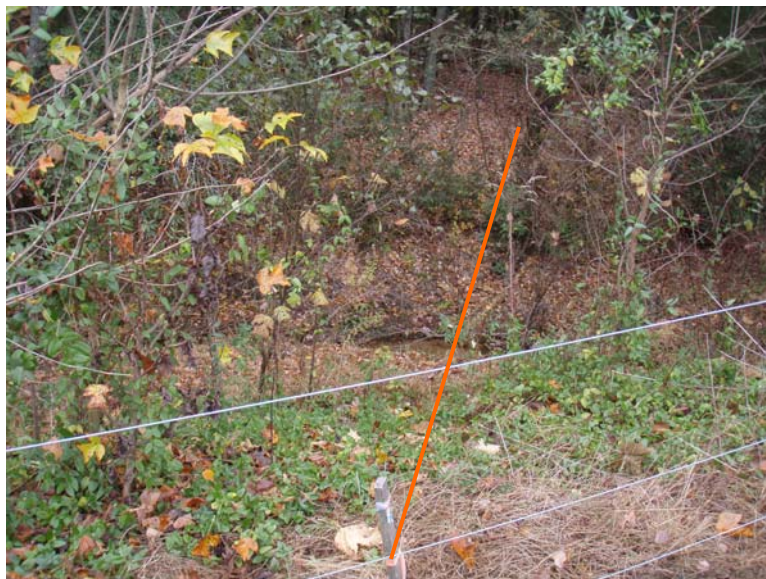
Cross-Section 10 Abbreviated Morphological Summary				
	MY0	MY1	MY2	MY3
Bankfull Cross Sectional Area (ft ²)	7.2	1.8	4.2	4.0
Maximum Bankfull Depth (ft)	1.2	0.7	1.3	1.2
Bankfull Mean Depth (ft)	0.7	0.5	0.7	0.7
Width/Depth Ratio	16.9	7.3	8.3	9.0
Entrenchment Ratio	1.8	2.7	2.6	3.0
Bankfull Width (ft)	11.0	3.7	5.9	6.0

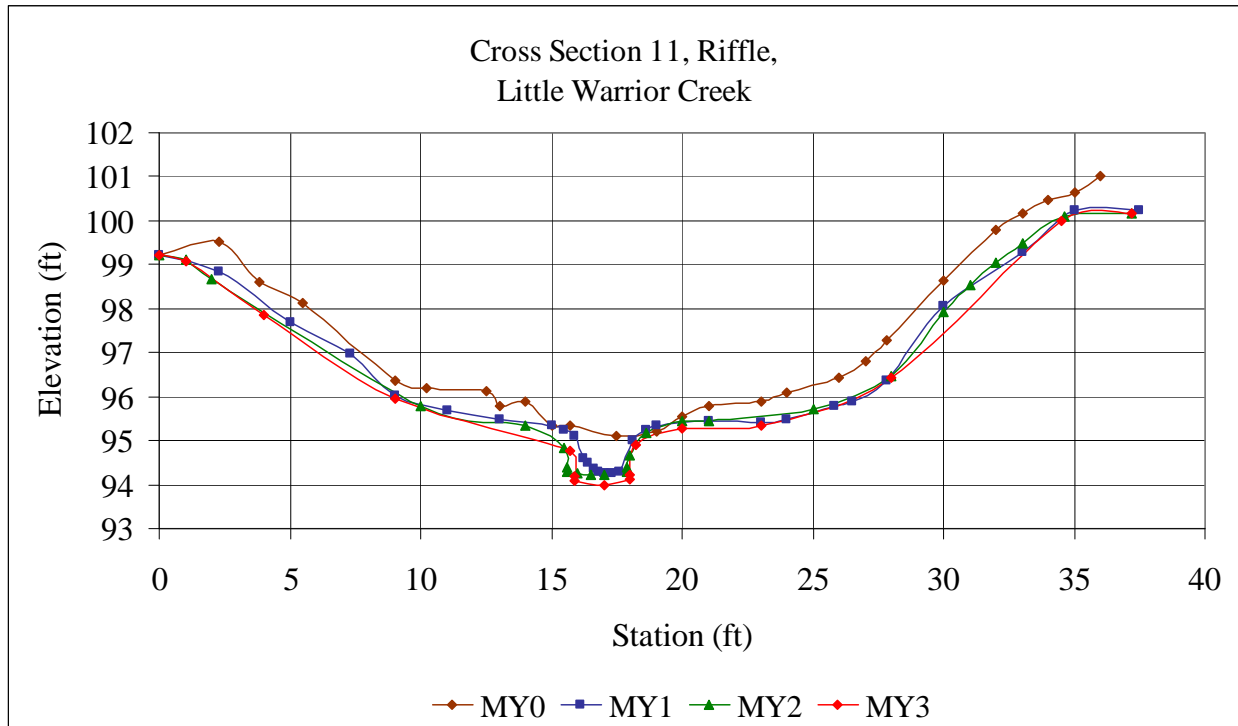
Appendix A.2. Continued.

Cross-Section 11 Abbreviated Morphological Summary				
	MY0	MY1	MY2	MY3
Bankfull Cross Sectional Area (ft ²)	3.8	1.4	4.1	4.2
Maximum Bankfull Depth (ft)	0.8	0.9	1.2	1.3
Bankfull Mean Depth (ft)	0.4	0.6	0.6	0.5
Width/Depth Ratio	21.3	4.2	12.3	18.4
Entrenchment Ratio	1.9	7.0	2.9	2.5
Bankfull Width (ft)	9.0	2.4	7.1	8.8

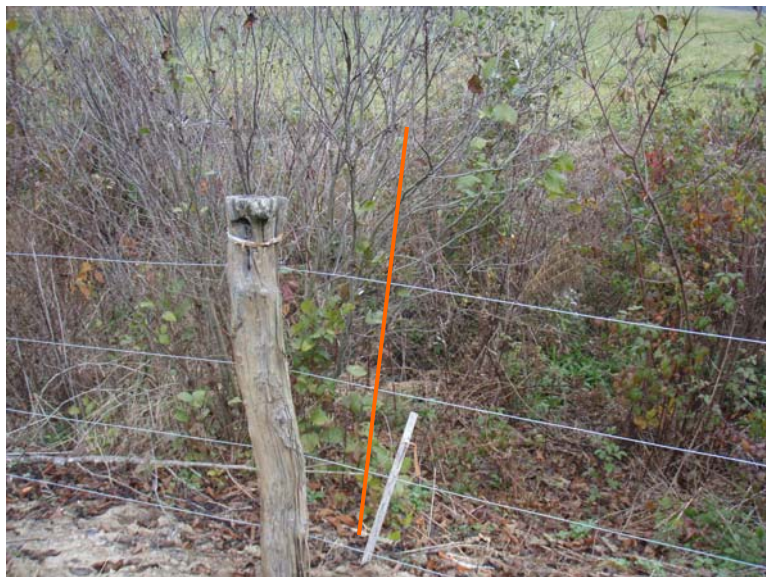
Cross-section 12 (Appendix A.2.): This cross-section transects a pool and is on an unnamed tributary to Little Warrior Creek. It was difficult to make data comparisons at this site because none of the four years of monitoring data appear to be in alignment. It is possible that this cross-section has aggraded and degraded given the number of years between the monitoring events and the sandy composition of the stream bed material. The banks are stable and well vegetated.

Cross-Section 12 Abbreviated Morphological Summary				
	MY0	MY1	MY2	MY3
Bankfull Cross Sectional Area (ft ²)	3.0	0.4	2.4	2.5
Maximum Bankfull Depth (ft)	0.6	0.7	1.0	0.8
Bankfull Mean Depth (ft)	0.3	0.2	0.4	0.5
Width/Depth Ratio	33.2	10.8	18.2	11.3
Entrenchment Ratio	1.4	6.6	2.4	2.8
Bankfull Width (ft)	10.0	2.1	6.6	5.3

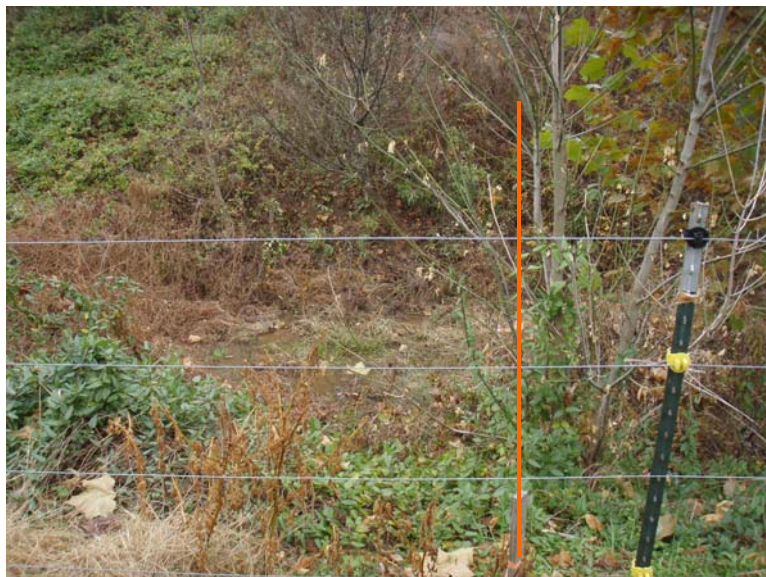
Cross-Section 13 Abbreviated Morphological Summary				
	MY0	MY1	MY2	MY3
Bankfull Cross Sectional Area (ft ²)	3.6	13.1	1.6	1.0
Maximum Bankfull Depth (ft)	1.1	1.8	0.4	0.2
Bankfull Mean Depth (ft)	0.4	0.8	0.2	0.1
Width/Depth Ratio	20.3	21.2	48.3	112.3
Entrenchment Ratio	2.1	1.4	2.0	2.3
Bankfull Width (ft)	8.5	16.7	8.8	10.7

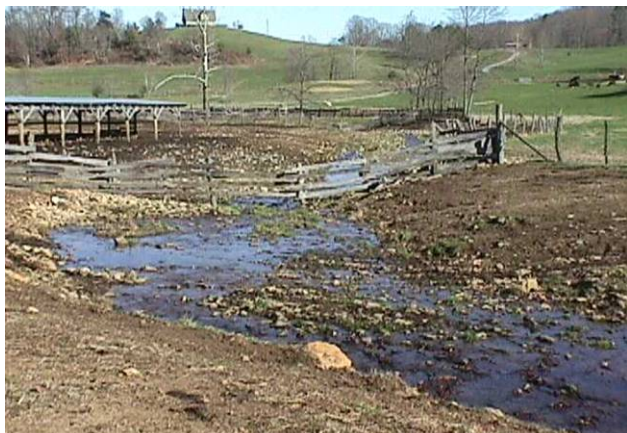
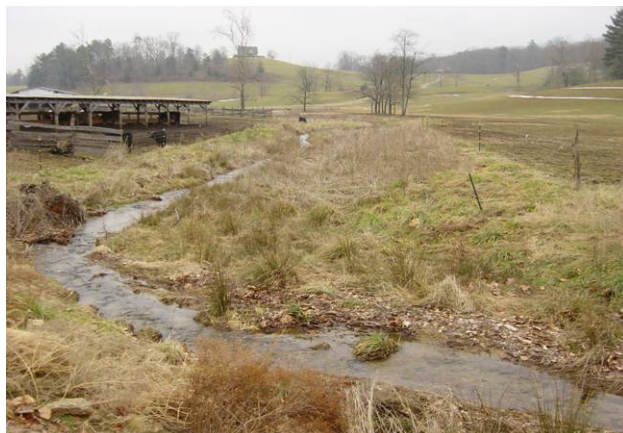
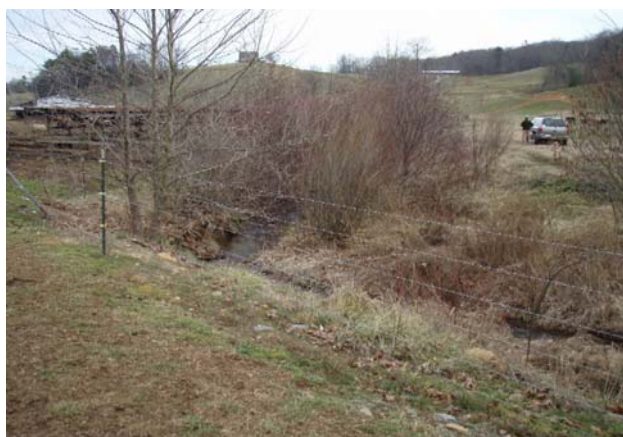
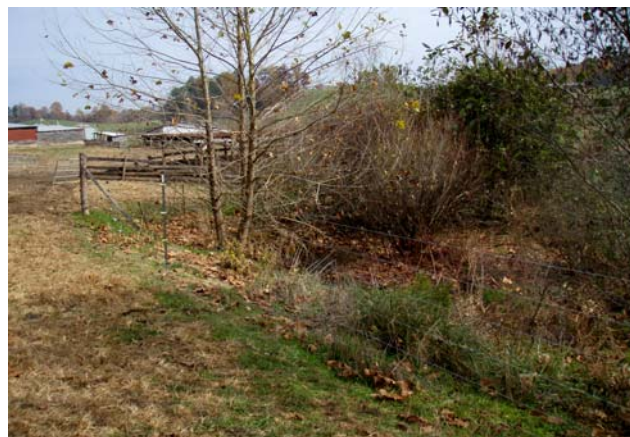
Photograph station 10, LDS, December 1998.

Photograph station 10, LDS, March 2003.

Photograph station 10, LDS, September 2007.

Photograph station 10, LDS, November 2008.

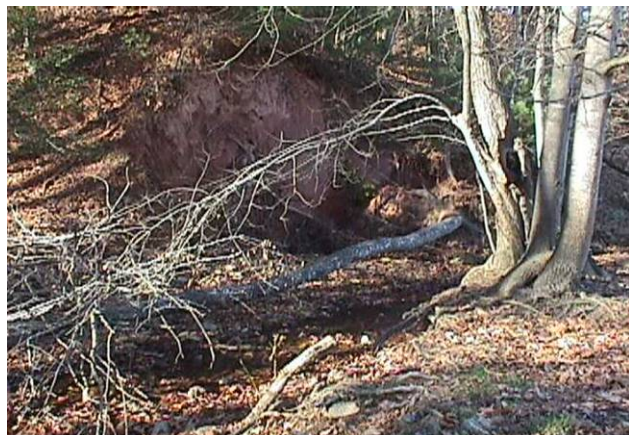
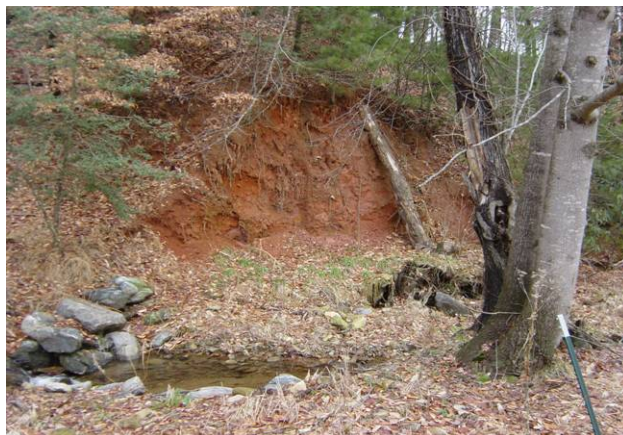
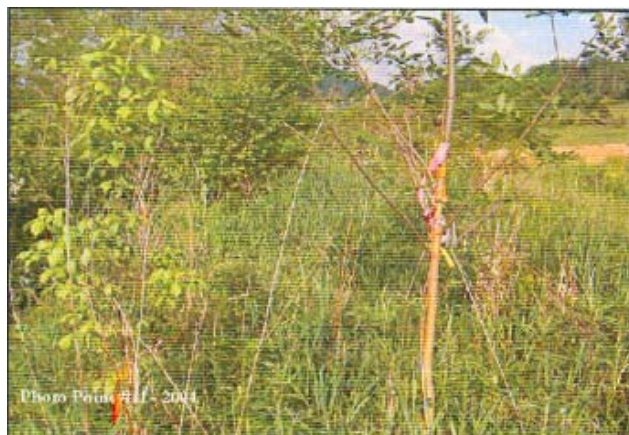
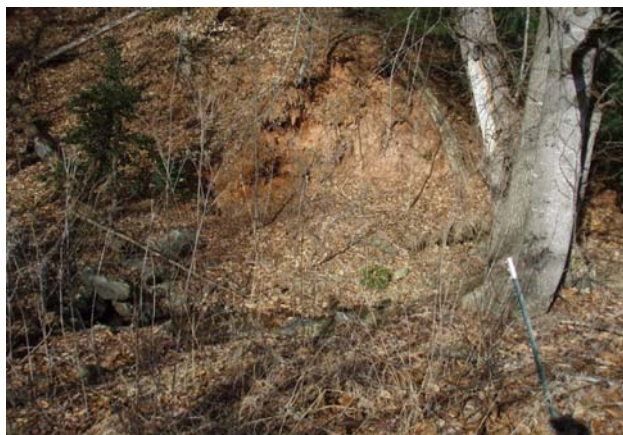
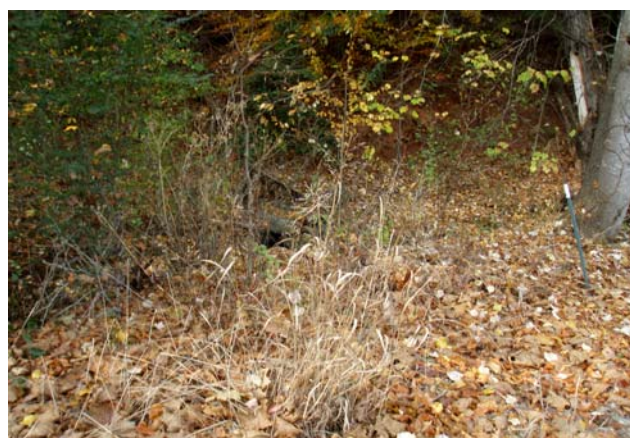
Photograph station 11, LDS, December, 1998.

Photograph station 11, LDS, March 2003.

Photograph station 11, LDS, August 2004.

Photograph station 11, LDS, September 2007.

Photograph station 11, LDS, November 2008.

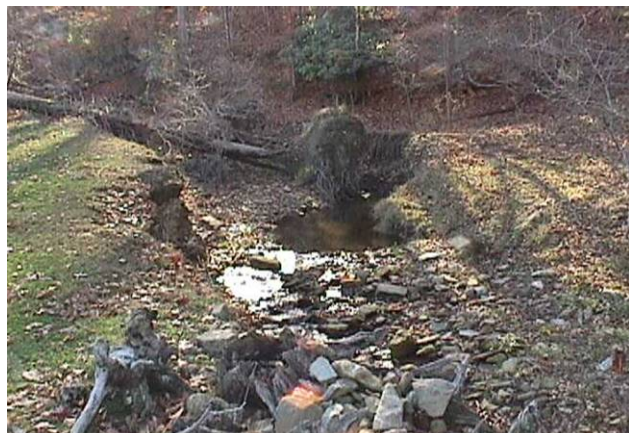
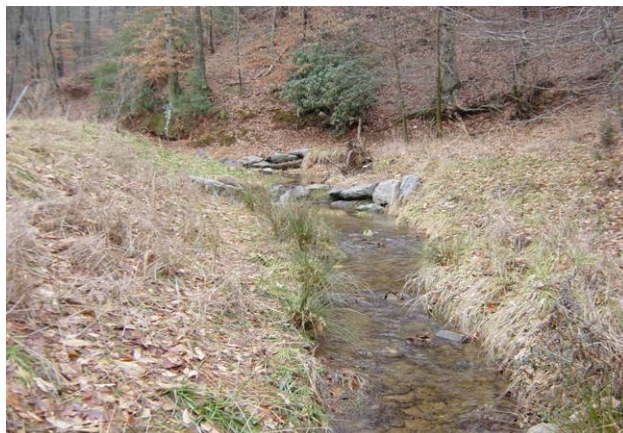
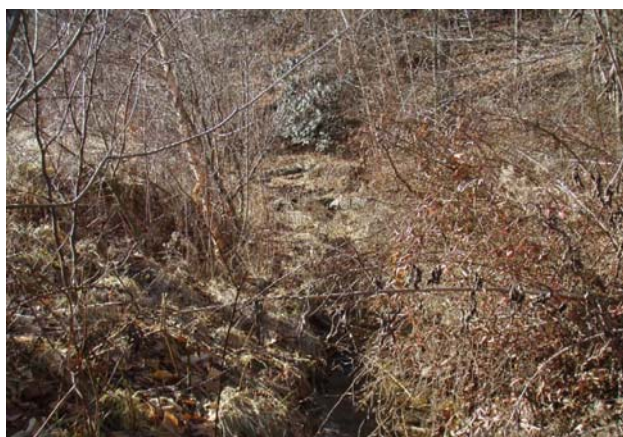
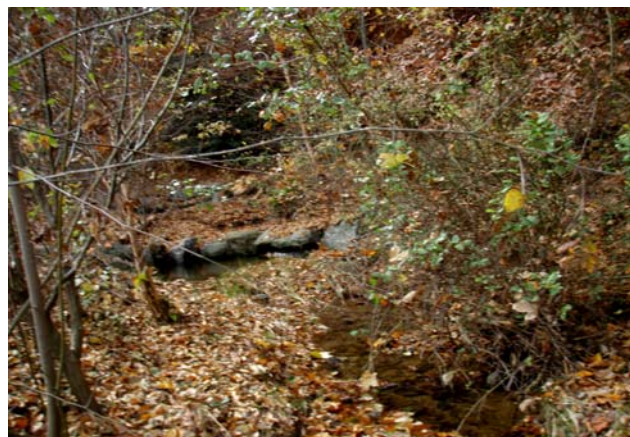
Photograph station 12, LUS, December 1998.

Photograph station 12, LUS, March 2003.

Photograph station 12, LUS, September 2007.

Photograph station 12, LUS, November 2008.

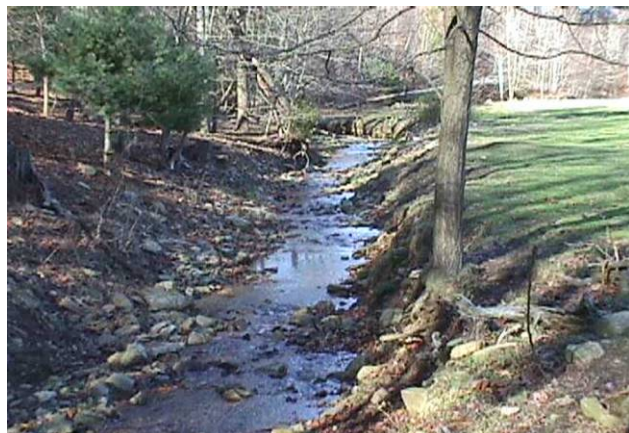
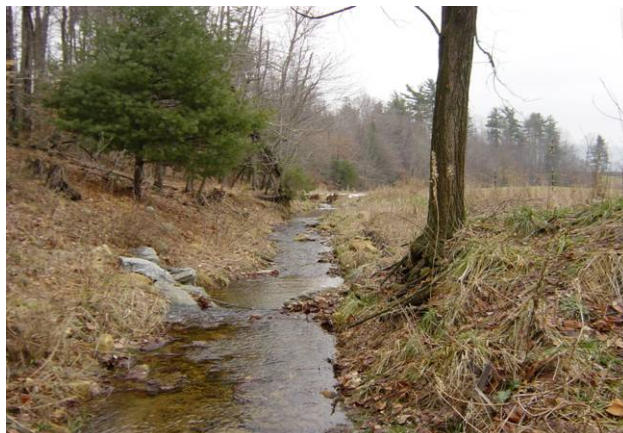
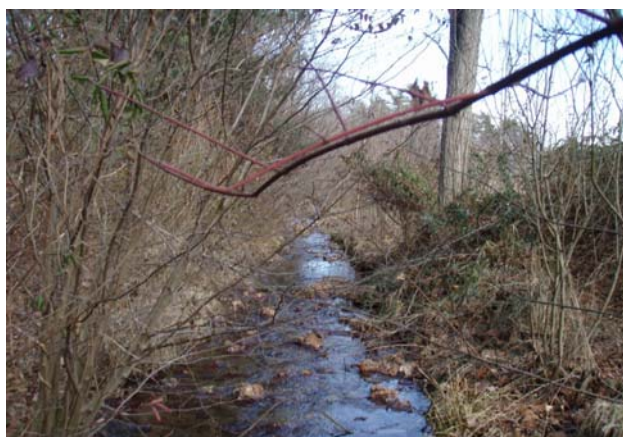
Photograph station 13, LDS, December 1998.

Photograph station 13, LDS, March 2003

Photograph station 13, LDS, September 2007.
