YEAR 3 MONITORING AND CLOSEOUT REPORT
BIG WARRIOR AND LITTLE WARRIOR CREEKS
MITIGATION SITE

Wilkes County, North Carolina

EEP Project Number: 92715
Contract Number D06082; Task Order Number 07MON01-(6)

Period Covered: October 2007 – October 2008

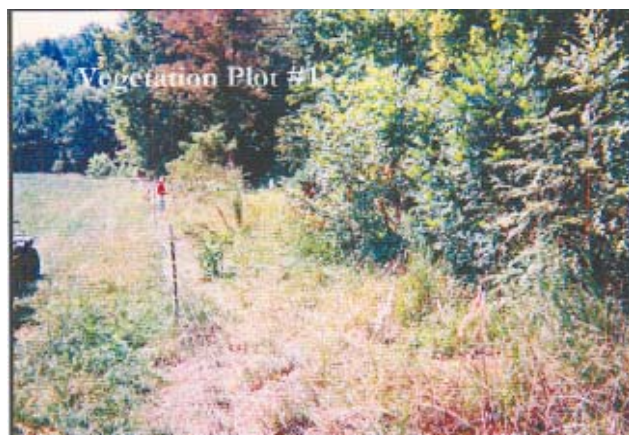
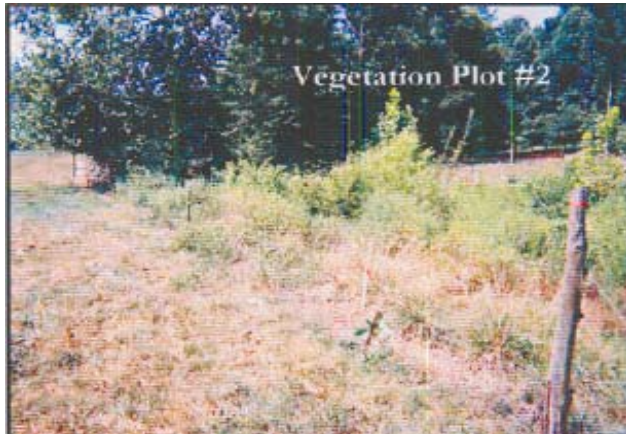
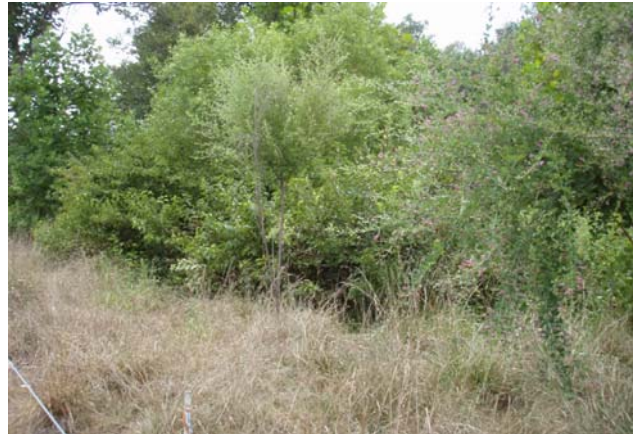
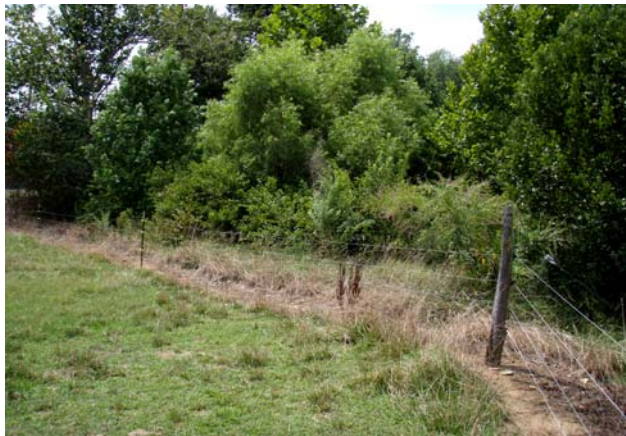
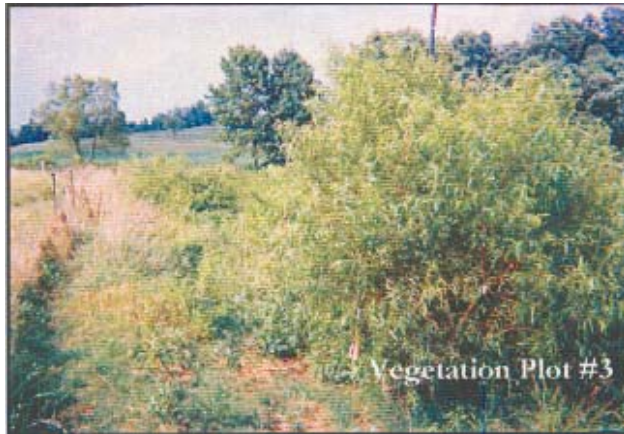
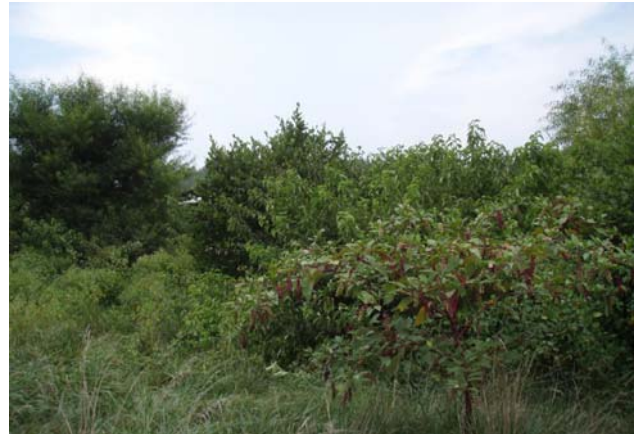
Vegetation plot 1, September 2004.

Vegetation plot 2, September 2004.

Vegetation plot 2, August 2007.

Vegetation plot 2, August 2008.

Vegetation plot 3, September 2004.

Vegetation plot 3, August 2007.

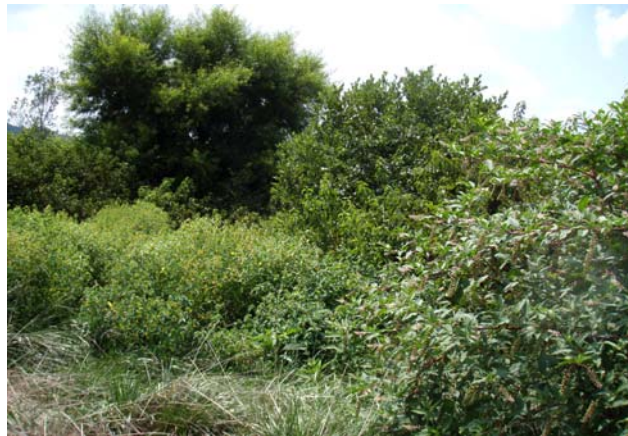
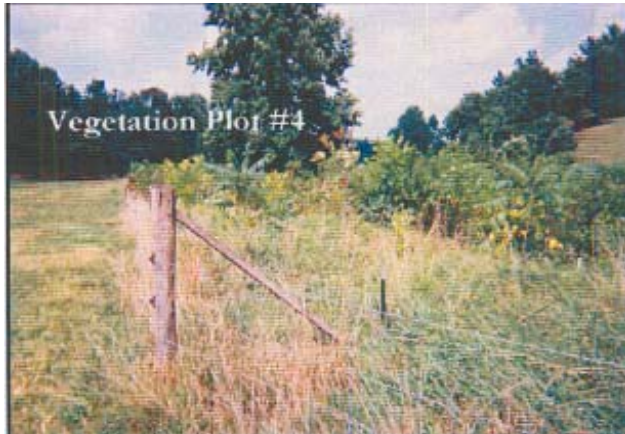
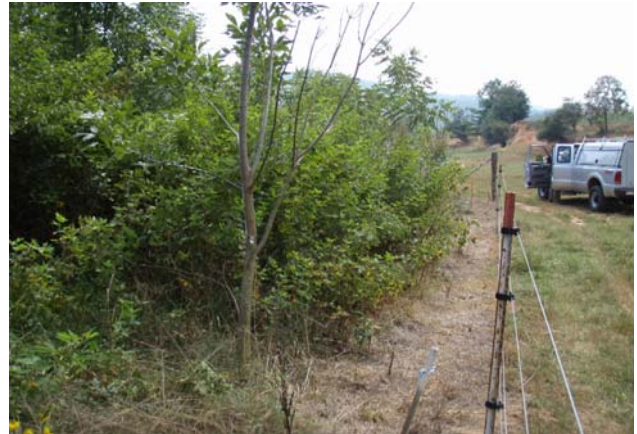
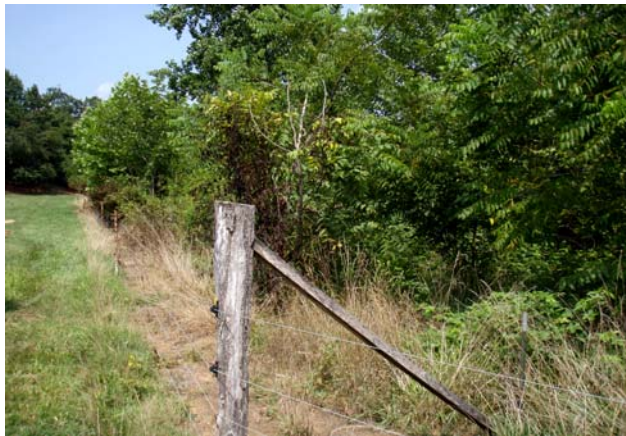
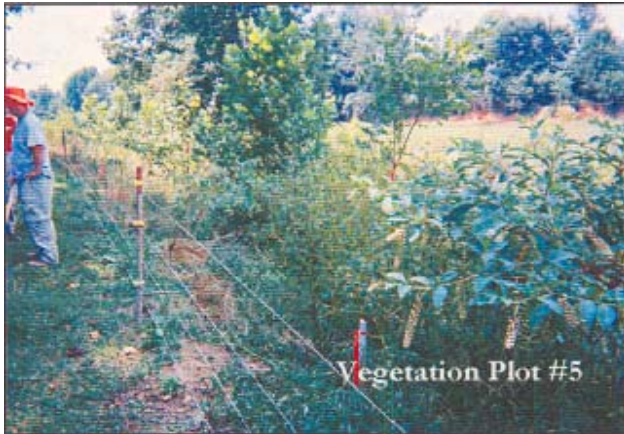
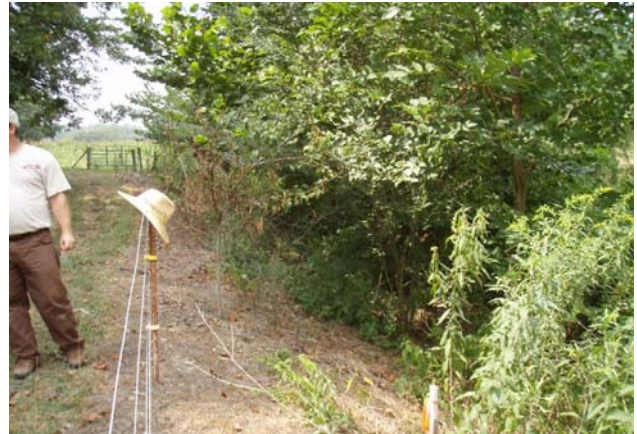
Vegetation plot 3, August 2008.

Vegetation plot 4, September 2004.

Vegetation plot 4, August 2007.

Vegetation plot 4, August 2008.

Vegetation plot 5, September 2004.

Vegetation plot 5, August 2007.

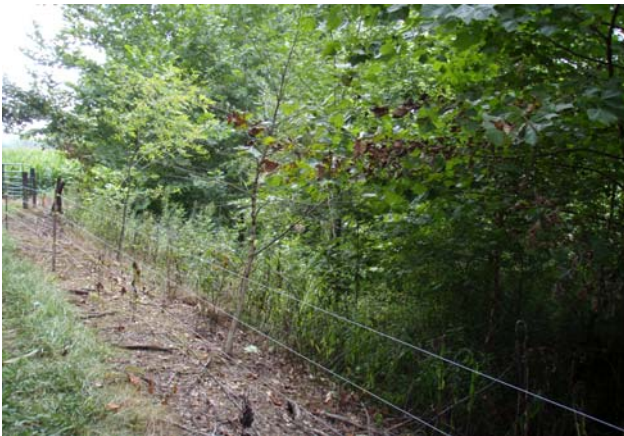
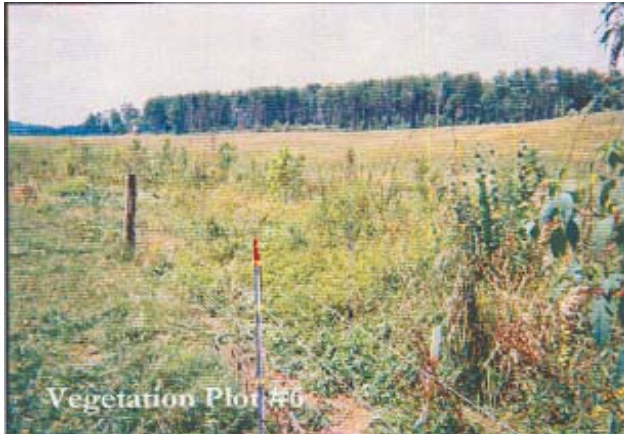
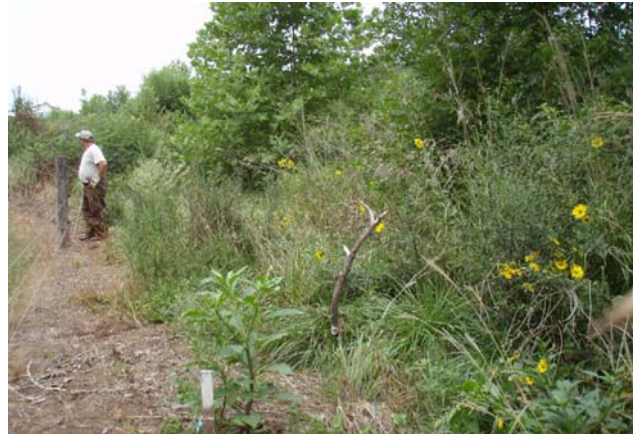
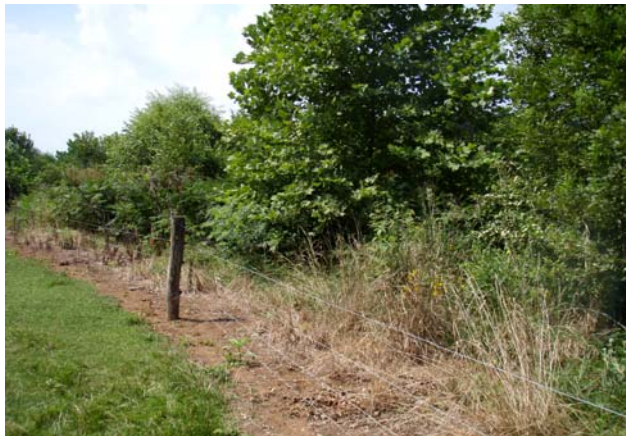
Vegetation plot 5, August 2008.

Vegetation plot 6, September 2004.

Vegetation plot 6, August 2007.

Vegetation plot 6, August 2008.

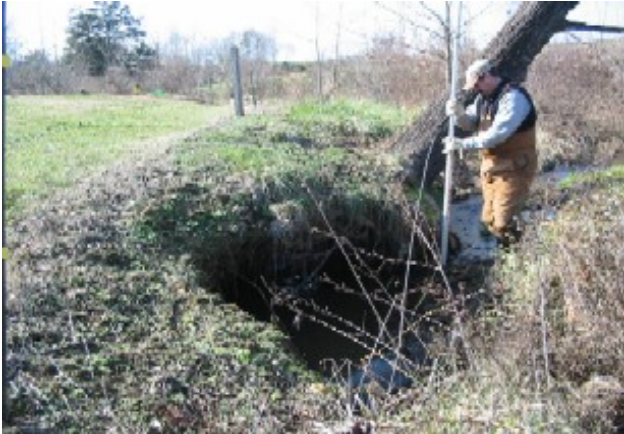
Area below cross-section 4, December 2007.
Note: large walnut tree leaning.

All four longitudinal profiles on Big Warrior creek show that there are no major channel bed changes other than the pools appeared to be getting smaller, but deeper in MY3. The majority of cross-sections on Big Warrior Creek also show little signs of instability. The pebble counts indicate that fine sediment is present throughout Big Warrior Creek, although visual observations suggest that the sediment is coming from sources outside of the conservation easement. The morphological summary data found in Table 3 also suggest that Big Warrior Creek is stable. It is categorized as a C4 stream type (Rosgen 1996). There are three areas of concern, all located within the lower pasture. These three areas will need remediation to protect the easement boundaries.

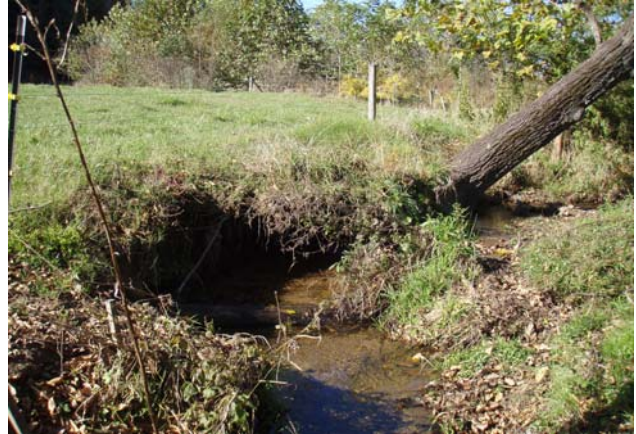
Area below cross-section 4, November 2008.

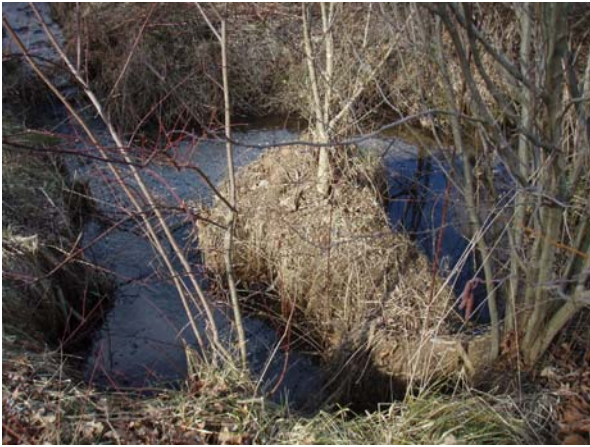
Area below cross-section 2, December 2007.
Photo taken looking right to left bank.

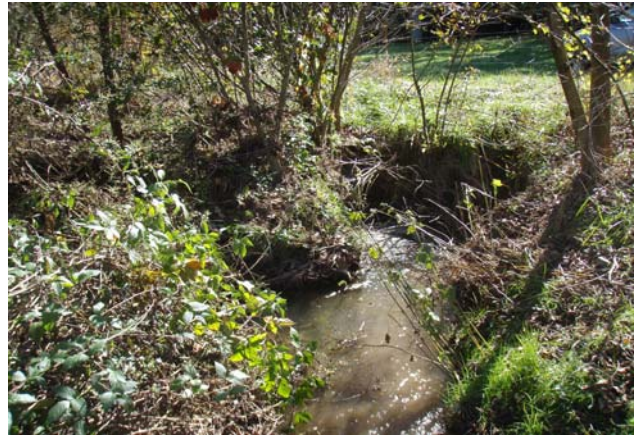
Area below cross-section 2, November 2008. Photo taken looking downstream.

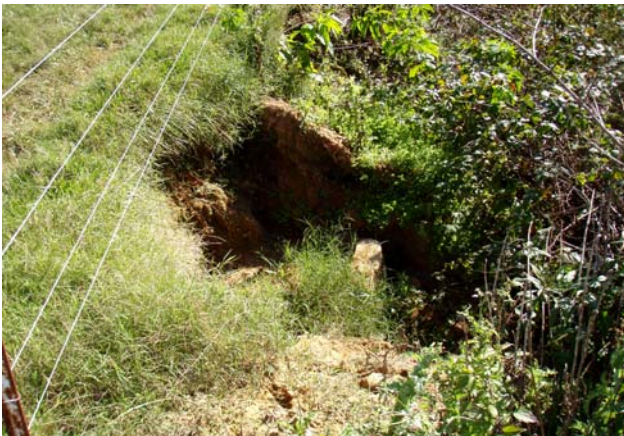
Area between cross-sections 3 and 4, November 2008. Photo taken at the top of the left bank.

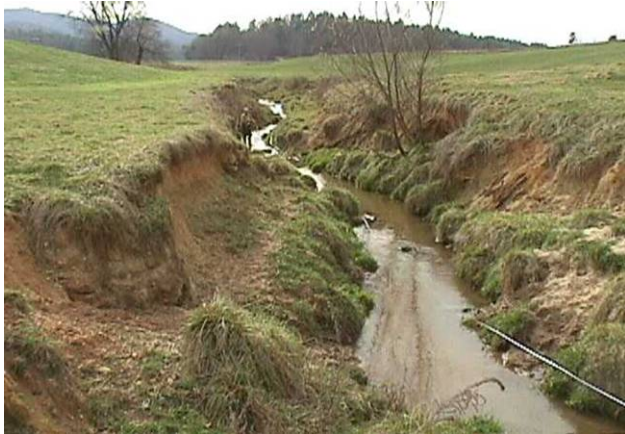
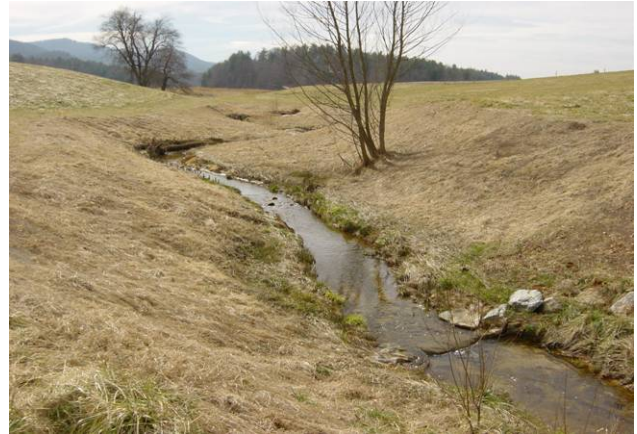
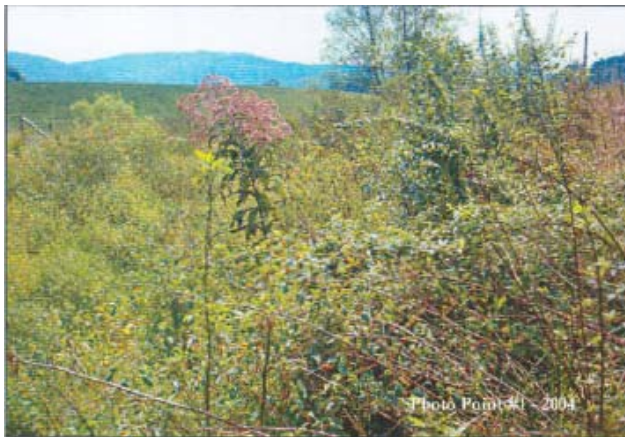
Photograph station 1, LUS, December 1998.

Photograph station 1, LUS, March 2003.

Photograph station 1, LUS, August 2004.

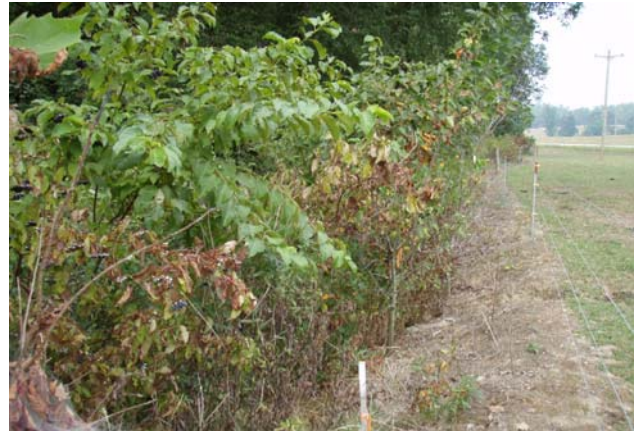
Vegetation Plot 3, August 2007.

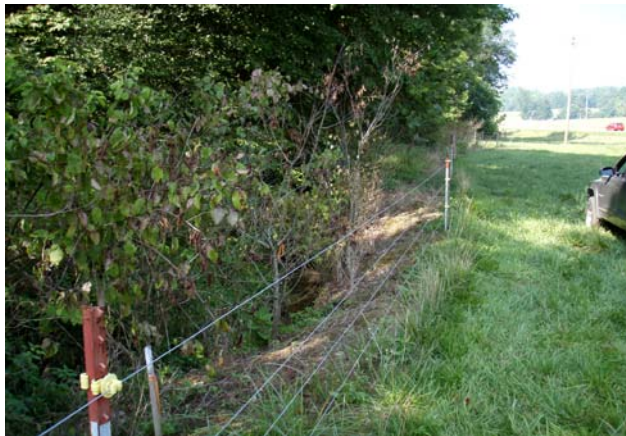
Vegetation Plot 3, August 2008.

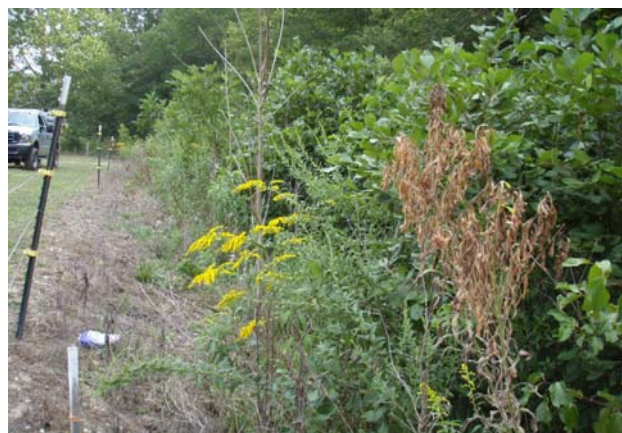
Vegetation Plot 4, August 2007.

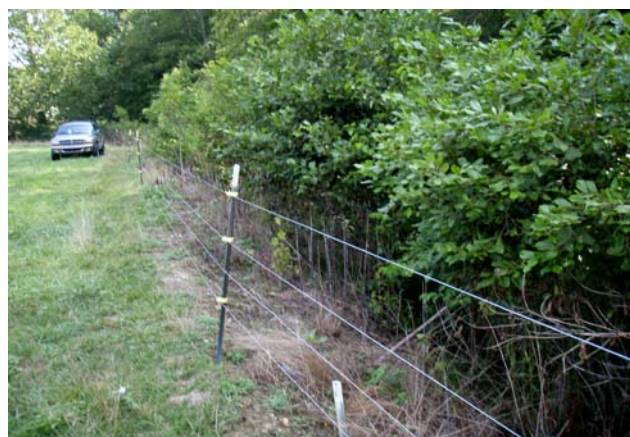
Vegetation Plot 4, August 2008.

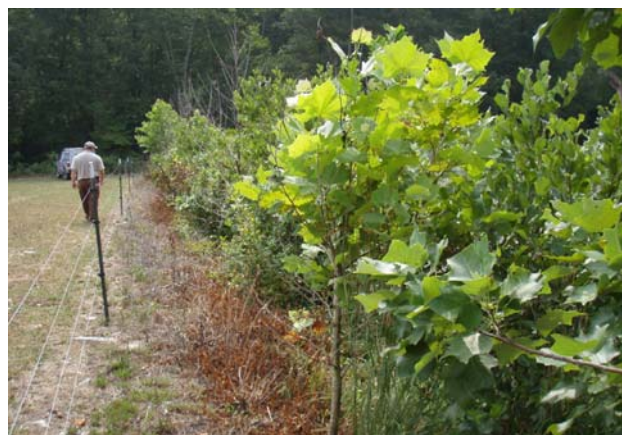
Vegetation Plot 5, August 2007.

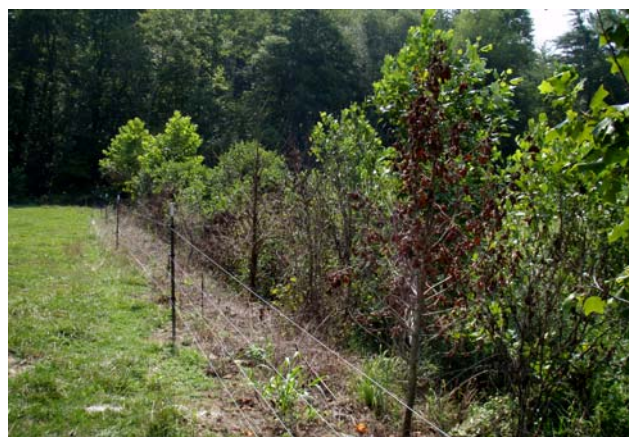
Vegetation Plot 5, August 2008.

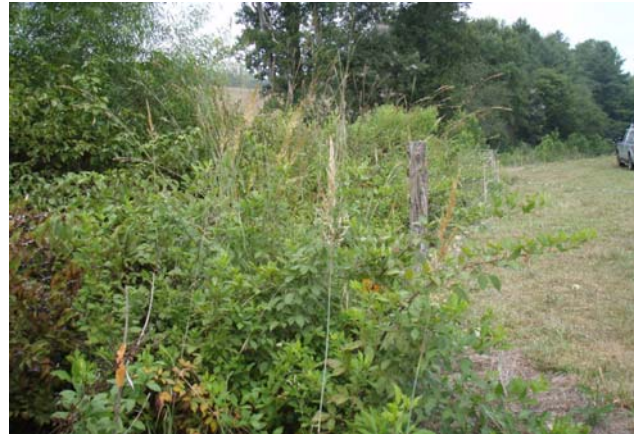
Vegetation Plot 6, August 2007.

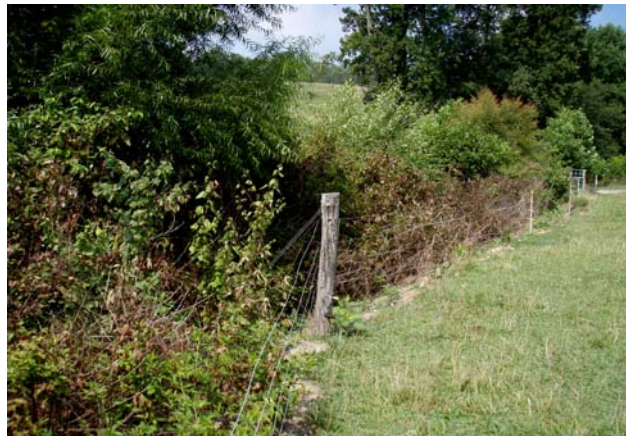
Vegetation Plot 6, August 2008.

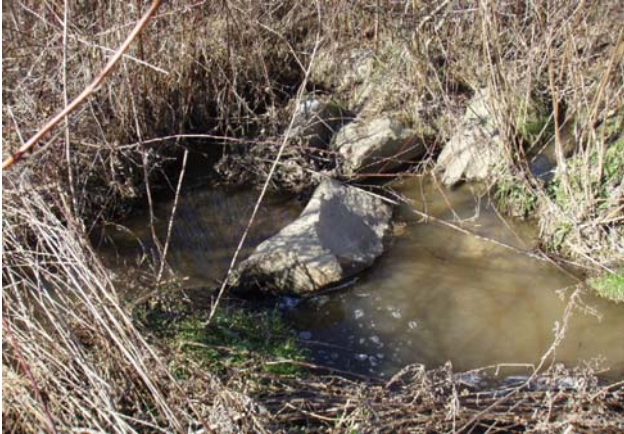
Area in the vicinity of cross-section 2. Water is piping through the boulders October 2007.

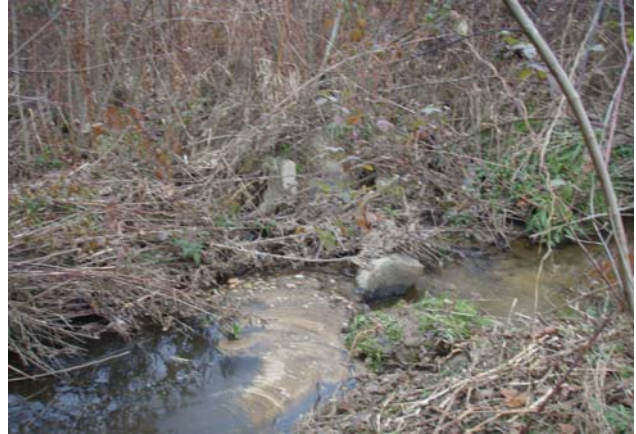
Area in the vicinity of cross-section 2. Water is piping through the boulders November 2008.

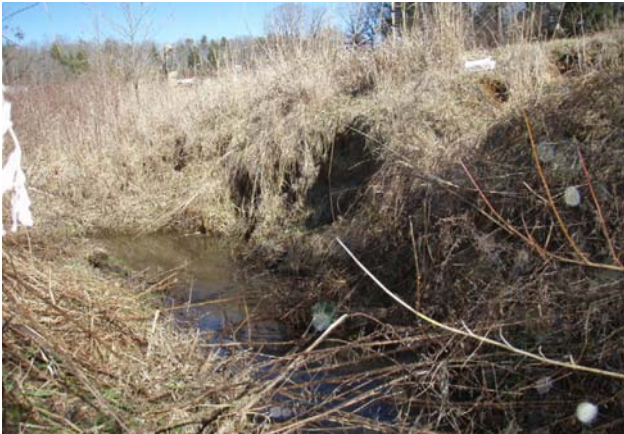
Area between cross-sections 1 and 2, LDS, October 2007.

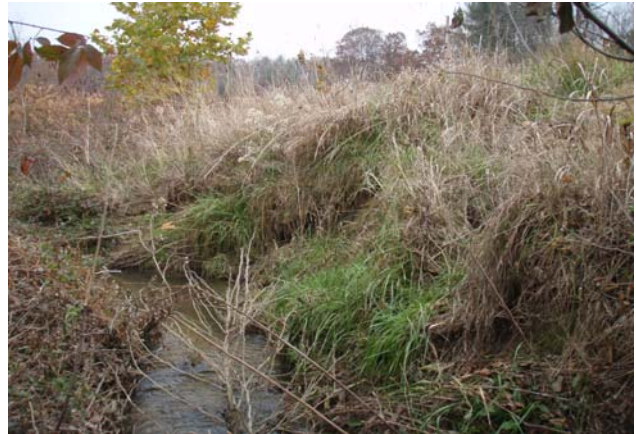
Area between cross-sections 1 and 2, LDS, November 2008.

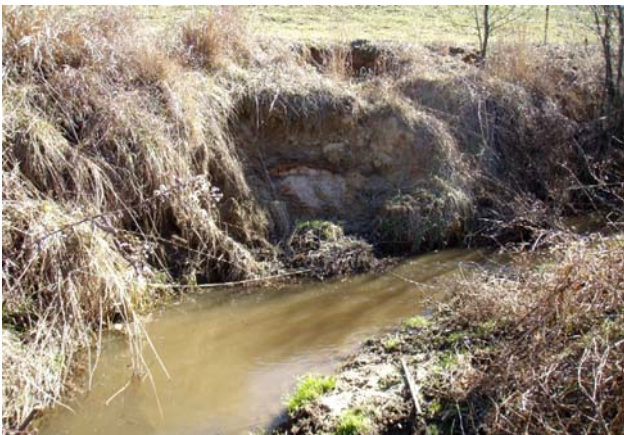
Area between cross-sections 1 and 2, LUS. Banks are sloughing due to overland flow, October 2007.

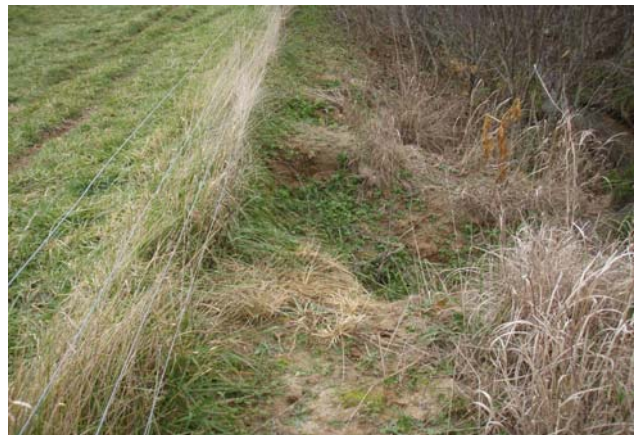
Area between cross-sections 1 and 2, LUS. Banks are sloughing due to overland flow, November 2008.

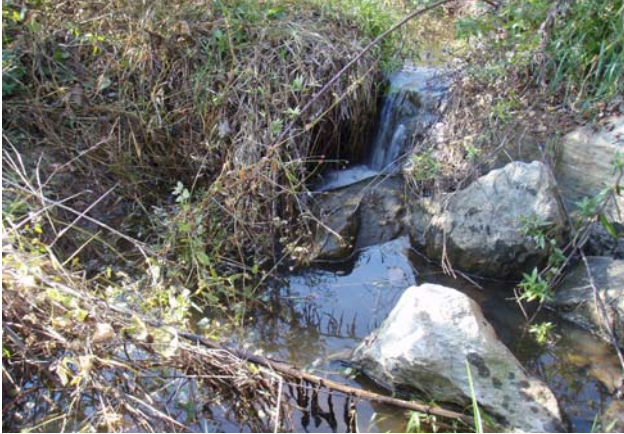
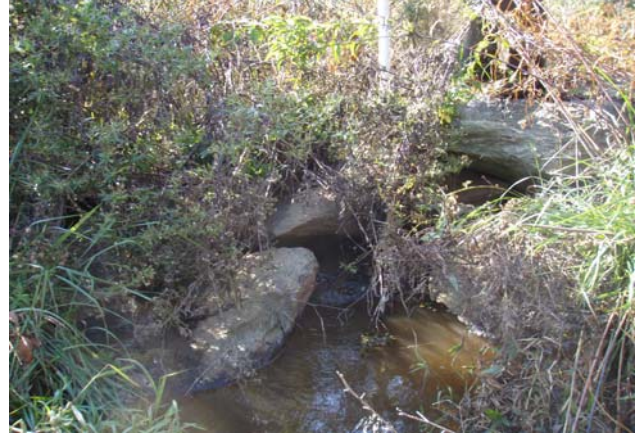
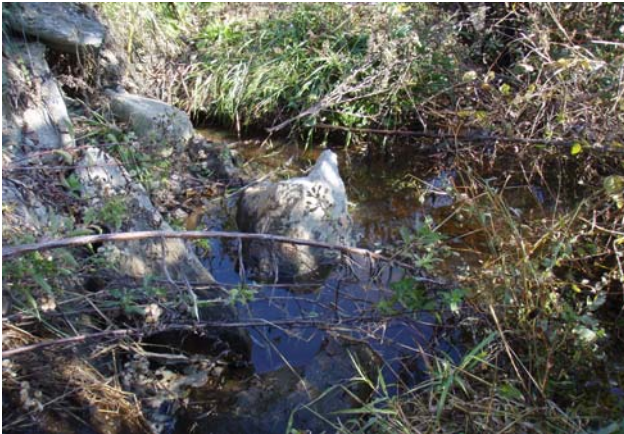
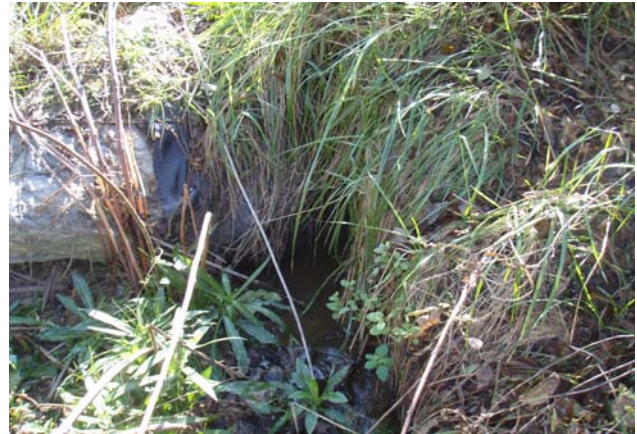
The four photographs below are in the vicinity of the confluence of an unnamed tributary to LWC and LWC below Andrews road (SR 1256). The stream problem as evidenced in these photographs is piping through the rock structures.

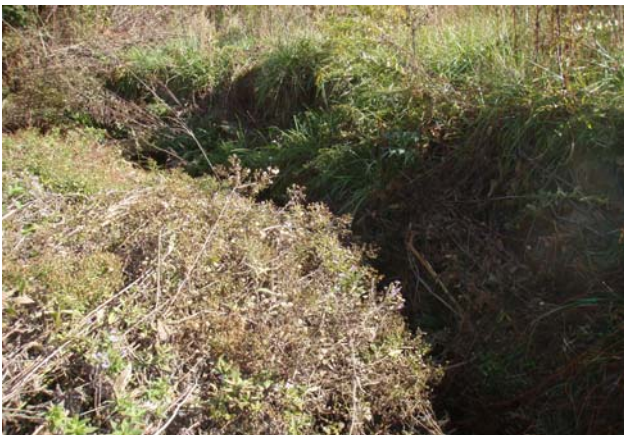
Eroding right bank below cross-section 6, LDS, November 2008.

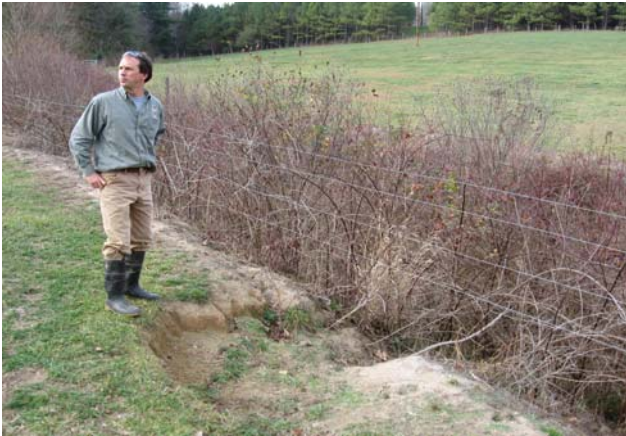
Area located on an unnamed tributary to LWC below cross-section 11, October 2007.

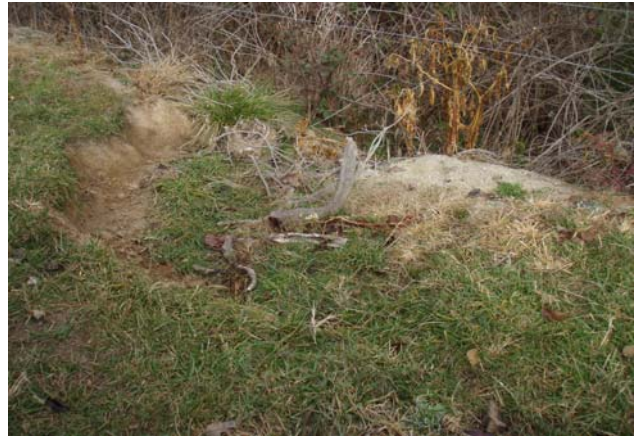
Area located on an unnamed tributary to LWC below cross-section 11, November 2008.

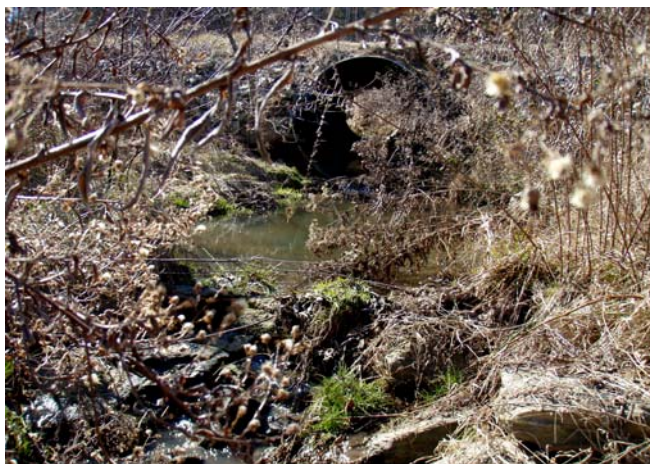
Photograph looking upstream at the culvert, December 2007.

Repositioned boulders and added geotextile fabric to the rock sill in front of the culvert, September 2005.

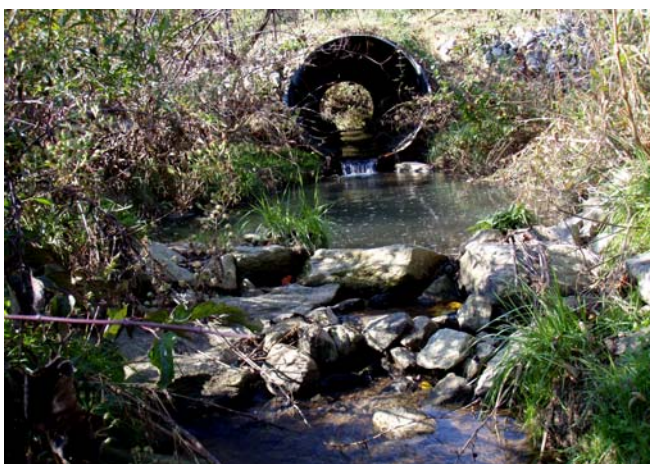
Photograph looking upstream at the culvert, November 2008.

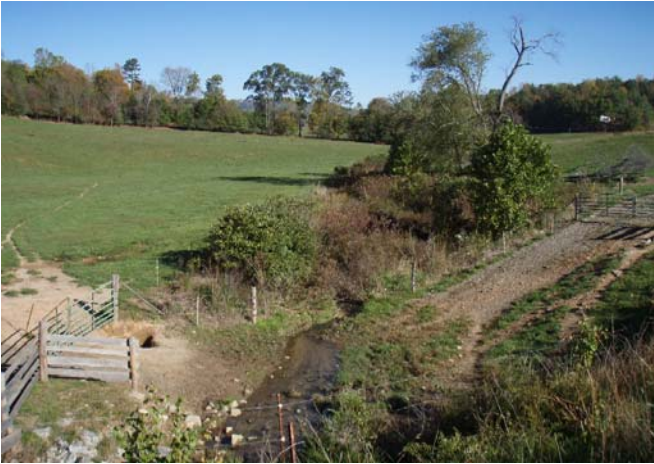
September 2007.

Repairs to the cattle drinker and reseeding, September 2005.

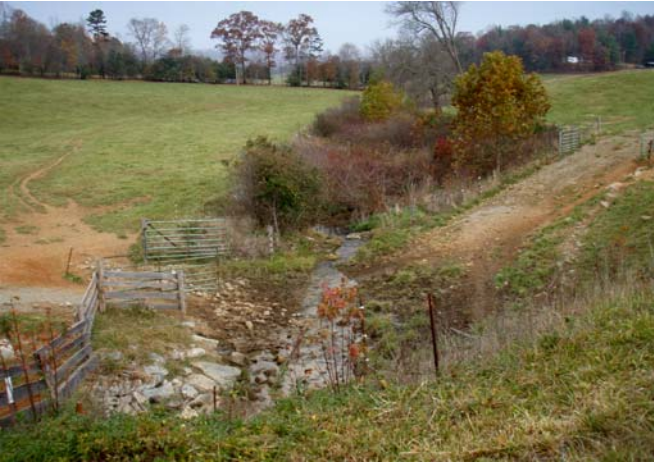
November 2008

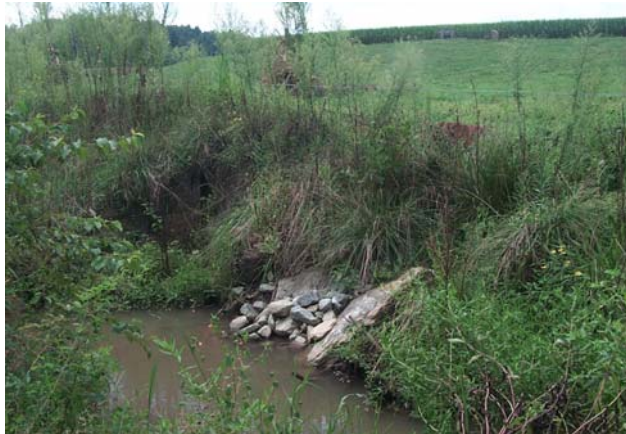
Before stream bank repairs to the left bank above cross-section 3, LUS, September 2005.

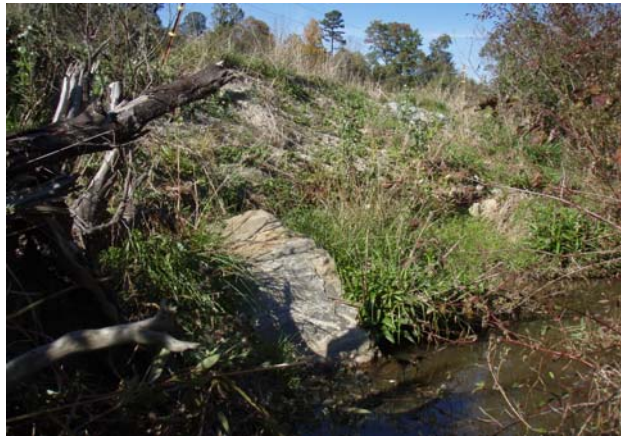
LDS, November 2008.

After stream bank repairs to the left bank above cross-section 3, LUS, September 2005.

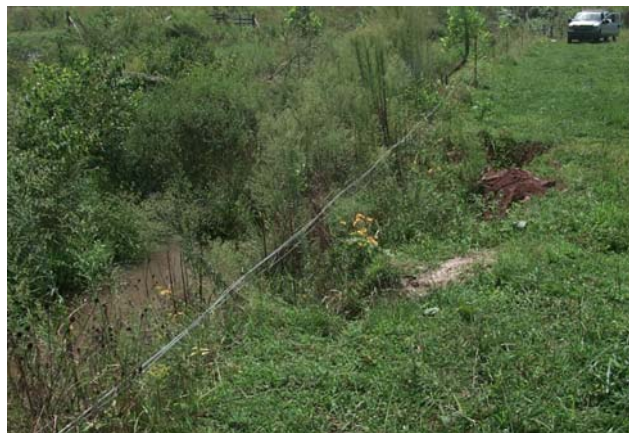
Before stream bank repairs to the left bank around cross-section 3, September 2005.

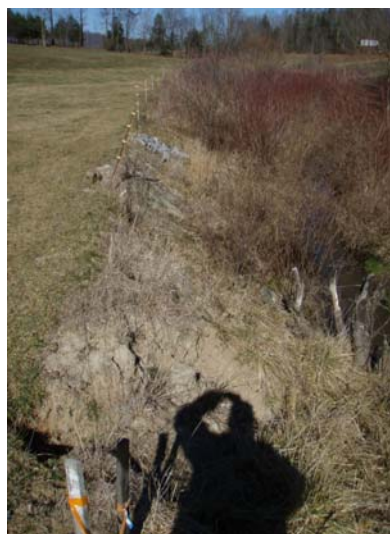
January 2008.

After stream bank repairs to the left bank around cross-section 3, September 2005.

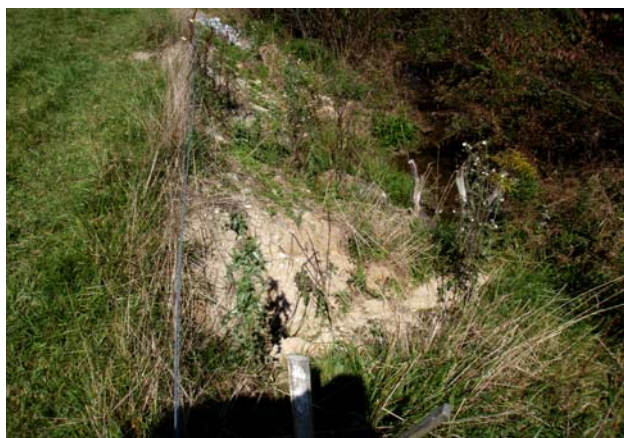
November 2008.
