BISHOP ROAD WETLAND RESTORATION PROJECT

HYDE COUNTY, NORTH CAROLINA
SCO PROJECT No. 050653801

FINAL RESTORATION PLAN
August 2006

Prepared by:
ARCADIS G&M of North Carolina, Inc.
801 Corporate Center Drive
Suite 300
Raleigh
North Carolina 27607
Tel 919 854 1282
Fax 919 854 5448

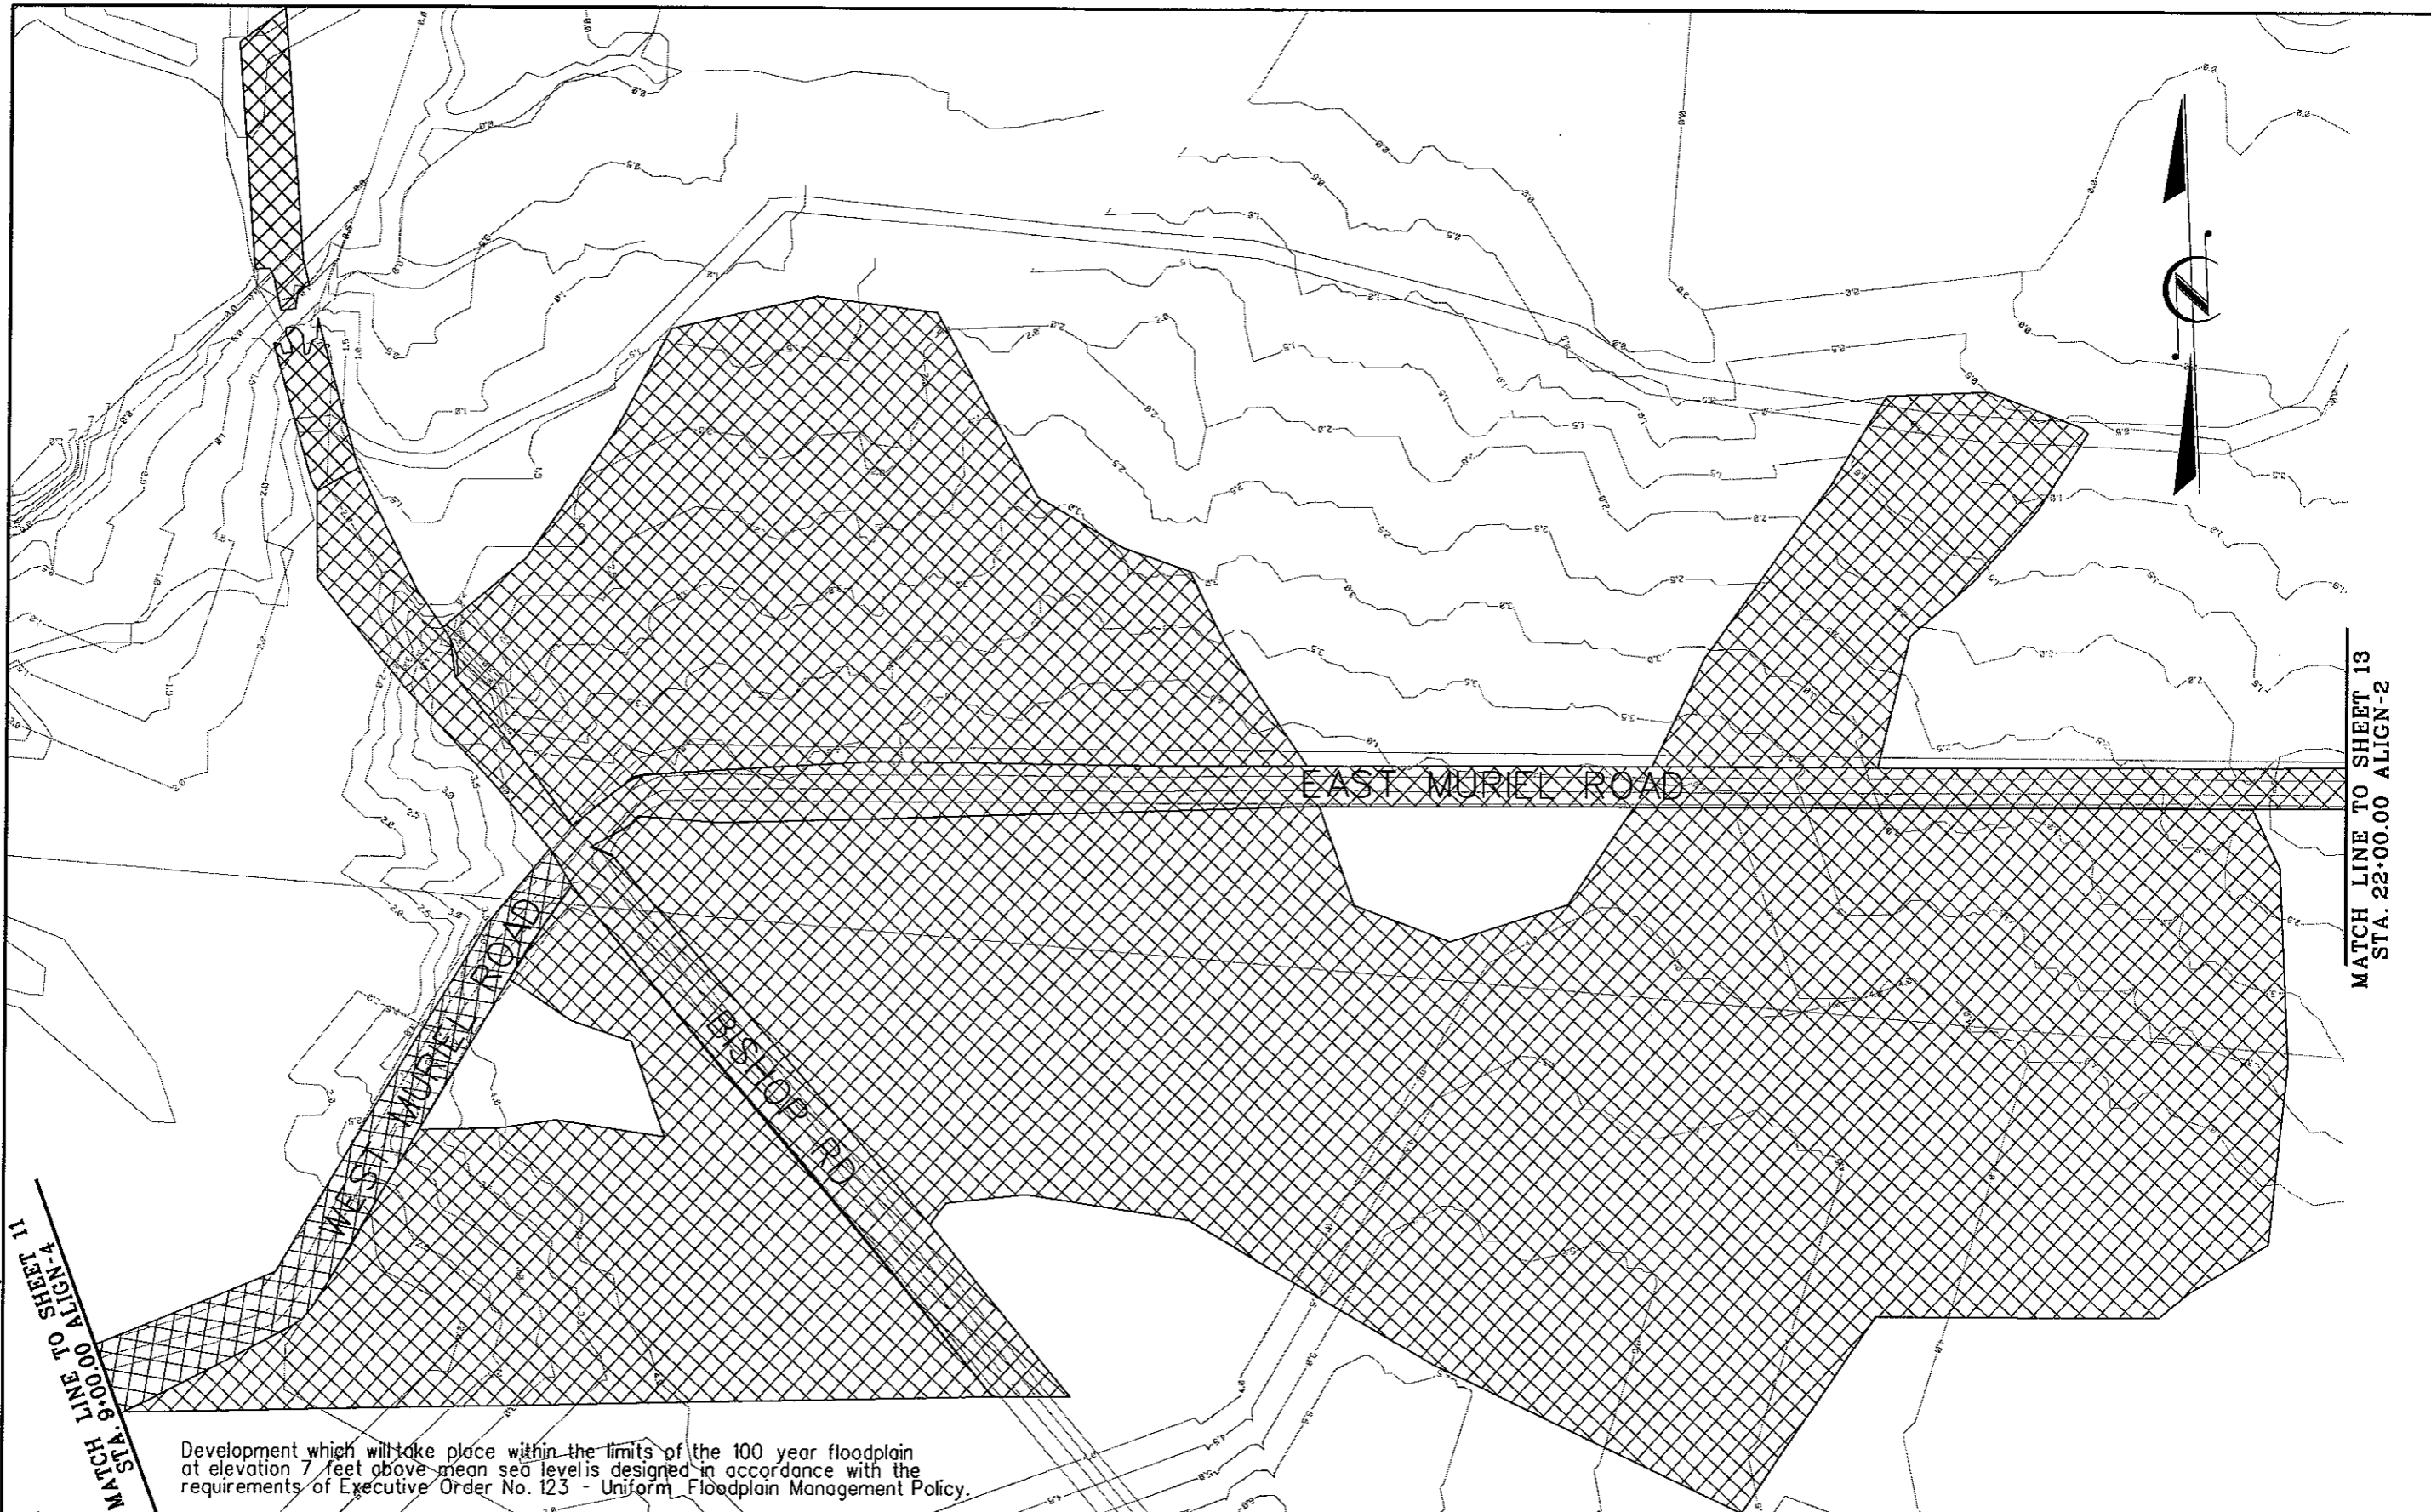
EROSION CONTROL SHEET NO. 11

STA. A. MATCH LINE TO SHEET 11
 9+00.00 ALIGN-4

MATCH LINE TO SHEET 13
 STA. 22+00.00 ALIGN-2

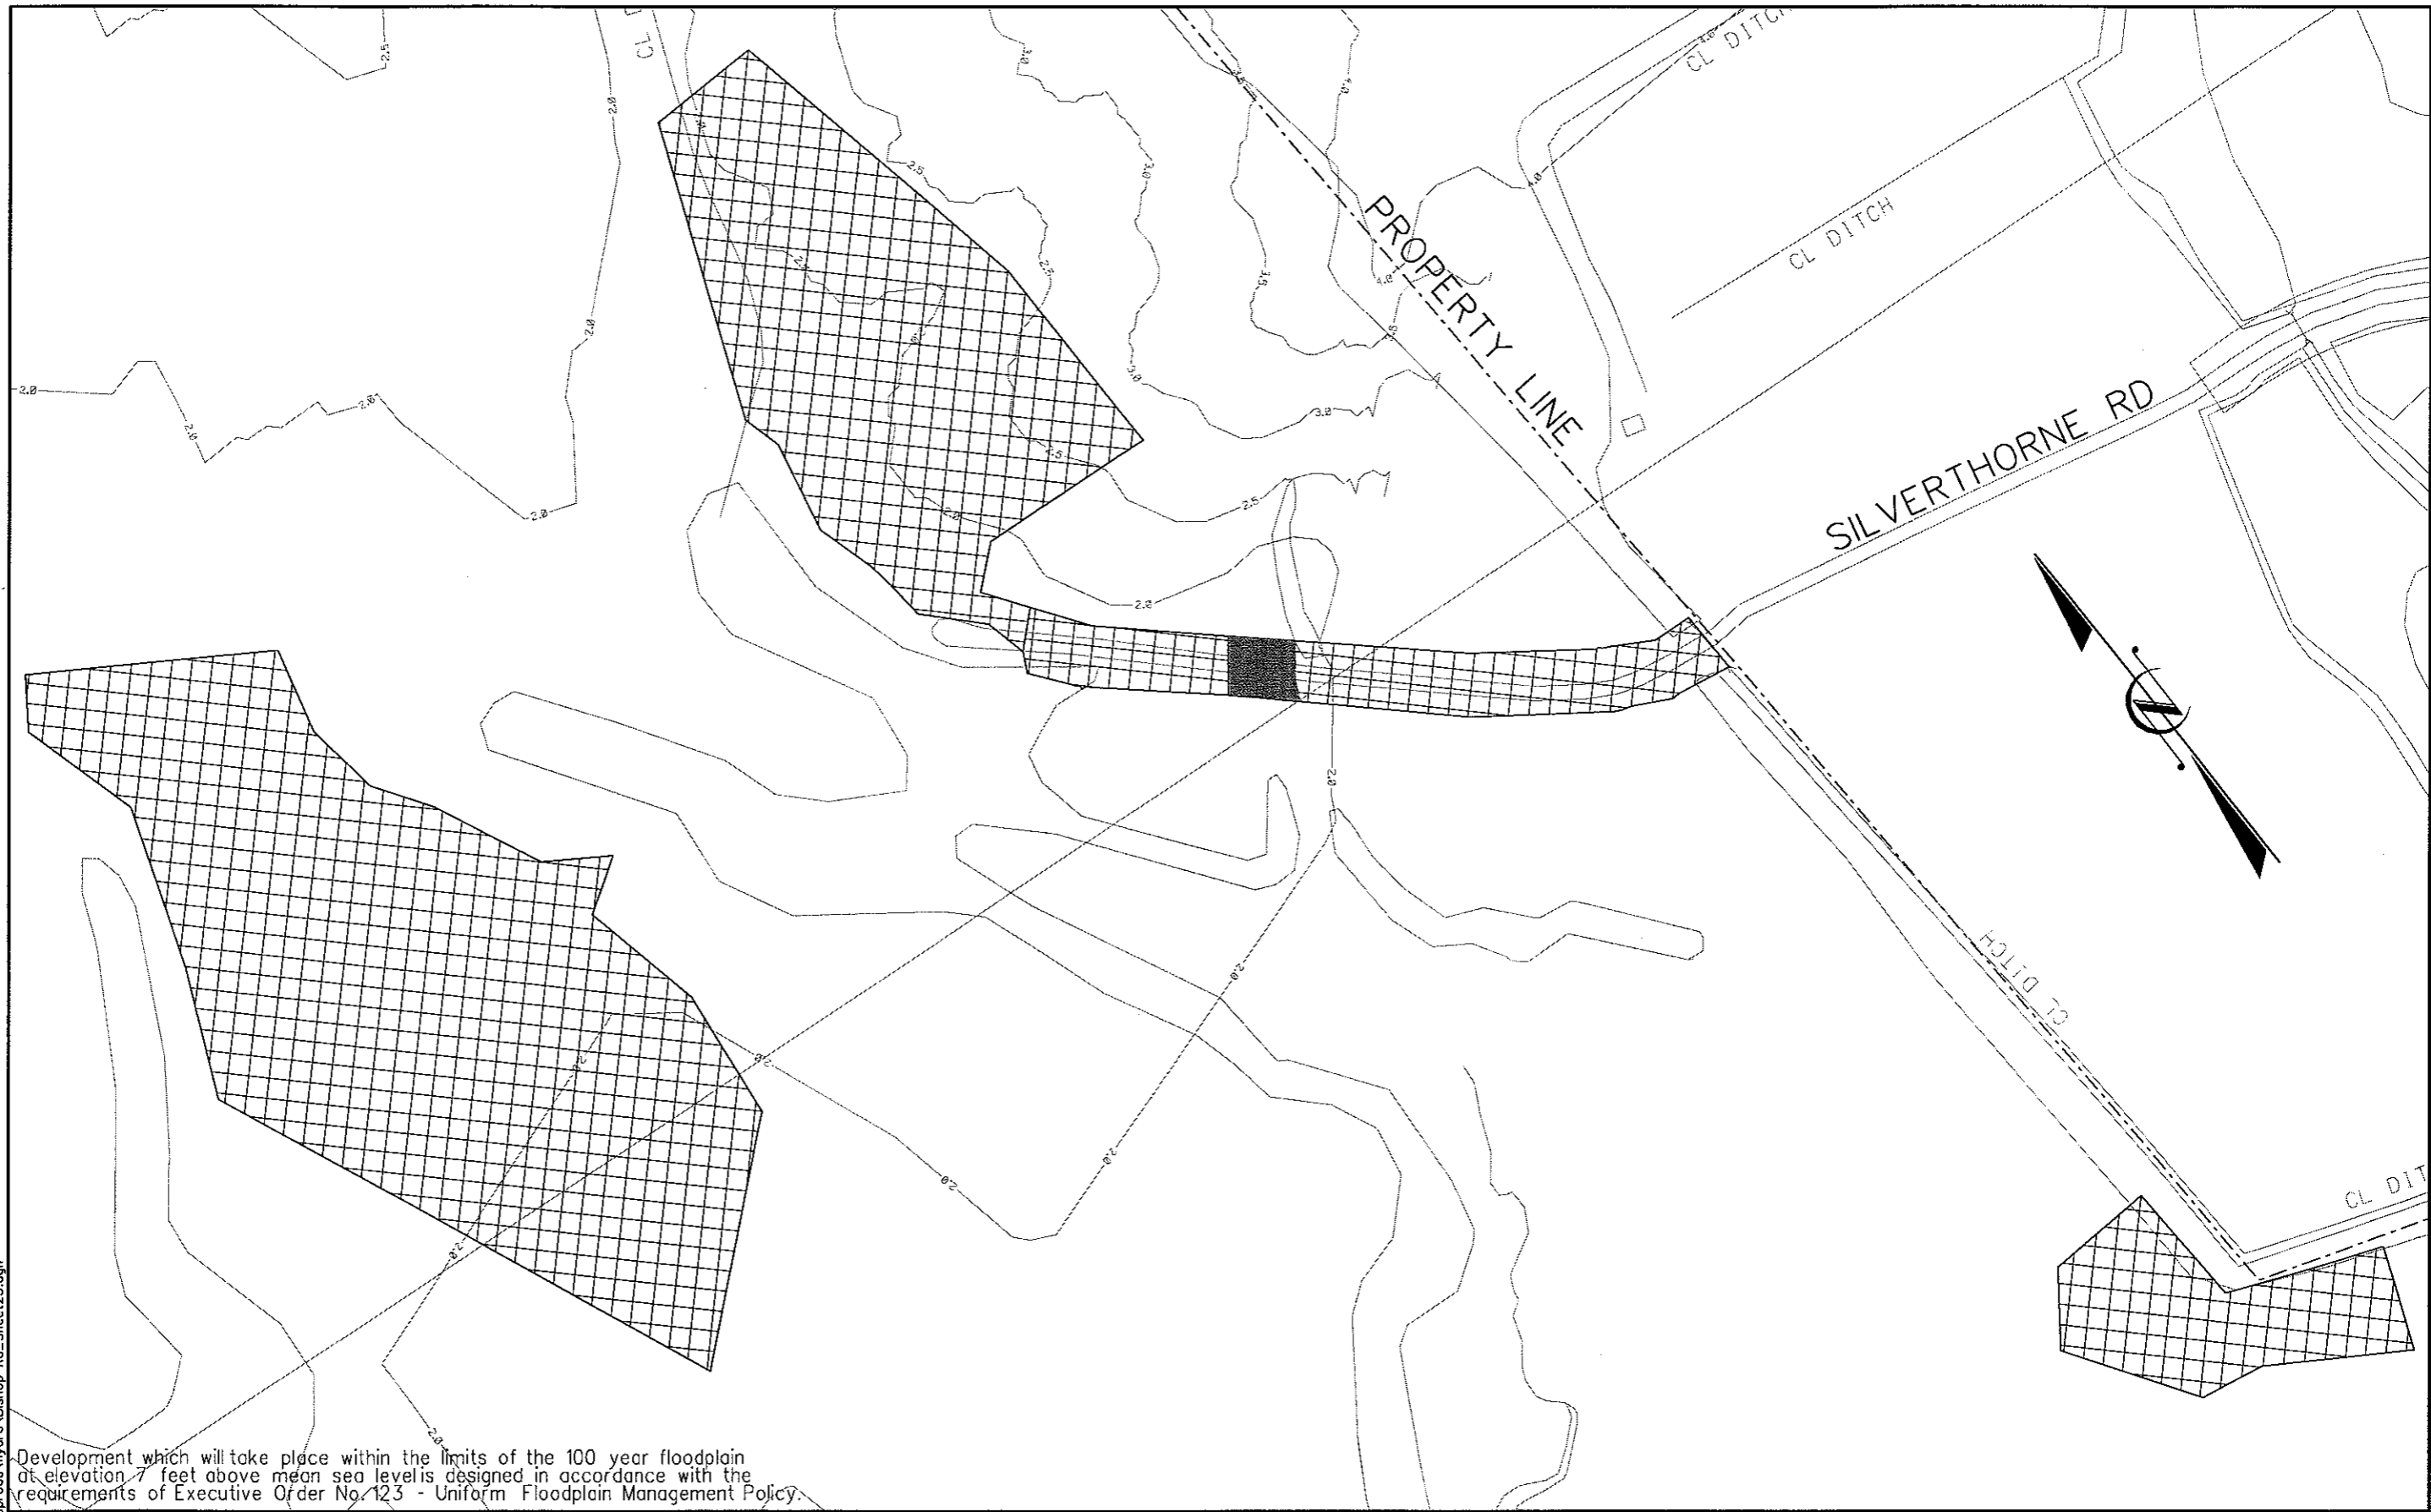
SHEET NO. 24

PLANTING PLAN

Development which will take place within the limits of the 100 year floodplain at elevation 7 feet above mean sea level is designed in accordance with the requirements of Executive Order No. 123 - Uniform Floodplain Management Policy.
