**Bishop Road Wetland Mitigation Site
Monitoring Year 1 (2009)**

**Hyde County, NC
State Construction Office Project No. 05-0653802
EEP Project No. 38**

FINAL Monitoring Report

December 2010

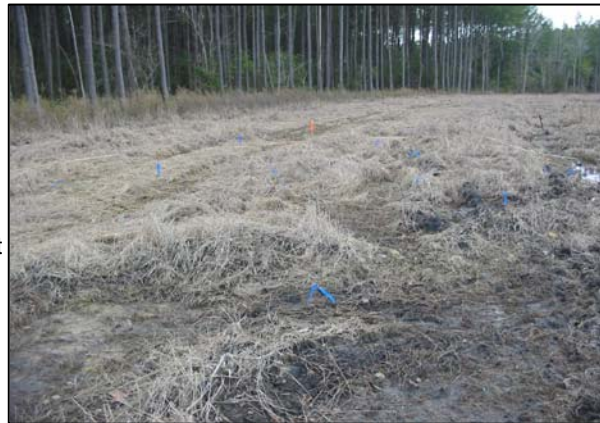
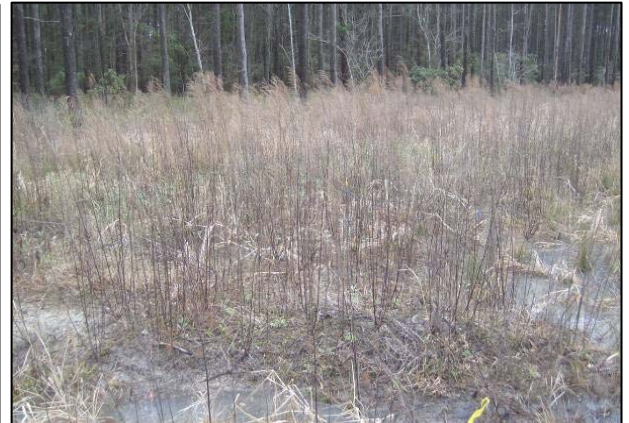
Photo #
VP-21
Facing West

Feature/Issue	Station/Range	Probable Cause	Photo #
Vegetation Plot # 21	n/a	Unknown	VP - 21
Vegetation Plot # 24	n/a	Inundation	VP - 24
Vegetation Plot # 25	n/a	Inundation	VP - 25
<i>Phragmites australis</i>	n/a	Invasive Species	n/a

In January 2010, EEP personnel met with the planting contractor to discuss supplemental plantings throughout the Project Site. The result of the meeting was that supplemental planting will occur and stem counts will be updated during Year 2 monitoring activities.
