**Bishop Road Wetland Mitigation Site  
Monitoring Year 2 (2010)**

**Hyde County, NC  
State Construction Office Project No. 05-0653802  
EEP Project No. 38**

**Final Monitoring Report**

**December 2010**

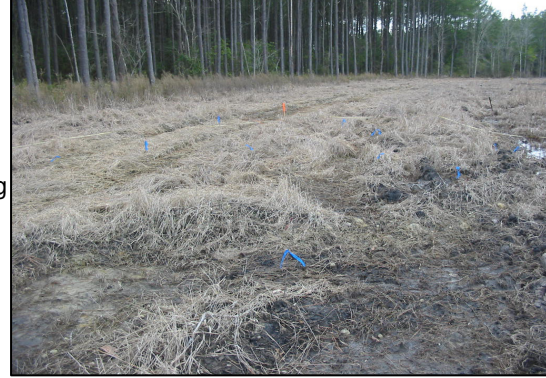
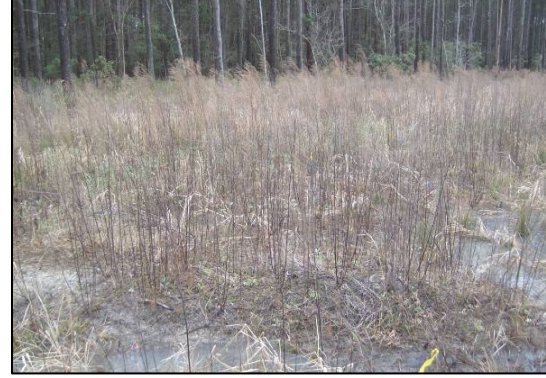
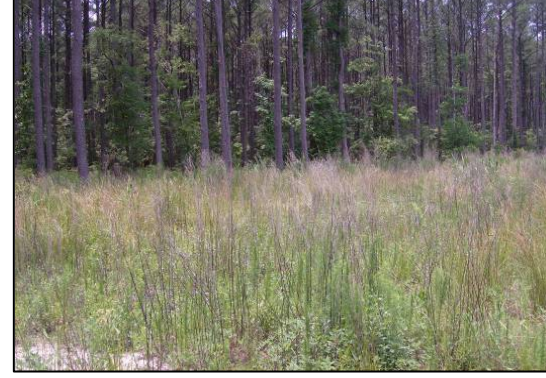
Photo #  
VP-21 Facing  
West

Feature/Issue	Station/Range	Probable Cause	Photo #
Vegetation Plot # 21	n/a	Unknown	VP - 21
Vegetation Plot #23	n/a	Inundation	VP -23
Vegetation Plot # 24	n/a	Inundation	VP - 24
Vegetation Plot # 25	n/a	Inundation	VP - 25
Vegetation Plot # Scranton Creek SW	n/a	Unknown	VP - Scranton SW
Vegetation Plot # Tarklin Creek	n/a	Unknown	VP - Tarklin Creek
<i>Phragmites australis</i>	n/a	Invasive Species	n/a

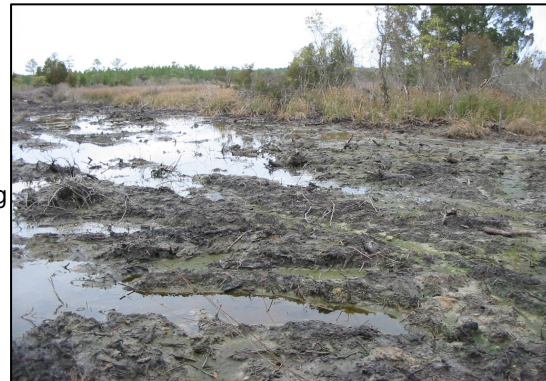
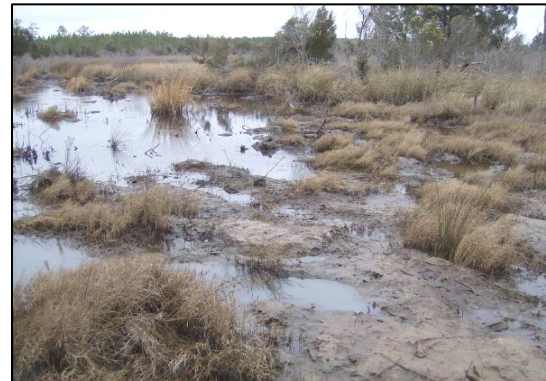
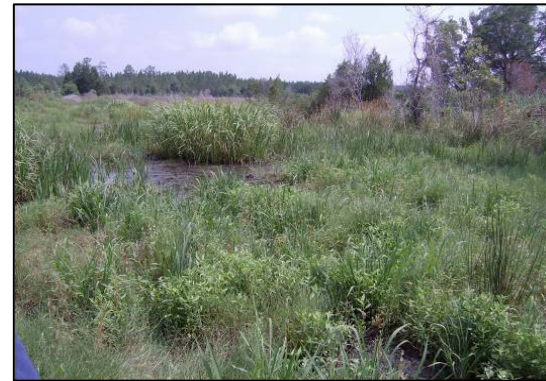
Photo #  
VP-24 Facing  
North

In addition, the two wetland vegetation plots (VP# 24 and 25) did not exhibit any cover during the Year 2 monitoring assessment. Cover was observed however, during the fall and winter months.

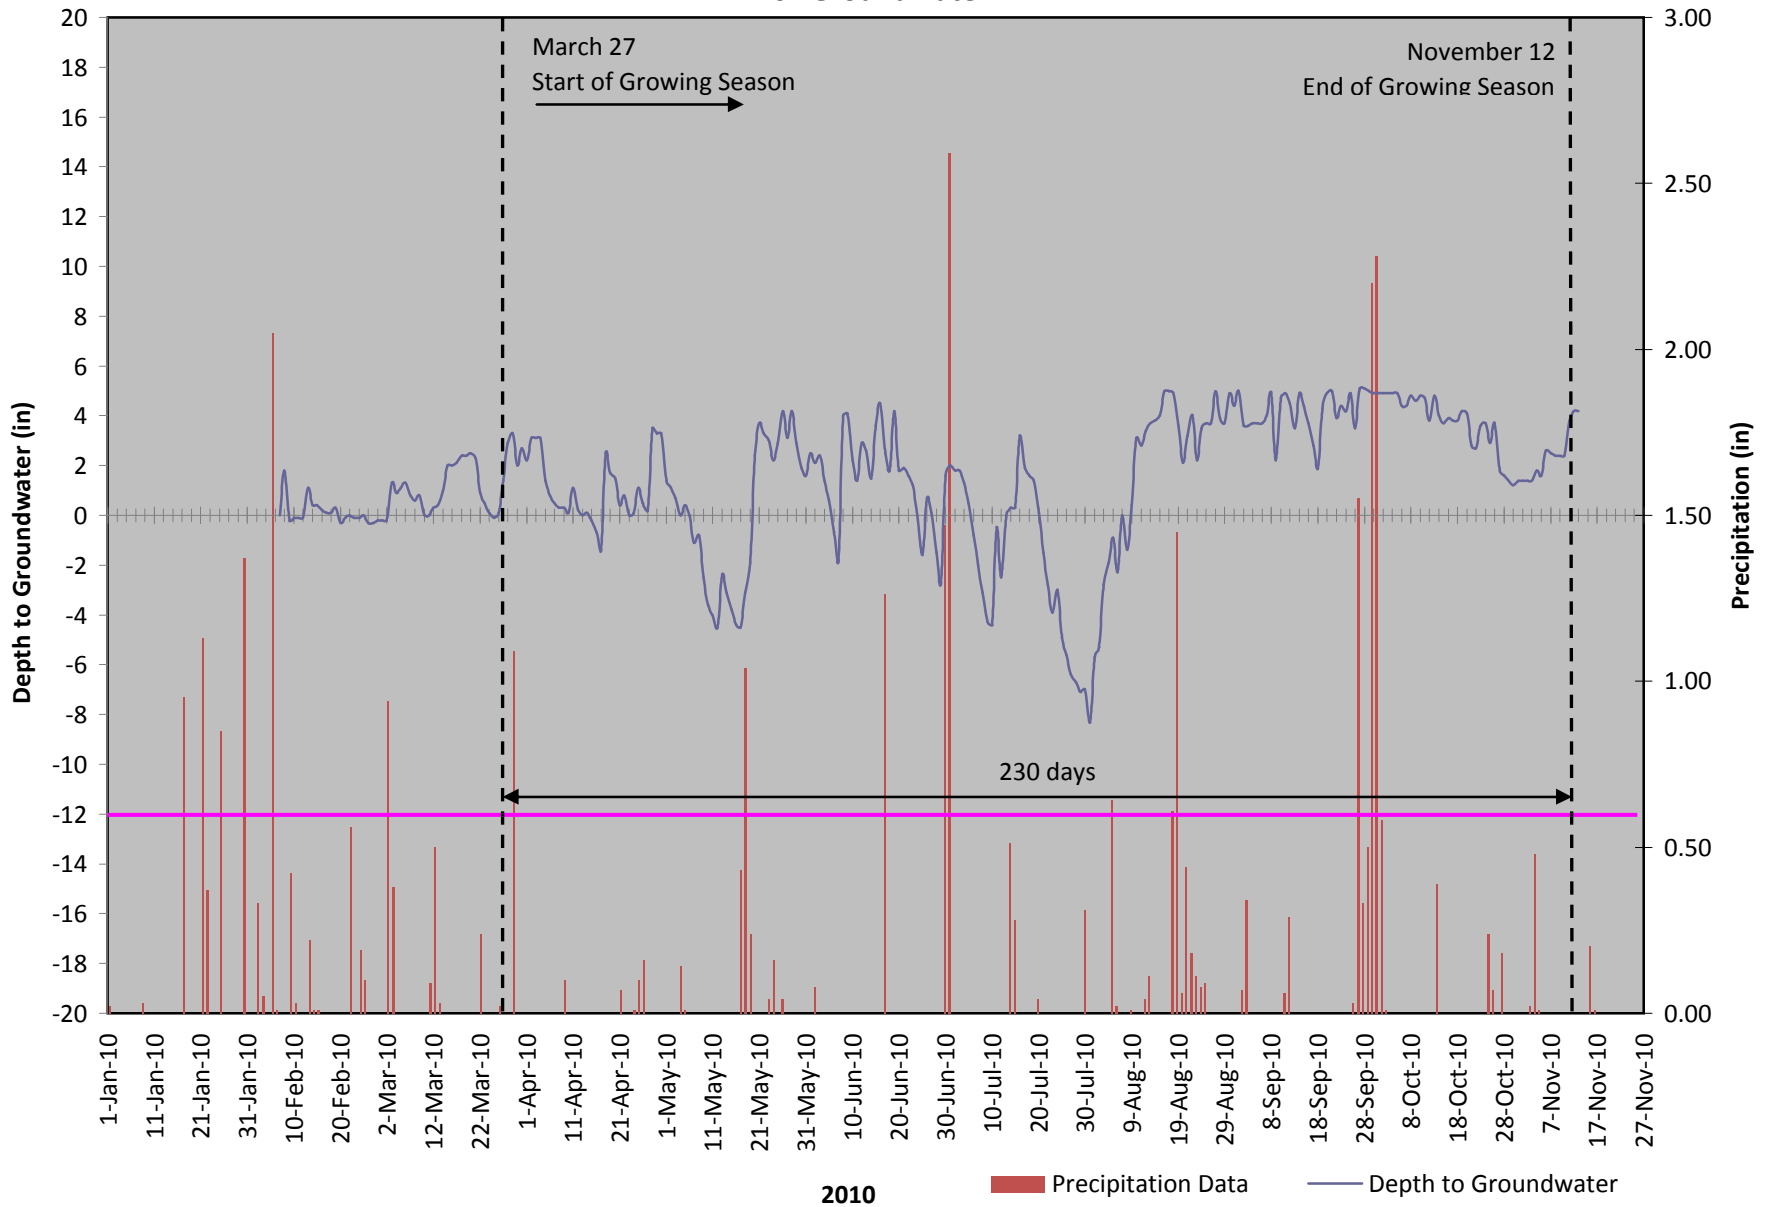
### Monitoring Well #7 40" Groundwater

All 12 of the monitoring wells met the hydrologic requirements of saturation within 12 inches of the ground surface for a period no less than 5% of the growing season. According to EEP (2009), the growing season at the Project Site is estimated at 230 total days, ranging from March 27 through November 12. Five of the wells exceeded the saturation requirements for more than 12.5% of the growing season.

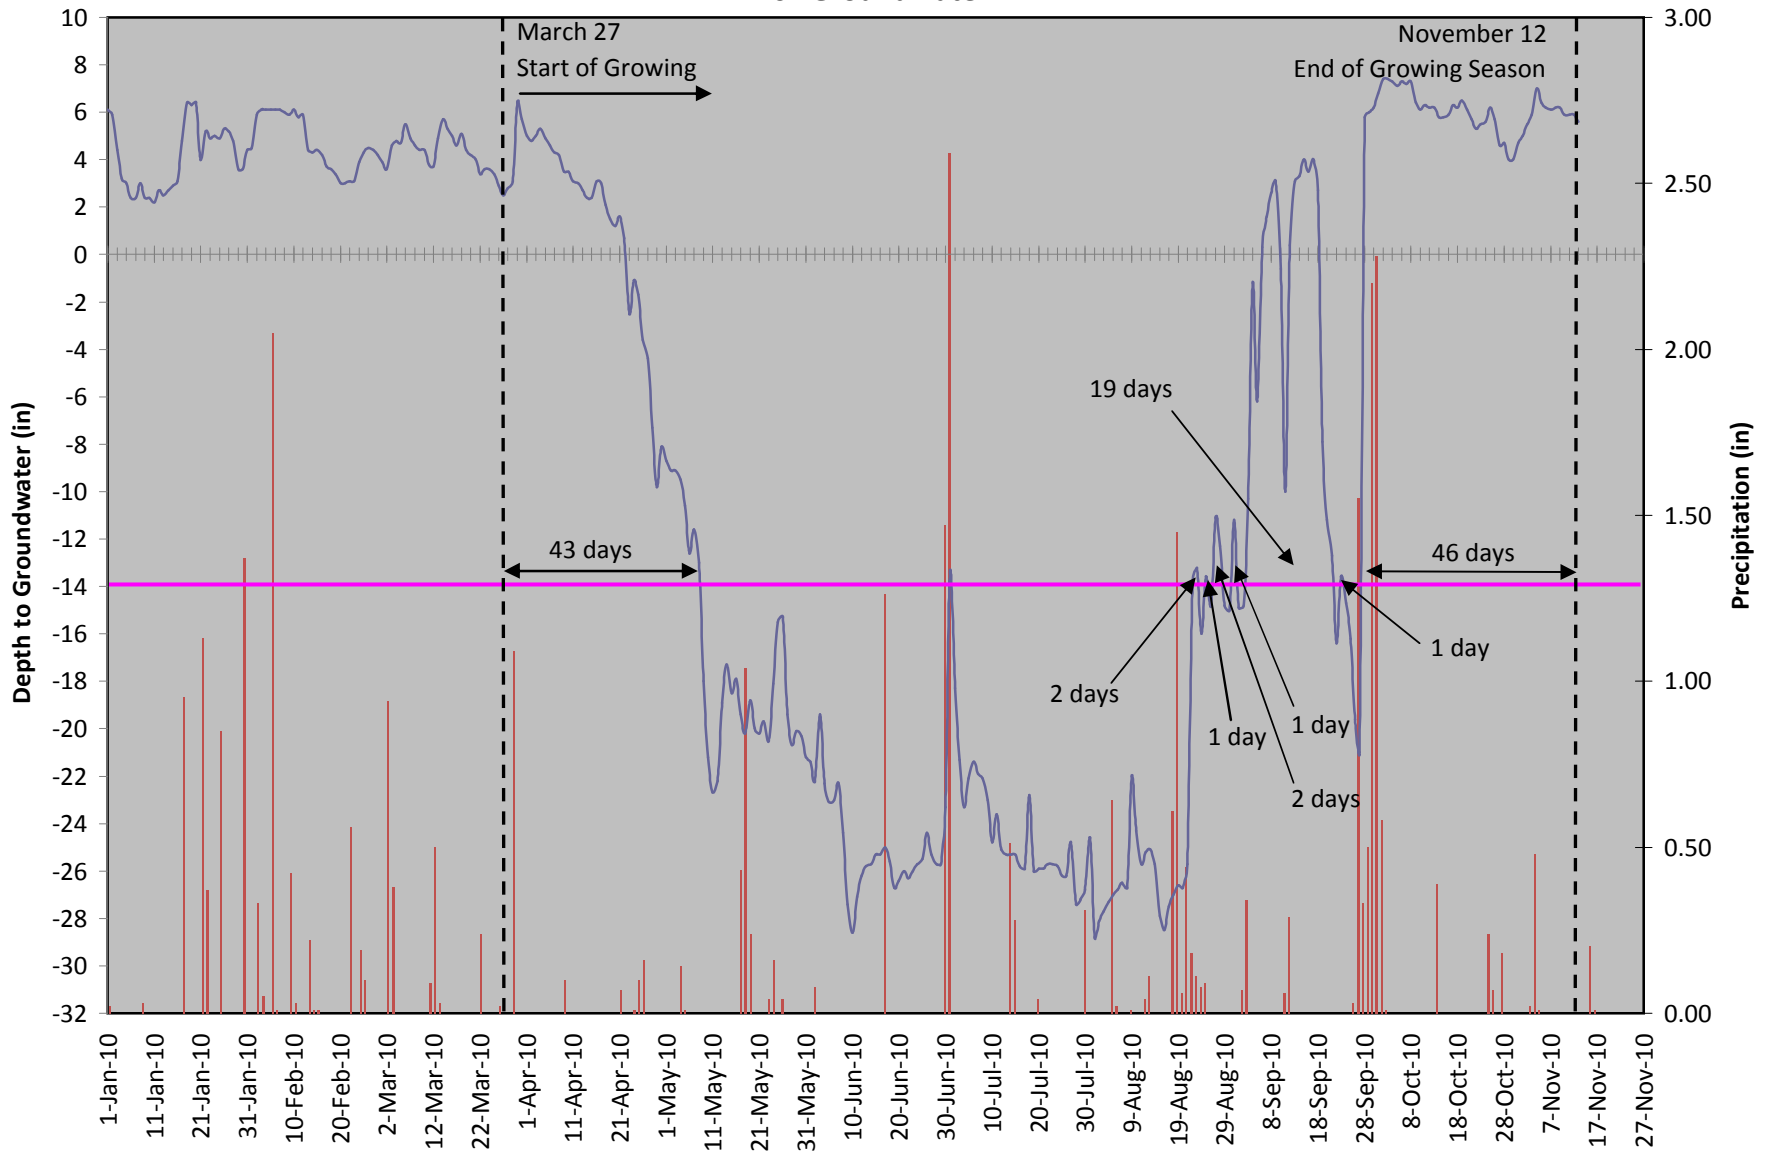
### Monitoring Well #14 40" Groundwater

Note: Calibration point is 2 inches above ground surface

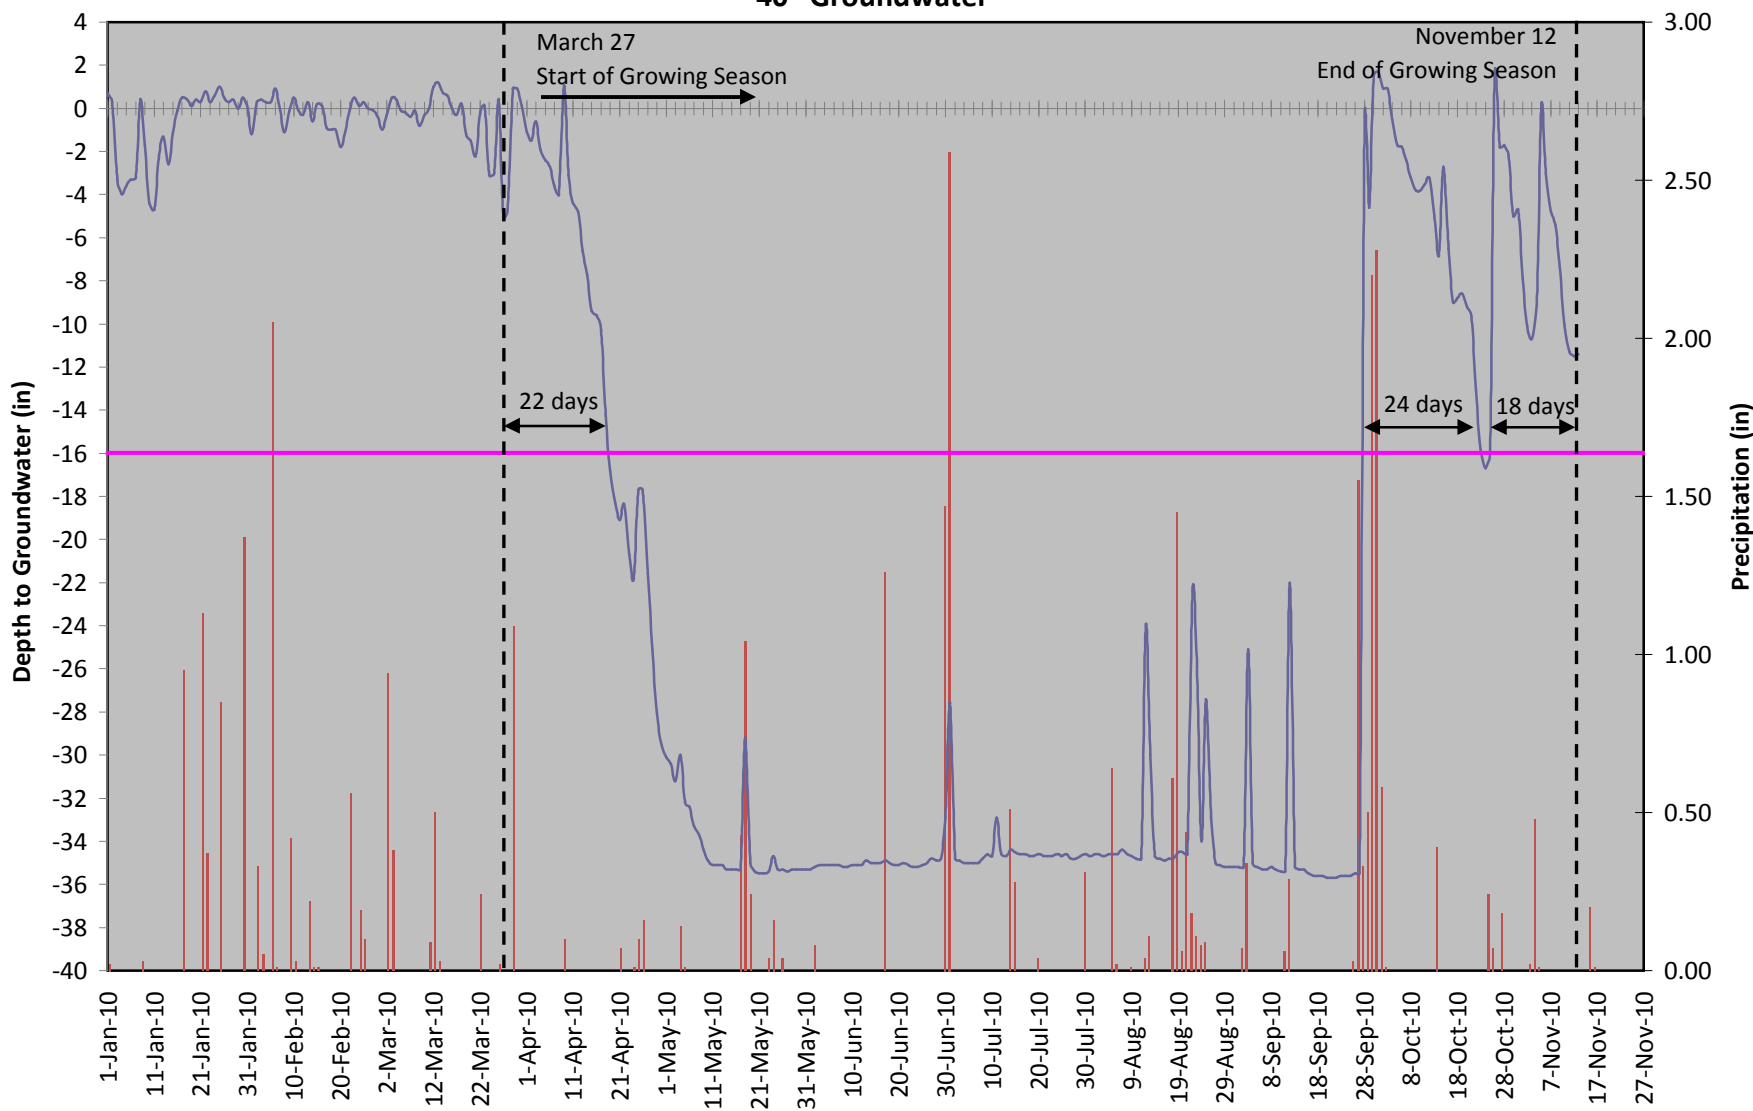
### Monitoring Well #21 40" Groundwater

Note: Calibration point is 4 inches above ground surface
