**Bishop Road Wetland Mitigation Site
Monitoring Year 3 (2011)**

**Hyde County, NC
State Construction Office Project No. 05-0653802**

Final Monitoring Report

December 2011

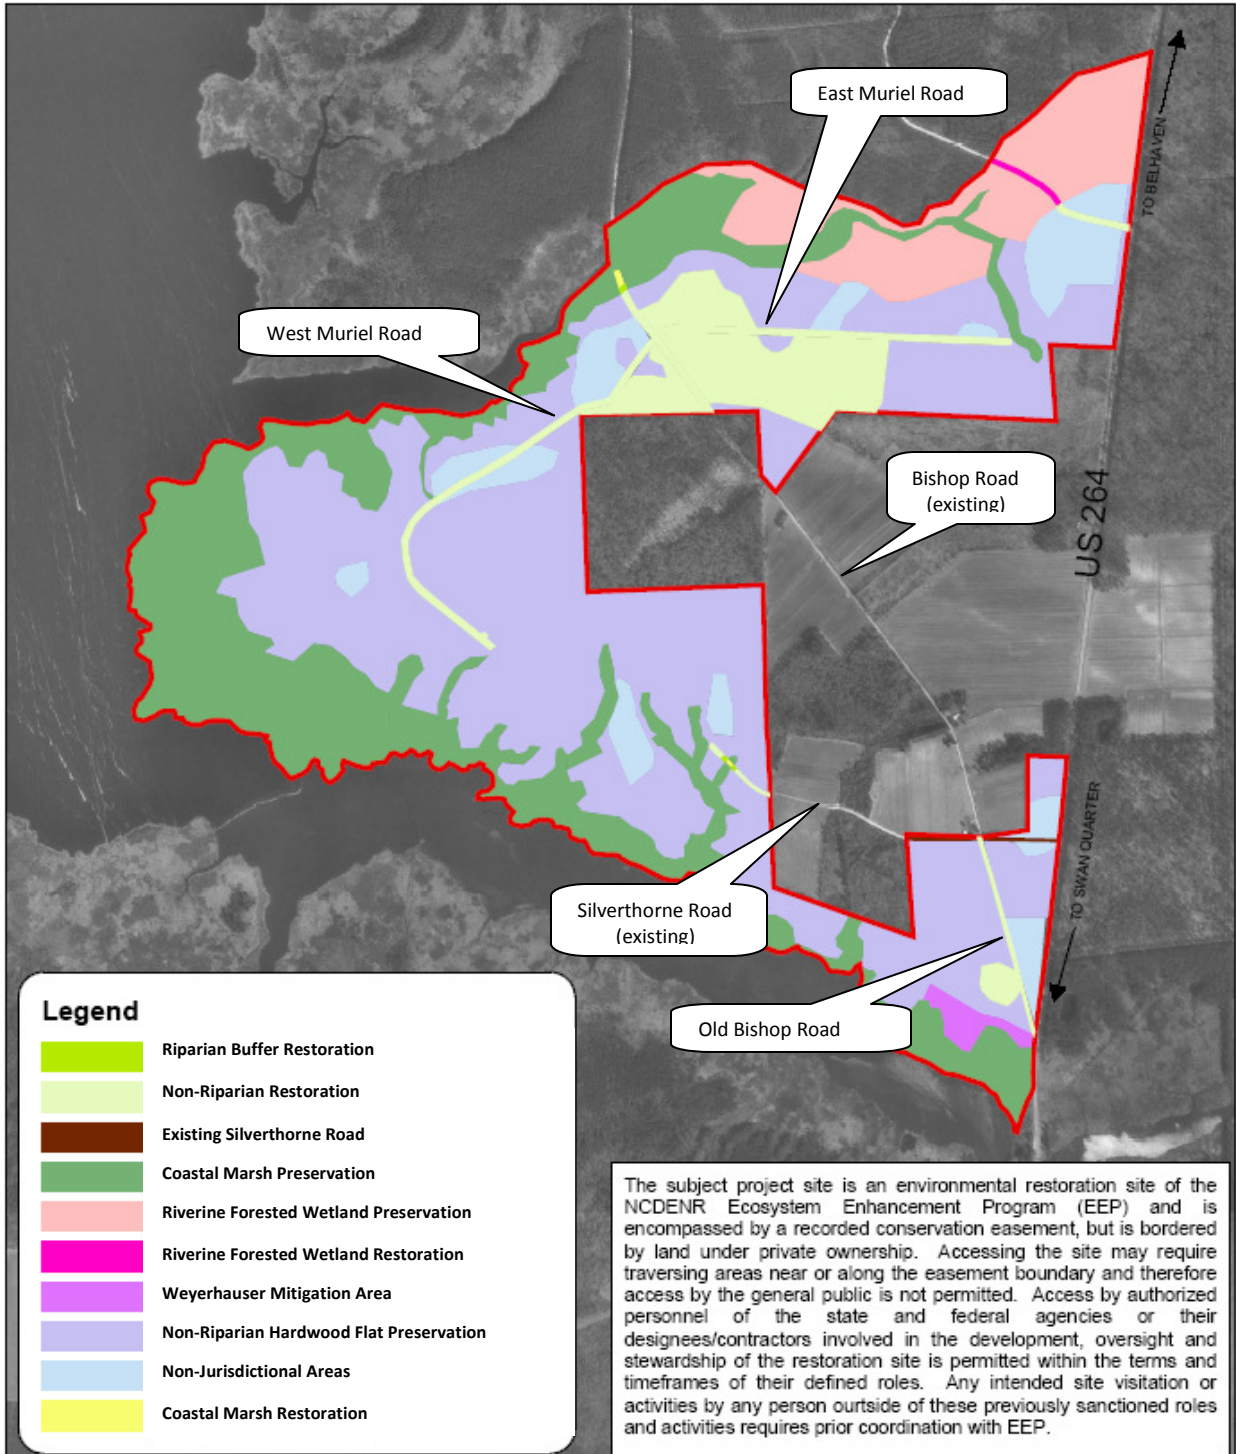
| | <p align="center"> PROJECT ATTRIBUTES Bishop Road Wetland Mitigation Site HYDE COUNTY, NORTH CAROLINA <i>Image: 1993 USGS DOQQ</i> </p> | <p align="center"> Figure No. 2 </p> |

Mitigation components include coastal marsh restoration and preservation, riverine forested wetland restoration and preservation, non-riparian hardwood flat restoration and preservation and riparian buffer restoration. Figure 2 depicts the locations of each mitigation component. Exhibit Table 1 denotes the final calculated acreages of each component.

Vehicle access barriers comprised of concrete Jersey barriers, an earthen berm and a metal gate were installed at strategic locations within the Project Site.

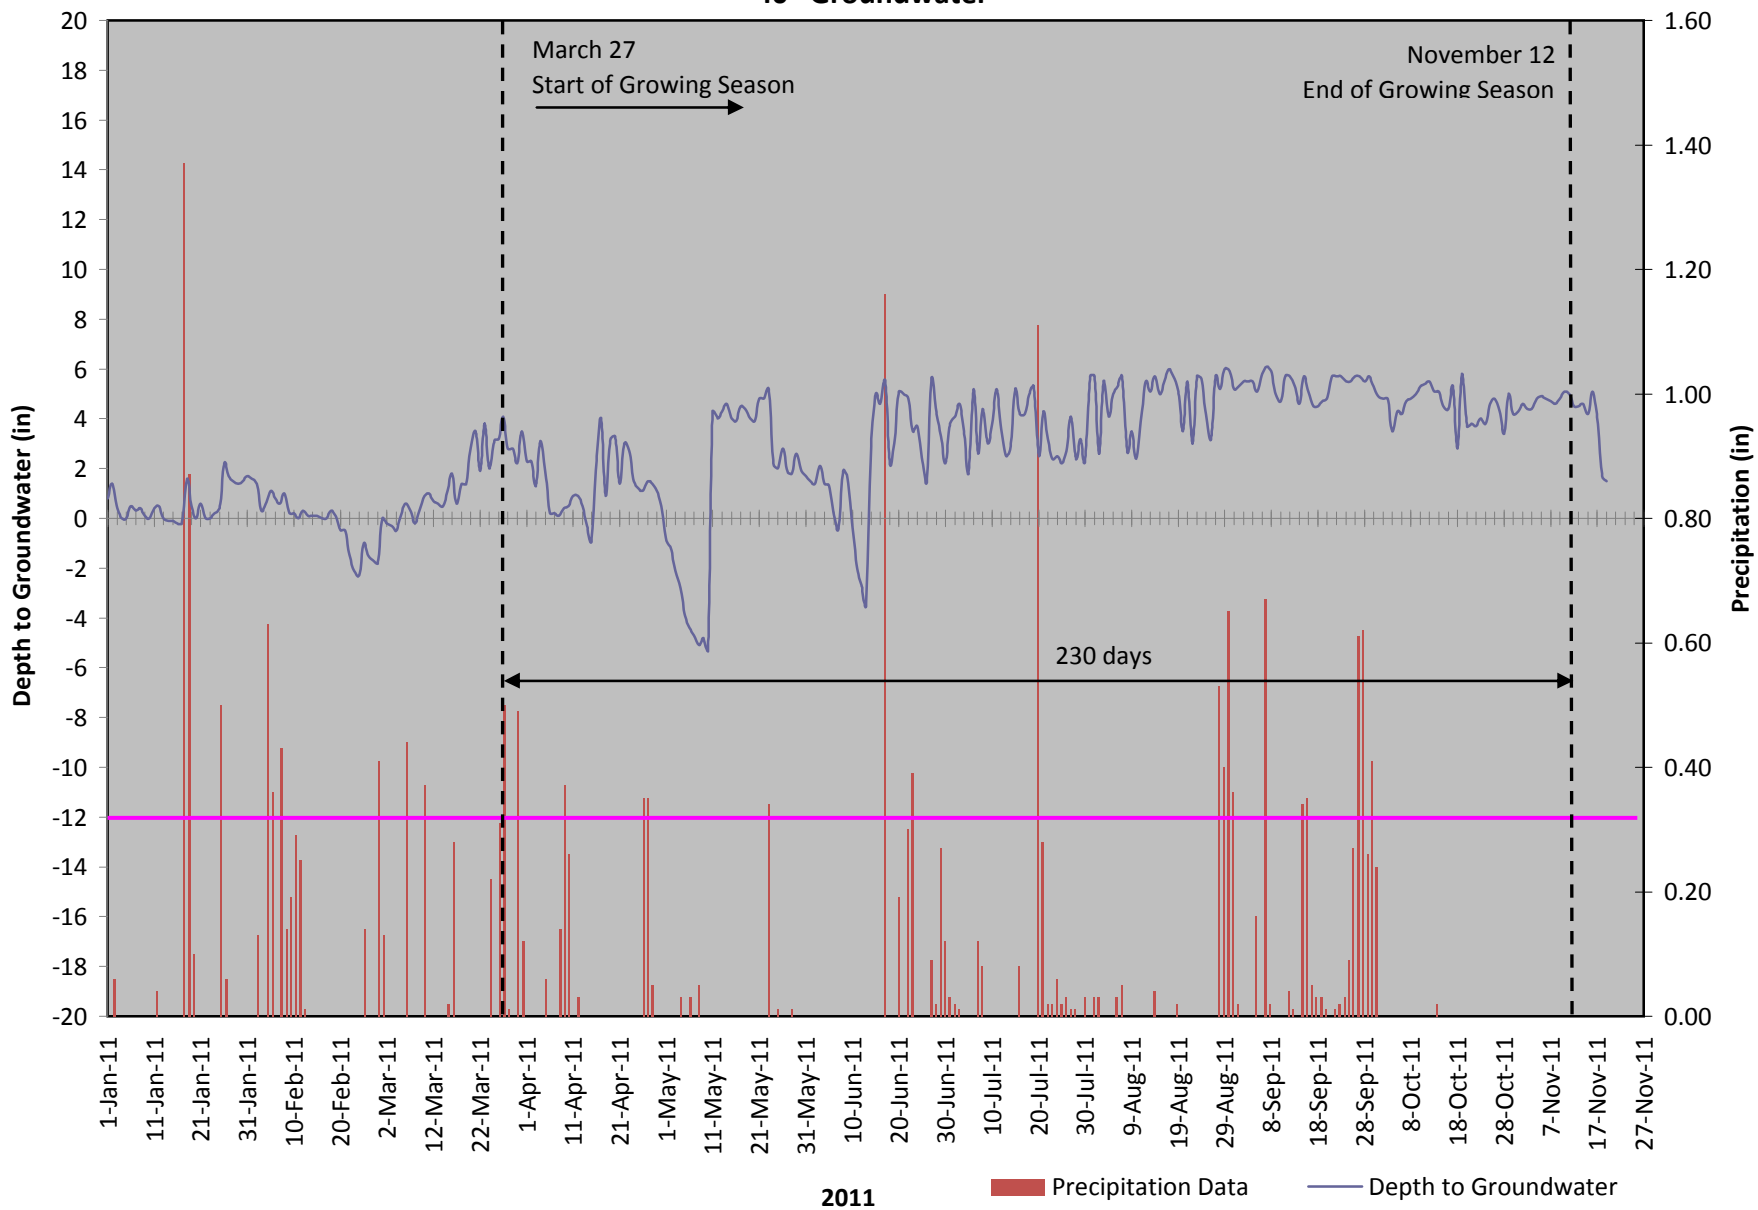
Monitoring Well #7 (Reference) 40" Groundwater

| Well ID | Well Hydrology Threshold Met? Percentage? | Tract Mean | Vegetation Plot ID | Vegetation Survival Threshold Met? | Tract Mean |
|---|---|---|---|---|---|
| MW# 7 (Reference) | Yes >12.5% | 29% | | | |

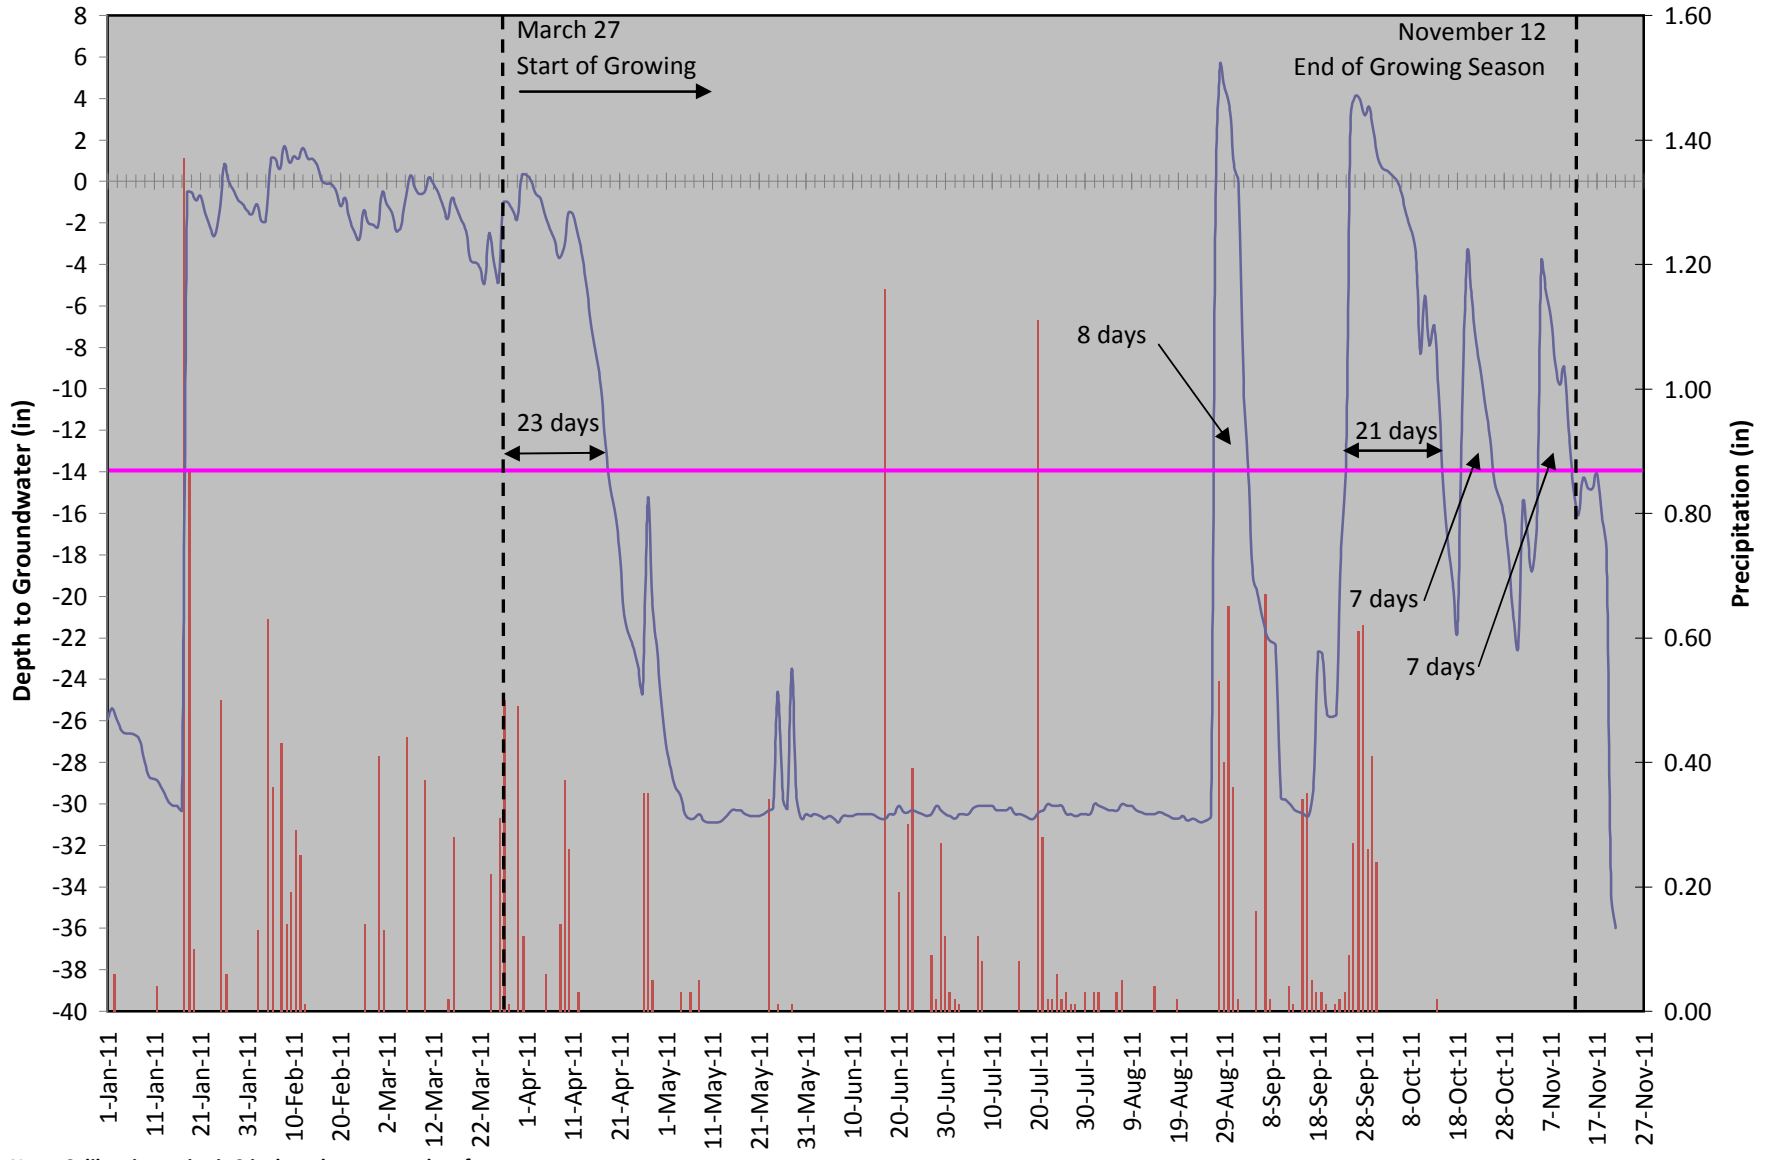
Monitoring Well #14 (Reference) 40" Groundwater

| Well ID | Well Hydrology Threshold Met? Percentage? | Tract Mean | Vegetation Plot ID | Vegetation Survival Threshold Met? | Tract Mean |
|---|---|---|---|---|---|
| MW# 14 (Reference) | Yes 5% - 12.5% | 10% | | | |

Note: Calibration point is 2 inches above ground surface

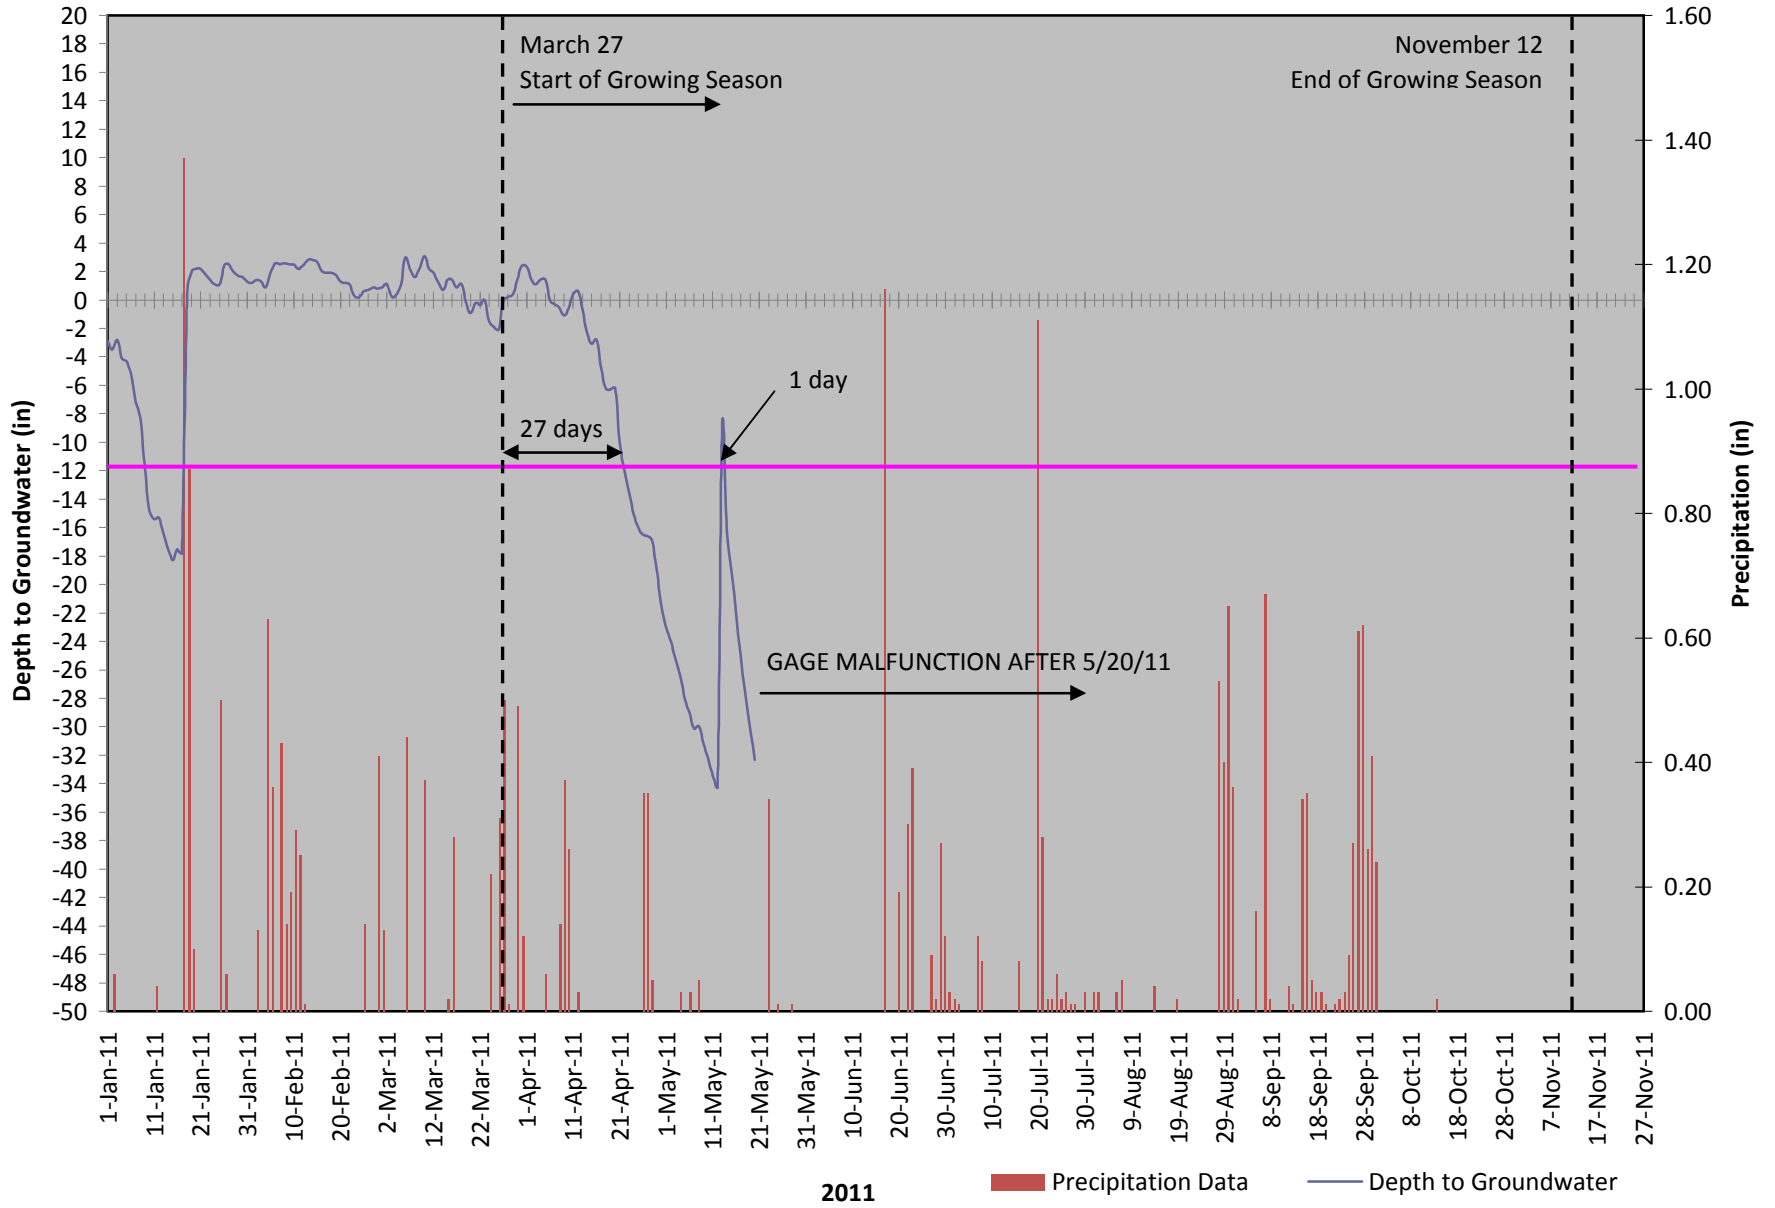
Monitoring Well #15 (Reference) 40" Groundwater

| Well ID | Well Hydrology Threshold Met? Percentage? | Tract Mean | Vegetation Plot ID | Vegetation Survival Threshold Met? | Tract Mean |
|---|---|---|---|---|---|
| MW# 15 (Reference) | Yes 5% -12.5% | 61% | | | |

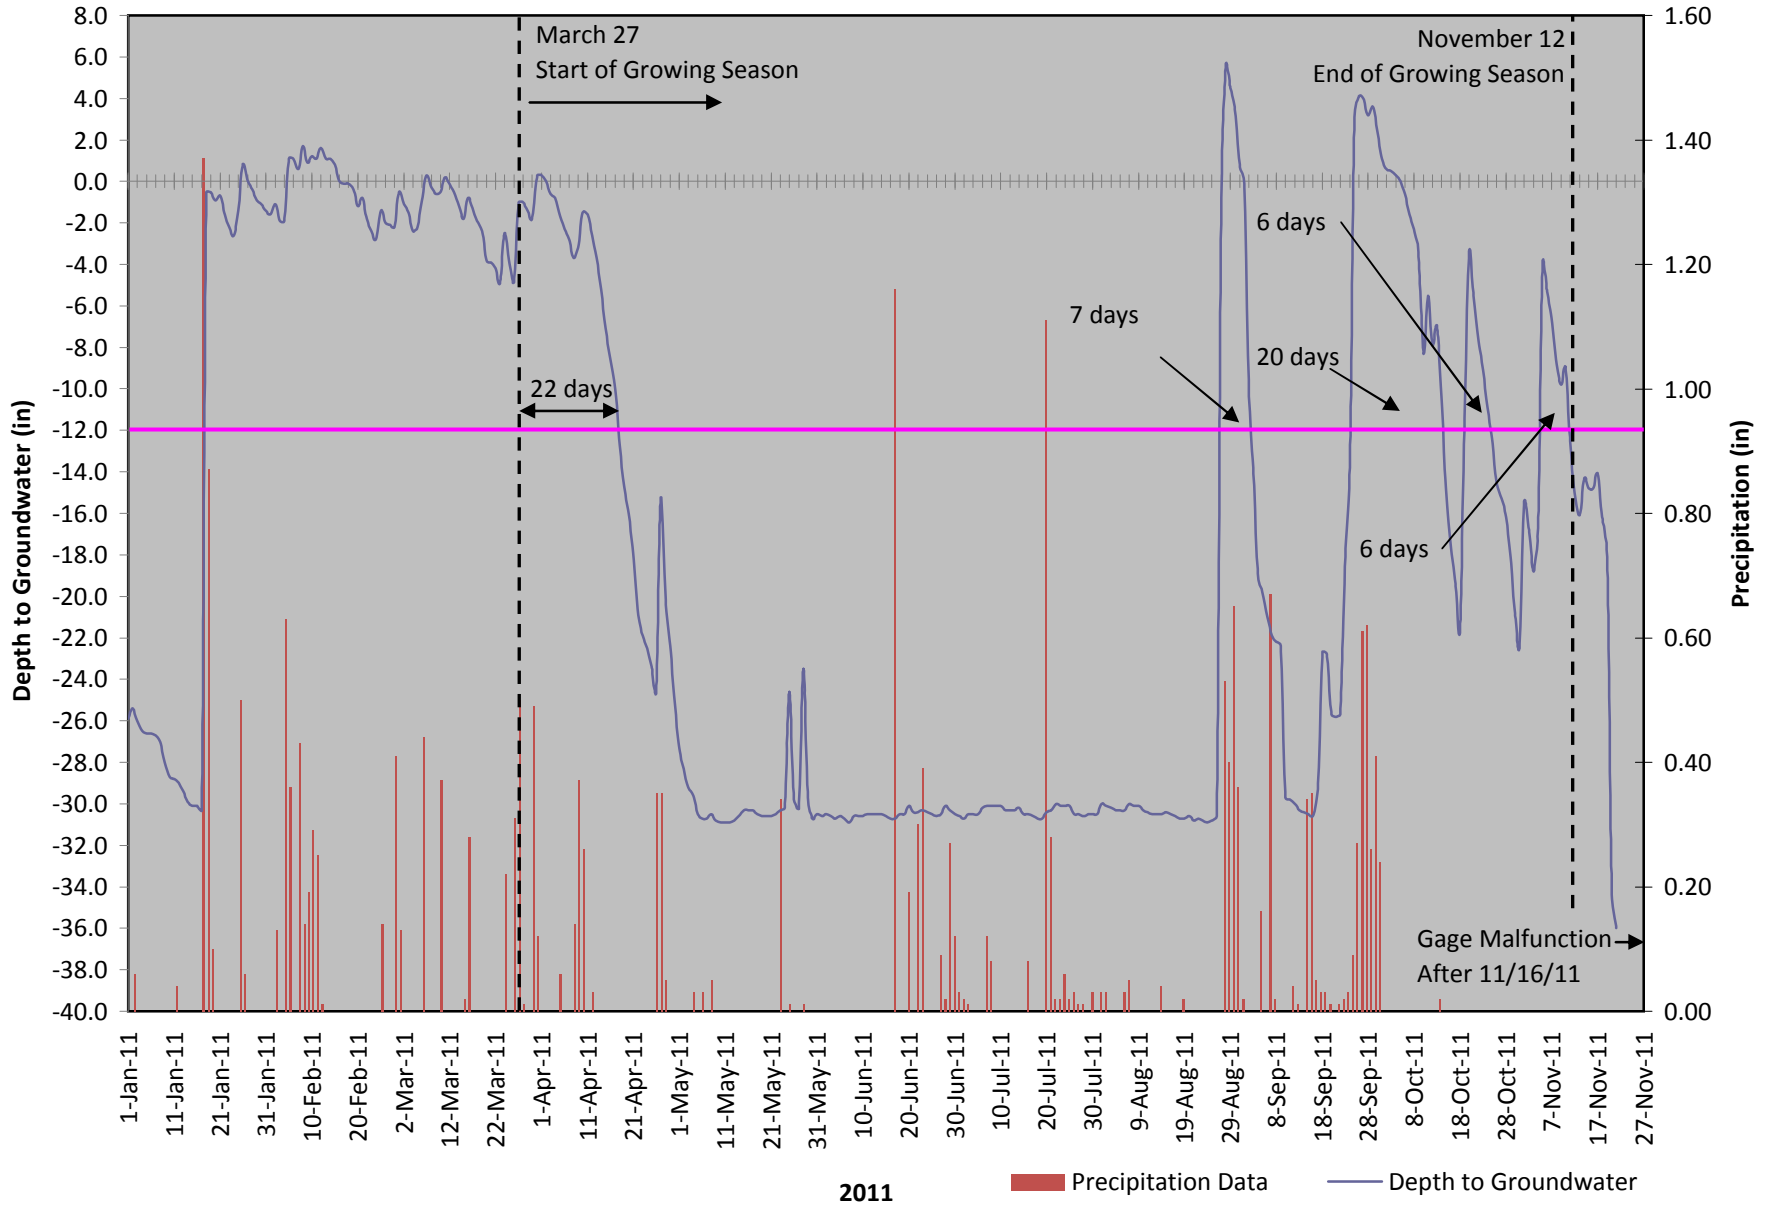
Monitoring Well #16 (Reference) 40" Groundwater

| Well ID | Well Hydrology Threshold Met? Percentage? | Tract Mean | Vegetation Plot ID | Vegetation Survival Threshold Met? | Tract Mean |
|---|---|---|---|---|---|
| MW# 16 (Reference) | Yes 5% -12.5% | | | | |

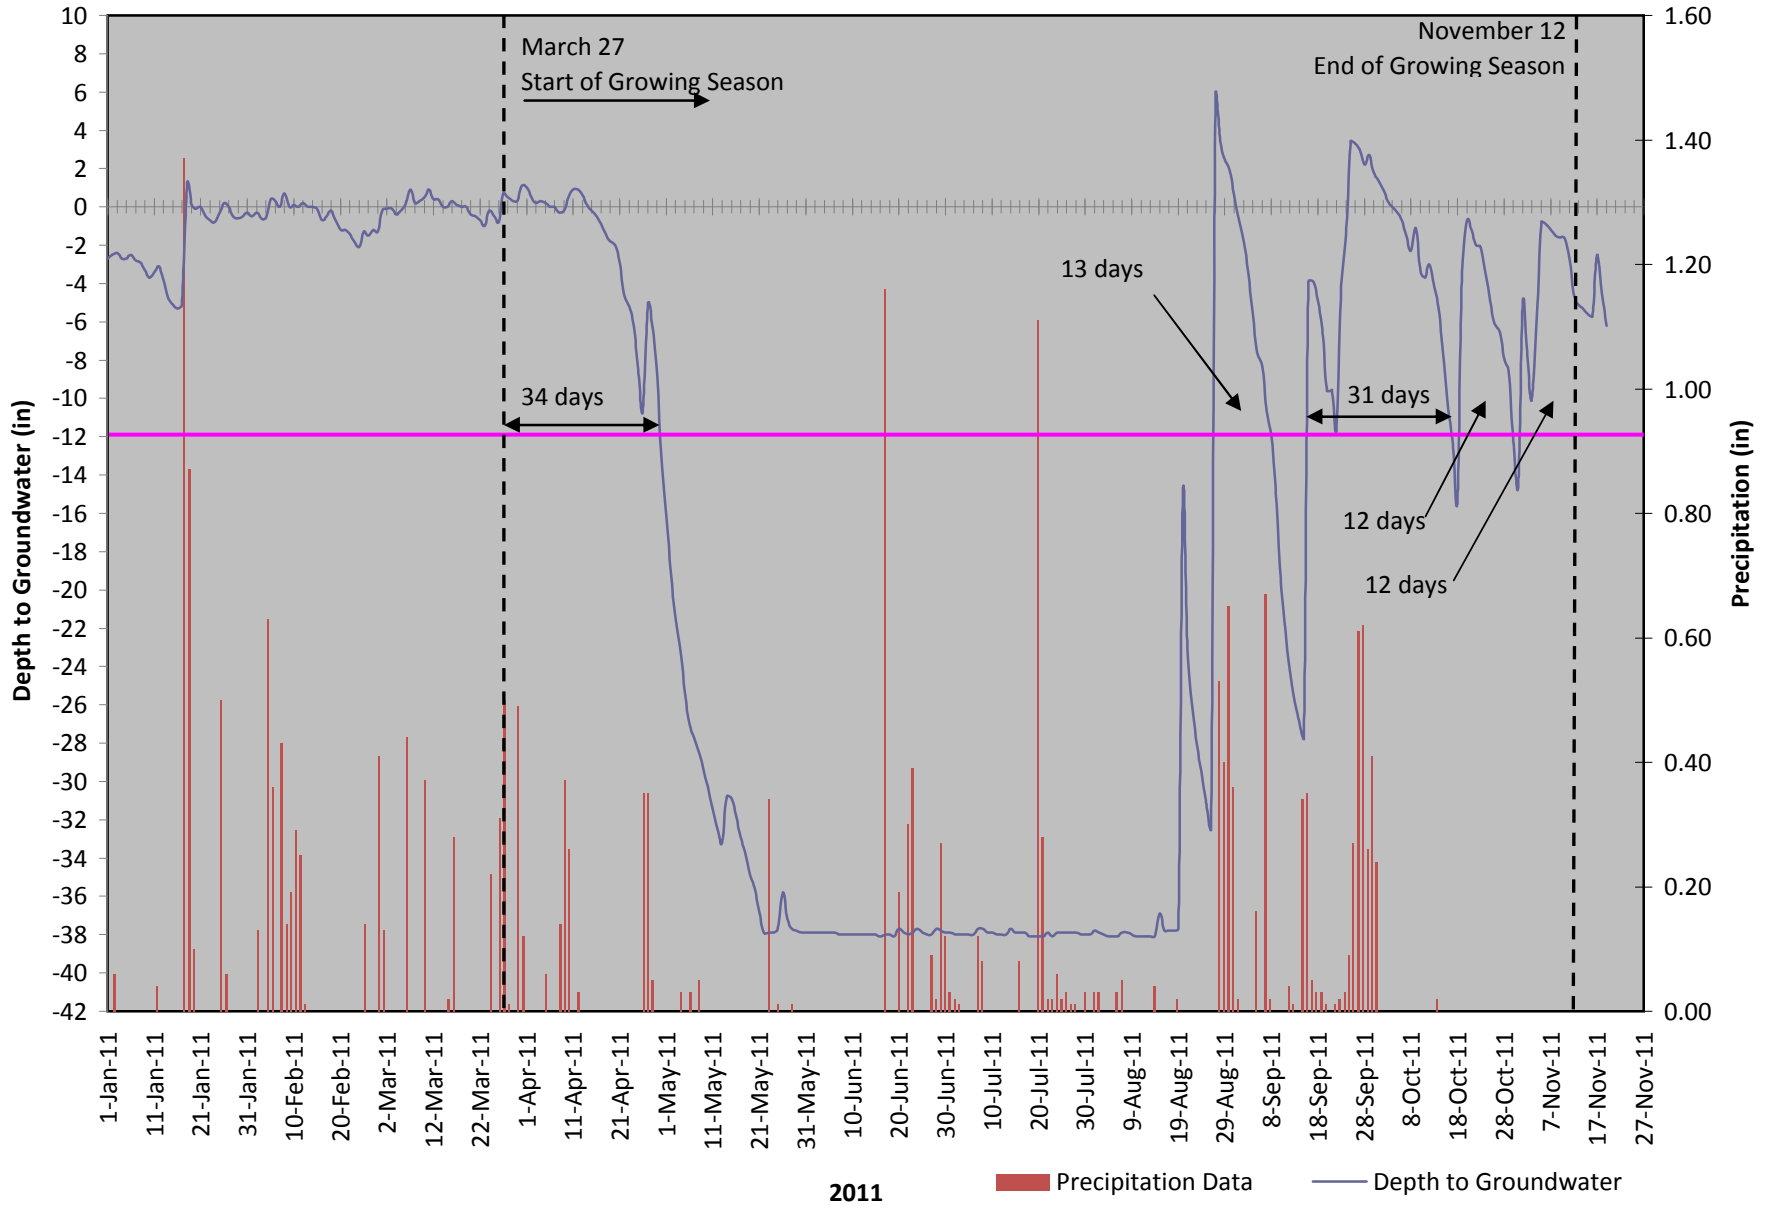
Monitoring Well #17 40" Groundwater

| Well ID | Well Hydrology Threshold Met? Percentage? | Tract Mean | Vegetation Plot ID | Vegetation Survival Threshold Met? | Tract Mean |
|---|---|---|---|---|---|
| MW# 17 | Yes >12.5% | 61% | VP# 17 | Yes | 61% |

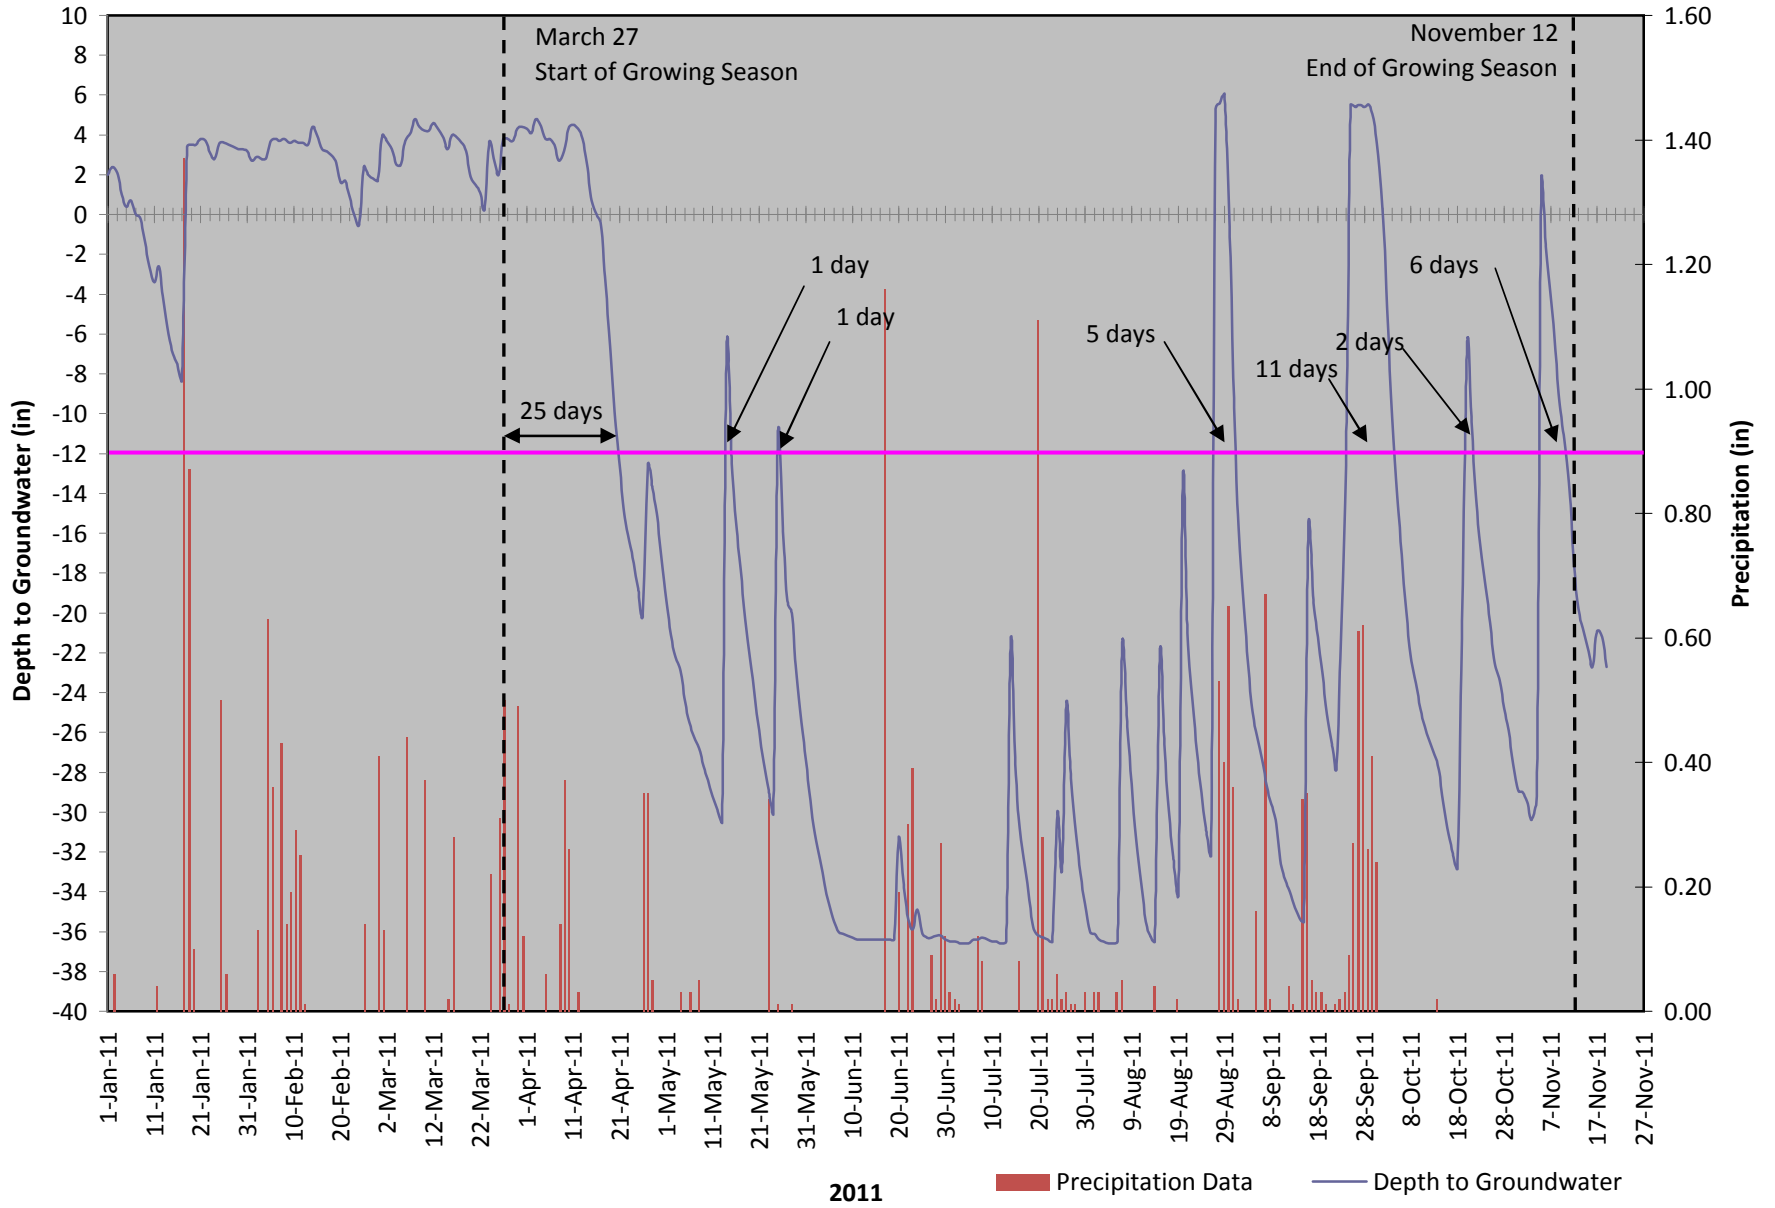
Monitoring Well #18 40" Groundwater

| Well ID | Well Hydrology Threshold Met? Percentage? | Tract Mean | Vegetation Plot ID | Vegetation Survival Threshold Met? | Tract Mean |
|---|---|---|---|---|---|
| MW# 18 | Yes 5% -12.5% | | VP# 18 | Yes | |

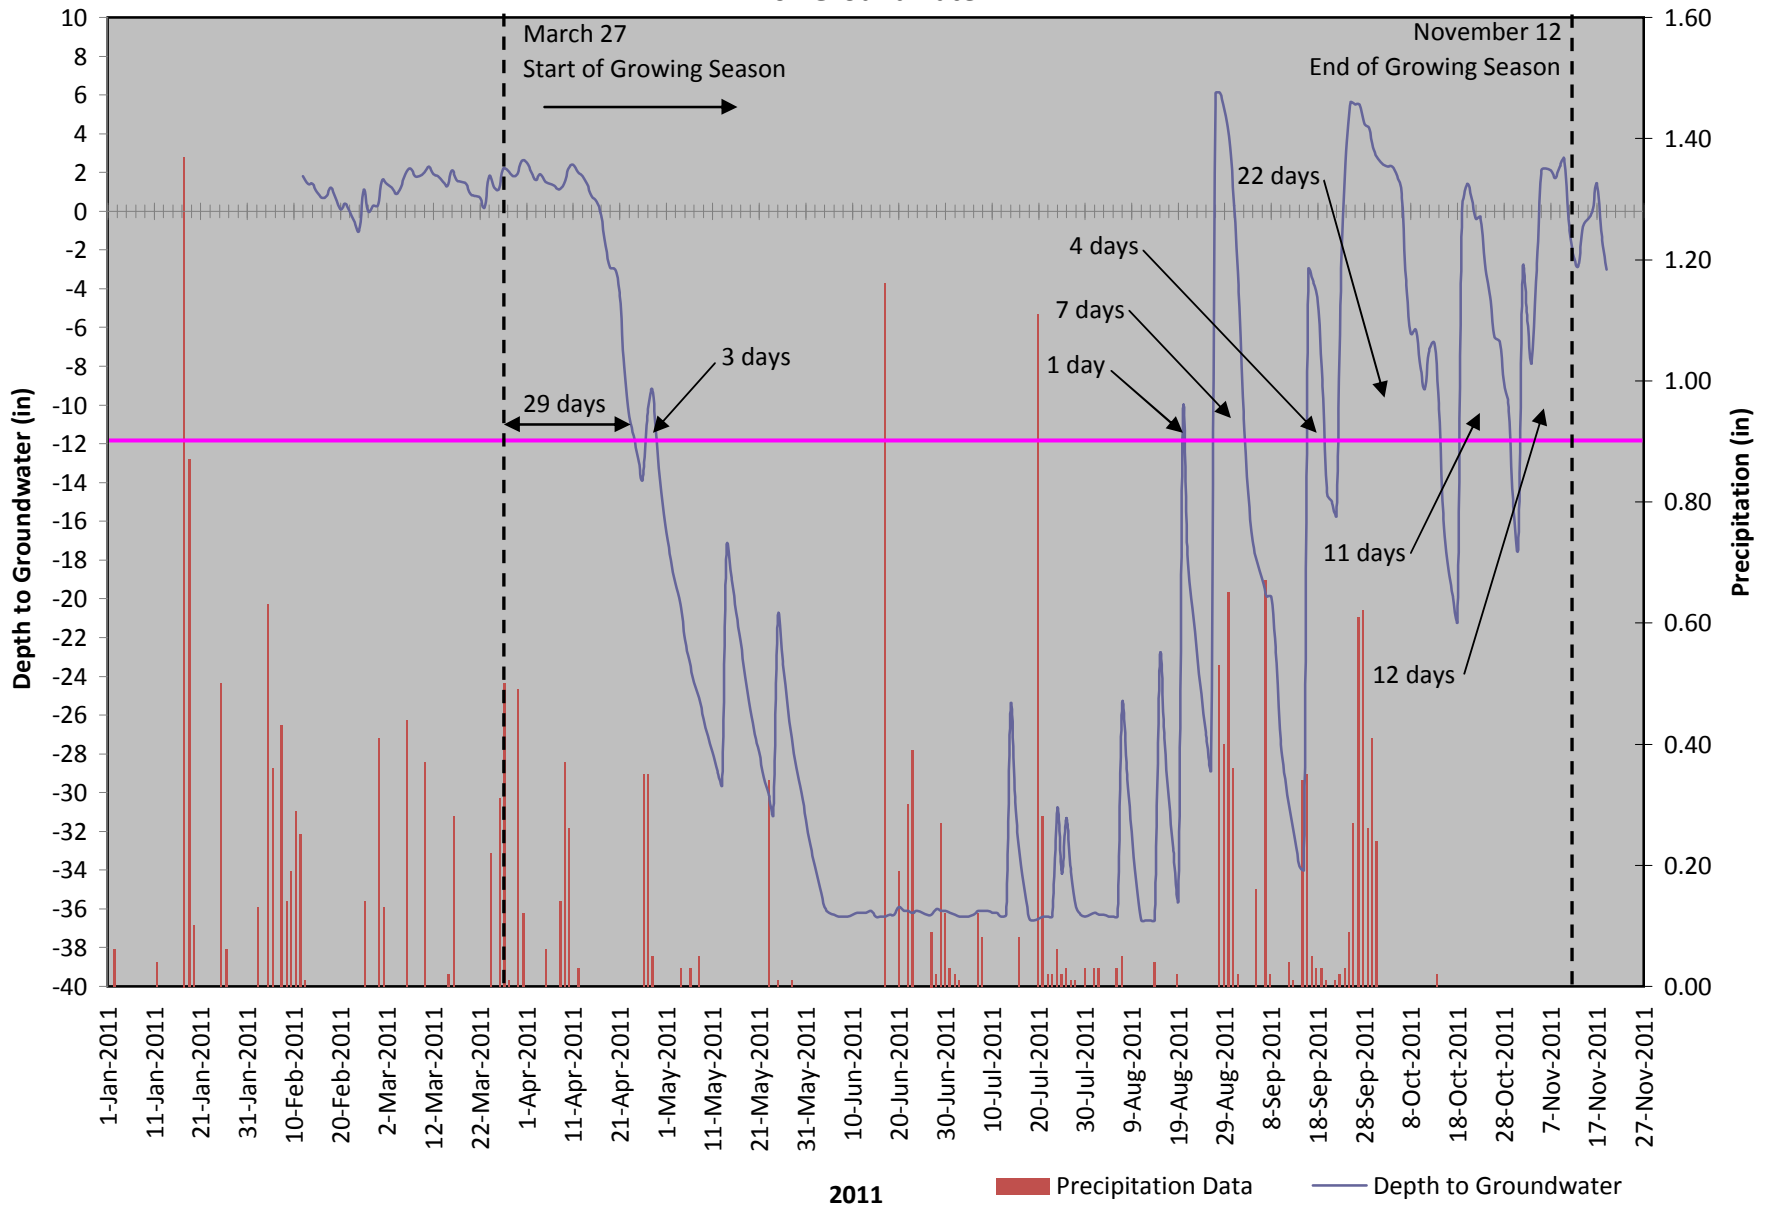
Monitoring Well #19 40" Groundwater

| Well ID | Well Hydrology Threshold Met? Percentage? | Tract Mean | Vegetation Plot ID | Vegetation Survival Threshold Met? | Tract Mean |
|---|---|---|---|---|---|
| MW# 19 | Yes >12.5% | | VP# 19 | Yes | |

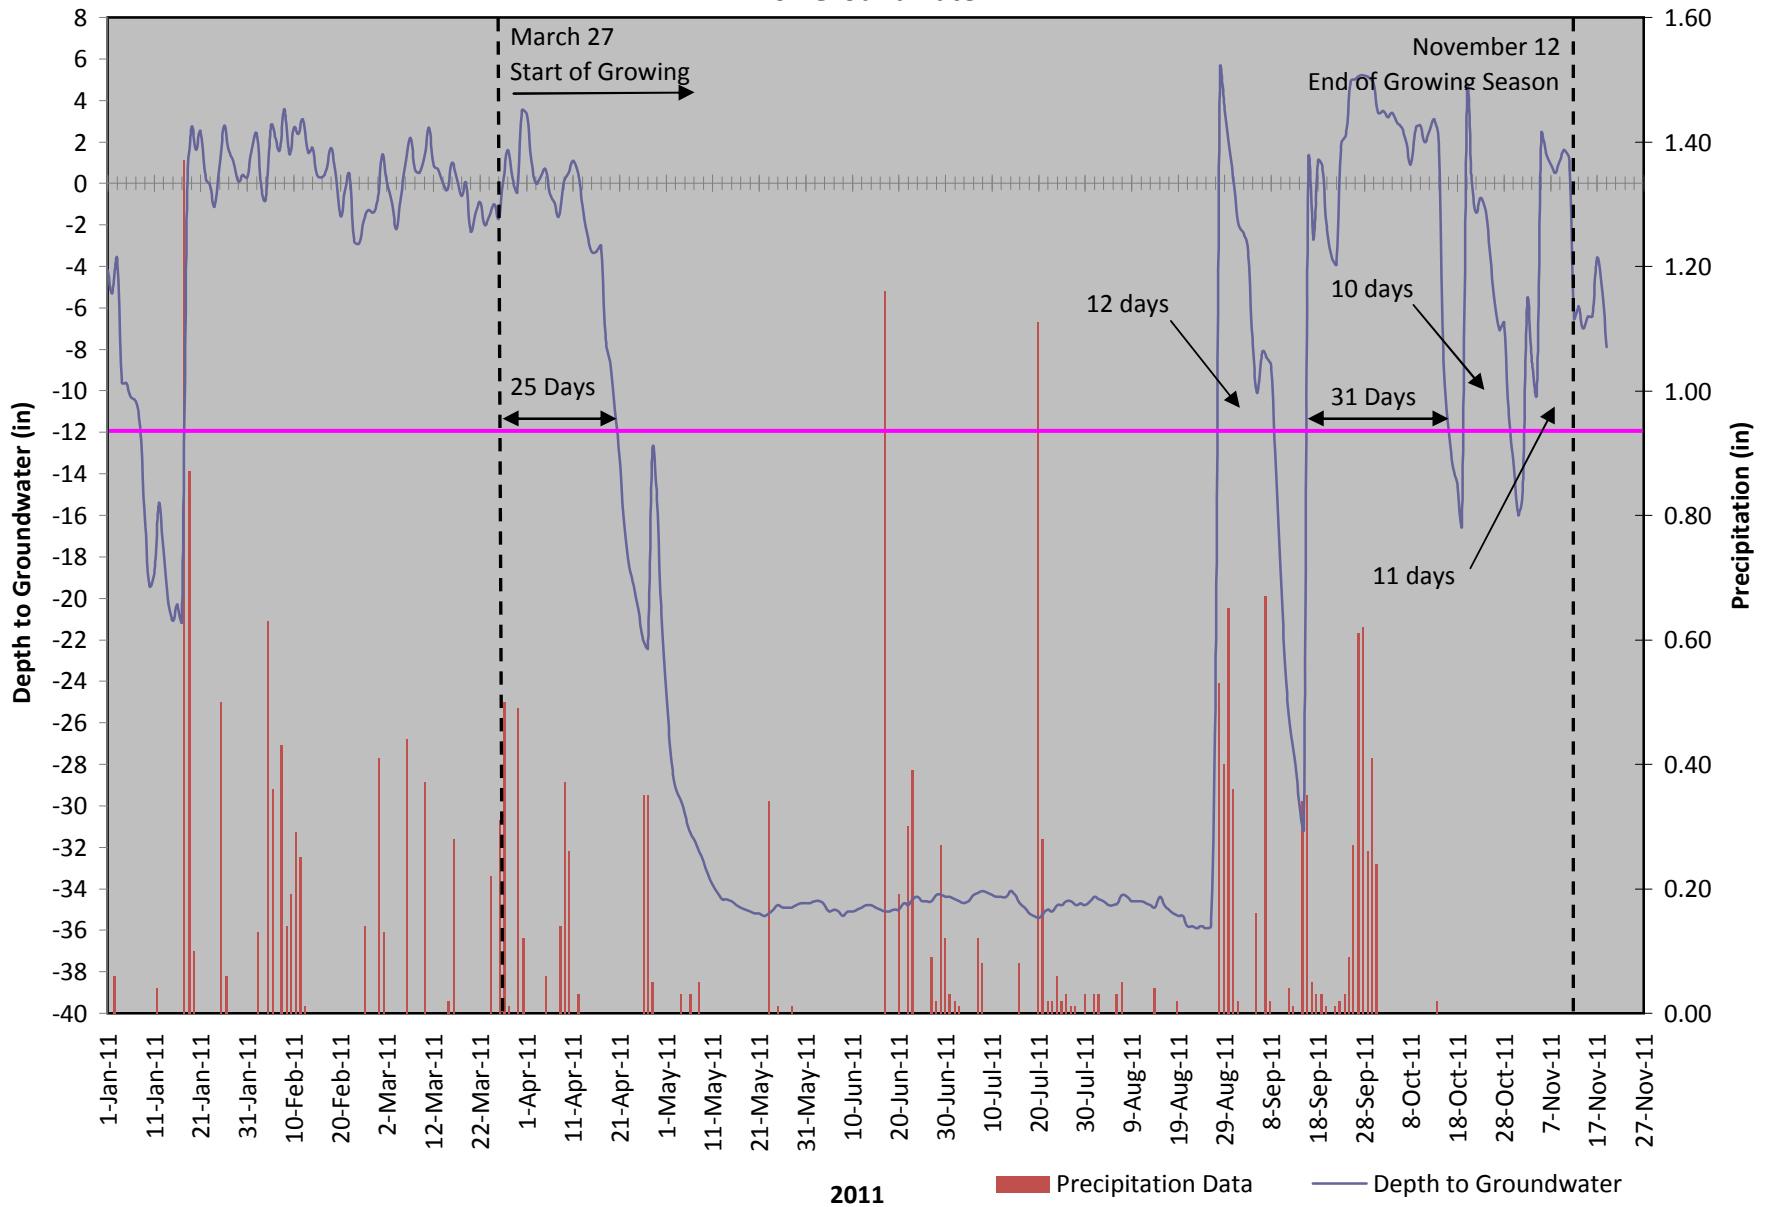
Monitoring Well #20 40" Groundwater

| Well ID | Well Hydrology Threshold Met? Percentage? | Tract Mean | Vegetation Plot ID | Vegetation Survival Threshold Met? | Tract Mean |
|---|---|---|---|---|---|
| MW# 20 | Yes >12.5% | | VP# 20 | No | |

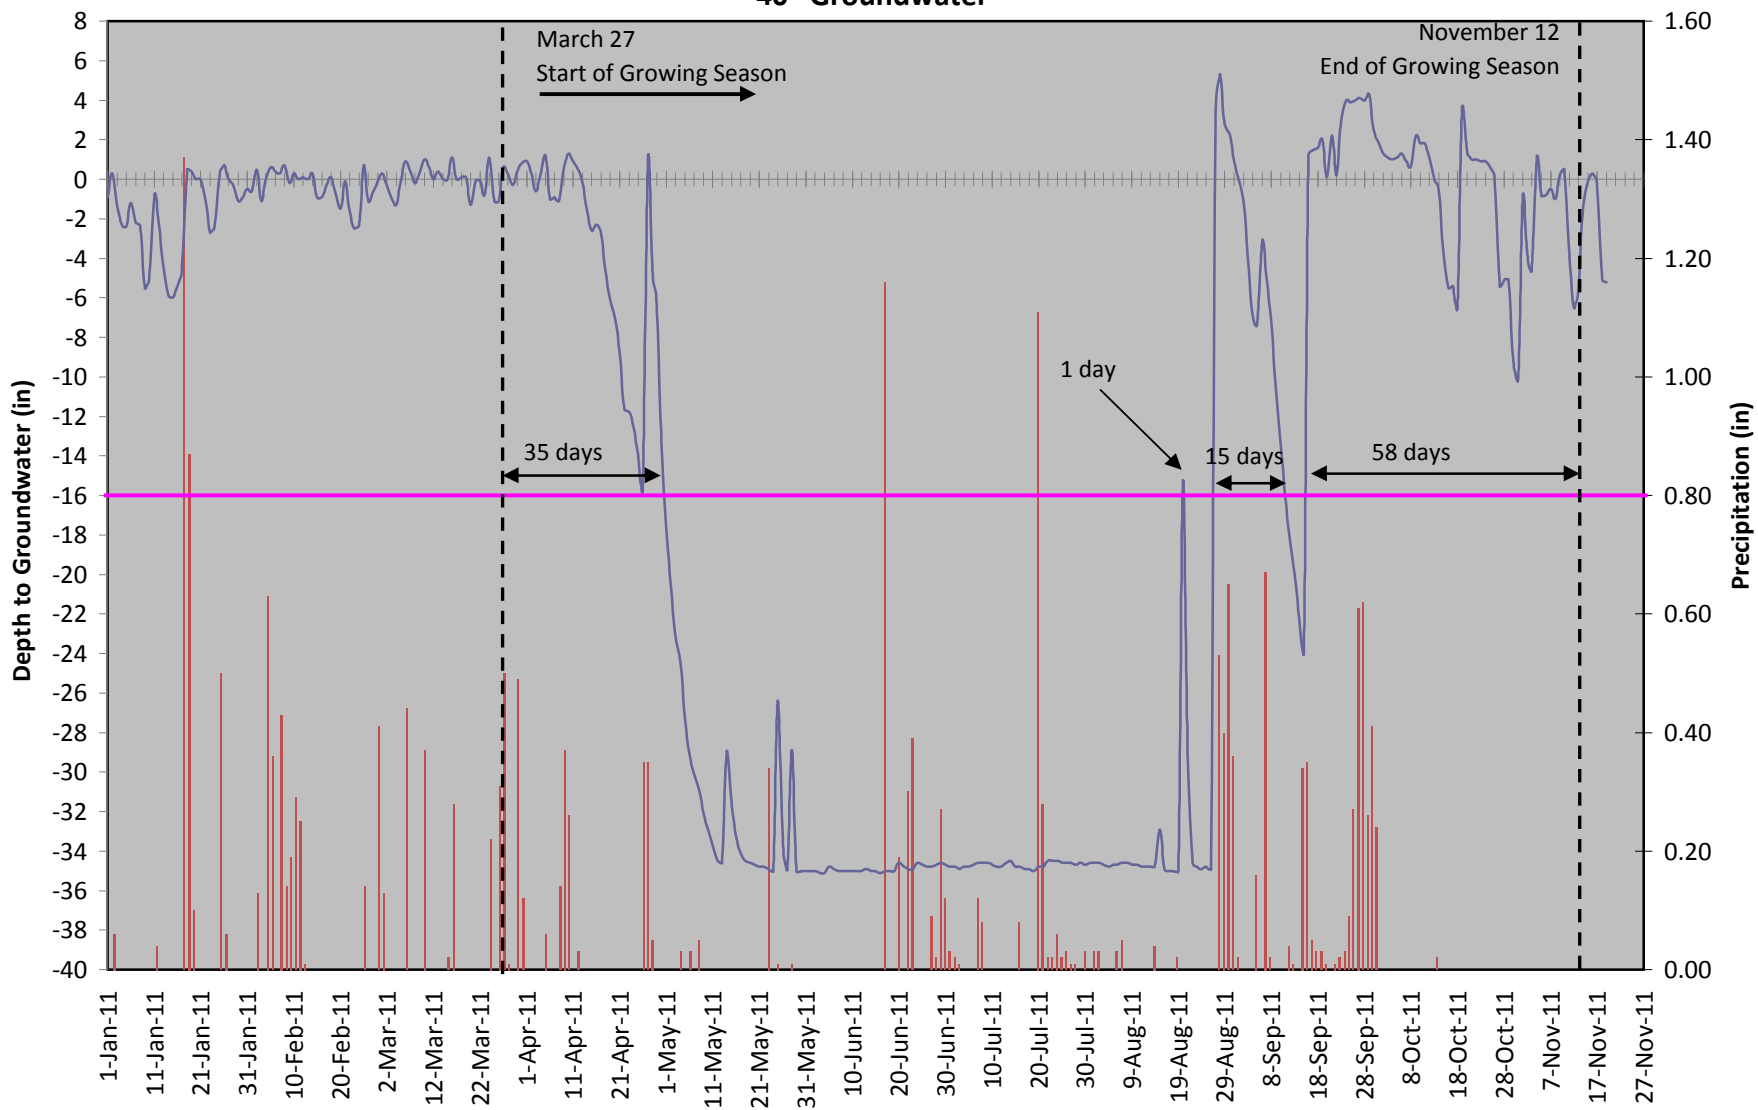
Monitoring Well #21 40" Groundwater

| Well ID | Well Hydrology Threshold Met? Percentage? | Tract Mean | Vegetation Plot ID | Vegetation Survival Threshold Met? | Tract Mean |
|---|---|---|---|---|---|
| MW# 21 | Yes >12.5% | | VP# 21 | No | |

Note: Calibration point is 4 inches above ground surface
