**Bishop Road Wetland Mitigation Site
Monitoring Year 3 (2011)**

**Hyde County, NC
State Construction Office Project No. 05-0653802**

Final Monitoring Report

December 2011

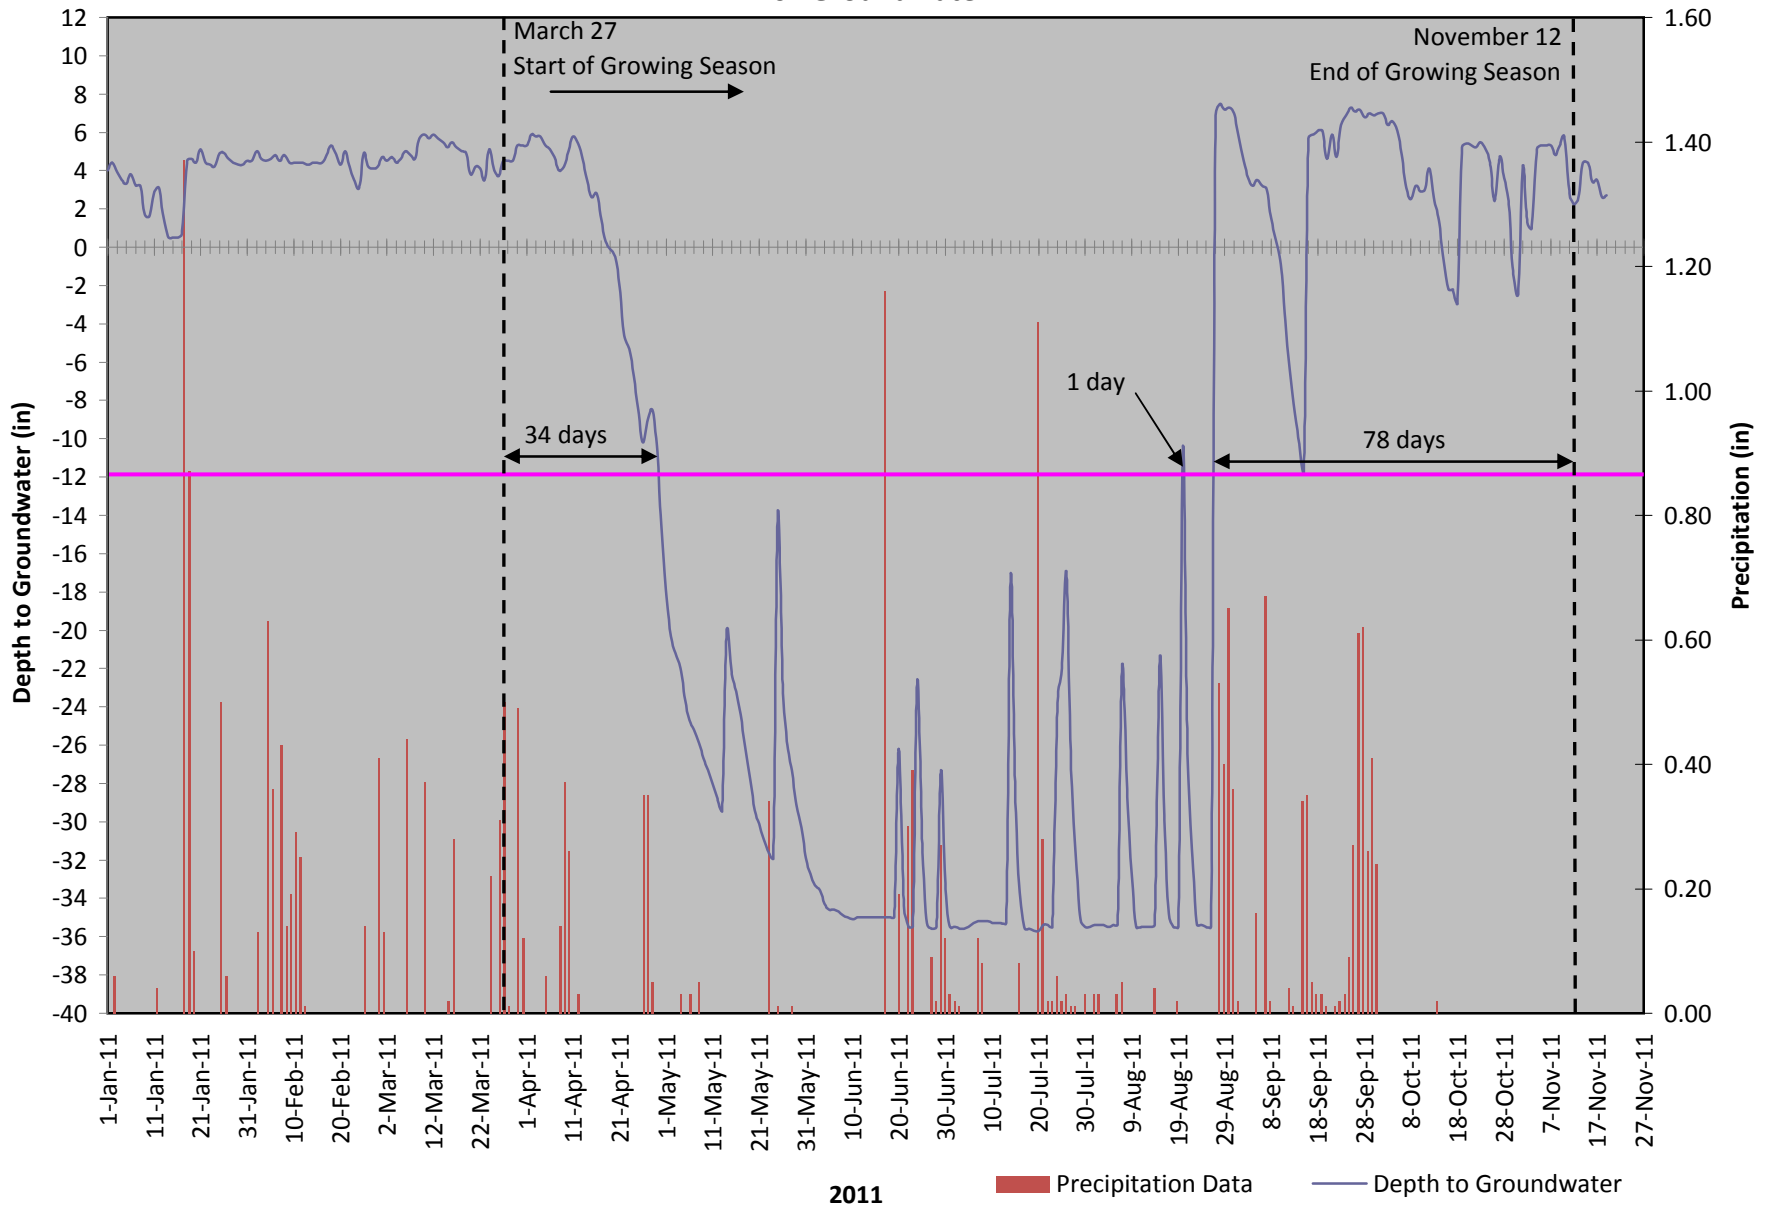
Monitoring Well #22 40" Groundwater

| Well ID | Well Hydrology Threshold Met? Percentage? | Tract Mean | Vegetation Plot ID | Vegetation Survival Threshold Met? | Tract Mean |
|---|---|---|---|---|---|
| MW# 22 | Yes >12.5% | | VP# 22 | Yes | |

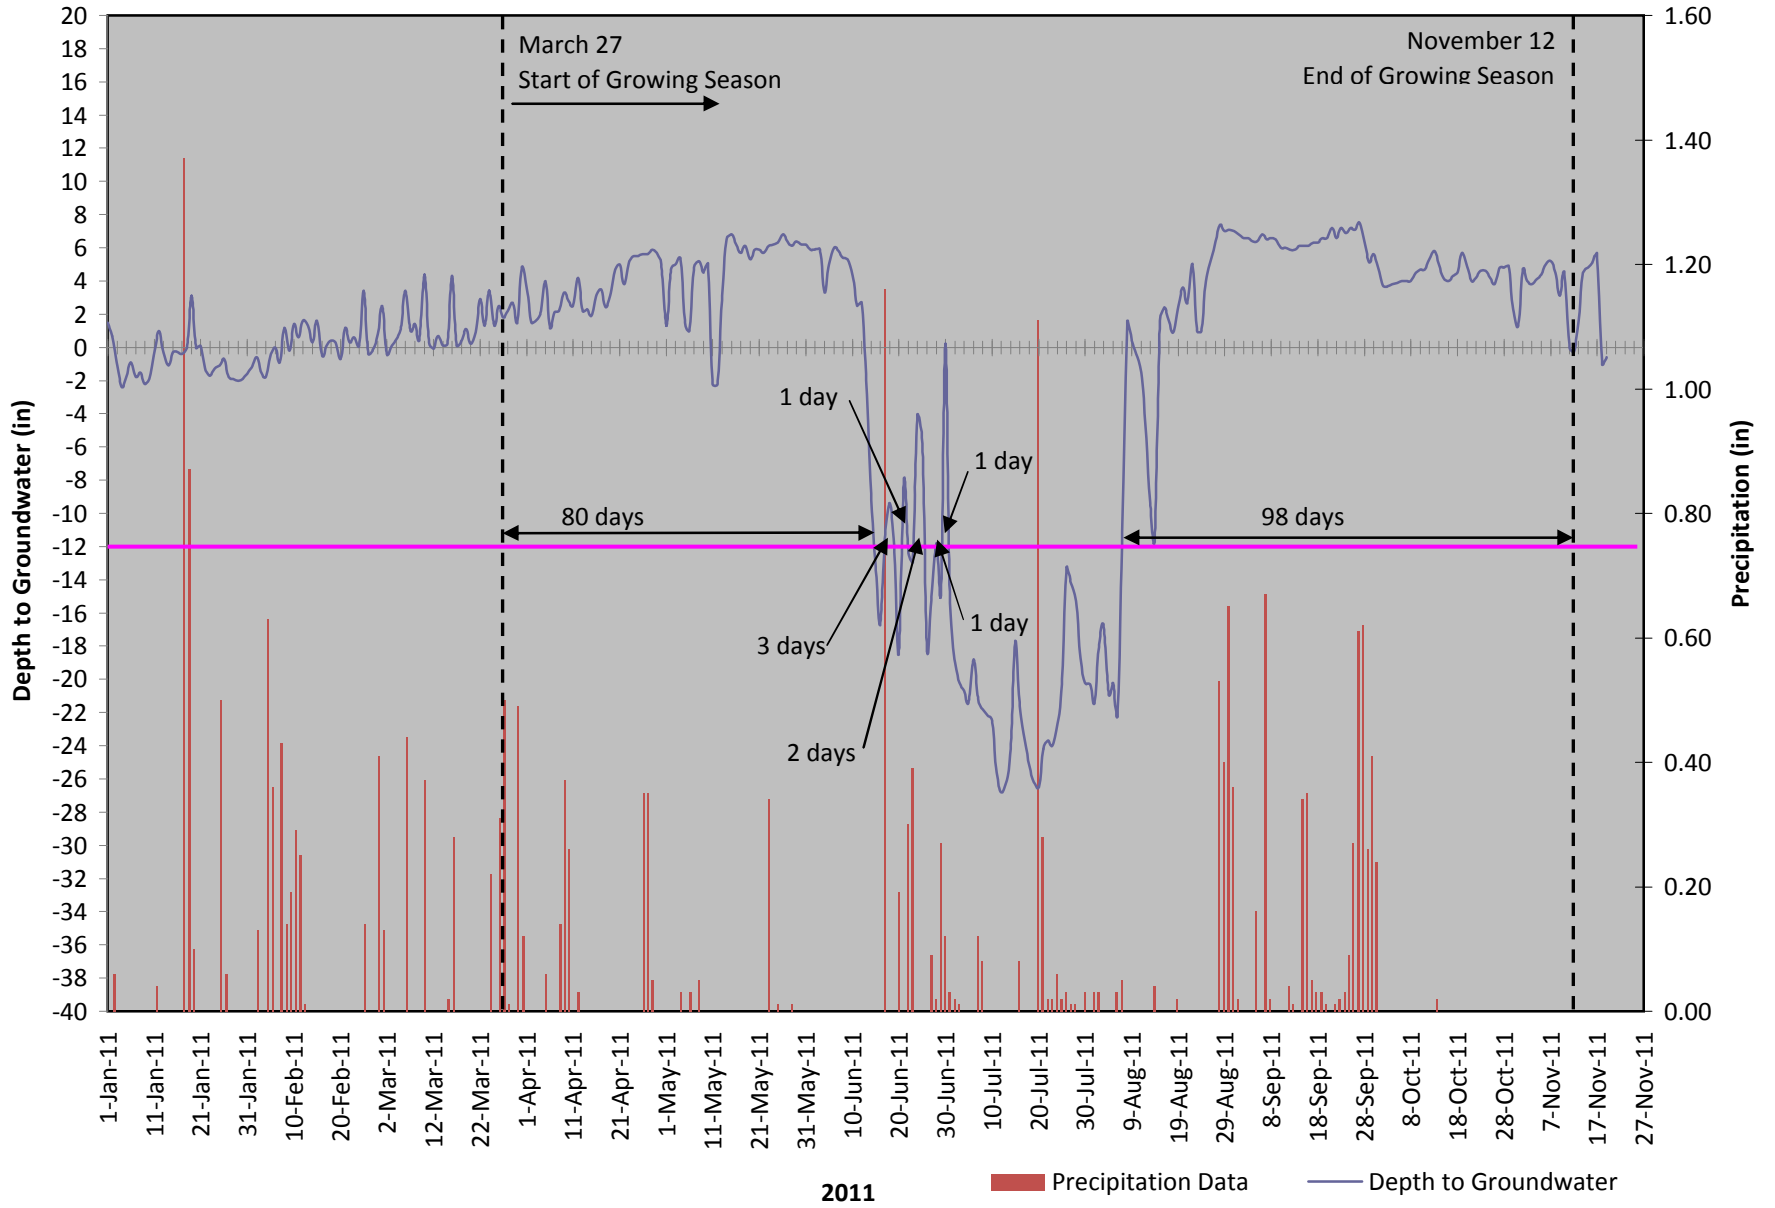
Monitoring Well #23 40" Groundwater

| Well ID | Well Hydrology Threshold Met? Percentage? | Tract Mean | Vegetation Plot ID | Vegetation Survival Threshold Met? | Tract Mean |
|---|---|---|---|---|---|
| MW# 23 | Yes >12.5% | 10% | VP# 23 | No | 10% |

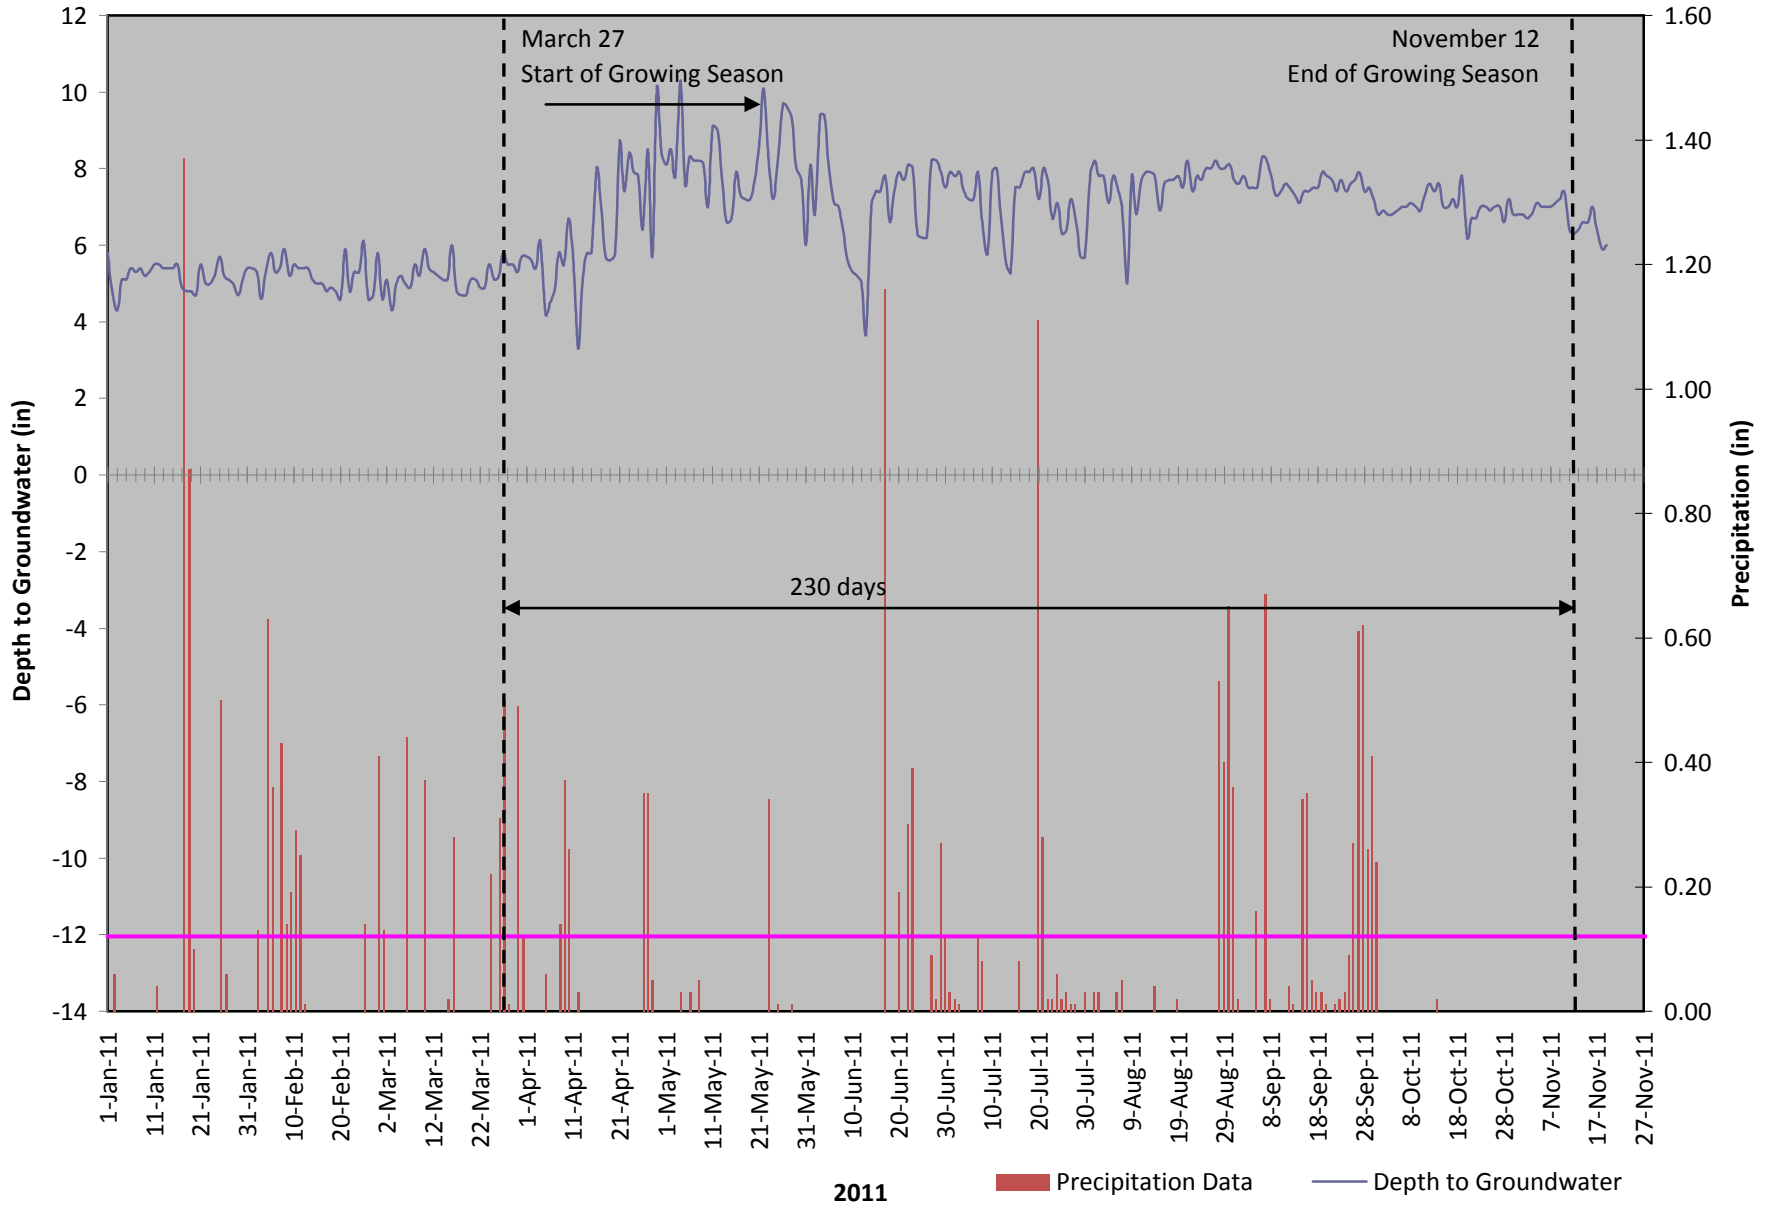
Monitoring Well #24 40" Groundwater

| Well ID | Well Hydrology Threshold Met? Percentage? | Tract Mean | Vegetation Plot ID | Vegetation Survival Threshold Met? | Tract Mean |
|---|---|---|---|---|---|
| MW# 24 | Yes >12.5% | 29% | VP# 24 | No | 29% |
