## As-Built Baseline Monitoring Report

Black Gum Creek Wetland Restoration Site

DMS Project Number 97063

April 2016

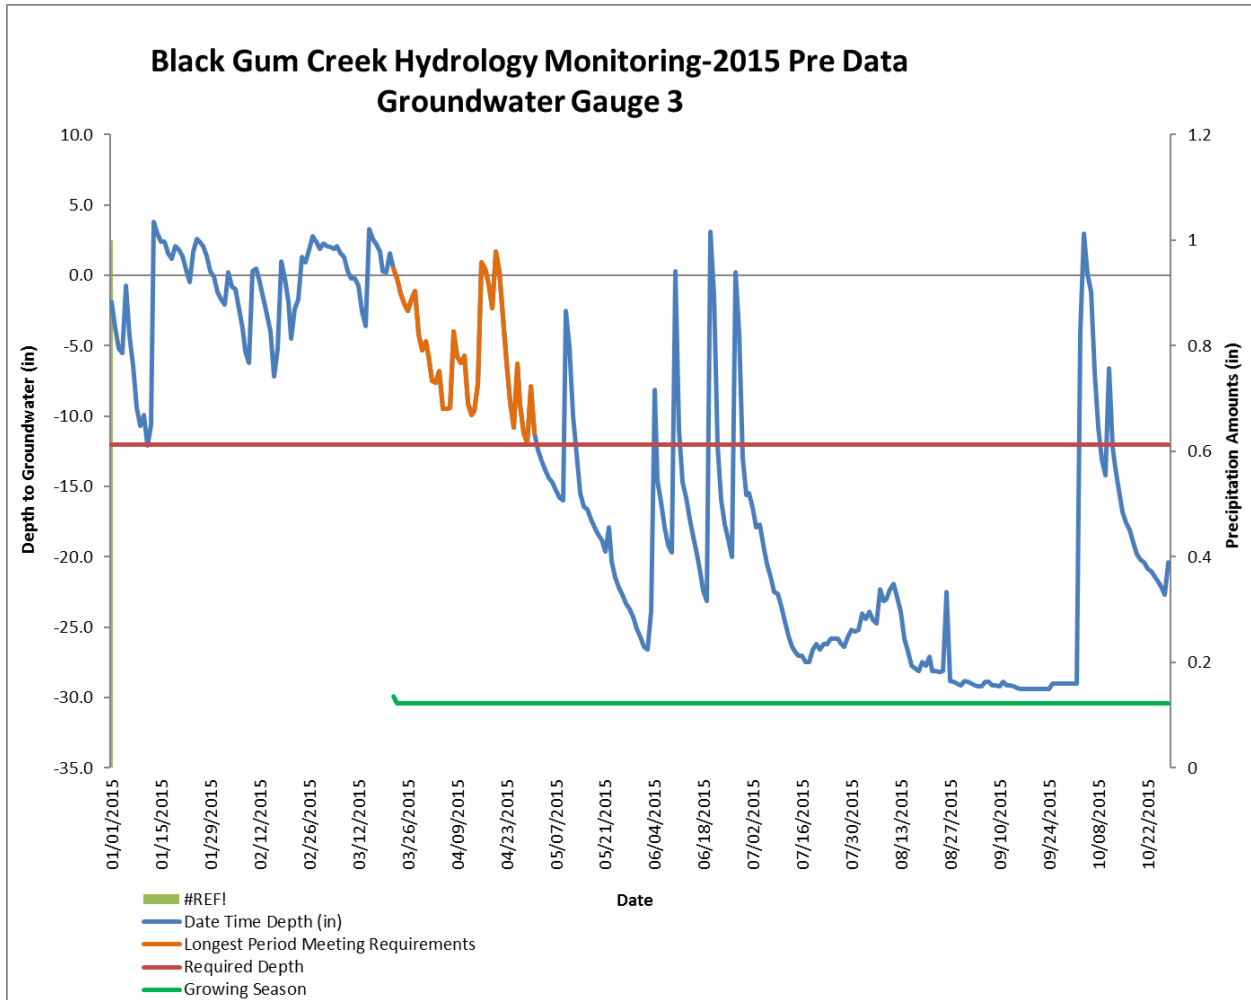
Figure 5a. Monitoring Gauge #3

Growing Season Days: 228 (Mar 22 – Nov 5)  
 Success Hydroperiod Percent: 8%  
 Required Number of Days Meeting Requirements: 18  
 Longest Period Meeting Requirements: 41  
 Hydroperiod Percent: 17.98%
