Year 1 Monitoring Report

Black Gum Creek Wetland Restoration Site

DMS Project Number 97063

December 2016

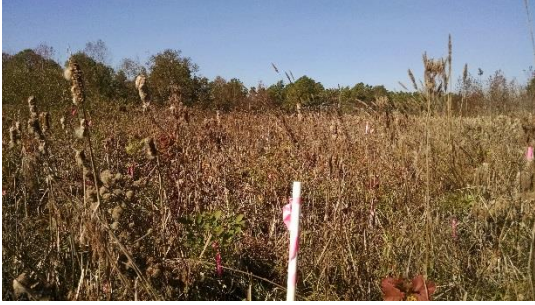
Photo Point 1

Site Photos (all photo points are located on the SE corner of the corresponding vegetation plot)

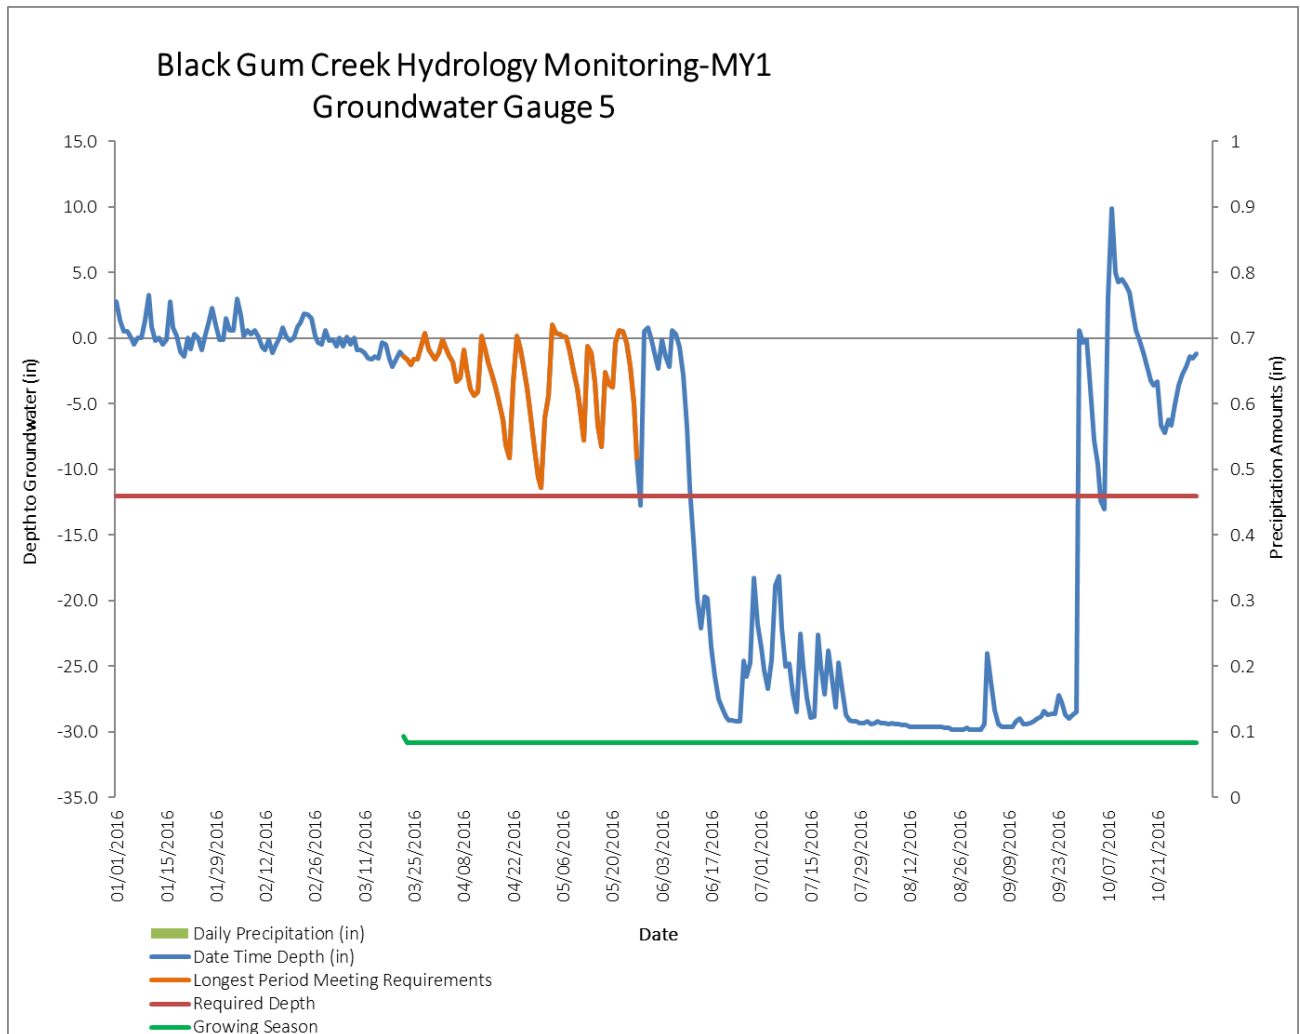
Figure 5e. Monitoring Gauge #5
 Black Gum Creek, DMS Project ID# 97063

Growing Season Days: 228 (Mar 22 – Nov 5)
 Target Hydroperiod Percent: 8%
 Required Number of Days Meeting Requirements: 18
 Longest Period Meeting Requirements: 67
 Hydroperiod Percent: 29.3%
