Year 2 Monitoring Report

Black Gum Creek Wetland Restoration Site

DMS Project Number 97063

December 2017

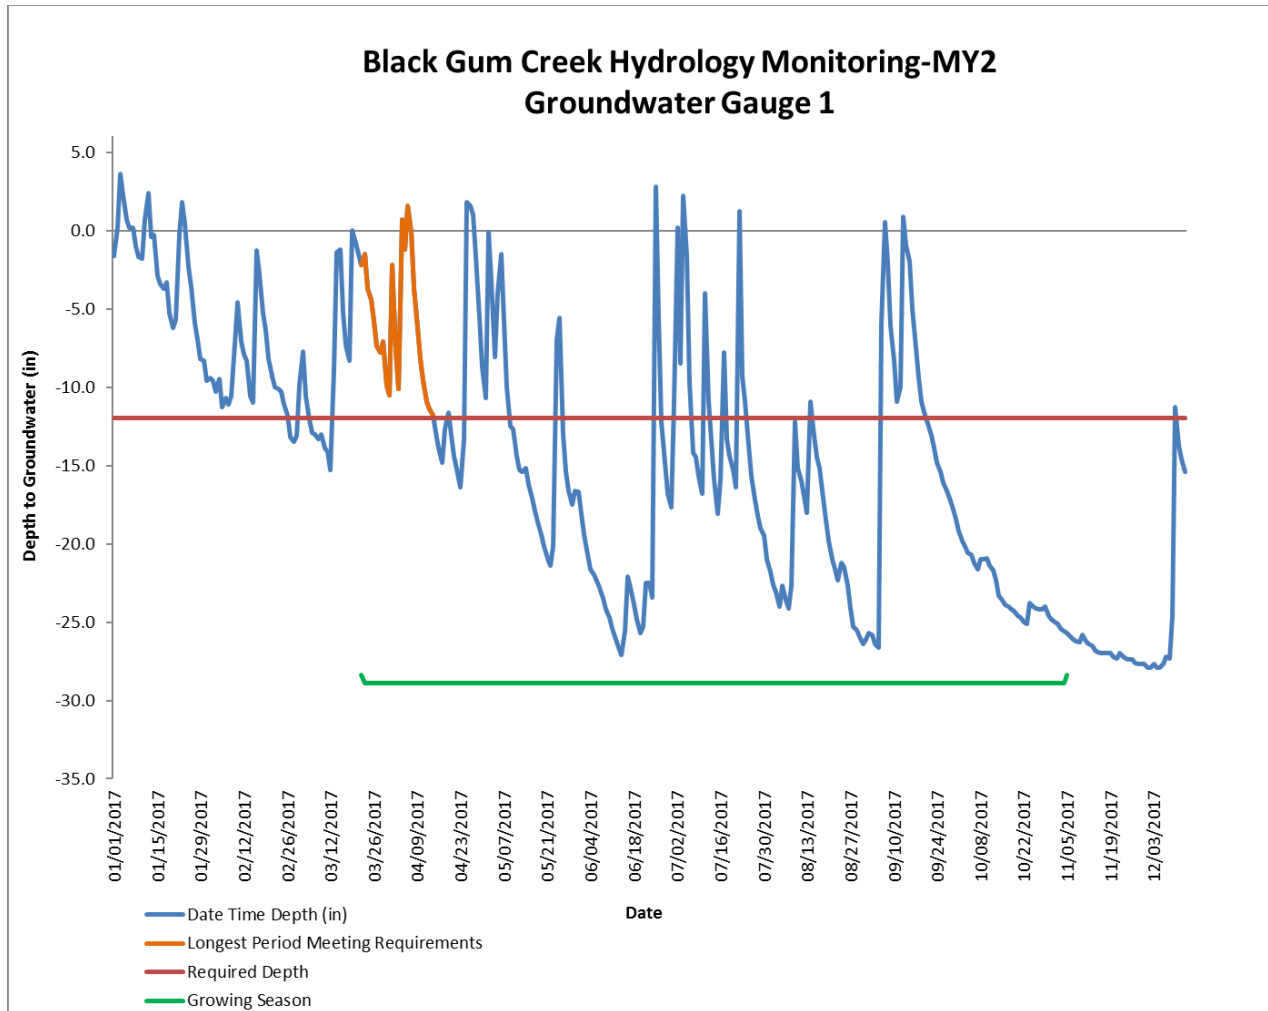
Figure 5a. Monitoring Gauge #1
 Black Gum Creek, DMS Project ID# 97063

Growing Season Days: 228 (Mar 22 – Nov 5)
 Target Hydroperiod Percent: 8%
 Required Number of Days Meeting Requirements: 18
 Longest Period Meeting Requirements: 24
 Hydroperiod Percent: 10.5%

Hydrology data indicated that two of three gauges in the rehabilitation area (gauges 1 & 5) met the hydrologic success target of greater than 8% of the growing season (Appendix D). Hydrology for gauge 4 did not meet success criteria. However, it is important to note that the location of gauge 4 exhibited signs of continuous inundation during multiple monitoring trips and has an established stand of obligate wetland grasses and rushes and several desirable species of volunteer trees. Because it is possible that this gauge malfunctioned due to the fire, it will be replaced in 2018. Gauges 2 and 3 are both located outside of the wetland rehabilitation areas. Gauge 2, which is just outside the rehabilitation asset line, indicated that the water table was continuously above 12" for 9.6% of the growing season while gauge 3, further away from any proposed wetland rehabilitation, only had 2.2% continuous hydrology; potentially indicating that the wetland asset lines for rehabilitation were drawn appropriately.

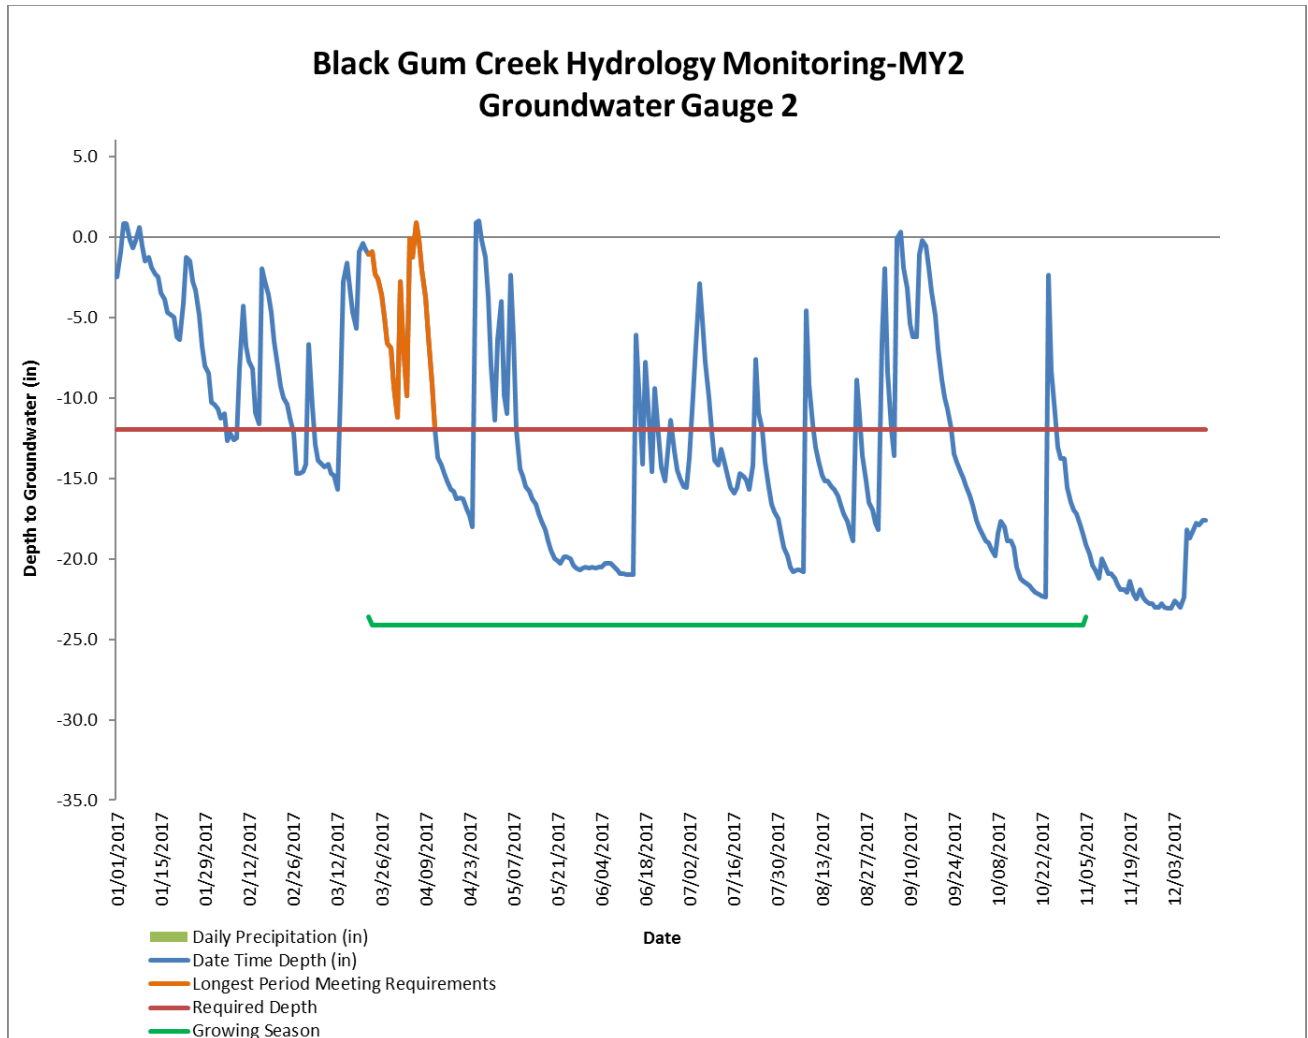
Figure 5b. Monitoring Gauge #2
 Black Gum Creek, DMS Project ID# 97063

Growing Season Days: 228 (Mar 22 – Nov 5)
 Target Hydroperiod Percent: 8%
 Required Number of Days Meeting Requirements: 18
 Longest Period Meeting Requirements: 22
 Hydroperiod Percent: 9.6%

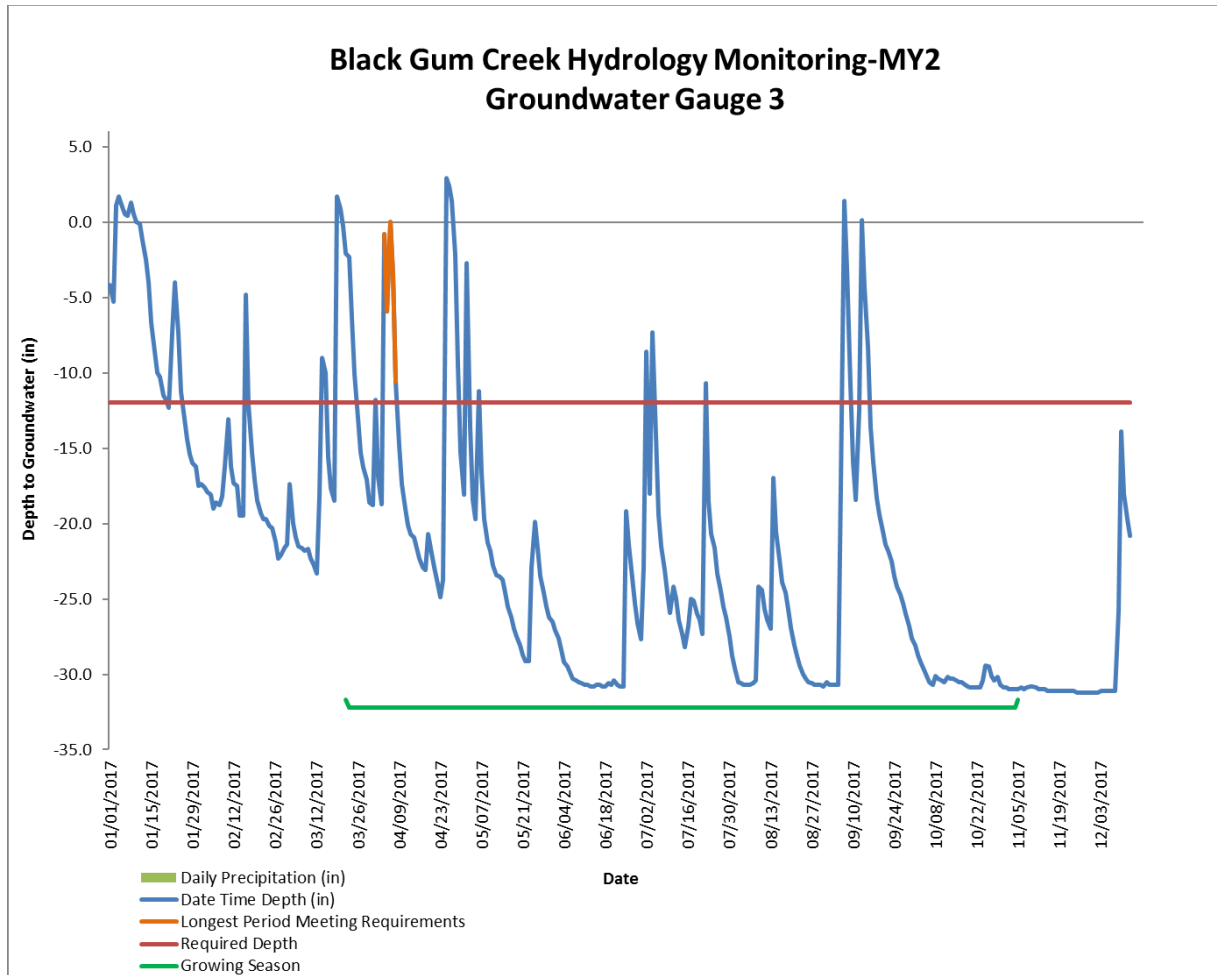
Figure 5c. Monitoring Gauge #3
 Black Gum Creek, DMS Project ID# 97063

Growing Season Days: 228 (Mar 22 – Nov 5)
 Target Hydroperiod Percent: 8%
 Required Number of Days Meeting Requirements: 18
 Longest Period Meeting Requirements: 5
 Hydroperiod Percent: 2.2%

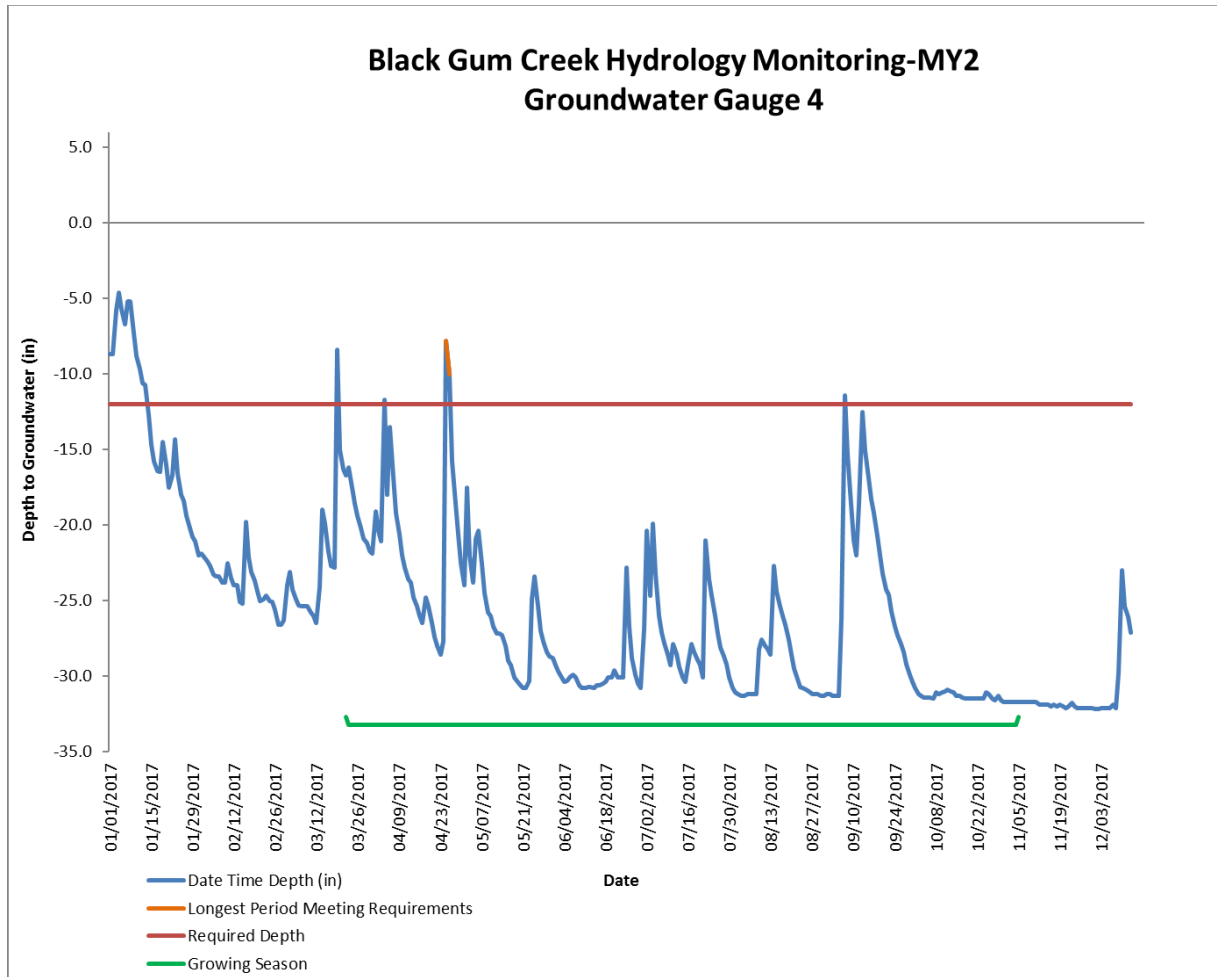
Figure 5d. Monitoring Gauge #4
 Black Gum Creek, DMS Project ID# 97063

Growing Season Days: 228 (Mar 22 – Nov 5)
 Target Hydroperiod Percent: 8%
 Required Number of Days Meeting Requirements: 18
 Longest Period Meeting Requirements: 2
 Hydroperiod Percent: 0.9%

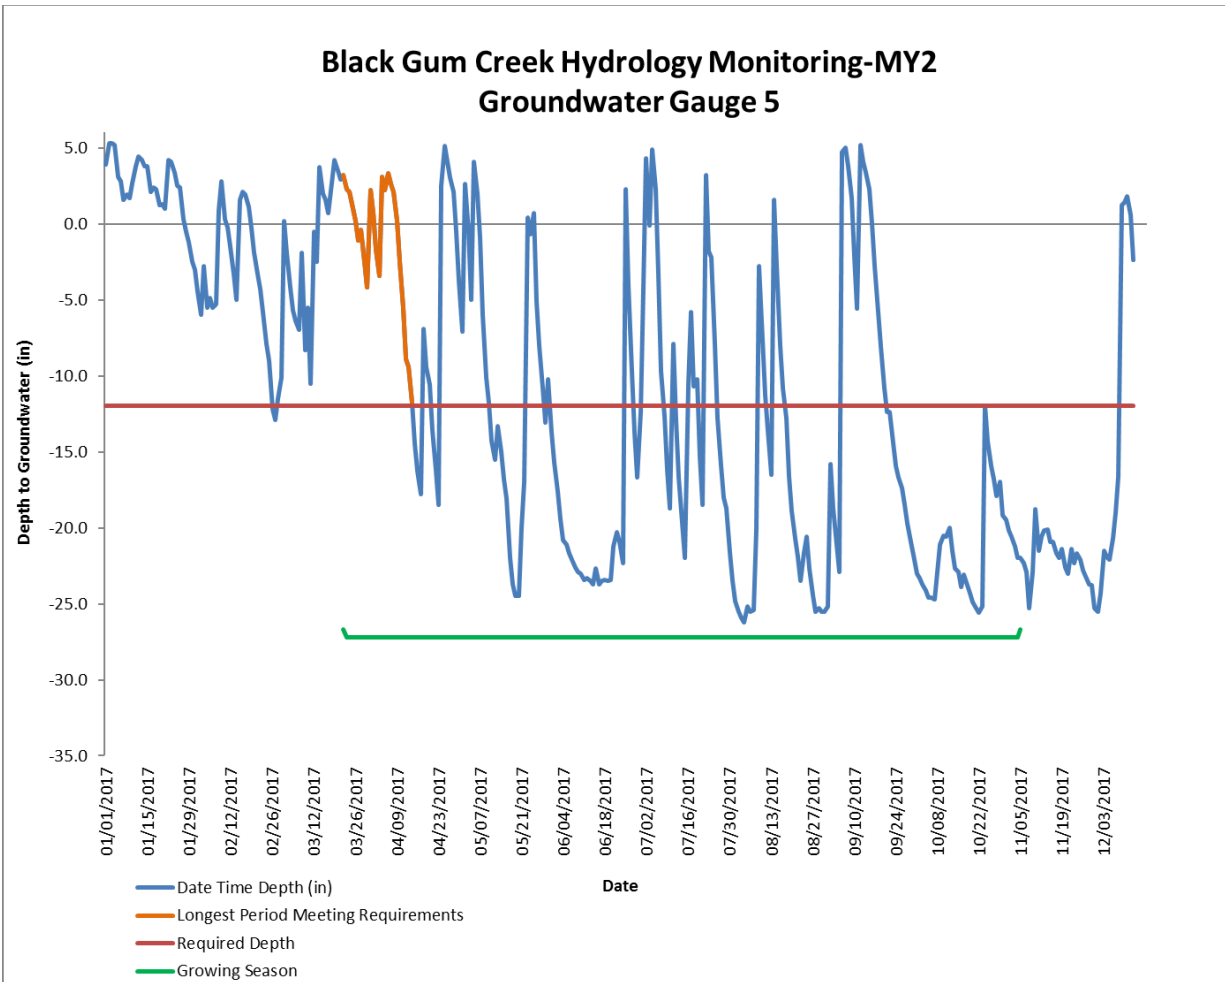
Figure 5e. Monitoring Gauge #5
 Black Gum Creek, DMS Project ID# 97063

Growing Season Days: 228 (Mar 22 – Nov 5)
 Target Hydroperiod Percent: 8%
 Required Number of Days Meeting Requirements: 18
 Longest Period Meeting Requirements: 24
 Hydroperiod Percent: 10.5%
