Year 3 Monitoring Report

Black Gum Creek Wetland Restoration Site

DMS Project Number 97063

December 2018

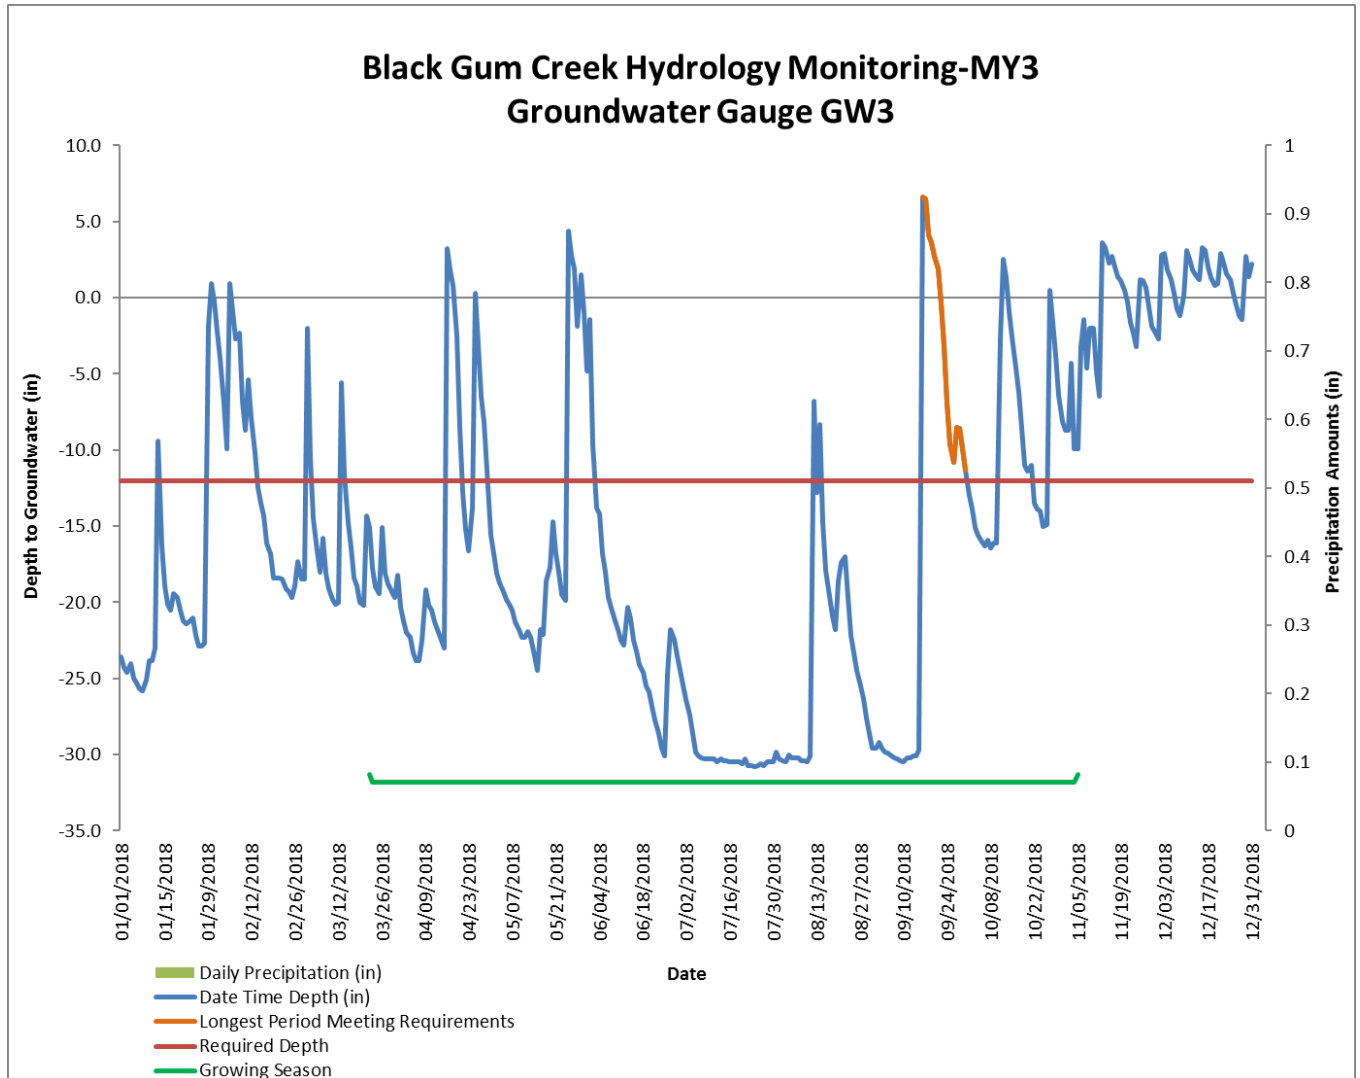
Figure 5c. Monitoring Gauge #3
 Black Gum Creek, DMS Project ID# 97063

Growing Season Days: 228 (Mar 22 – Nov 5)
 Target Hydroperiod Percent: 8%
 Required Number of Days Meeting Requirements: 18
 Longest Period Meeting Requirements: 15
 Hydroperiod Percent: 6.6%

** Gauge 2 and 3 are located outside of asset areas.

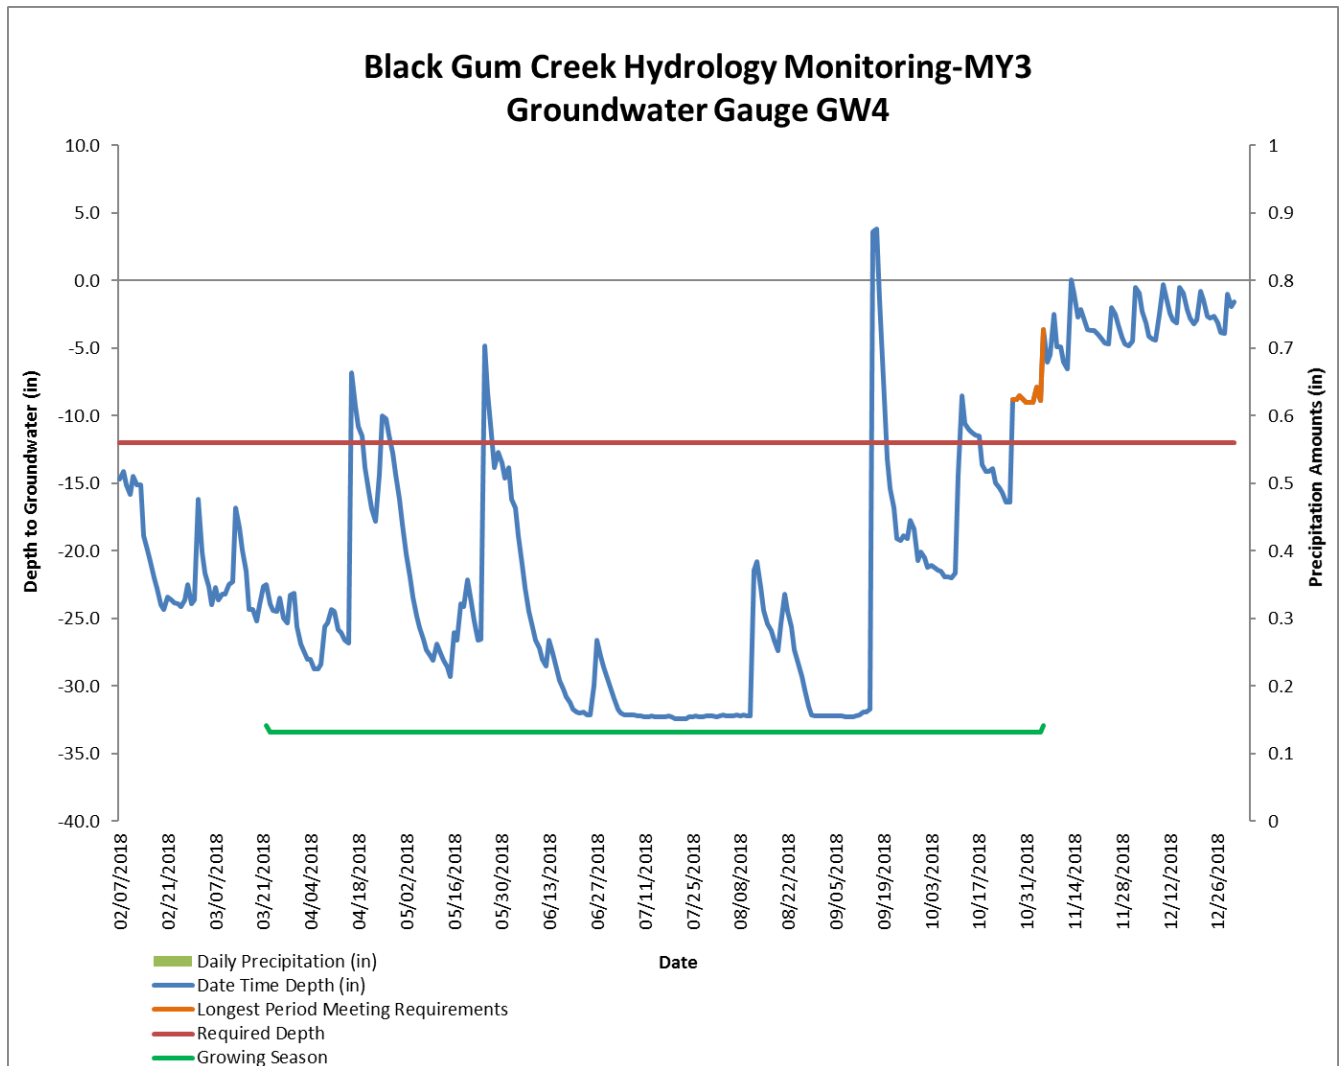
Figure 5d. Monitoring Gauge #4
 Black Gum Creek, DMS Project ID# 97063

Growing Season Days: 228 (Mar 22 – Nov 5)
 Target Hydroperiod Percent: 8%
 Required Number of Days Meeting Requirements: 18
 Longest Period Meeting Requirements: 10
 Hydroperiod Percent: 4.4%

Hydrology data indicated that two of three gauges in the rehabilitation area (gauges 1 & 5) met the hydrologic success target of greater than 8% of the growing season (Appendix D). Hydrology for gauge 4 did not meet success criteria. However, it is important to note that the location of gauge 4 exhibited signs of continuous inundation during multiple monitoring trips and has an established stand of obligate wetland grasses and rushes and several desirable species of volunteer trees. Gauge 4 was replaced February 6, 2018 due to a fire that burned through the northernmost portion of the project rehabilitation area in the late 2016-17 dormant season. Gauges 2 and 3 are both located outside of the wetland rehabilitation areas. Gauge 2, which is just outside the rehabilitation asset line, indicated that the water table was continuously above 12" for 22.7% of the growing season while gauge 3, further away from any proposed wetland rehabilitation, only had 6.6% continuous hydrology; potentially indicating that the wetland asset lines for rehabilitation were drawn appropriately.
