## Year 4 Monitoring Report

Black Gum Creek Wetland Restoration Site

DMS Project Number 97063

February 2020

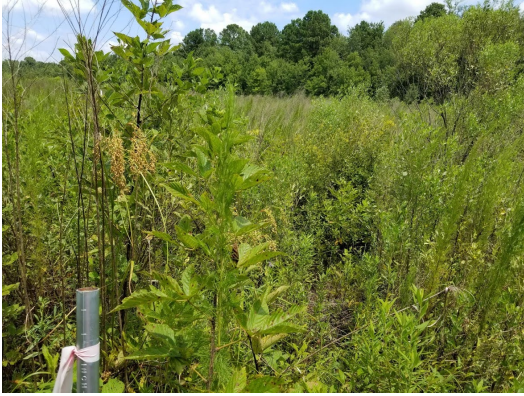
Photo Point 1

Photos 1-8 taken 7/24/2019 (all photo points are located on the SE corner of the corresponding vegetation plot)

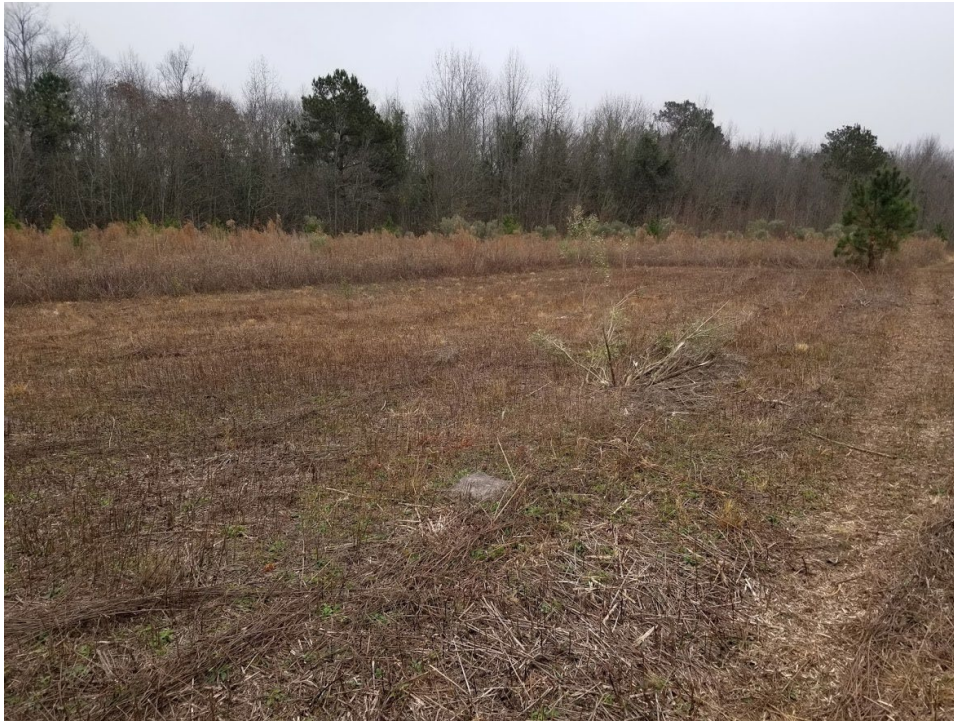
Large shooting field mowed outside credit /planted area East of wetland gauge 2. Area approximately 100' x 40' = 0.1 acre 12/9/20

Between the July and December site visits, there was trespass in the easement and along the credit line where someone bush hogged path that destroyed gauge 1 and mowed a shooting field outside the credit area to the east of gauge 2 (see pictures). DMS is working with Property attempting to reconcile the trespass because it is a remote site with an absentee landowner. Gauge 1 will be reinstalled, and a small number of trees replanted in the dormant season 2020 to ensure that the credit line is vegetated adequately. The length of path mowed inside the credit area is ~275' and ~4' wide (1,100 sf, see CCPV Figure 3).

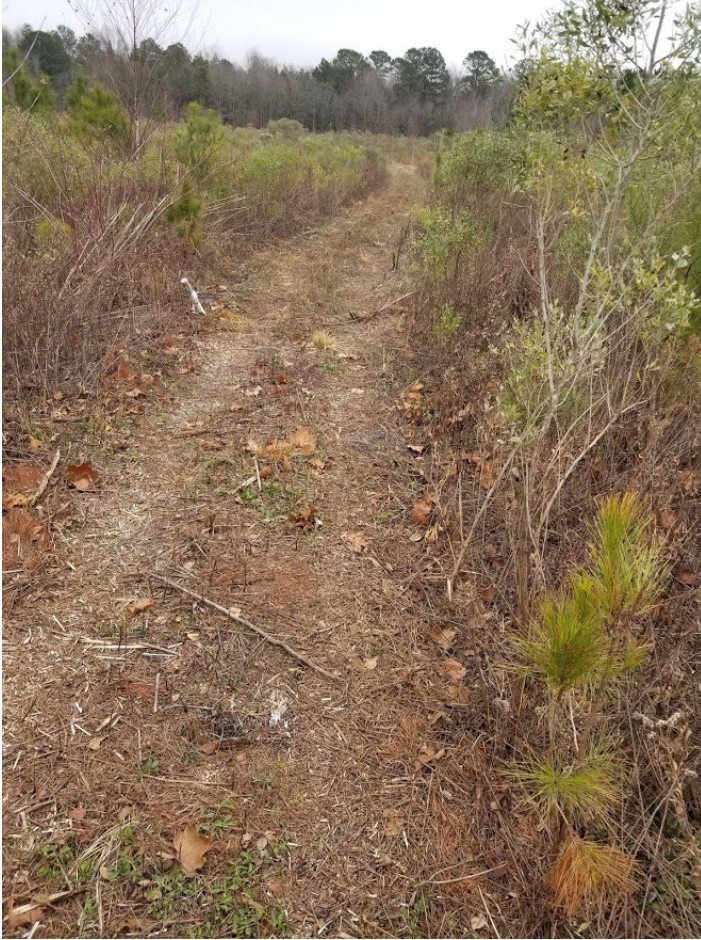
Mowed path inside credit area and destroyed wetland gauge 1. 12/9/20  
Total area of mowed path ~1,200' x 4' wide = 0.1 acre

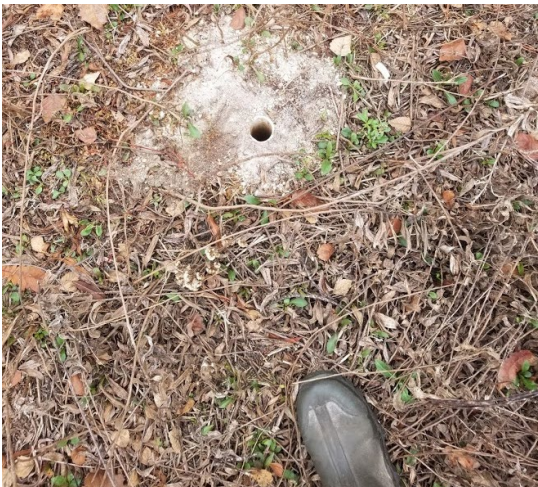
Gauge 6 destroyed by bear (top and right) 12/9/20

There were 5 gauges on this site, and a 6<sup>th</sup> gauge was installed 4/30/2019 (nearby gauge 4) for additional hydrologic data. This gauge (6) functioned through the July monitoring, but was destroyed by wildlife (likely a bear) before the December download. Nevertheless, gauge 6 performed at 11% hydroperiod during this time. It will be reinstalled in 2020.

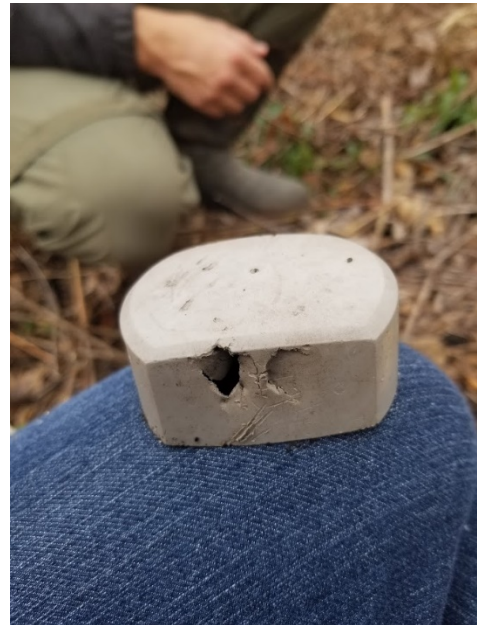
All six gauges met the hydrologic success target of greater than 8% of the growing season (Appendix D). Gauges 1 & 6 met success criteria despite being damaged. Hydrology for these gauges are represented through July 2019. Gauges 2 and 3 are both located outside of the wetland rehabilitation areas. Gauge 2, which is just outside the rehabilitation asset line, indicated that the water table was continuously above 12" for 16.6% of the growing season and gauge 3, further away from any proposed wetland rehabilitation, had 16.2% continuous hydrology. This information may indicate that the site's hydrologic footprint is expanding more than anticipated for the project.

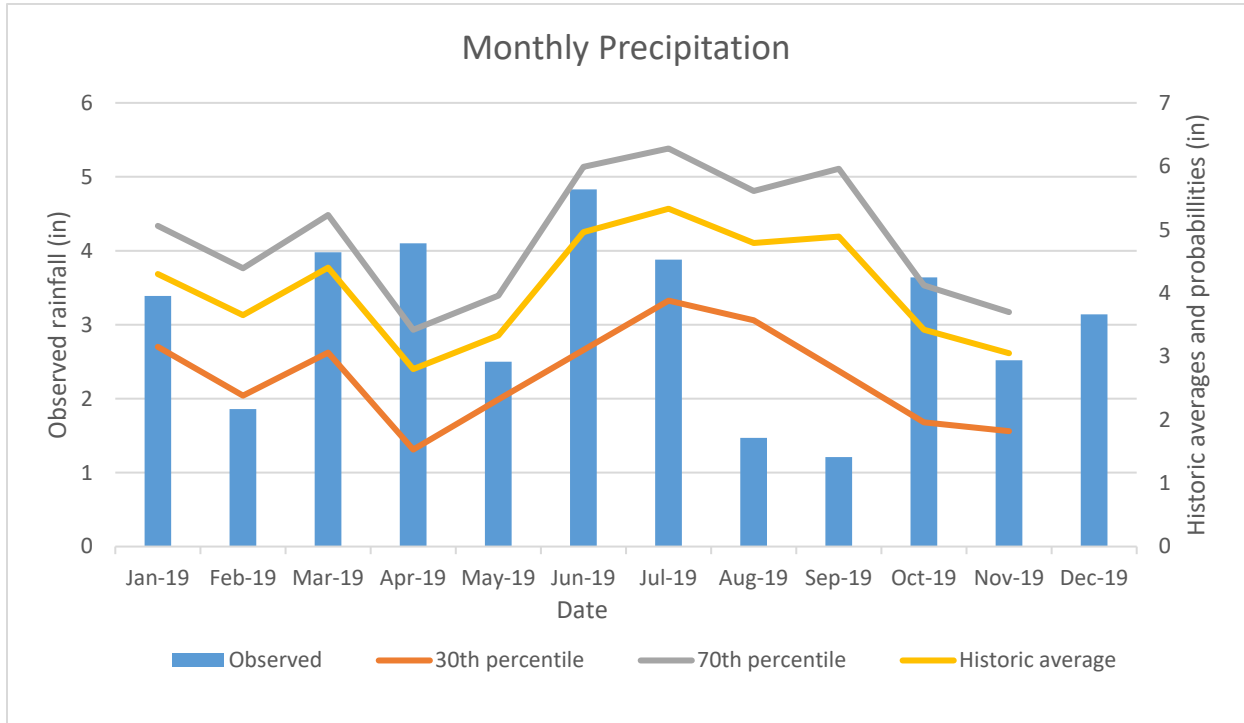
Figure 4. Monthly Rainfall Data  
 Black Gum Creek, DMS Project ID# 97063

MY3 (2018) and MY4 (2019) observed and historic rainfall data collected from the USDA-NRCS Agricultural Applied Climate Information System, Laurinburg-Maxton Airport monitoring station in Scotland County. Data acquired for MY2 (2017) from USDA-NRCS Agricultural Applied Climate Information System (Red Springs 1 SE monitoring station) in Robeson County was not used for proceeding years due to missing data and/or data errors.

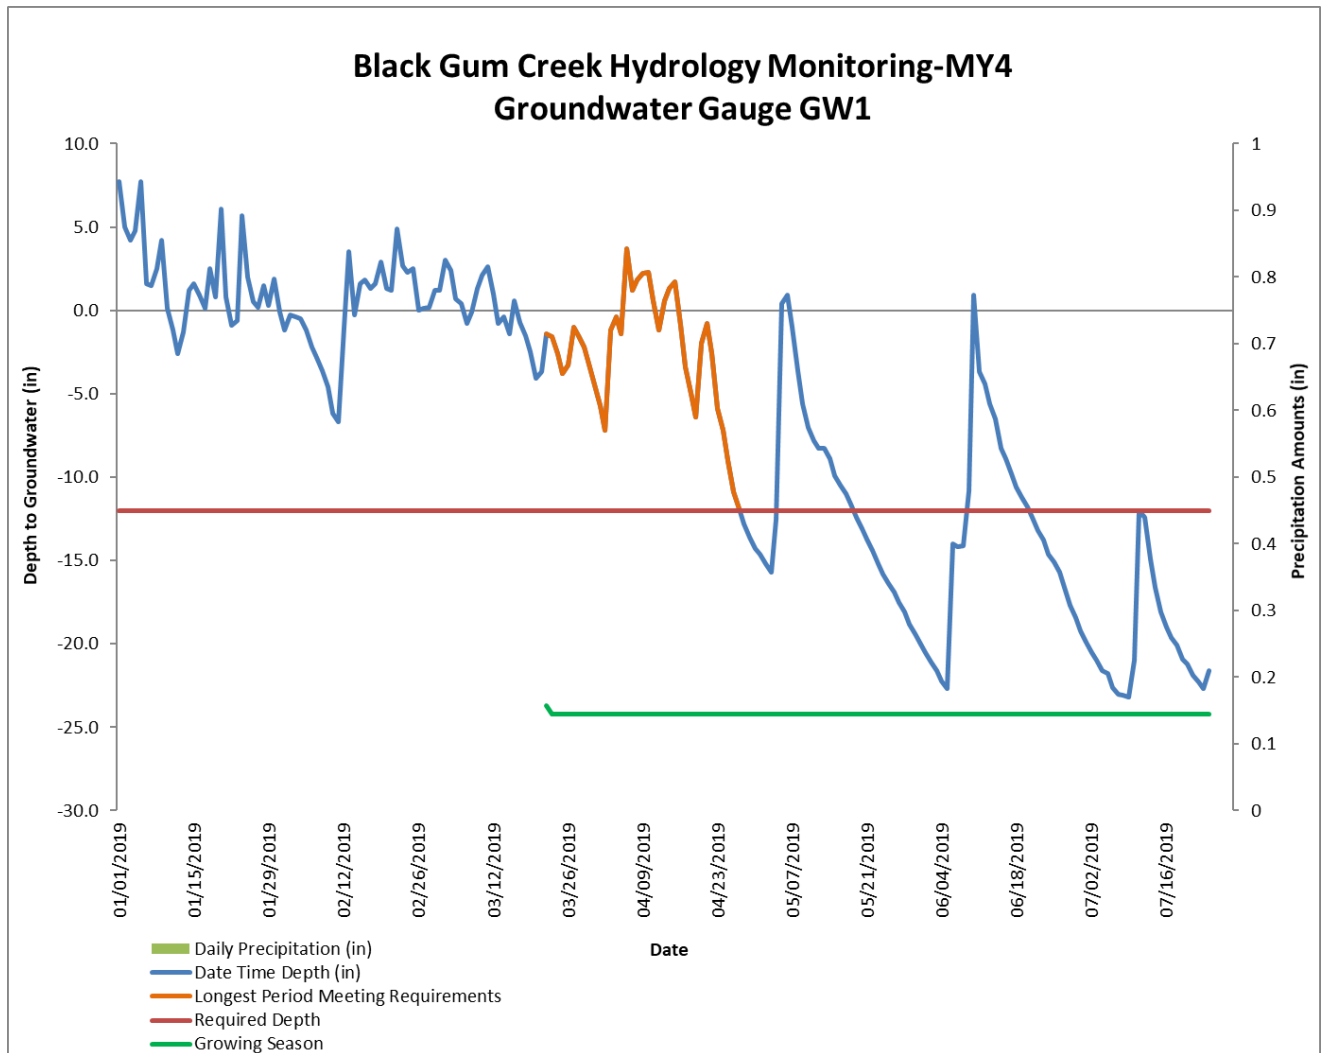
Figure 5a. Monitoring Gauge #1  
 Black Gum Creek, DMS Project ID# 97063

Growing Season Days: 228 (Mar 22 – Nov 5)  
 Target Hydroperiod Percent: 8%  
 Required Number of Days Meeting Requirements: 18  
 Longest Period Meeting Requirements: 37  
 Hydroperiod Percent: 16.2%

Gauge 6 was installed 4/30/2019. Gauge 1 and 6 were destroyed in 2019 and data could not be retrieved for the entire duration of the monitoring year. Data for these gauges for MY4 are indicative of hydrology through July 23, 2019.

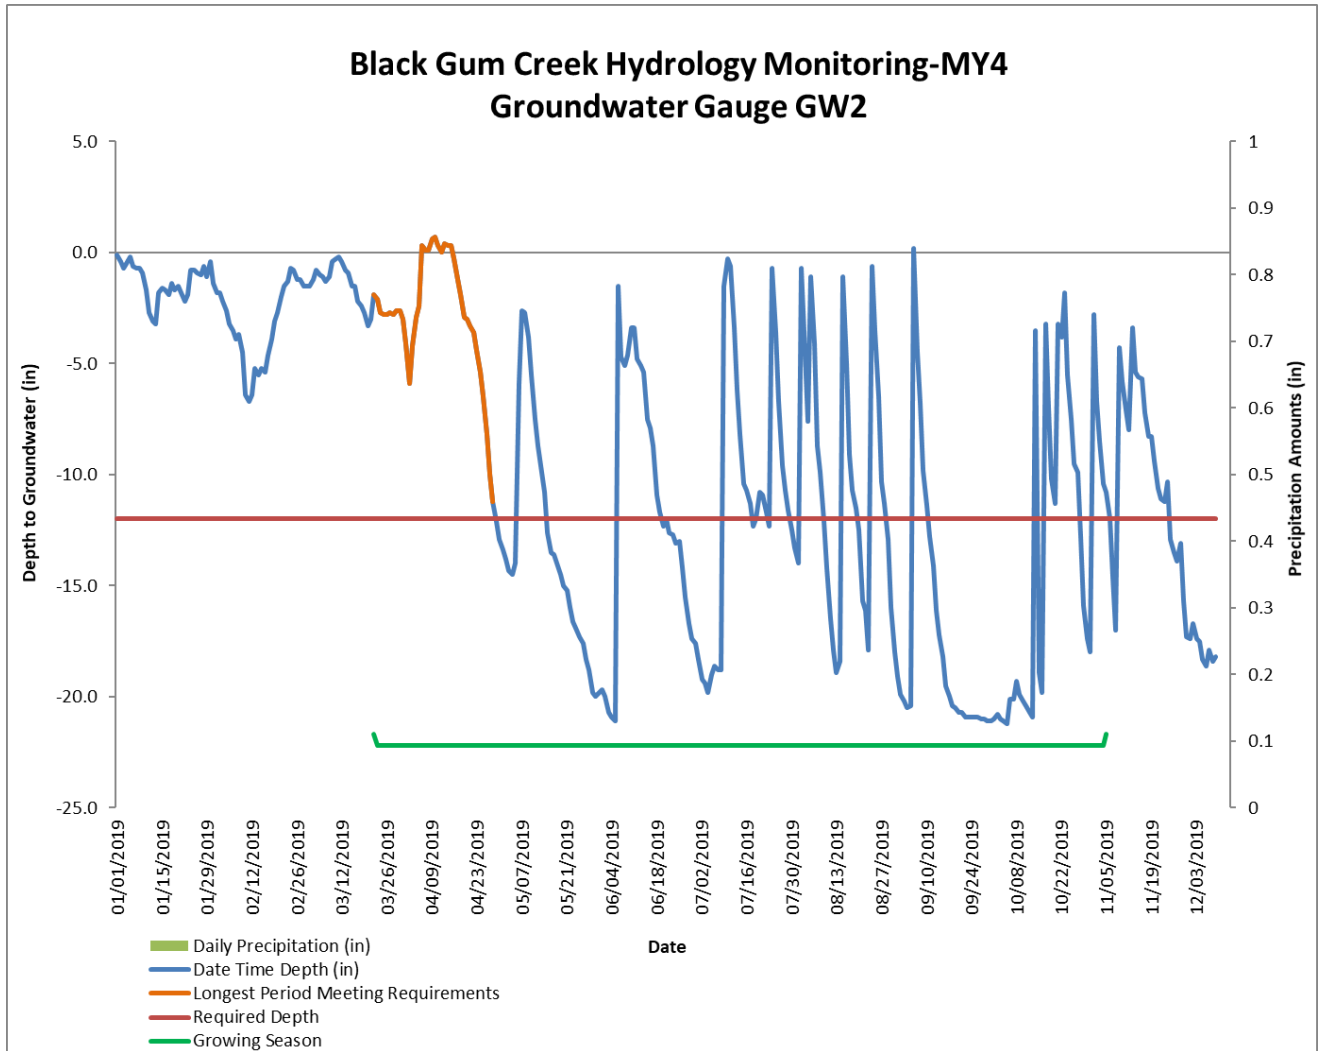
Figure 5b. Monitoring Gauge #2  
 Black Gum Creek, DMS Project ID# 97063

Growing Season Days: 228 (Mar 22 – Nov 5)  
 Target Hydroperiod Percent: 8%  
 Required Number of Days Meeting Requirements: 18  
 Longest Period Meeting Requirements: 38  
 Hydroperiod Percent: 16.6%

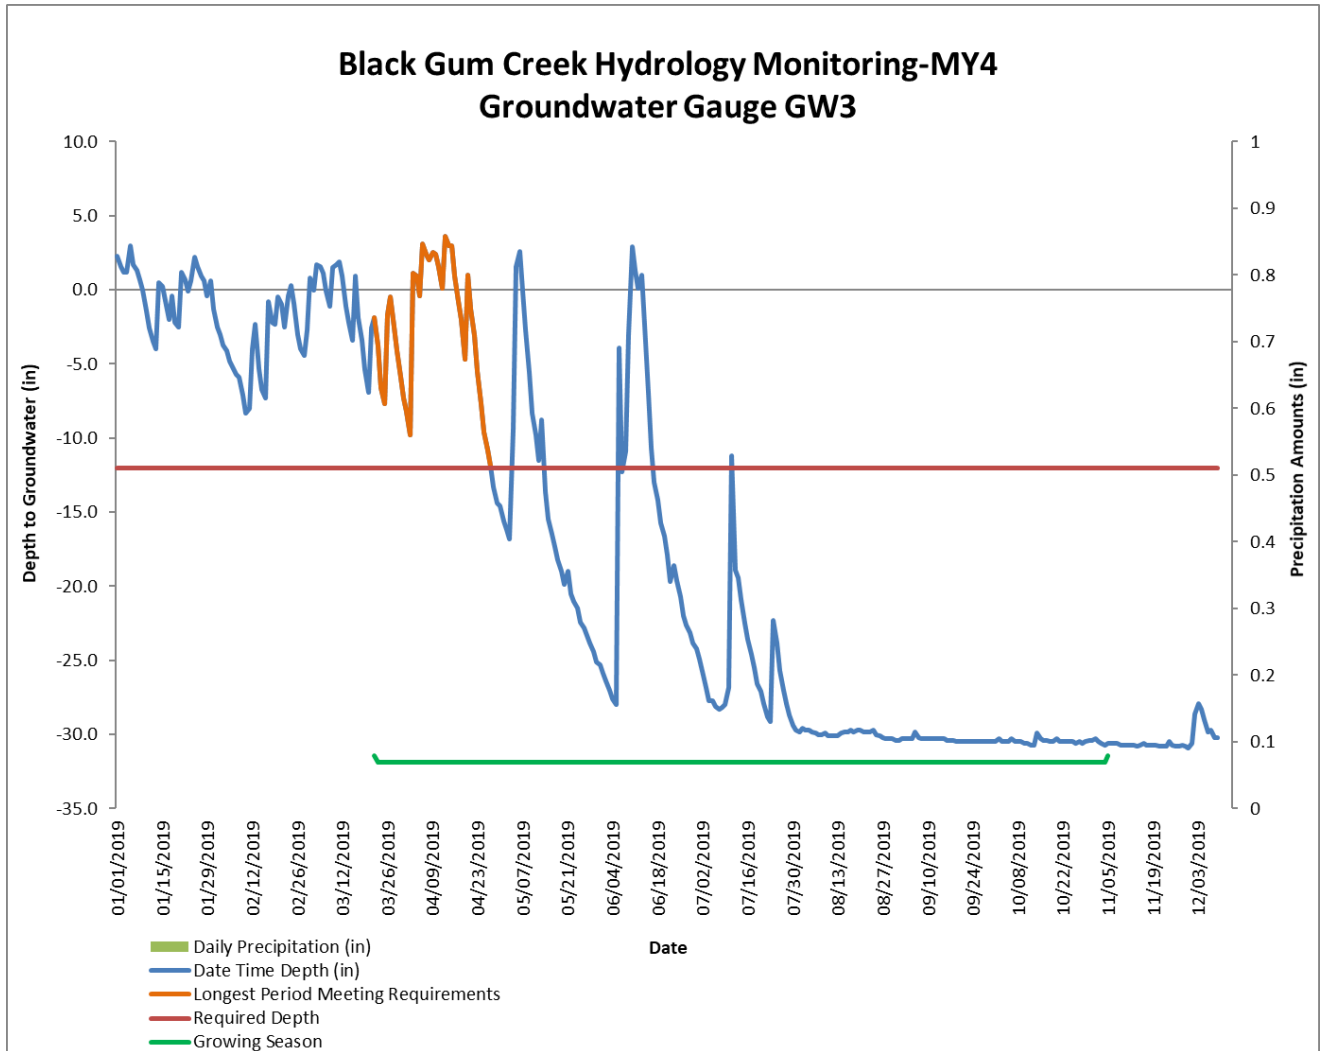
Figure 5c. Monitoring Gauge #3  
 Black Gum Creek, DMS Project ID# 97063

Growing Season Days: 228 (Mar 22 – Nov 5)  
 Target Hydroperiod Percent: 8%  
 Required Number of Days Meeting Requirements: 18  
 Longest Period Meeting Requirements: 37  
 Hydroperiod Percent: 16.2%

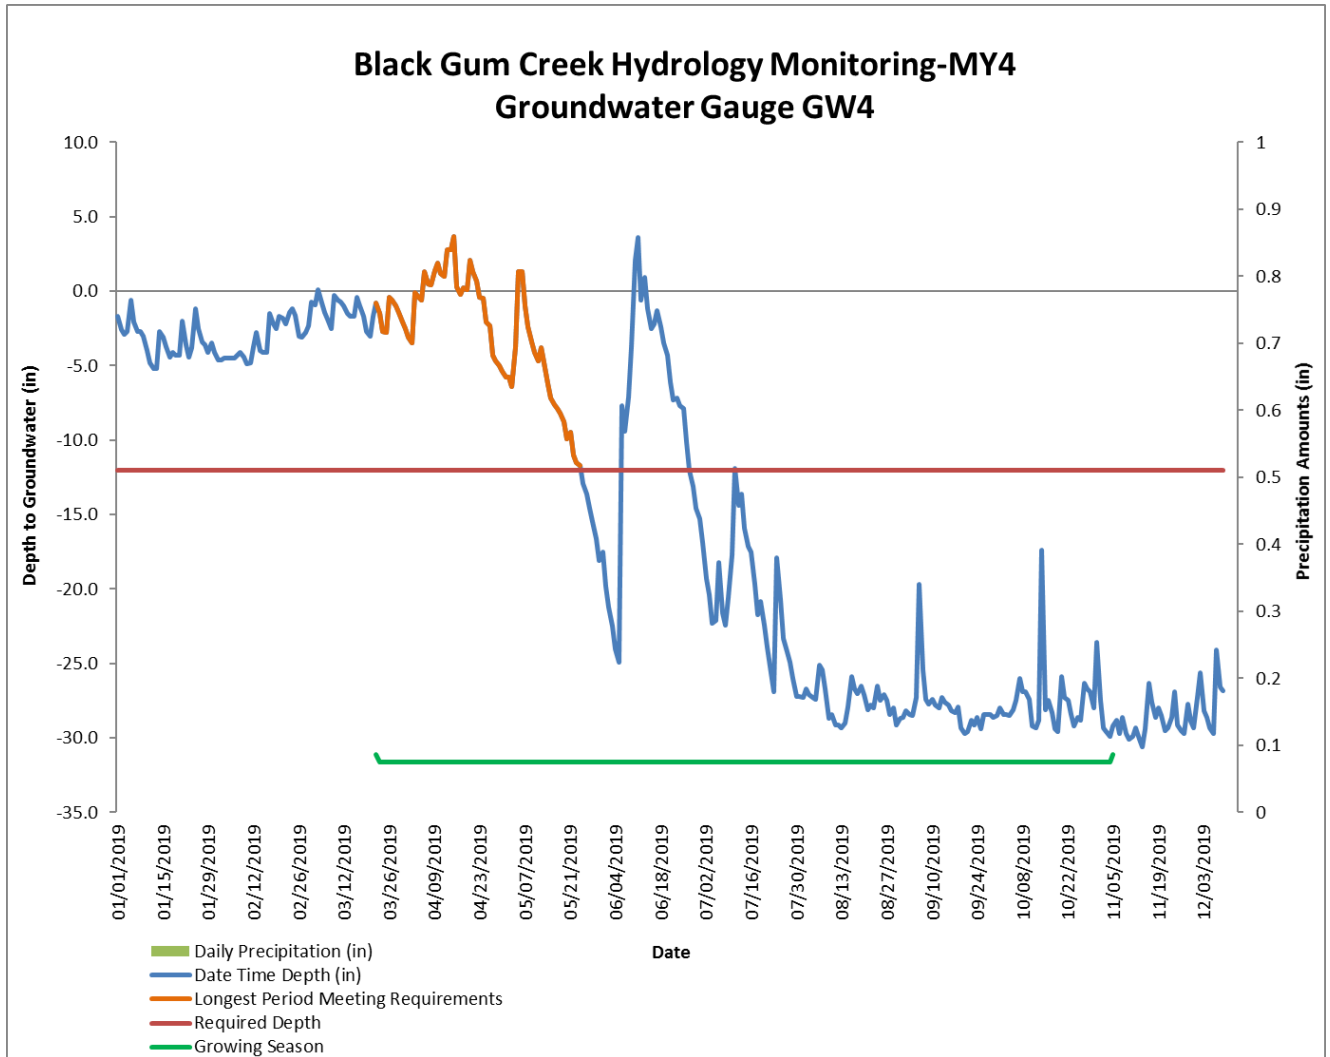
Figure 5d. Monitoring Gauge #4  
 Black Gum Creek, DMS Project ID# 97063

Growing Season Days: 228 (Mar 22 – Nov 5)  
 Target Hydroperiod Percent: 8%  
 Required Number of Days Meeting Requirements: 18  
 Longest Period Meeting Requirements: 64  
 Hydroperiod Percent: 27.9%

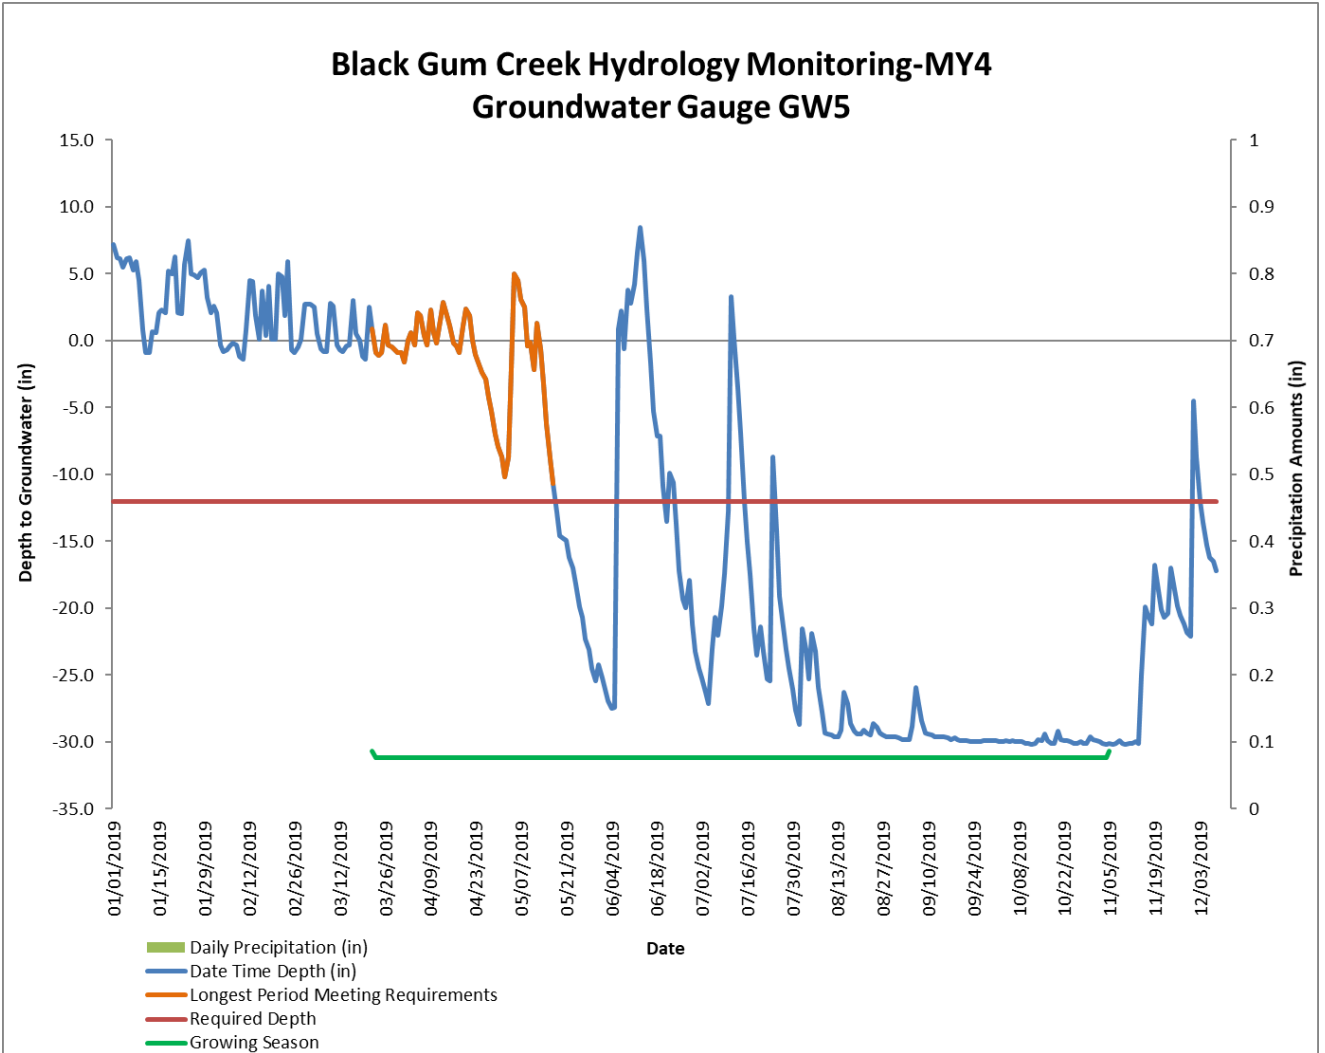
Figure 5e. Monitoring Gauge #5  
 Black Gum Creek, DMS Project ID# 97063

Growing Season Days: 228 (Mar 22 – Nov 5)  
 Target Hydroperiod Percent: 8%  
 Required Number of Days Meeting Requirements: 18  
 Longest Period Meeting Requirements: 57  
 Hydroperiod Percent: 24.9%

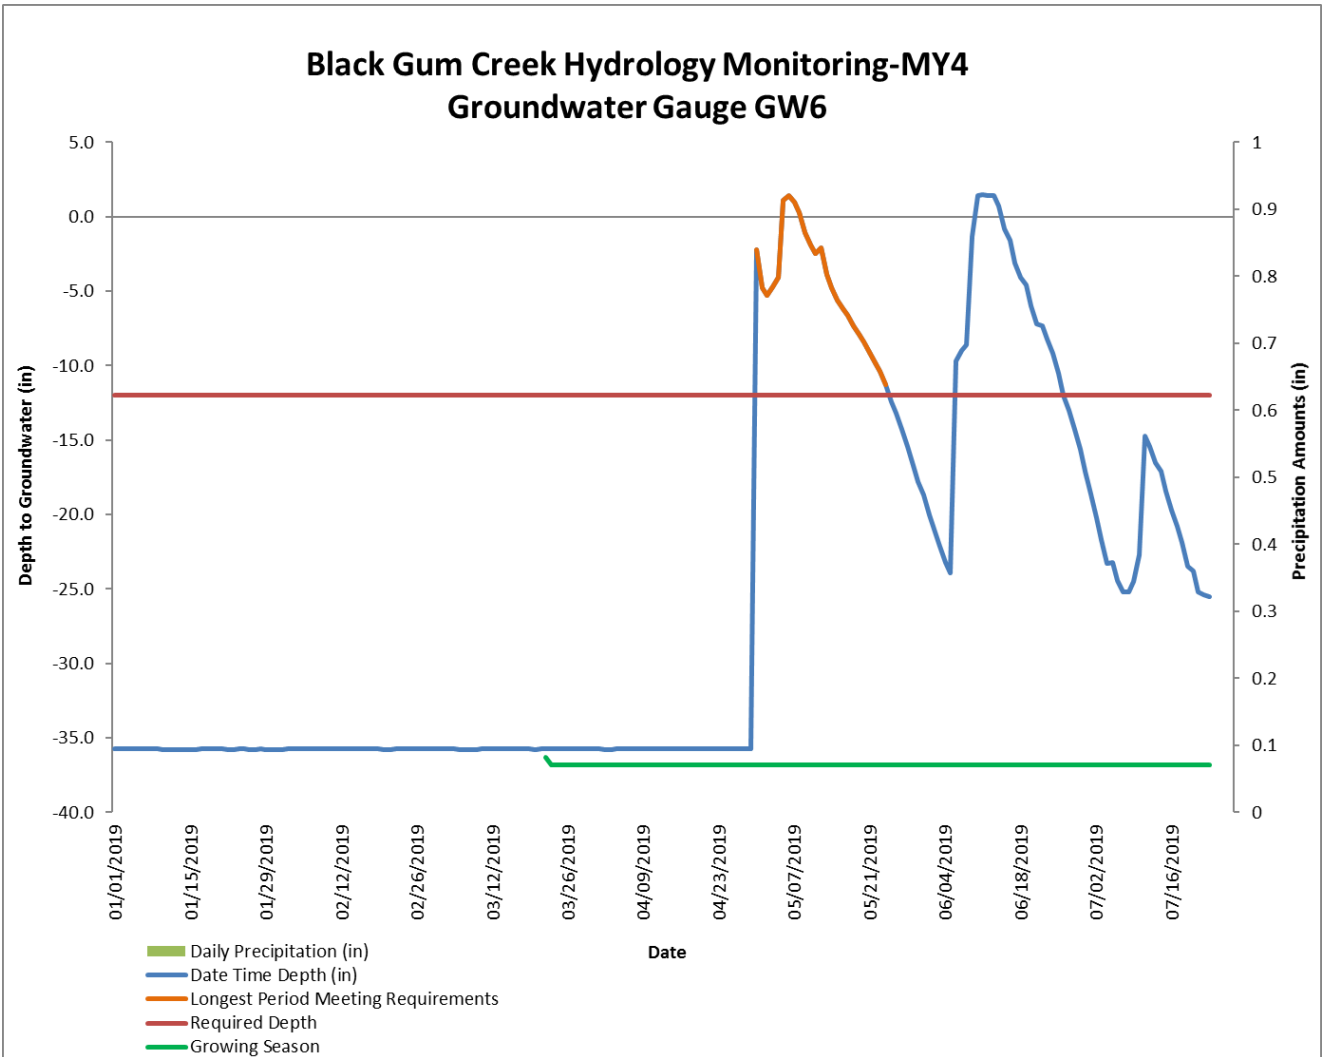
Figure 5f. Monitoring Gauge #6  
 Black Gum Creek, DMS Project ID# 97063

Growing Season Days: 228 (Mar 22-Nov 5)  
 Target Hydroperiod Percent: 8%  
 Required Number of Days Meeting Requirements: 18  
 Longest Period Meeting Requirements: 25  
 Hydroperiod Percent: 10.9%
