Black Gum Creek

Year 5 Monitoring Report
DMS Project Number 97063
DWR Number 2006-1819 USACE Action ID SAW-2015-01605
Lumber River Basin 03040203
Robeson County, North Carolina
February 2021

Year 5 Annual Monitoring Report
Black Gum Creek 97063

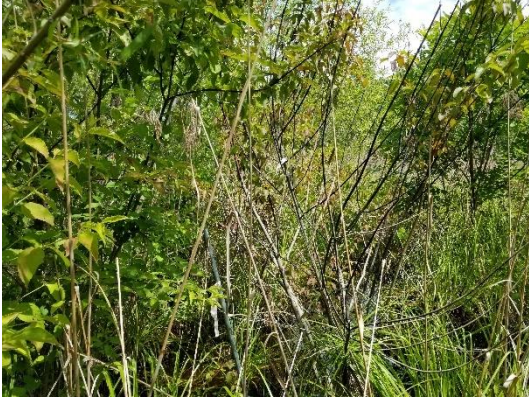
Photo Point 1

Photos 1-8 taken 7/24/2019 (all photo points are located on the SE corner of the corresponding vegetation plot)

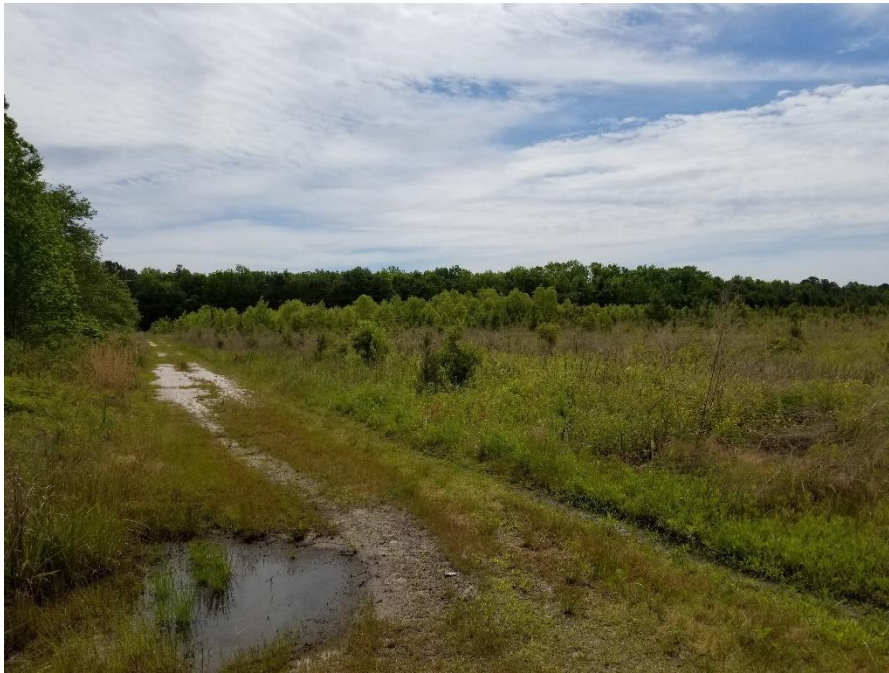
Facing east towards planted area of rehabilitation (VP 3 and 4), line depicting difference of planted and unplanted areas.

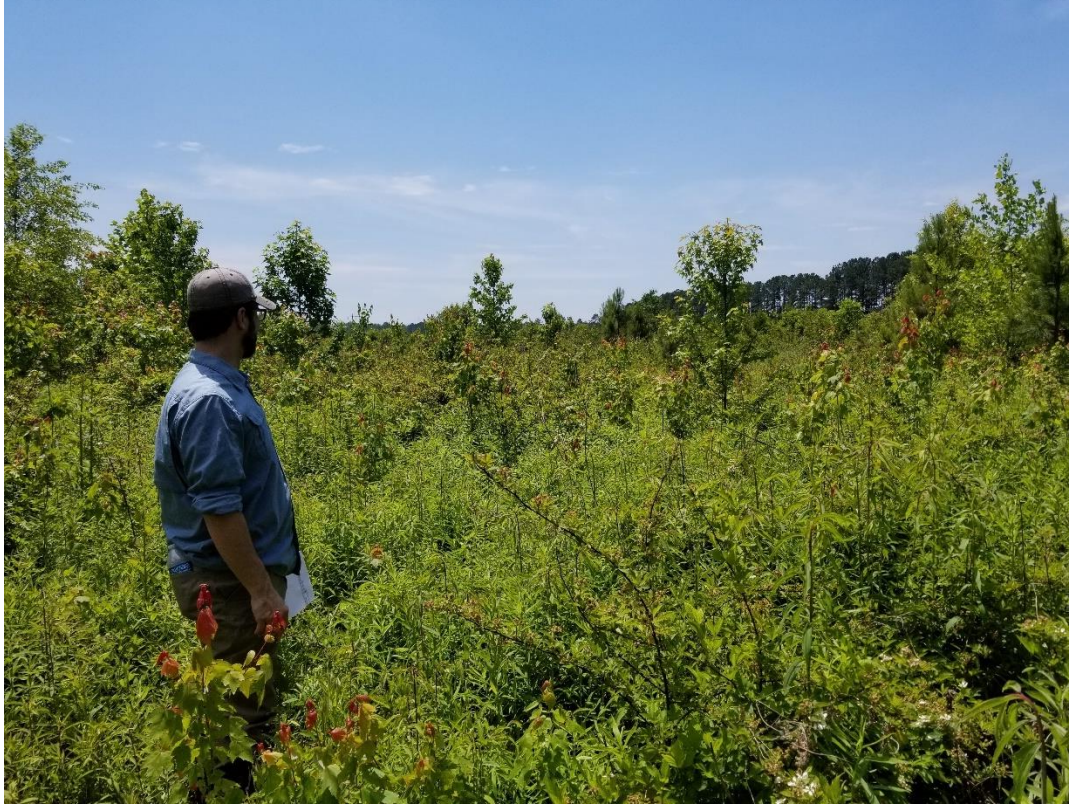
Average height of site planted trees compared to averaged size 6' tall man.

All the vegetation plots met the vegetative success criteria with a project-wide average of 430 stems per acre planted and 981 stems per acre including volunteers. Only one vegetation plot fell below the threshold for success in the planted stems category (VP8), due to the encroachment described below. Although there was no height requirement for success, 6 of the 8 plots were well over the threshold of 7' height, indicating high vigor rates. Plot 6 and plot 8 have a large in-plot height range (Appendix C).

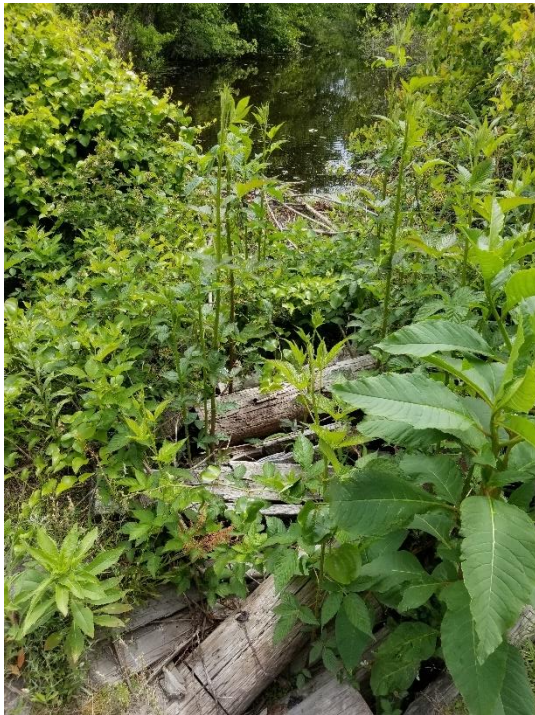
Excessively clogged culvert along entrance road

Despite low antecedent conditions, all gauges met the hydrologic success target of greater than 8% of the growing season besides gauge one, which malfunctioned (Appendix D). Gauges 2 and 3 are both located outside of the wetland rehabilitation areas. Gauge 2, which is just outside the rehabilitation asset line, indicated that the water table was continuously above 12" for 24.5% of the growing season and gauge 3, further away from any proposed wetland rehabilitation, had 19.7% continuous hydrology. This information may indicate that the site's hydrologic footprint is expanding more than anticipated for the project and this trend is apparent in the gauge data which has improved steadily throughout the project. Additional DMS monitoring staff observations have shown increased hydrology sitewide over the 7 years of monitoring, likely due to agricultural abandonment, clogged culvert, and overall site high water tables due to elevation and climate.

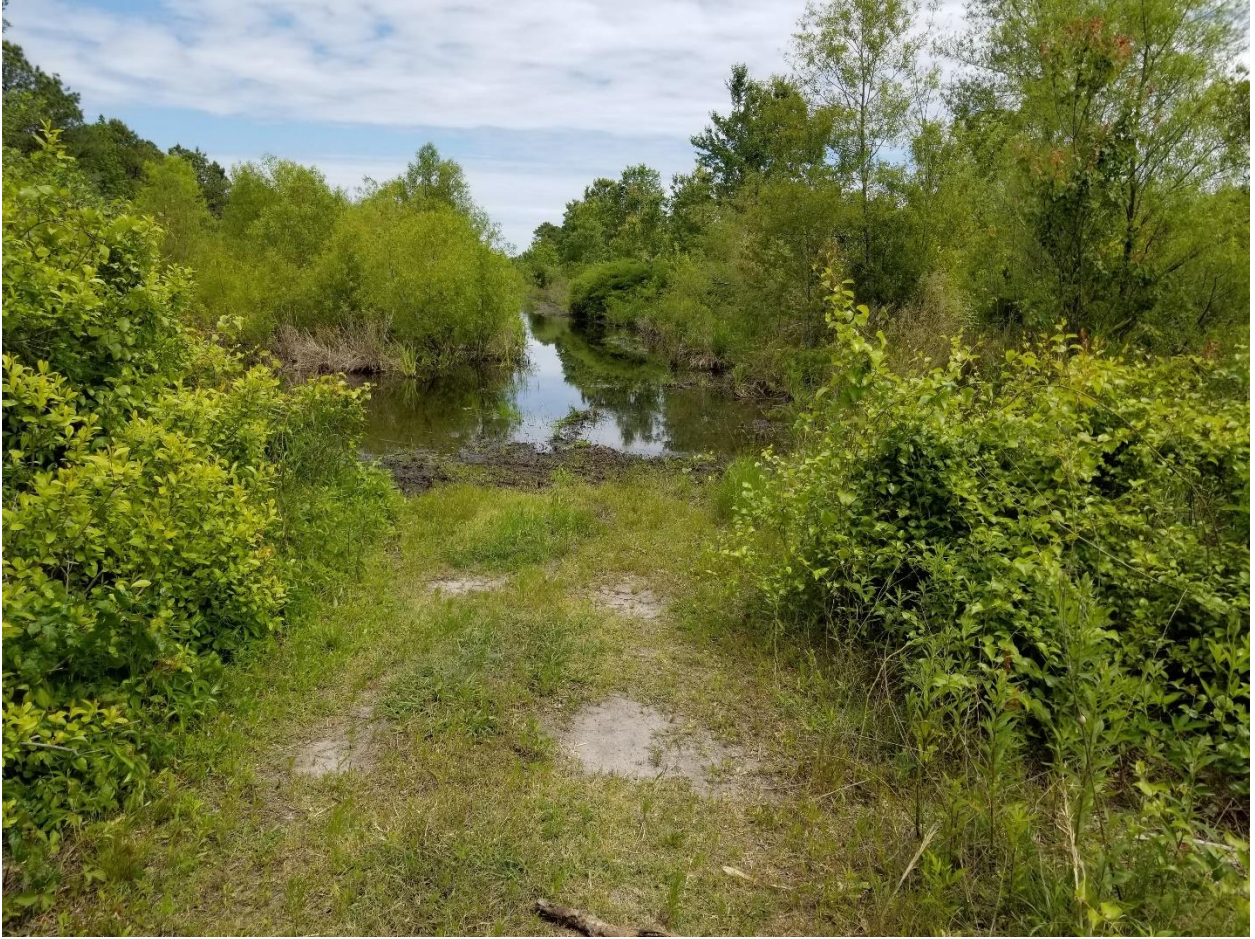
Standing water held by clogged culvert on road in August.

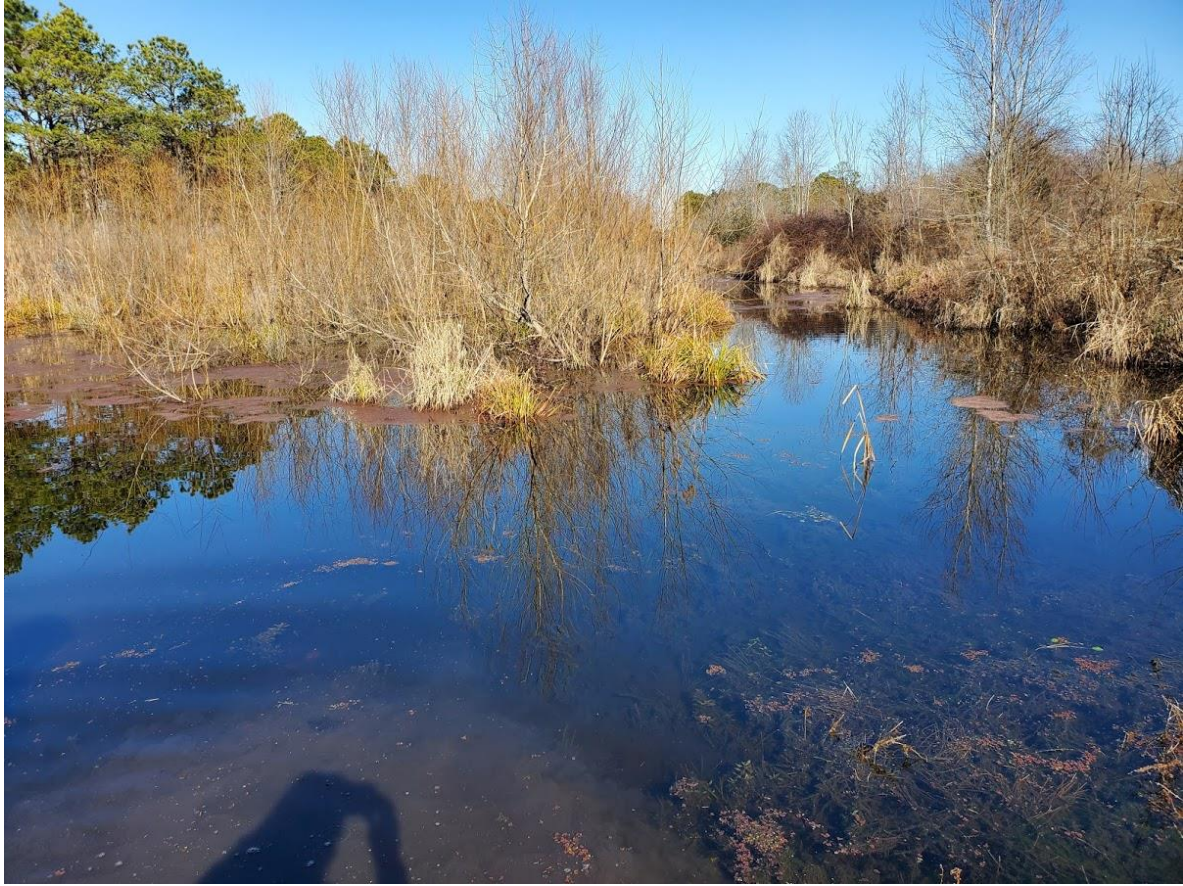
Standing water held by clogged culver on entrance road in January, depth 12".

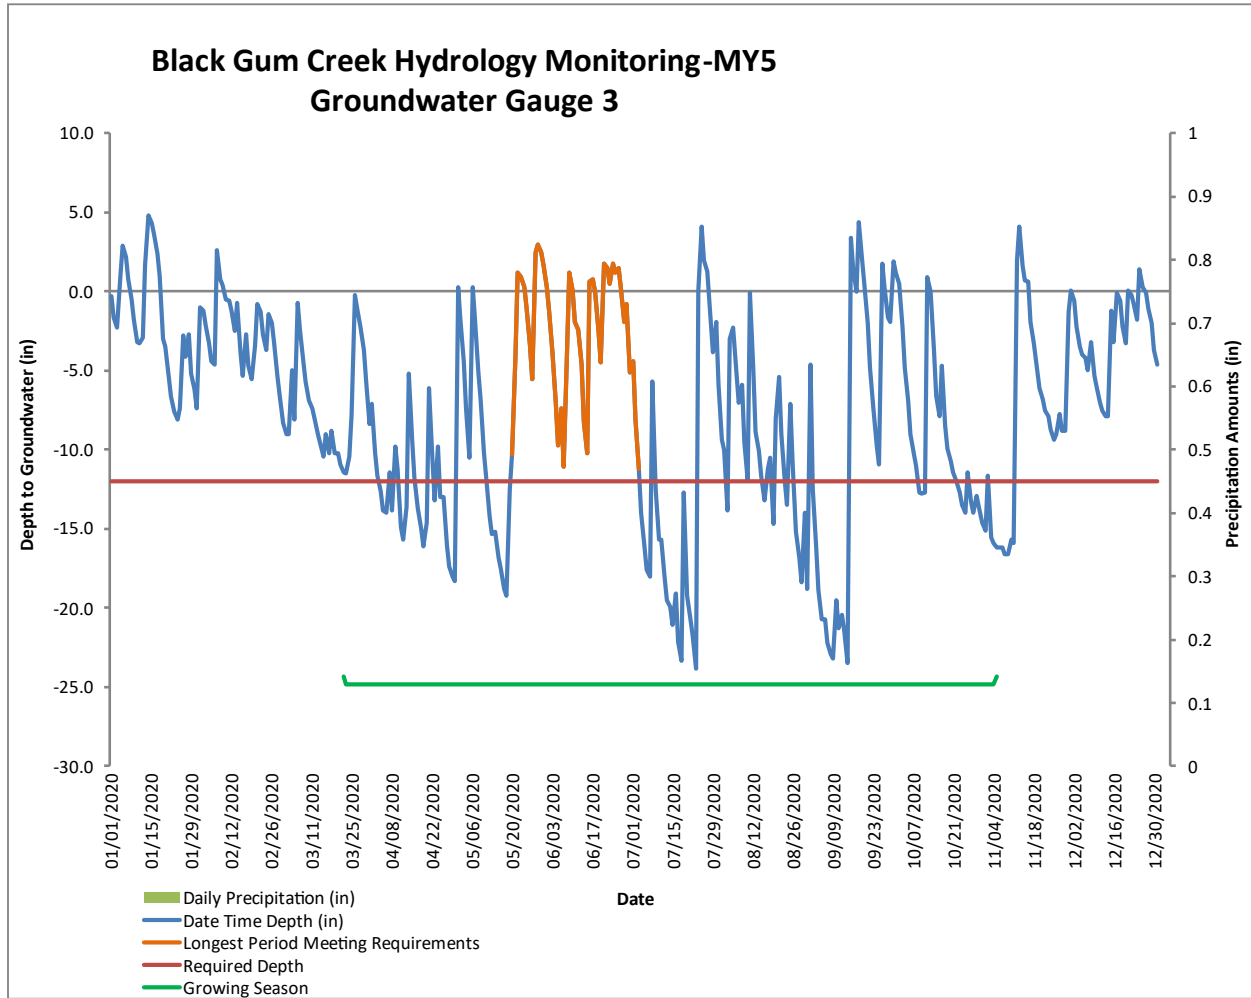
Figure 5c. Monitoring Gauge #3

Growing Season Days: 228 (Mar 22 – Nov 5)
 Target Hydroperiod Percent: 8%
 Required Number of Days Meeting Requirements: 18
 Longest Period Meeting Requirements: 45
 Hydroperiod Percent: 19.7%
