Blair Creek Mitigation Project

Mitigation Plan – FINAL

Clay County, North Carolina

DMS Project ID No. 100047, DEQ Contract No. 7415, DMS RFP #16-007278

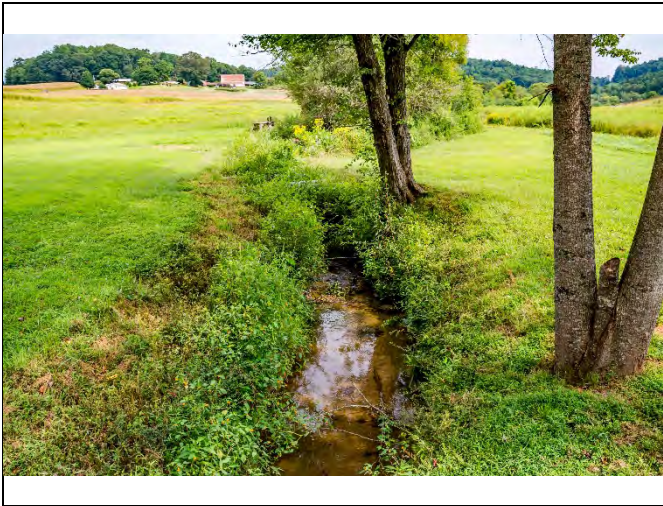
Upper Reach 1, downstream (Aug 2017)

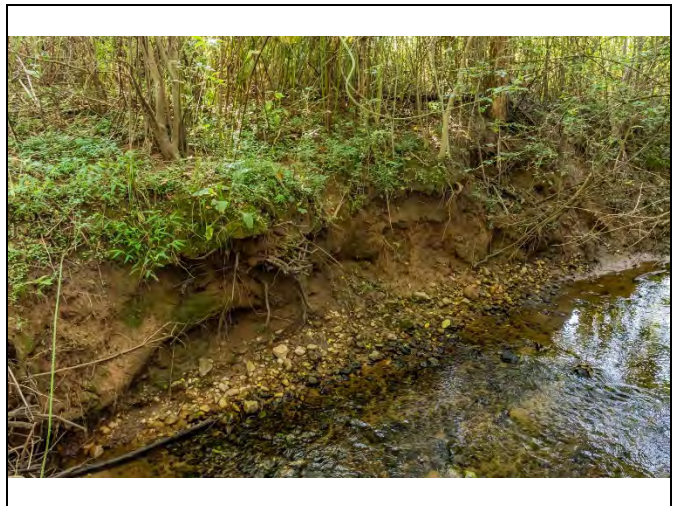
Upper Reach R1, right bank (Aug 2017)

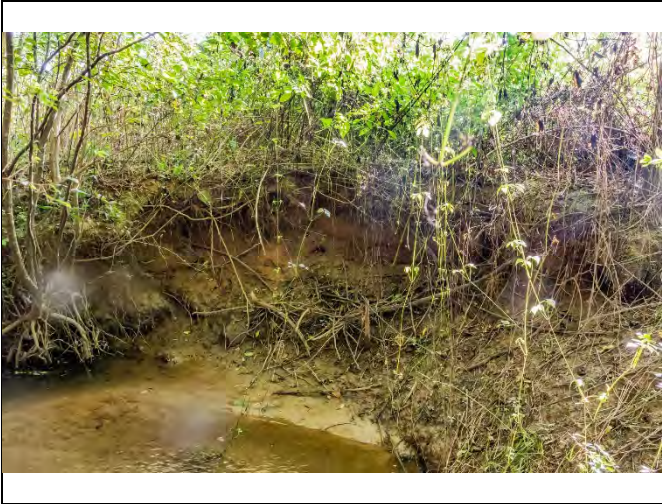
Upper Reach R1, right bank (Aug 2017)

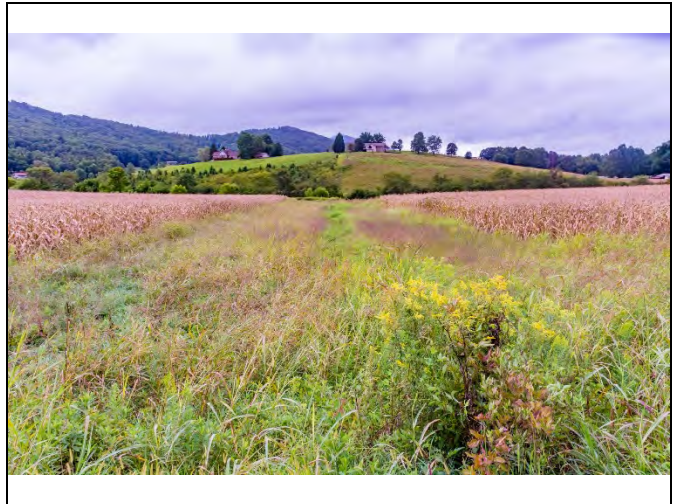
Upper Reach R1, adjacent field drain into right bank (Aug 2017)

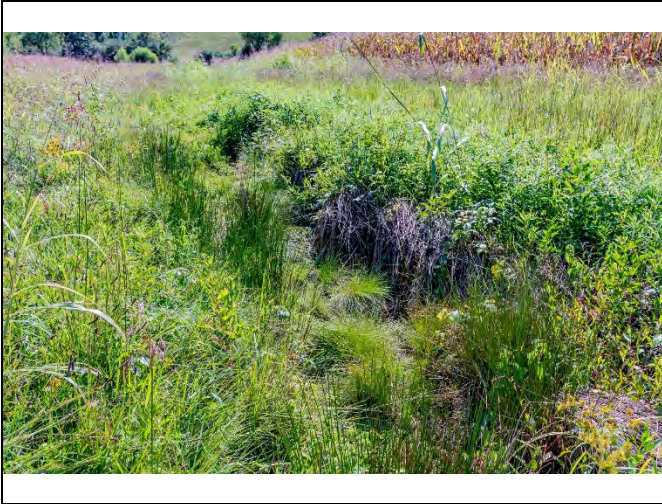
Upper Reach R1, adjacent field drain into left bank (Aug 2017)

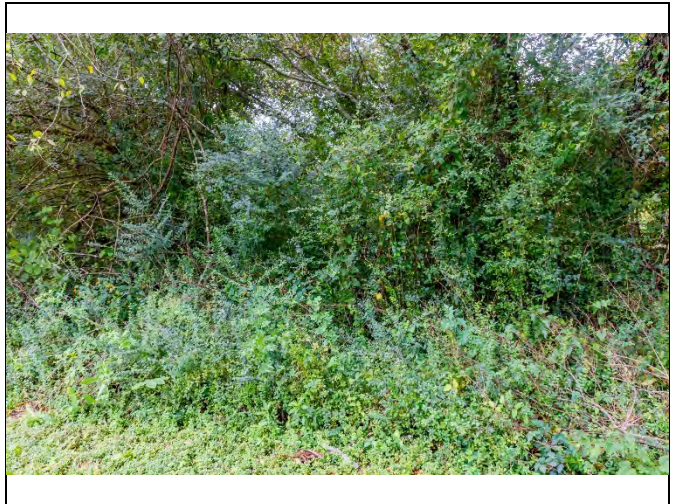
Lower Reach R1, dense privet along stream bank (Aug 2017)

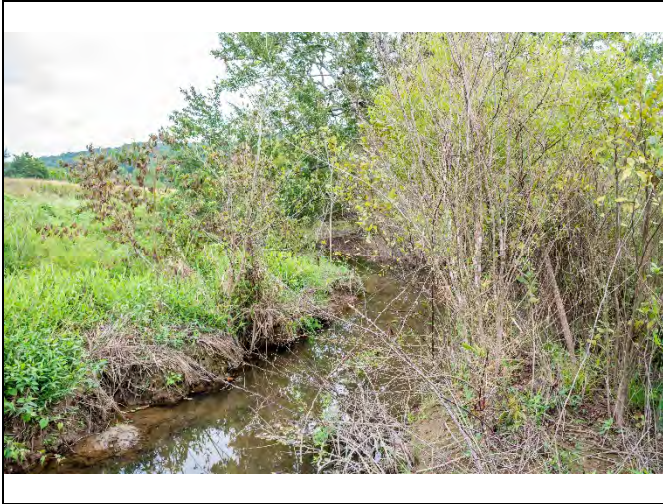
Lower Reach R1, upstream (Aug 2017)

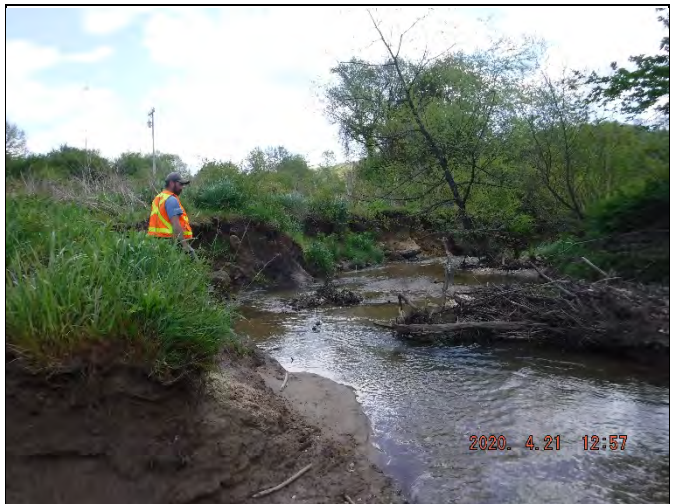
Lower Reach R1, downstream (4/21/20)

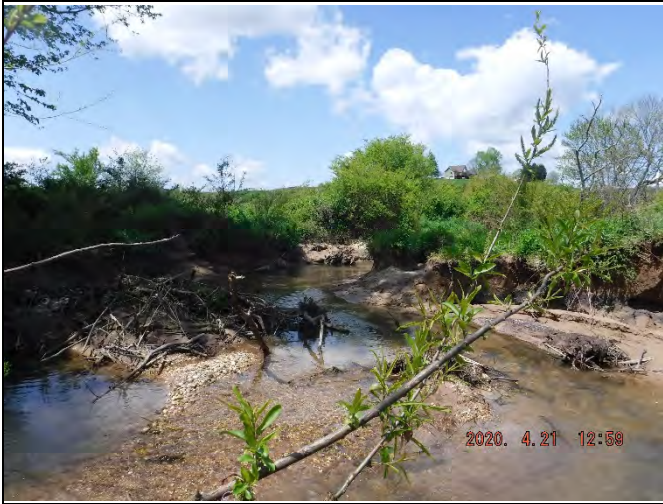
Lower Reach R1, upstream above confluence with R2/R3 (4/21/20)

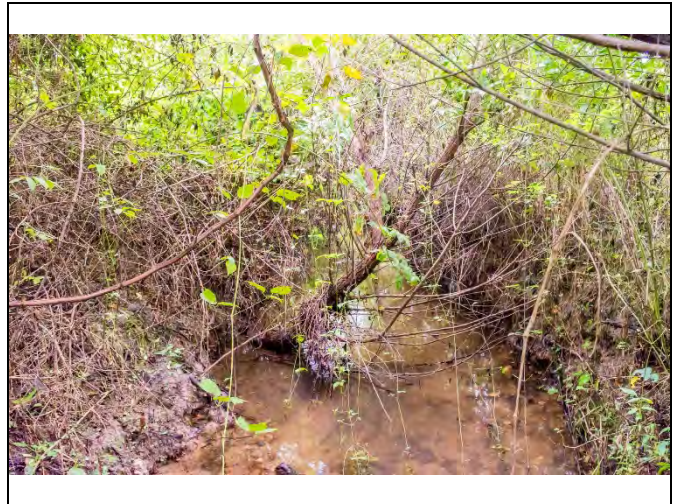
Upper Reach R2, upstream (Aug 2017)

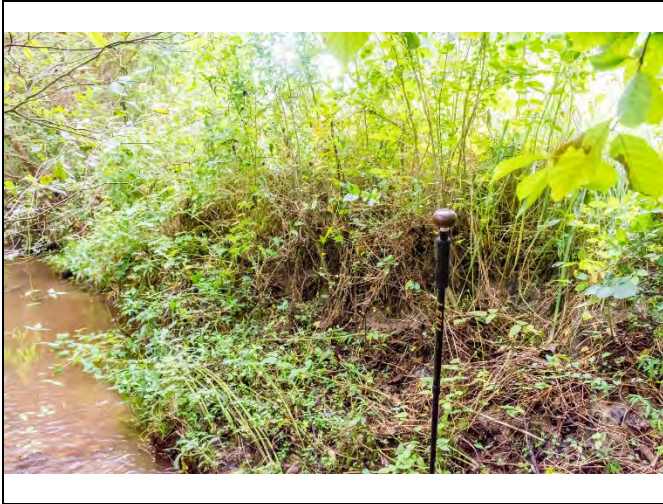
Upper Reach R2, right bank (Aug 2017)

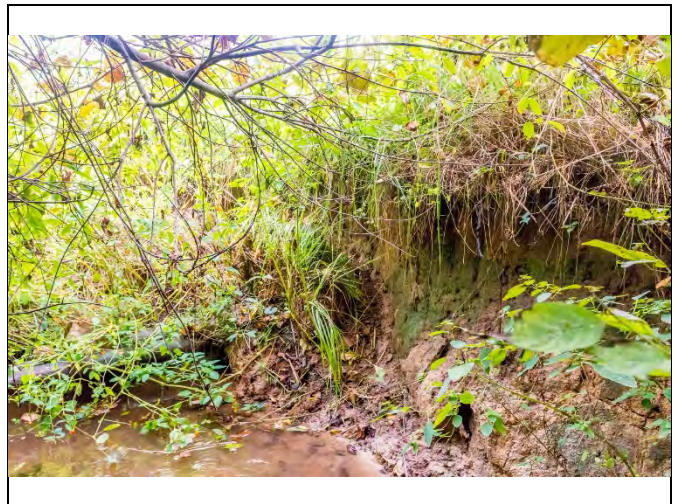
Lower Reach R2, right bank (Aug 2017)

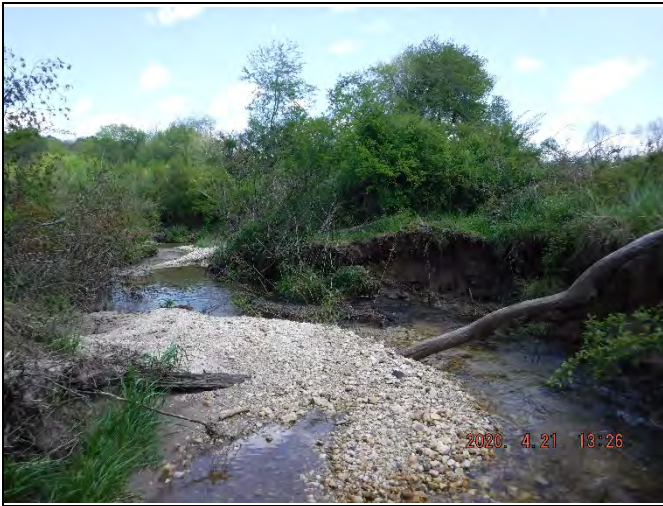
Lower Reach R2, downstream (4/21/20)

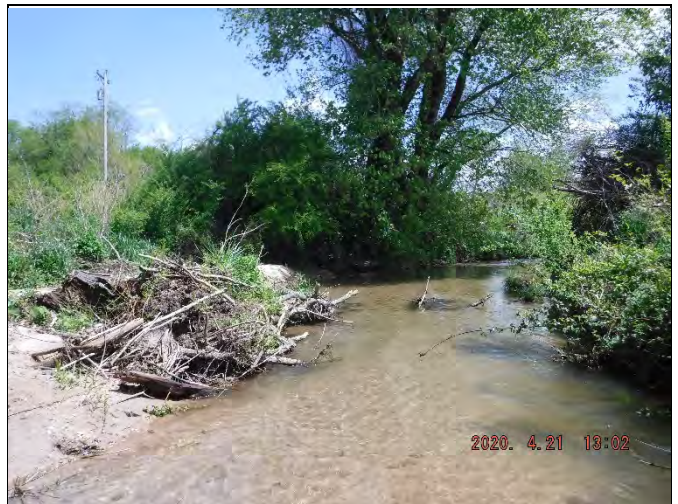
Reach R3, downstream (4/21/20)

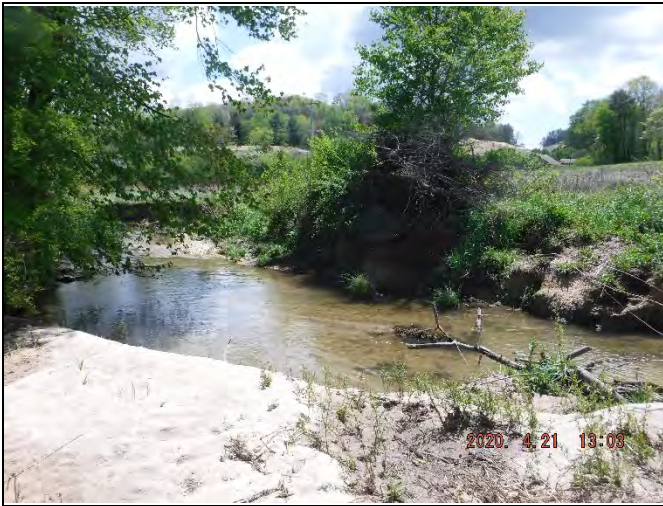
Reach R3, downstream (4/21/20)

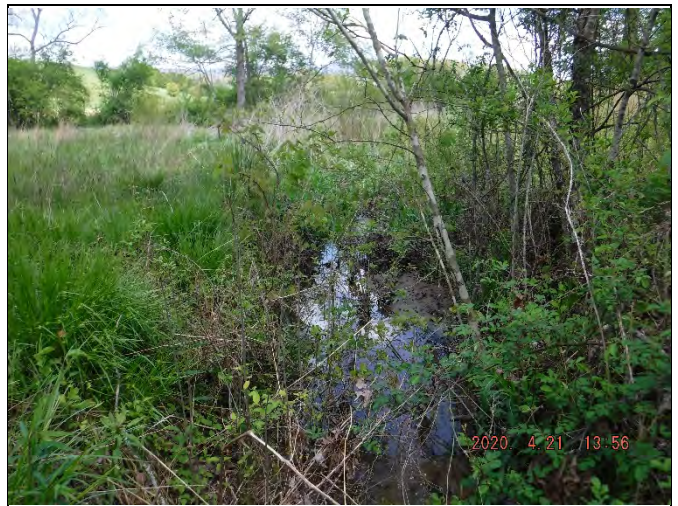
Reach UT1, downstream (4/21/20)

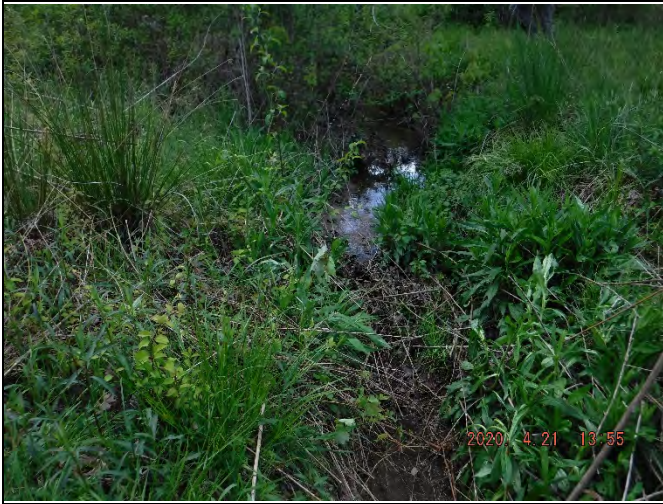
Reach UT1, upstream (4/21/20)

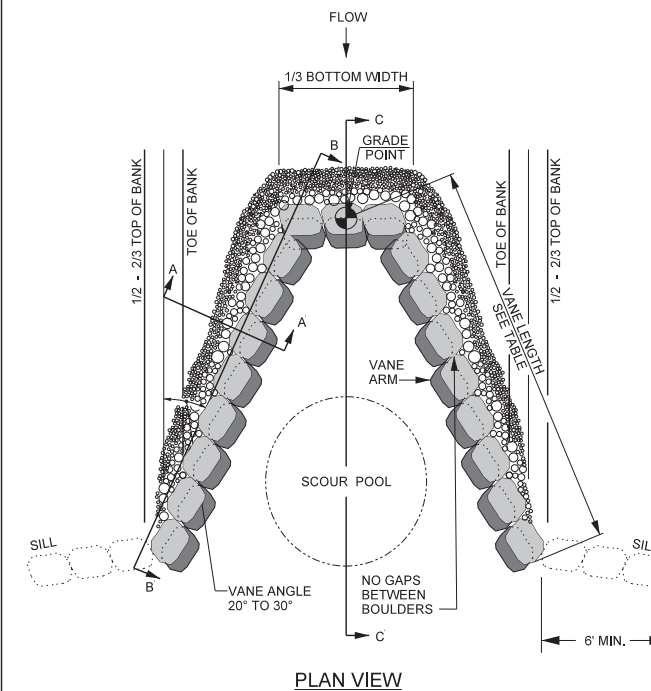
ROCK CROSS VANE

REACH	VANE LENGTH	BOULDER SIZE
REACH 1	15'	2'x3'x4'
REACH 2	15'	2'x3'x4'
REACH 3	21'	2'x3'x4'

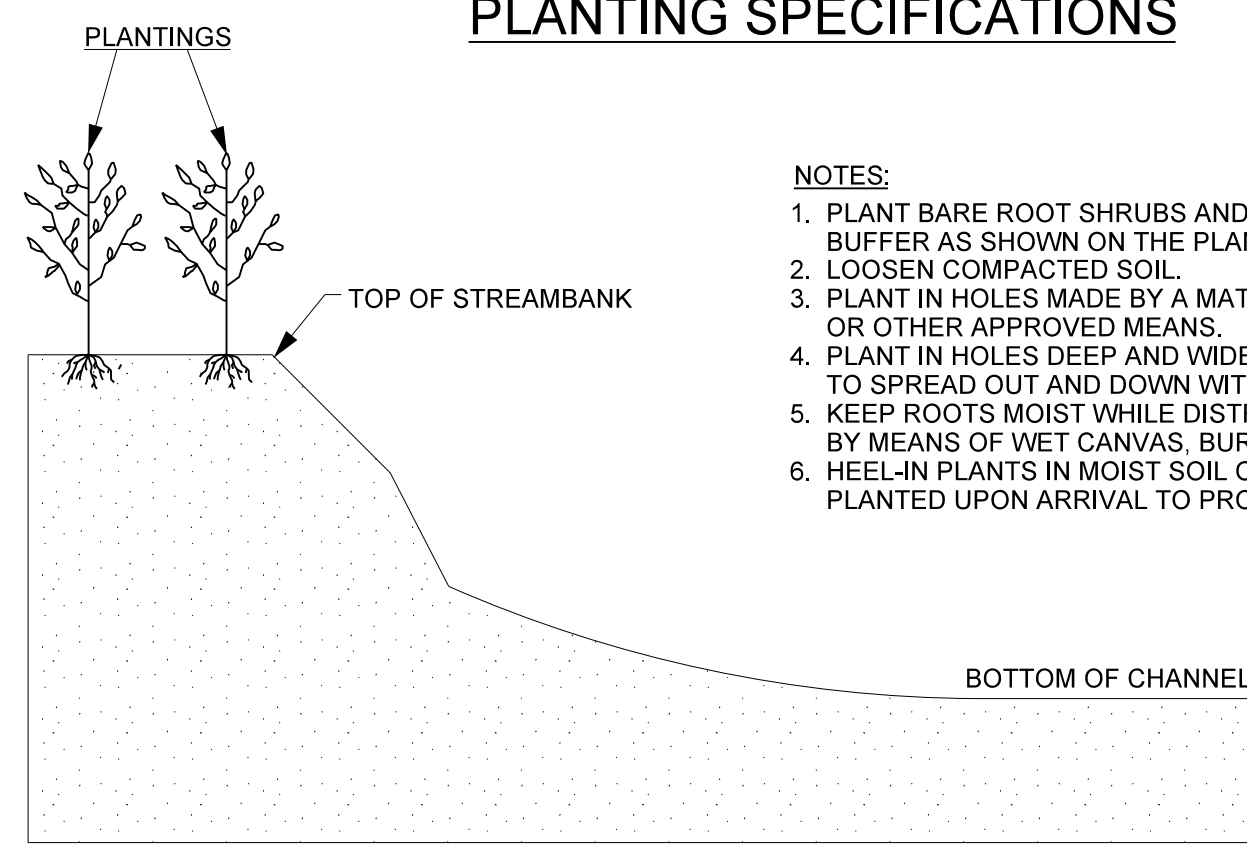
CROSS SECTION VIEW OF BARE ROOT PLANTING

1. PLANT BARE ROOT SHRUBS AND TREES TO THE WIDTH OF THE BUFFER AS SHOWN ON THE PLANS.
2. LOOSEN COMPACTED SOIL.
3. PLANT IN HOLES MADE BY A MATTOCK, DIBBLE, PLANTING BAR, OR OTHER APPROVED MEANS.
4. PLANT IN HOLES DEEP AND WIDE ENOUGH TO ALLOW THE ROOTS TO SPREAD OUT AND DOWN WITHOUT J-ROOTING.
5. KEEP ROOTS MOIST WHILE DISTRIBUTING OR WAITING TO PLANT BY MEANS OF WET CANVAS, BURLAP, OR STRAW.
6. HEEL-IN PLANTS IN MOIST SOIL OR SAWDUST IF NOT PROMPTLY PLANTED UPON ARRIVAL TO PROJECT SITE.
