Baseline Monitoring Report

BOSEMAN BUFFER MITIGATION SITE

Edgecombe County, NC

DMS ID No. 100119

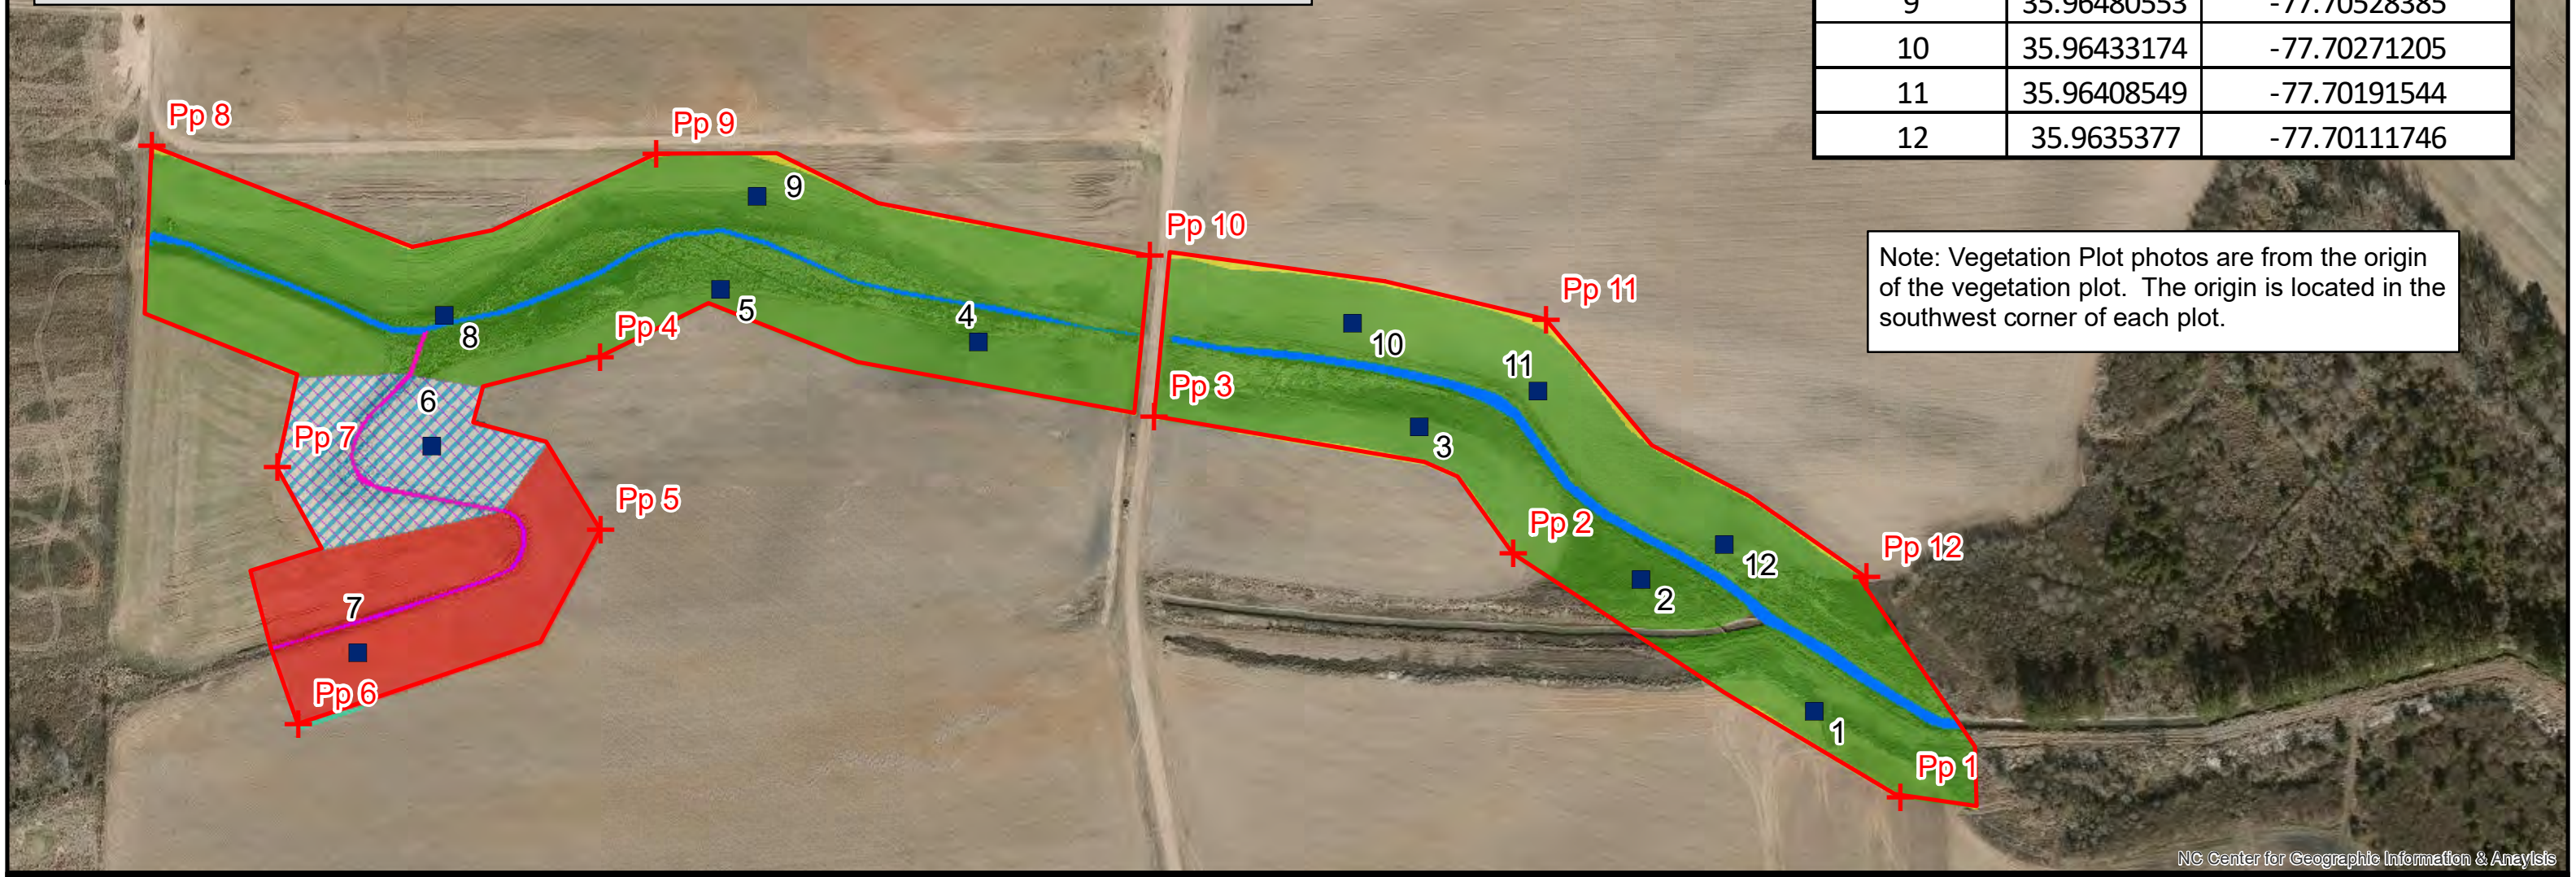
Figure 3

Monitoring Plan View Map
Boseman Buffer Mitigation Site
Baseline Monitoring Report (MY0)
Tar-Pamlico 03020101
Edgecombe County, North Carolina
May 2020
 2017 Aerial from NCOneMap

(Appendix 1: Figure 3). All photo points were located by survey and georeferenced for map production to provide a consistent means for photo replication annually and in the event a plot or photo location must be reestablished during the monitoring period. Photo orientation (direction and bearing) were recorded as well as approximate vertical position for consistency in photo logging.

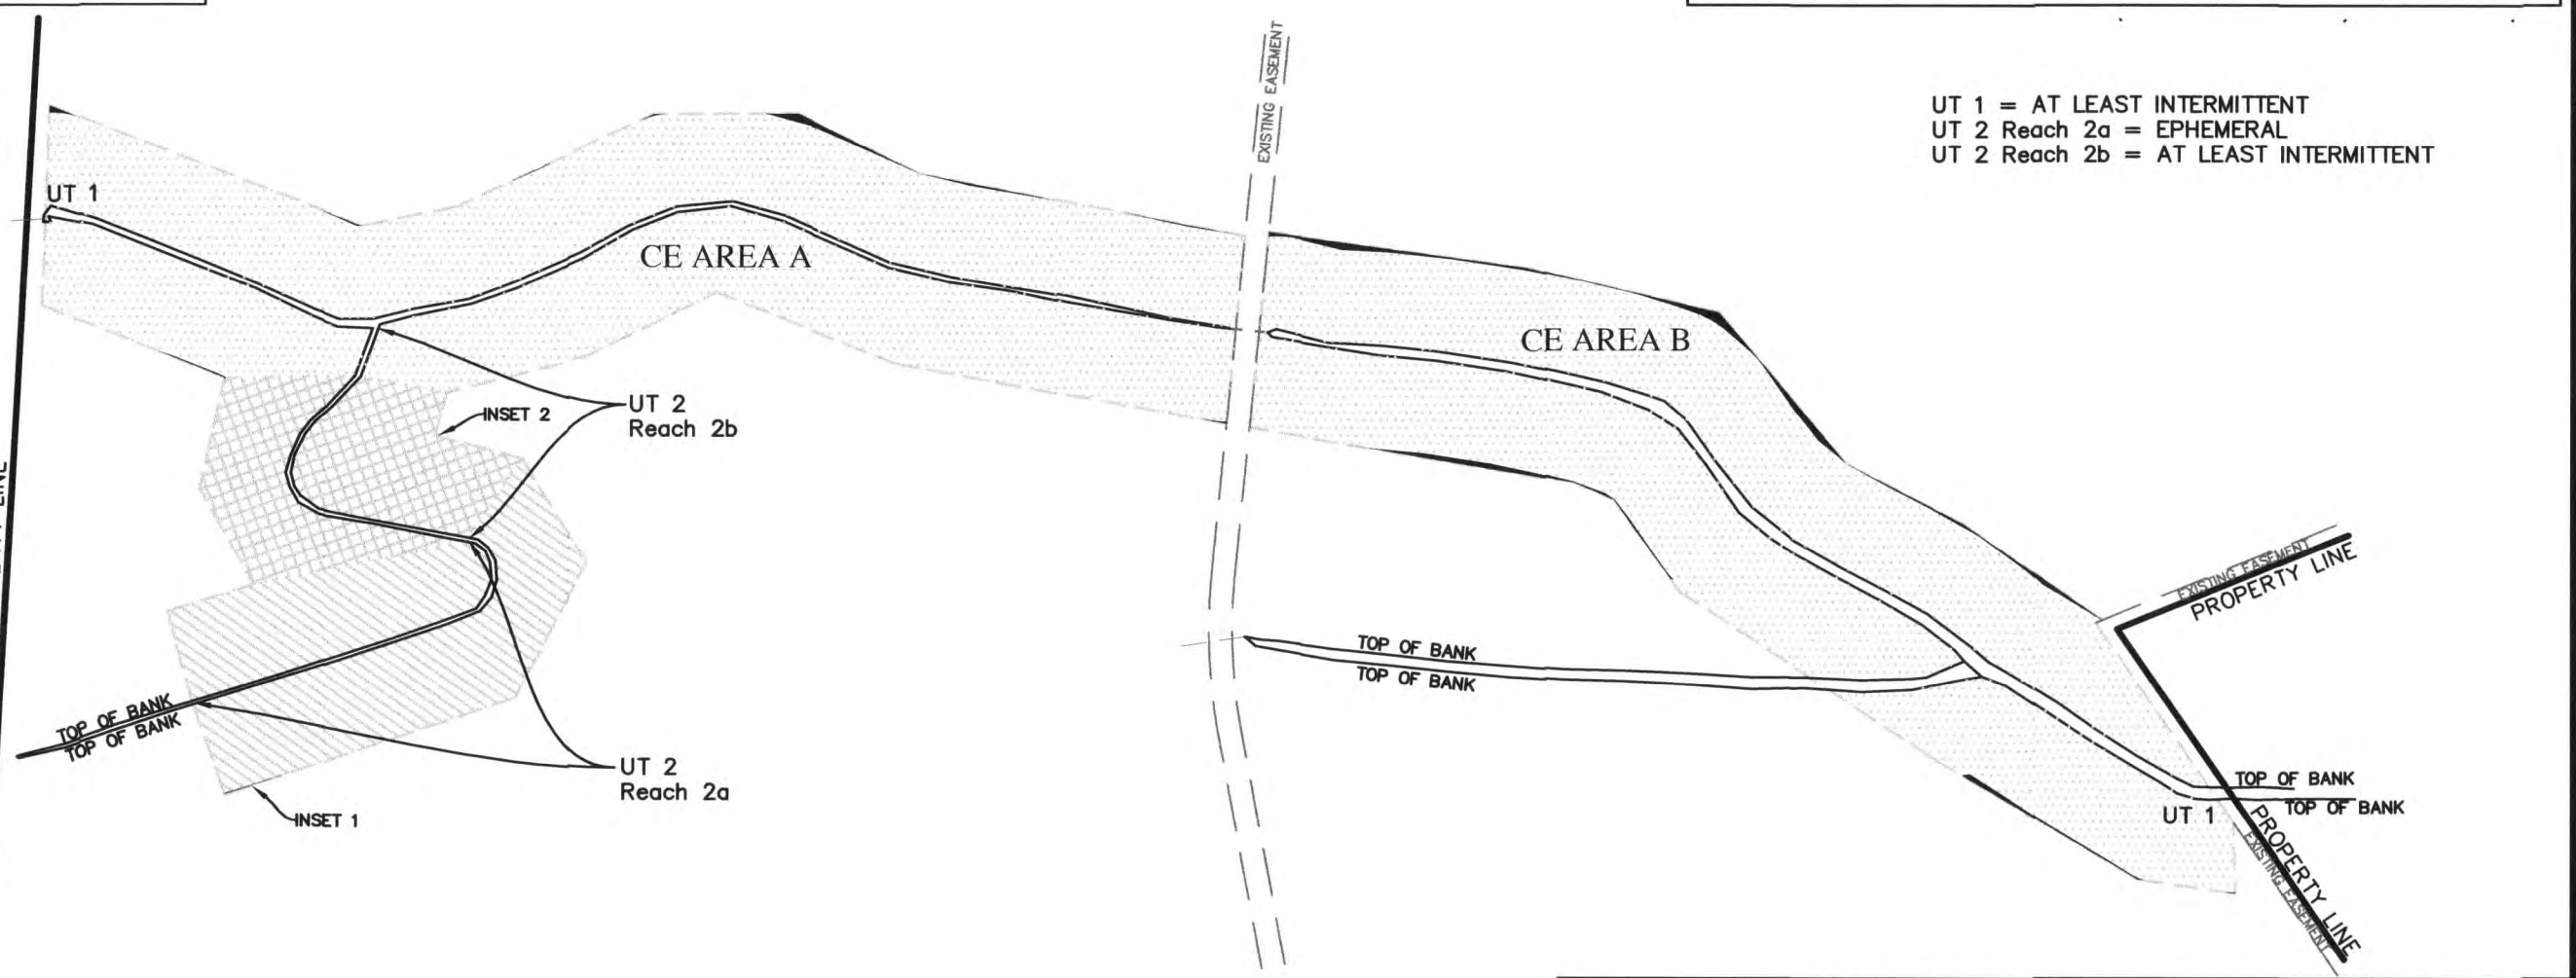
AS-BUILT SURVEY

UT 1 = AT LEAST INTERMITTENT
 UT 2 Reach 2a = EPHEMERAL
 UT 2 Reach 2b = AT LEAST INTERMITTENT
