Baseline Monitoring Report
FINAL

Bowl Basin Wetland Restoration Site
Onslow County, North Carolina
DMS Contract 005012
DMS Project Number 95721

Monitoring Data Collected: May 2015

Date Submitted: July 2015

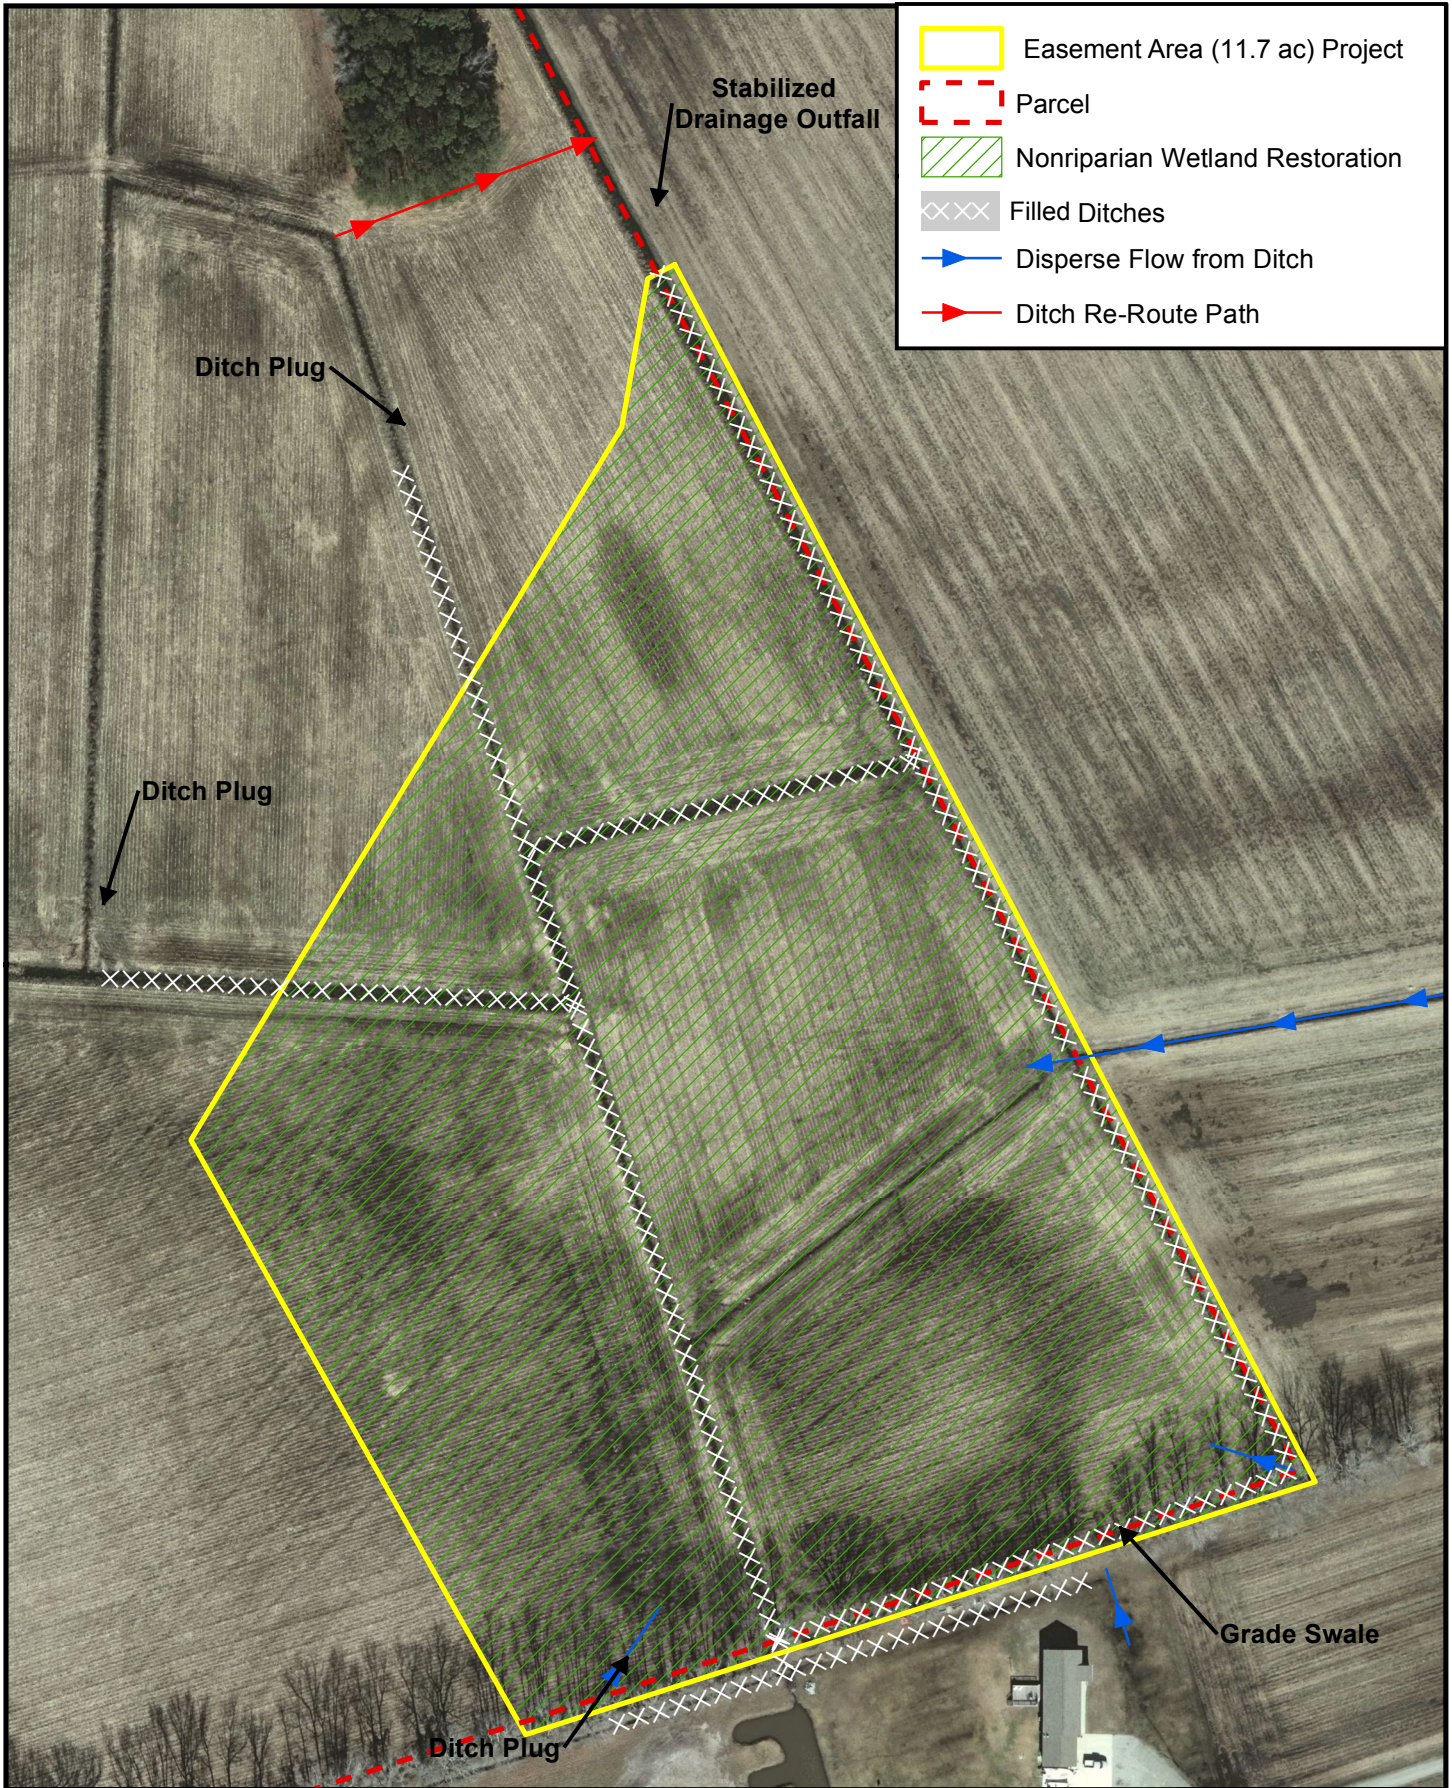
FIGURE 2: PROJECT SITE PROPOSED MITIGATION PLAN VIEW
BOWL BASIN WETLAND RESTORATION SITE
ONslow COUNTY, NC

The mitigation work included approximately 11.7 acres of non-riparian wetland restoration for a total of 11.7 Wetland Mitigation Units as shown in Figure 2 and described in Table 1 in Appendix A. Planting occurred within the 11.7-acre conservation easement. The target natural community consists of Hardwood Flats Community (NCWAM, v. 4.1 2010).

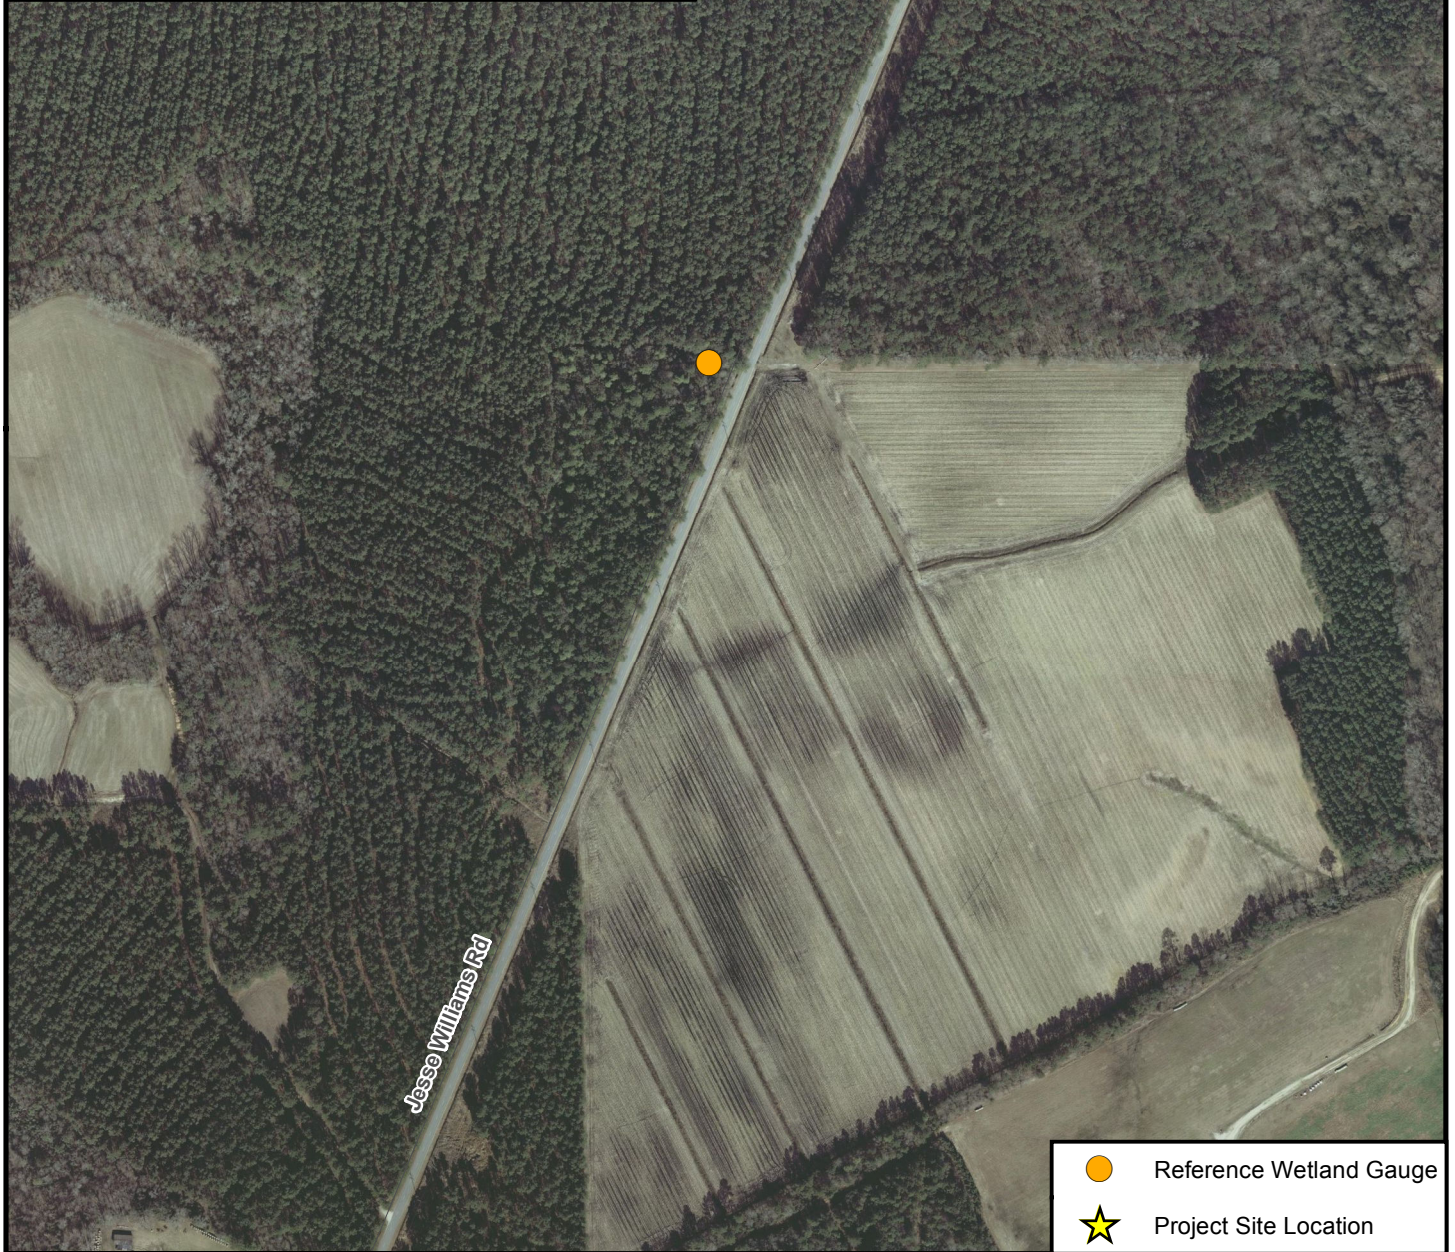
**FIGURE 4: PROJECT SITE REFERENCE WETLAND
BOWL BASIN WETLAND RESTORATION SITE
ONSWLOW COUNTY, NC**

A suitable reference wetland was found approximately 16 miles west of the BBWRS. The reference wetland is comprised of deciduous hardwoods over a shrub layer with broad-leaved evergreens and is consistent with the Hardwood Flats Community that will be the primary wetland type at the project site. A groundwater monitoring well has been installed to document the reference wetland hydrology during the course of monitoring.

Eight groundwater monitoring gauges were set up and assessed for the baseline monitoring to evaluate the attainment of jurisdictional wetland hydrology. Verification of wetland hydrology will be determined by automatic recording well data collected within the project area and reference wetland. The wetland gauges will be checked and/or downloaded every other month. Daily data will be collected from the automatic gauges over the 7-year monitoring period following wetland construction. The nearby reference wetland will also be monitored using the same procedures for comparative analysis (See Figure 4 in Appendix A).
