**Bowl Basin Restoration Site
Monitoring Report MY04
DMS Project # 95721
DMS Contract # 005012**

**Onslow County, NC
CU# 03020106
DWR# 2013-0864
SAW# 2013-00393**

**Construction Completed: February 2015
Data Collection: 2018
Submitted: December 2018**

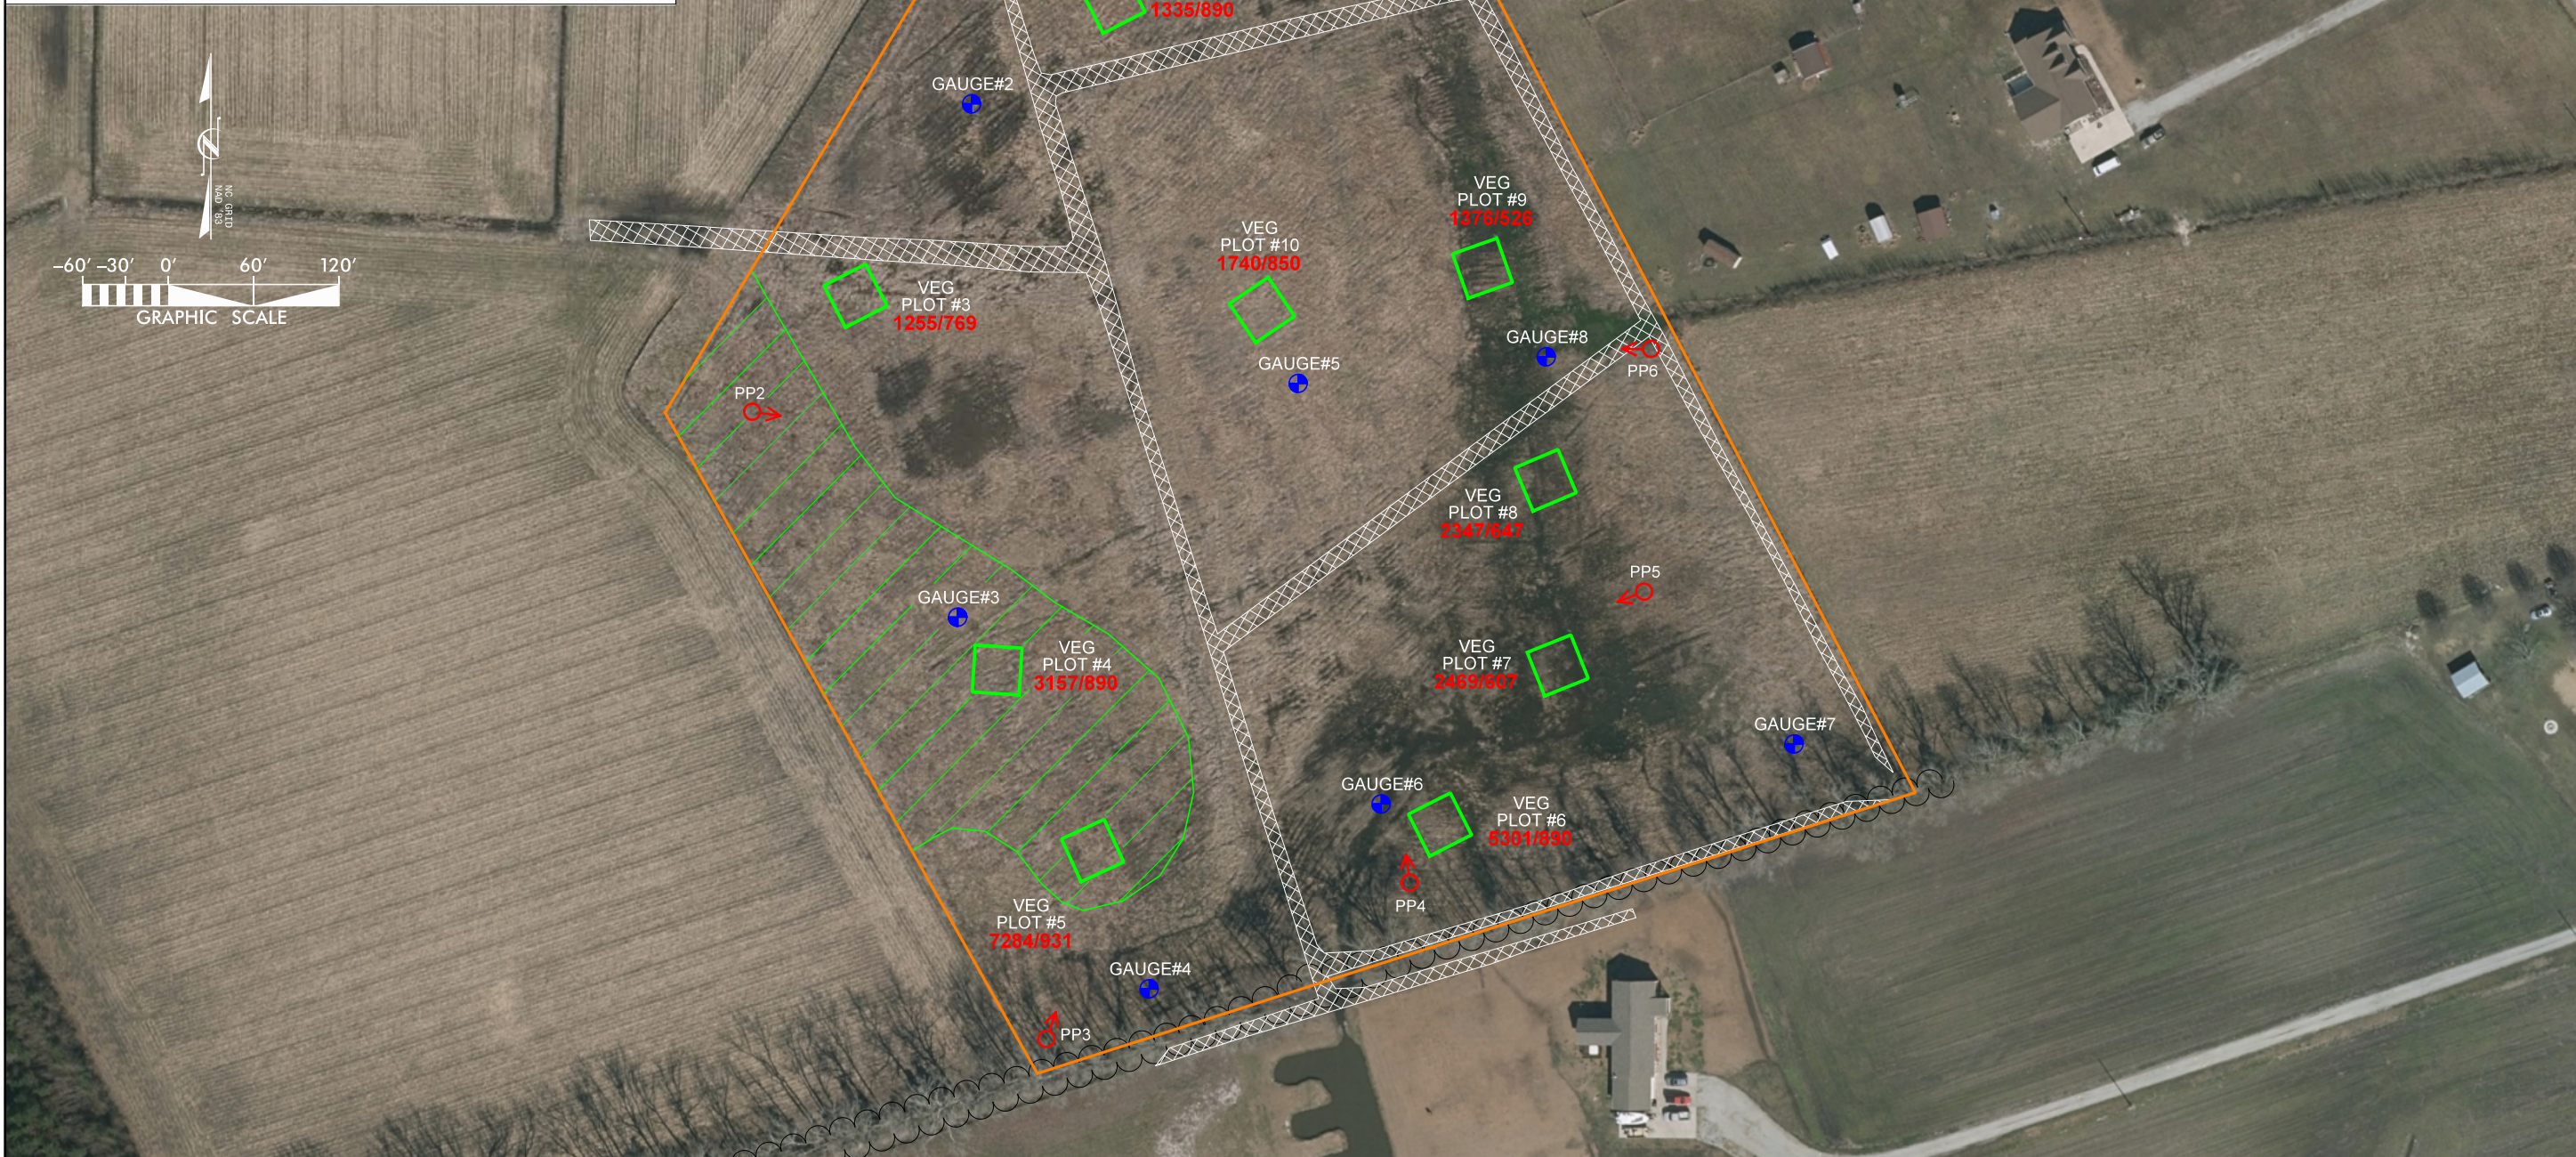
SHEET 1 OF 1
FIGURE 3

- VEG PLOT ACHIEVING DENSITY CRITERION*
- VEG PLOT BELOW DENSITY CRITERION*
- VEG PLOT TOTAL / PLANTED STEM DENSITY* ----- **3072/773**
- WETLAND GAUGE ACHIEVING HYDROLOGIC CRITERION +
- WETLAND GAUGE BELOW HYDROLOGIC CRITERION +
- PHOTO POINT (PP) ⊙
- FILLED DITCHES
- CONSERVATION EASEMENT =
- NONRIPARIAN WETLAND RESTORATION = 11.7 ACRES
- SWEETGUM TREATMENT

CURRENT CONDITION PLAN VIEW

During 2018, an area of densely growing sweetgum was treated. In this area sweetgum trees that were between 4 and 10 feet tall were cut and sprayed with herbicide. See Appendix B for more information.

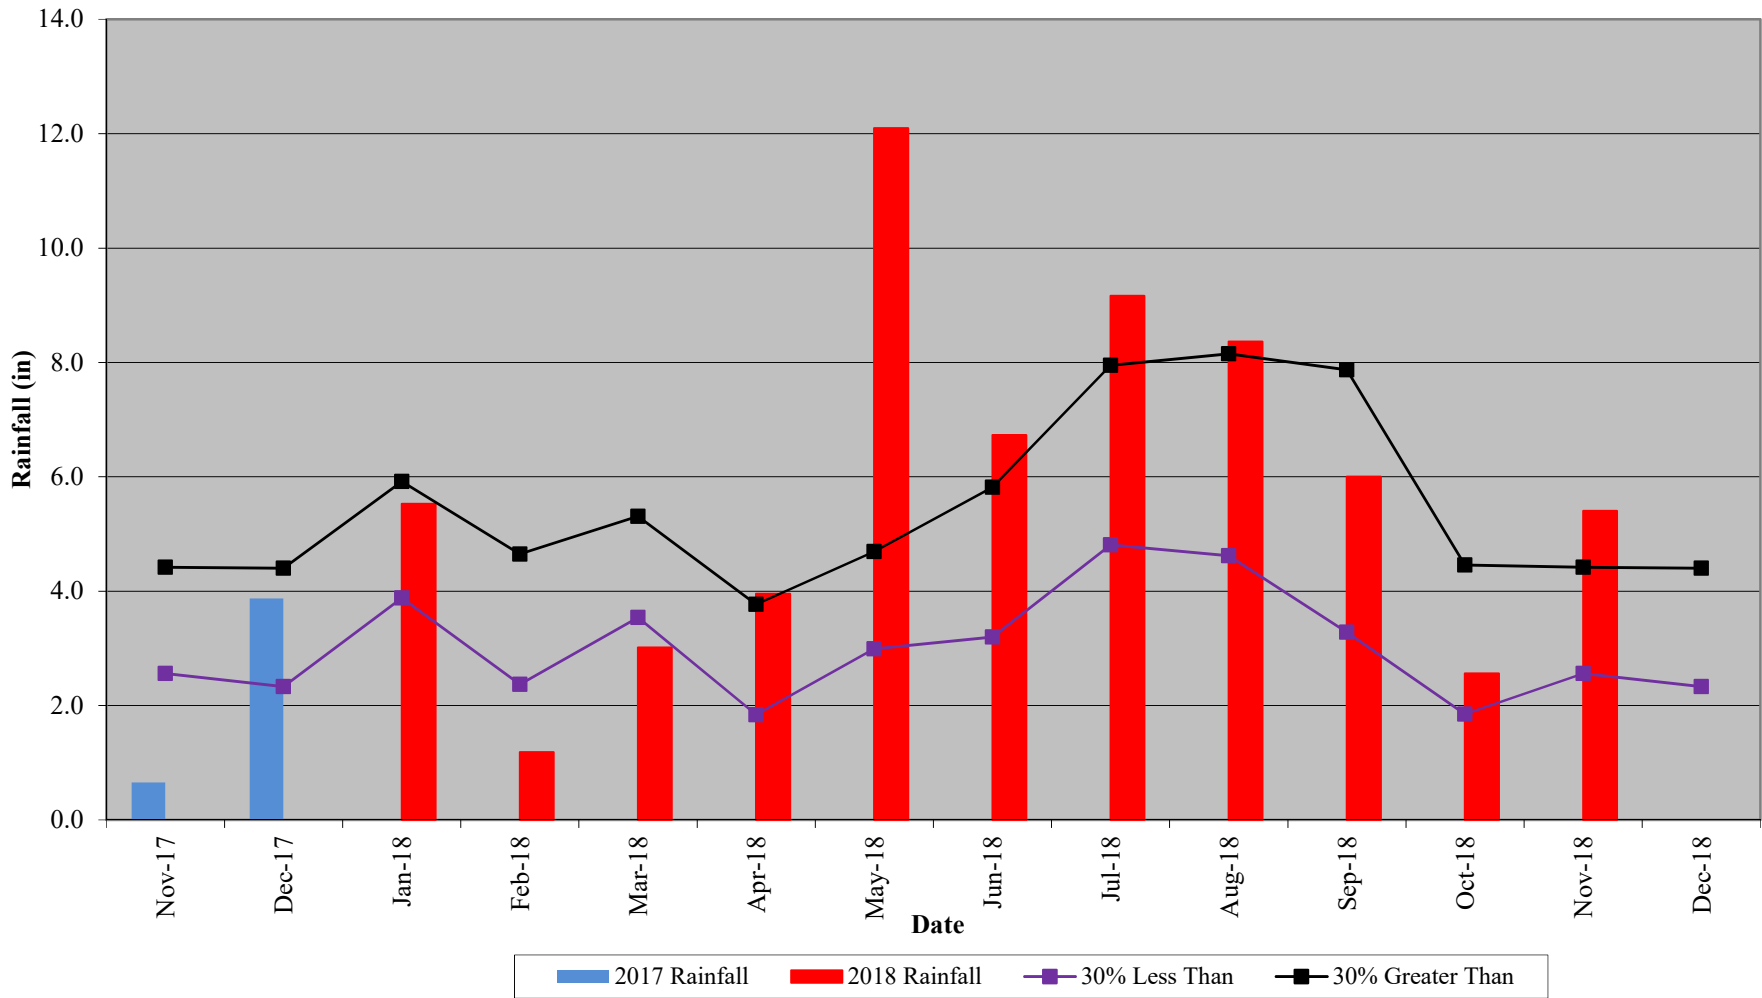
**Bowl Basin Wetland Restoration Site
30-70 Percentile Graph
WETS Station Name: Maysville, NC**

The daily rainfall data was obtained from a local weather station in Pumpkin Center, NC; provided by the NC State Climate Office. For the 2018 year, the months of April, May, June, July, August, and November experienced above average rainfall, while February and March recorded below average rainfall for the site. The months of January, September, and October experienced average rainfall. Overall, the area experienced above average rainfall during the 2018 growing season.

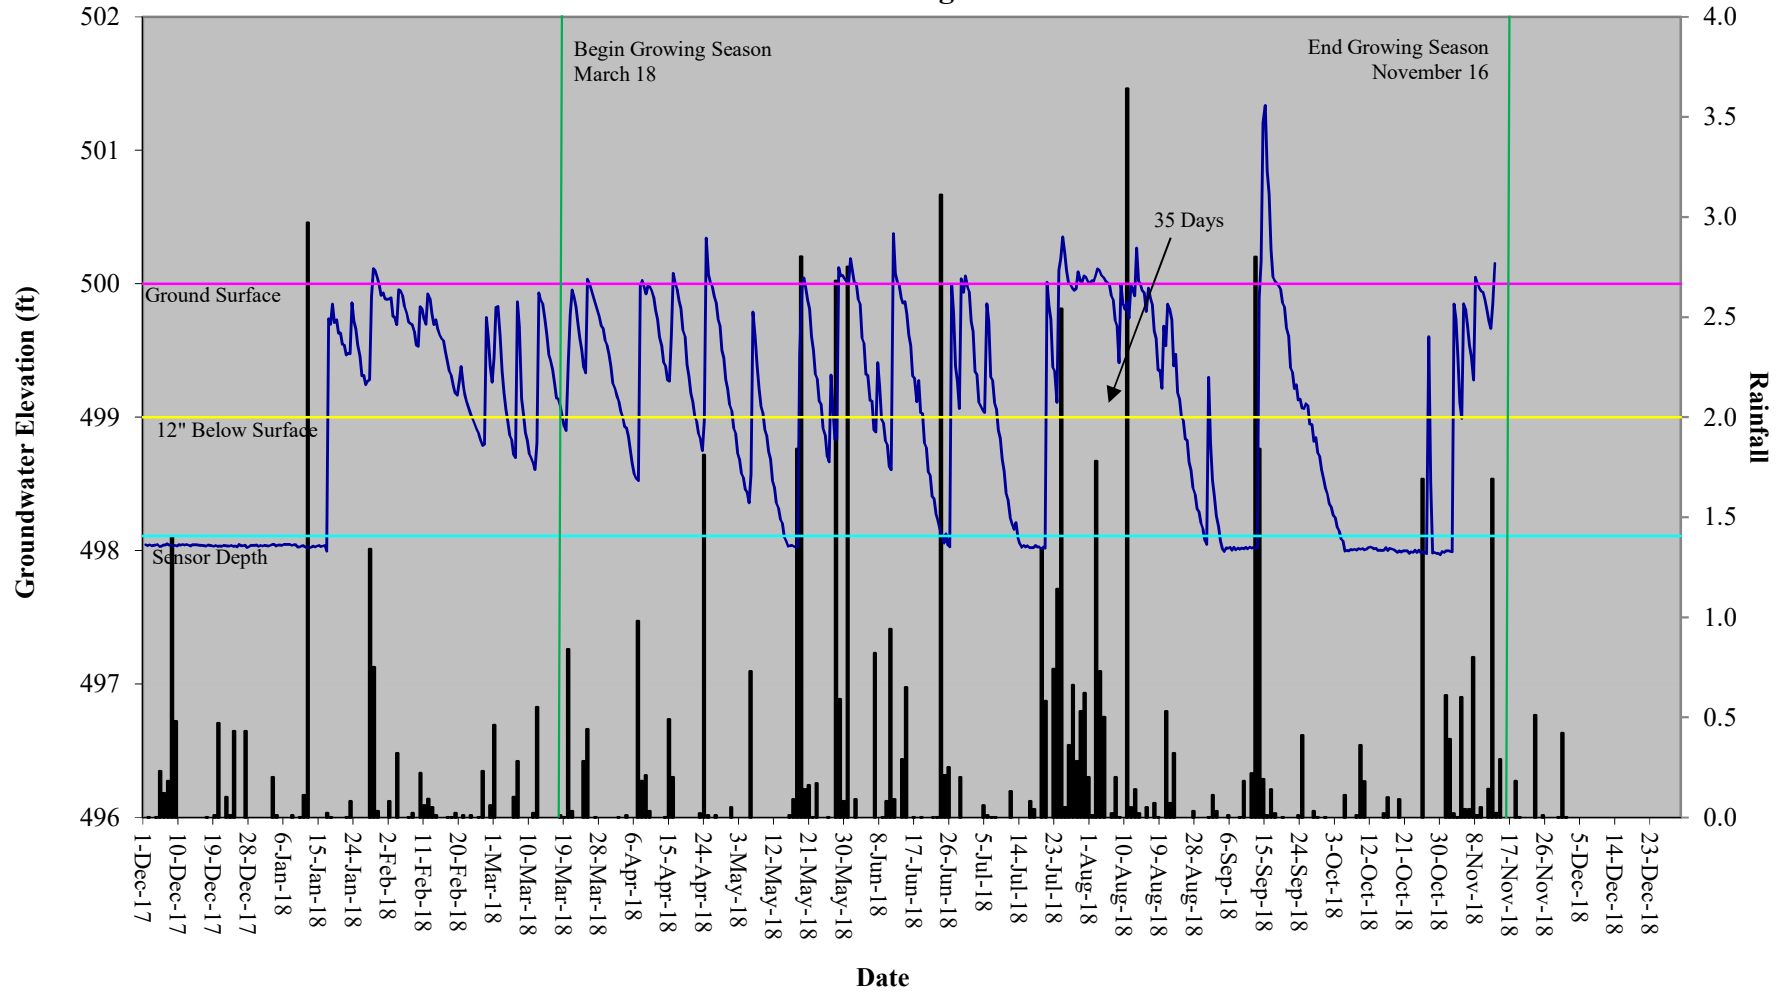
Bowl Basin Restoration Site Hydrograph Wetland Gauge 1

| Table 9. Wetland Hydrology Criteria Attainment Table | | | | | | | |
|---|---|---|---|---|---|---|---|
| Gauge 1 | Yes/37 (15.0%) | Yes/29 (11.7%) | Yes/24 (9.9%) | Yes/35 (14.4%) | | | |

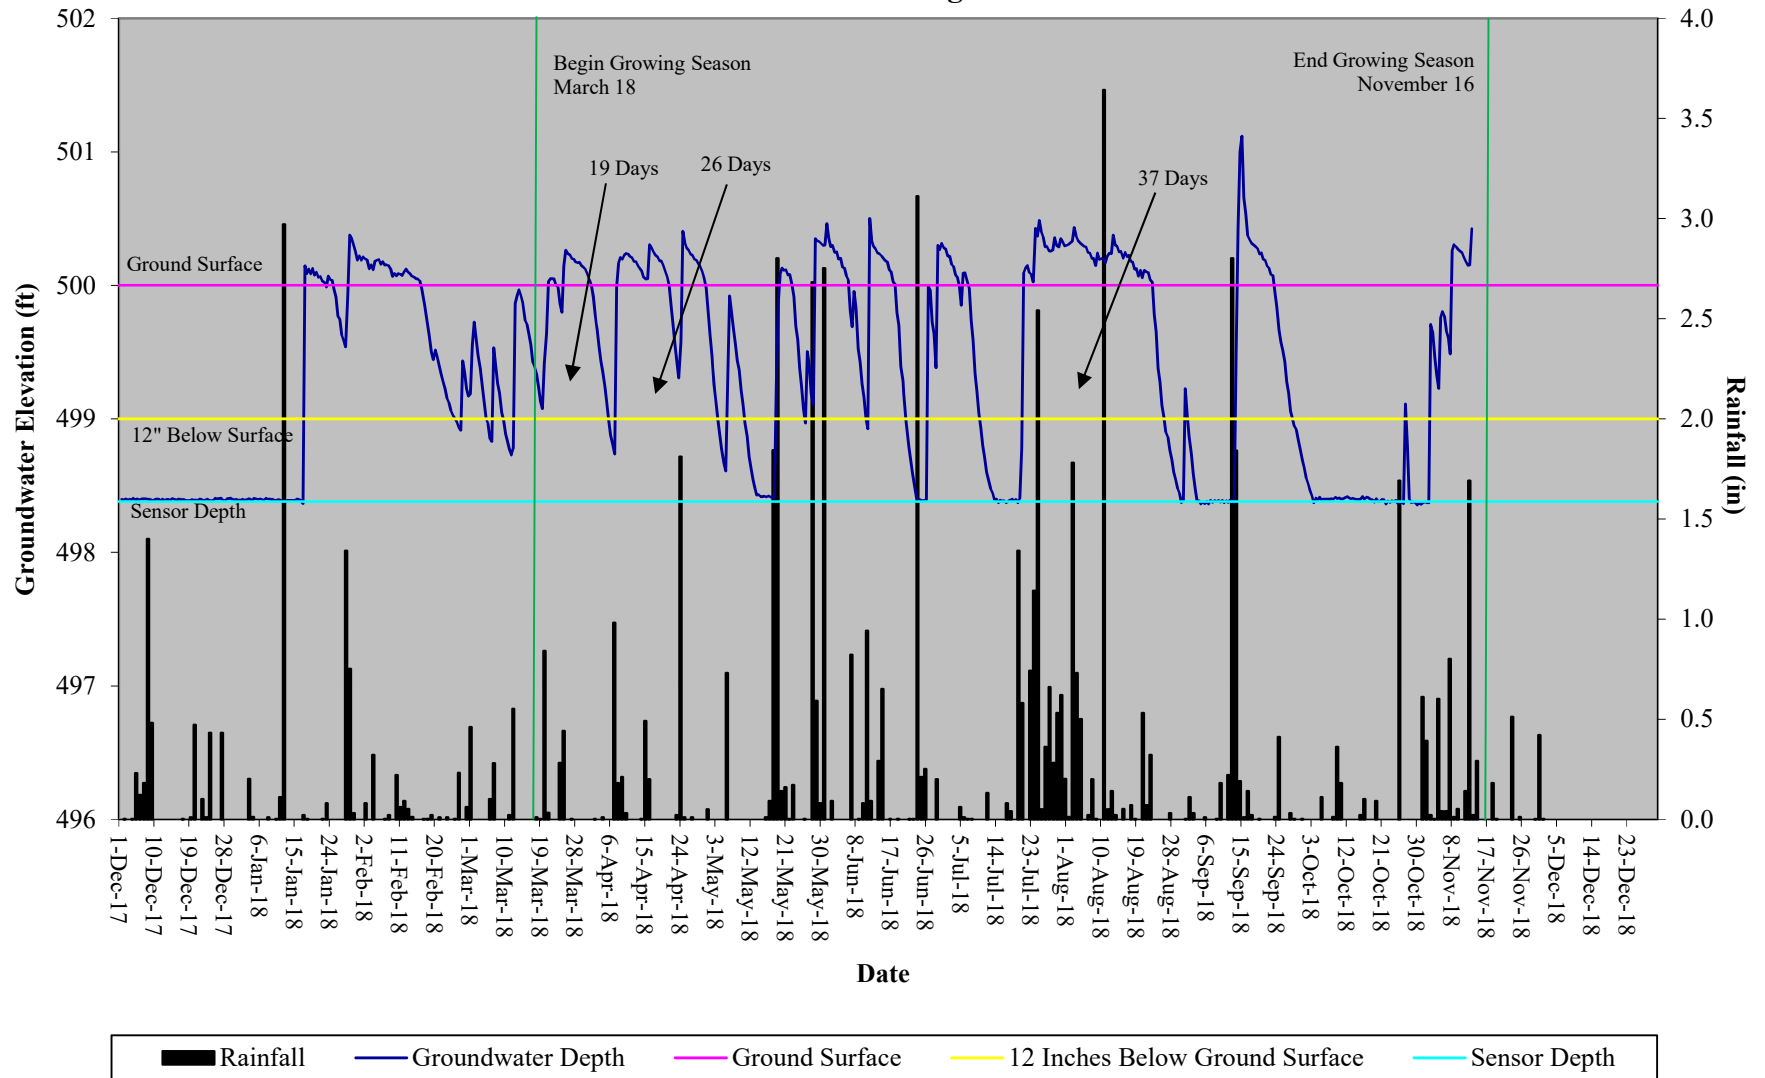
Bowl Basin Restoration Site Hydrograph Wetland Gauge 2

| Table 9. Wetland Hydrology Criteria Attainment Table | | | | | | | |
|---|---|---|---|---|---|---|---|
| Gauge 2 | Yes/69 (28.4%) | Yes/49 (20.0%) | Yes/32 (13.2%) | Yes/37 (15.2%) | | | |

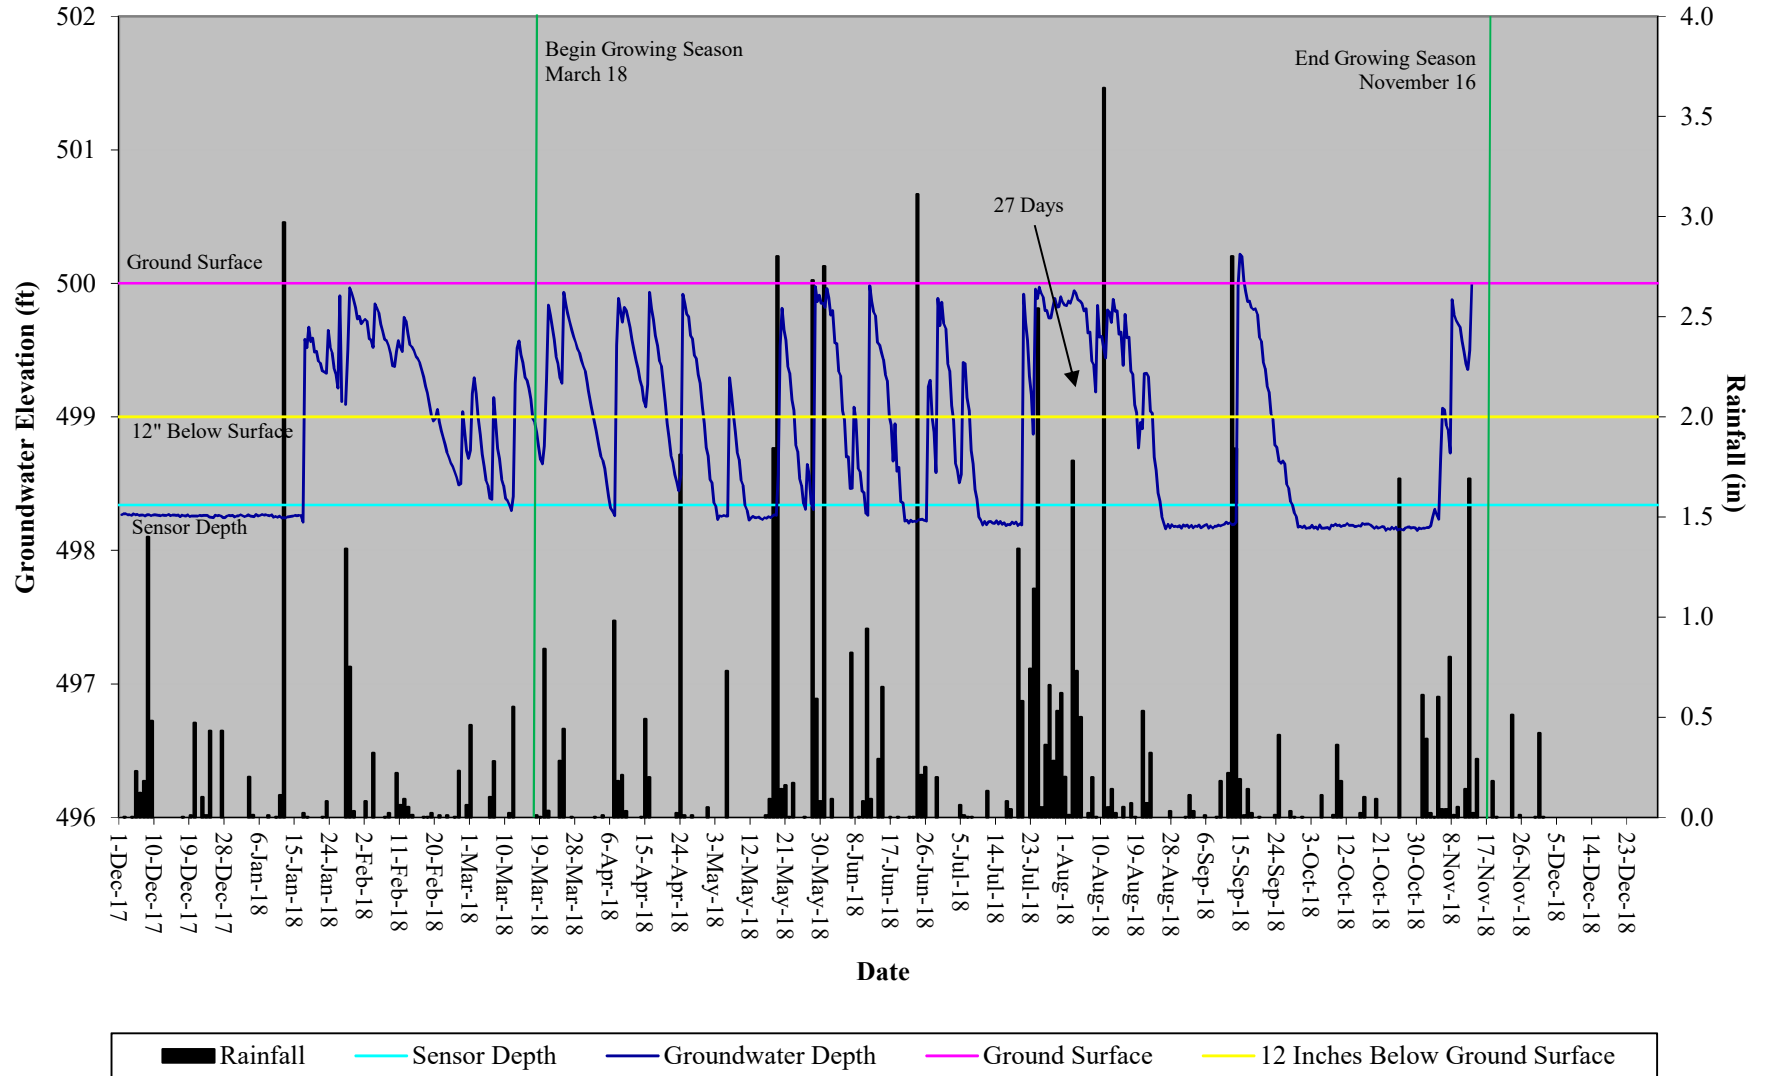
Bowl Basin Restoration Site Hydrograph Wetland Gauge 3

| Table 9. Wetland Hydrology Criteria Attainment Table | | | | | | | |
|---|---|---|---|---|---|---|---|
| Gauge 3 | No/20 (8.2%) | Yes/27 (11.1%) | No/13 (5.3%) | Yes/27 (11.1%) | | | |

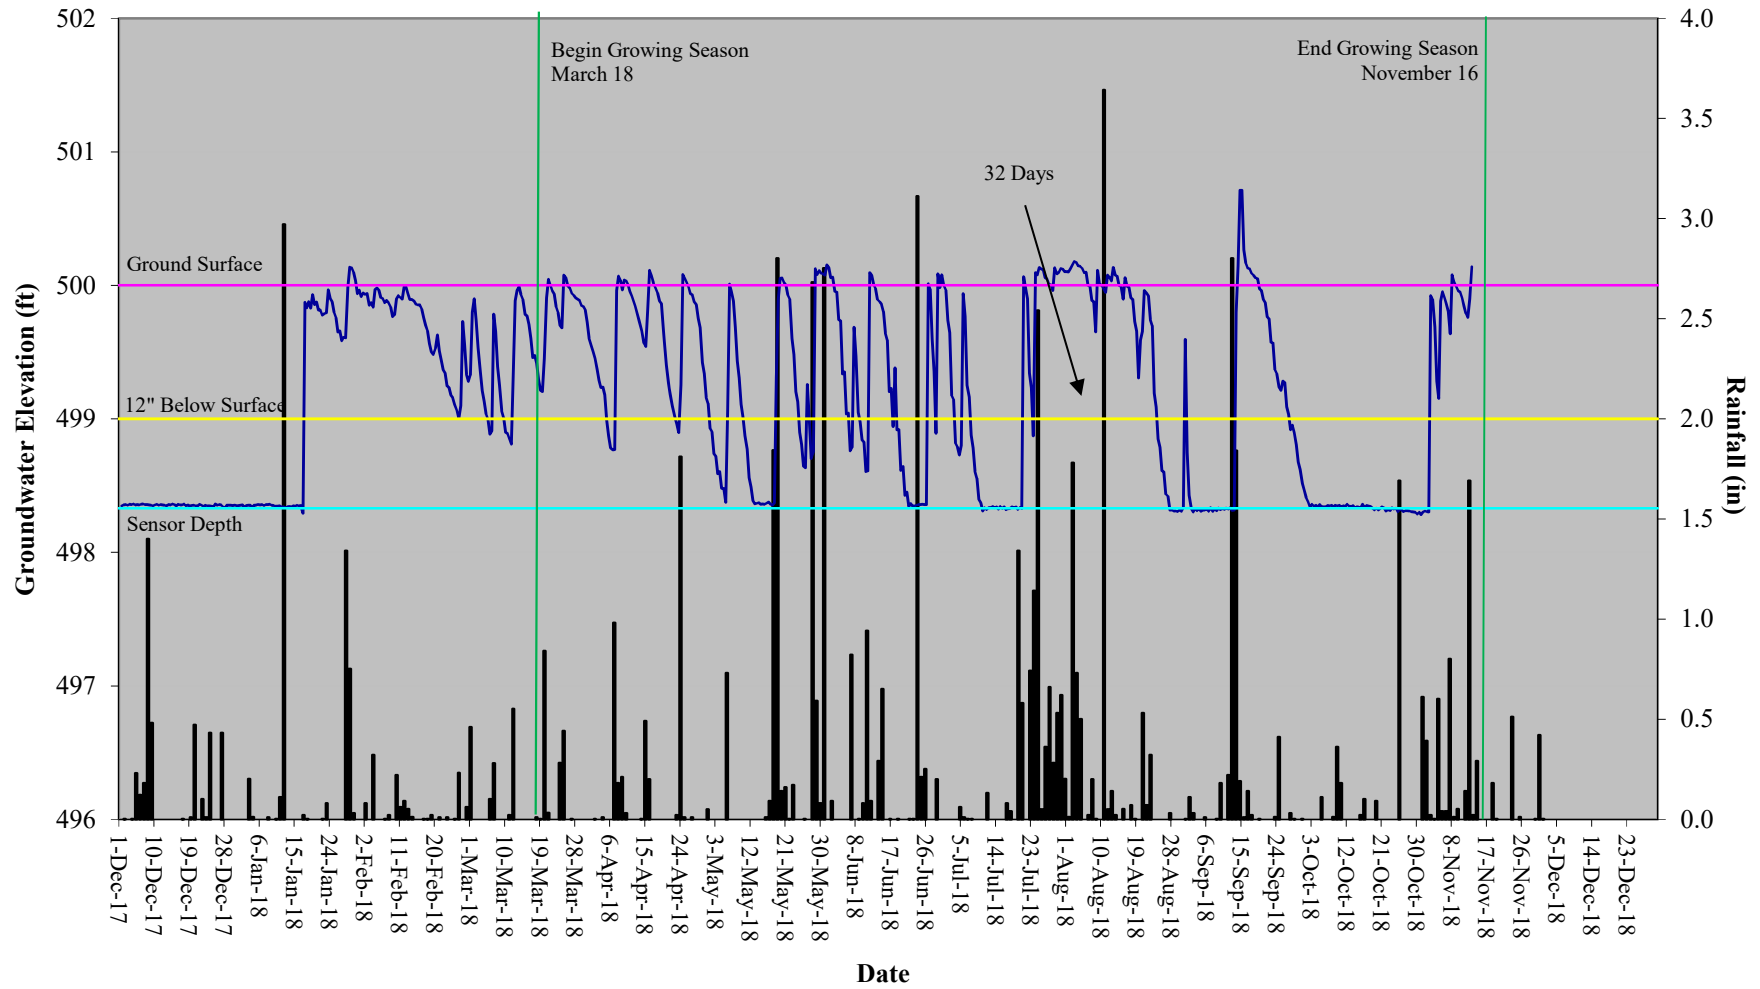
Bowl Basin Restoration Site Hydrograph Wetland Gauge 4

| Table 9. Wetland Hydrology Criteria Attainment Table | | | | | | | |
|---|---|---|---|---|---|---|---|
| Gauge 4 | Yes/29 (11.7%) | Yes/41 (16.9%) | Yes/26 (10.7%) | Yes/32 (13.2%) | | | |

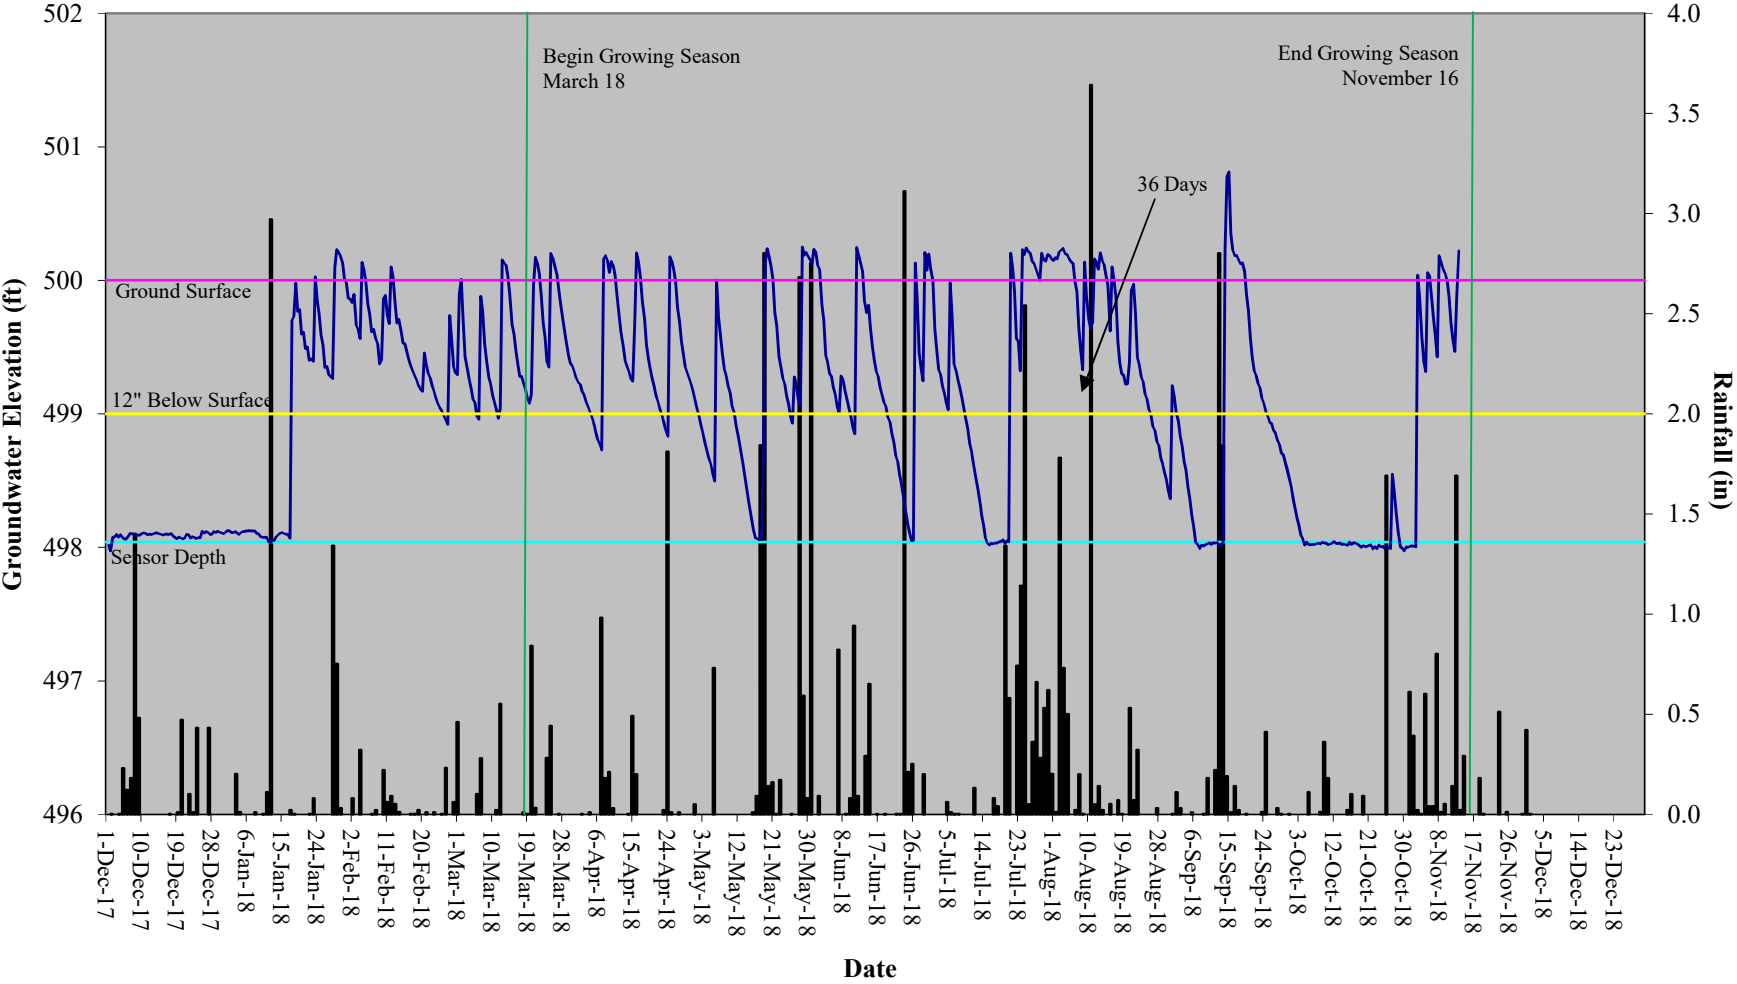
Bowl Basin Restoration Site Hydrograph Wetland Gauge 5

| Table 9. Wetland Hydrology Criteria Attainment Table | | | | | | | |
|---|---|---|---|---|---|---|---|
| Gauge 5 | Yes/24 (9.9%) | Yes/52 (21.2%) | Yes/50 (20.6%) | Yes/36 (14.8%) | | | |

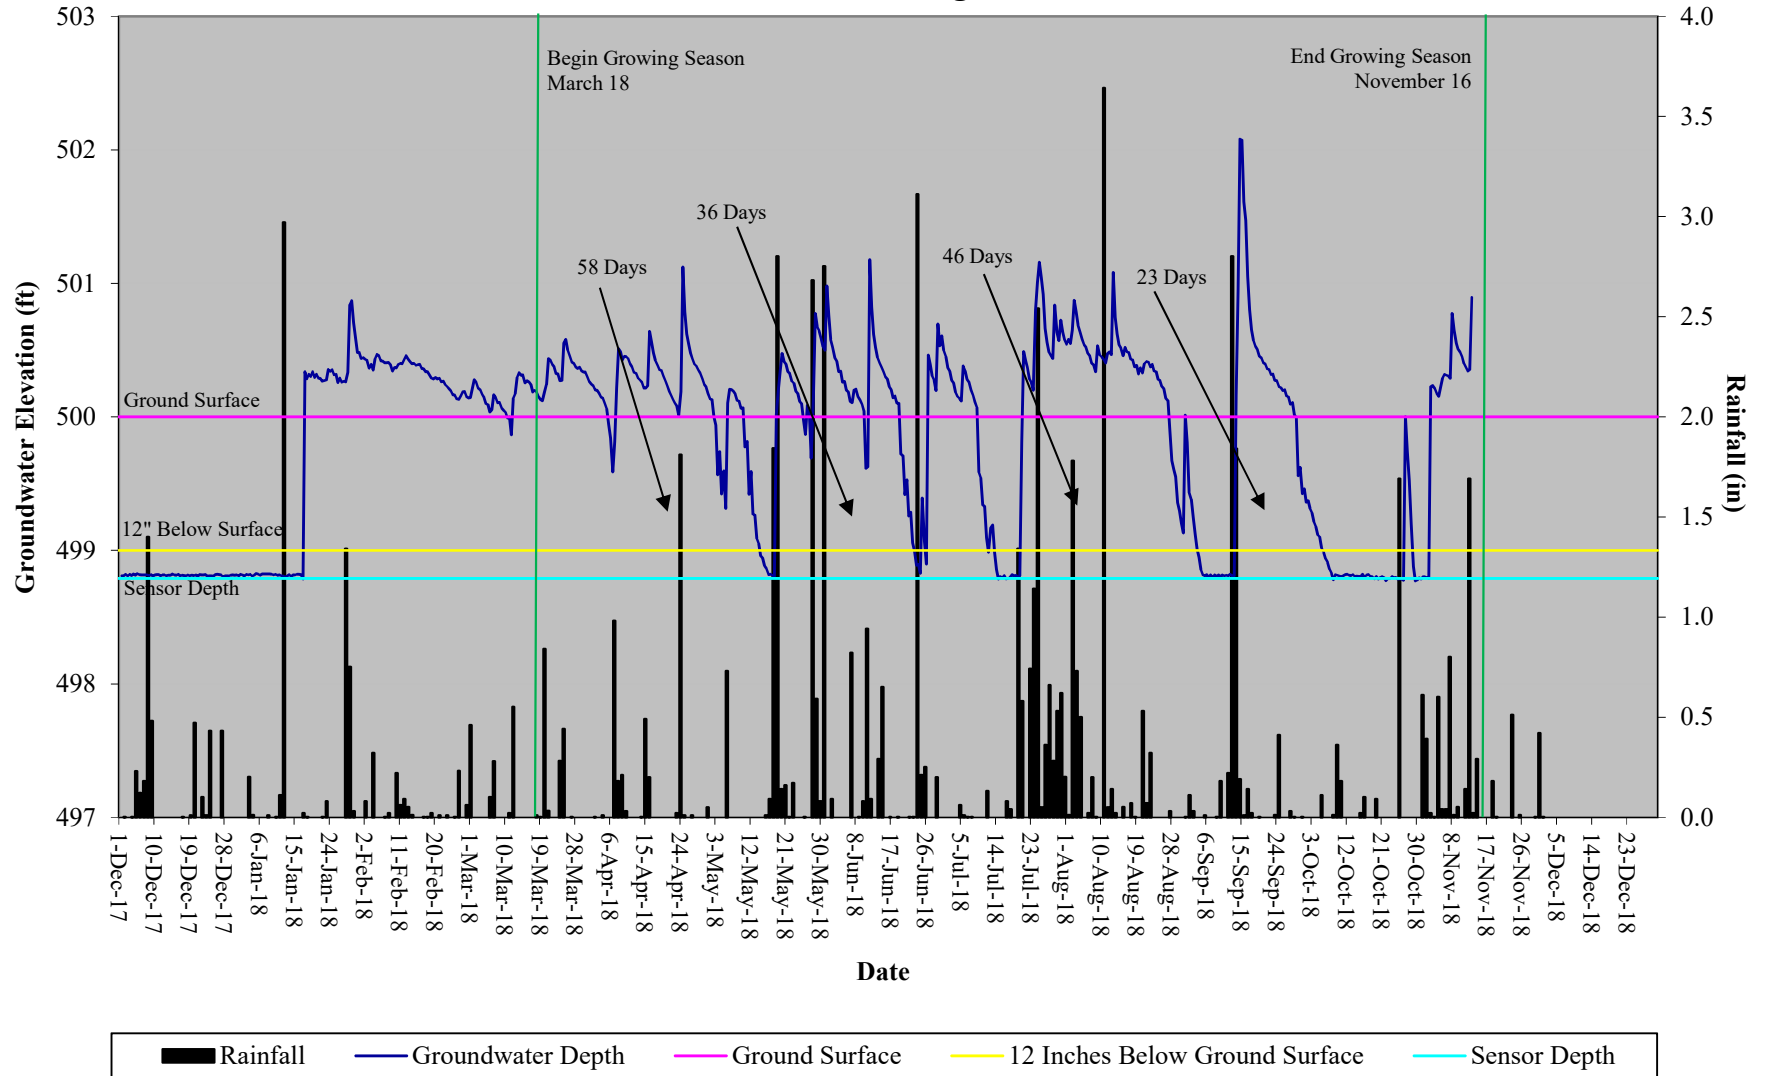
Bowl Basin Restoration Site Hydrograph Wetland Gauge 6

| Table 9. Wetland Hydrology Criteria Attainment Table | | | | | | | |
|---|---|---|---|---|---|---|---|
| Gauge 6 | Yes/79 (32.3%) | Yes/60 (24.5%) | Yes/62 (25.5%) | Yes/58 (23.9%) | | | |

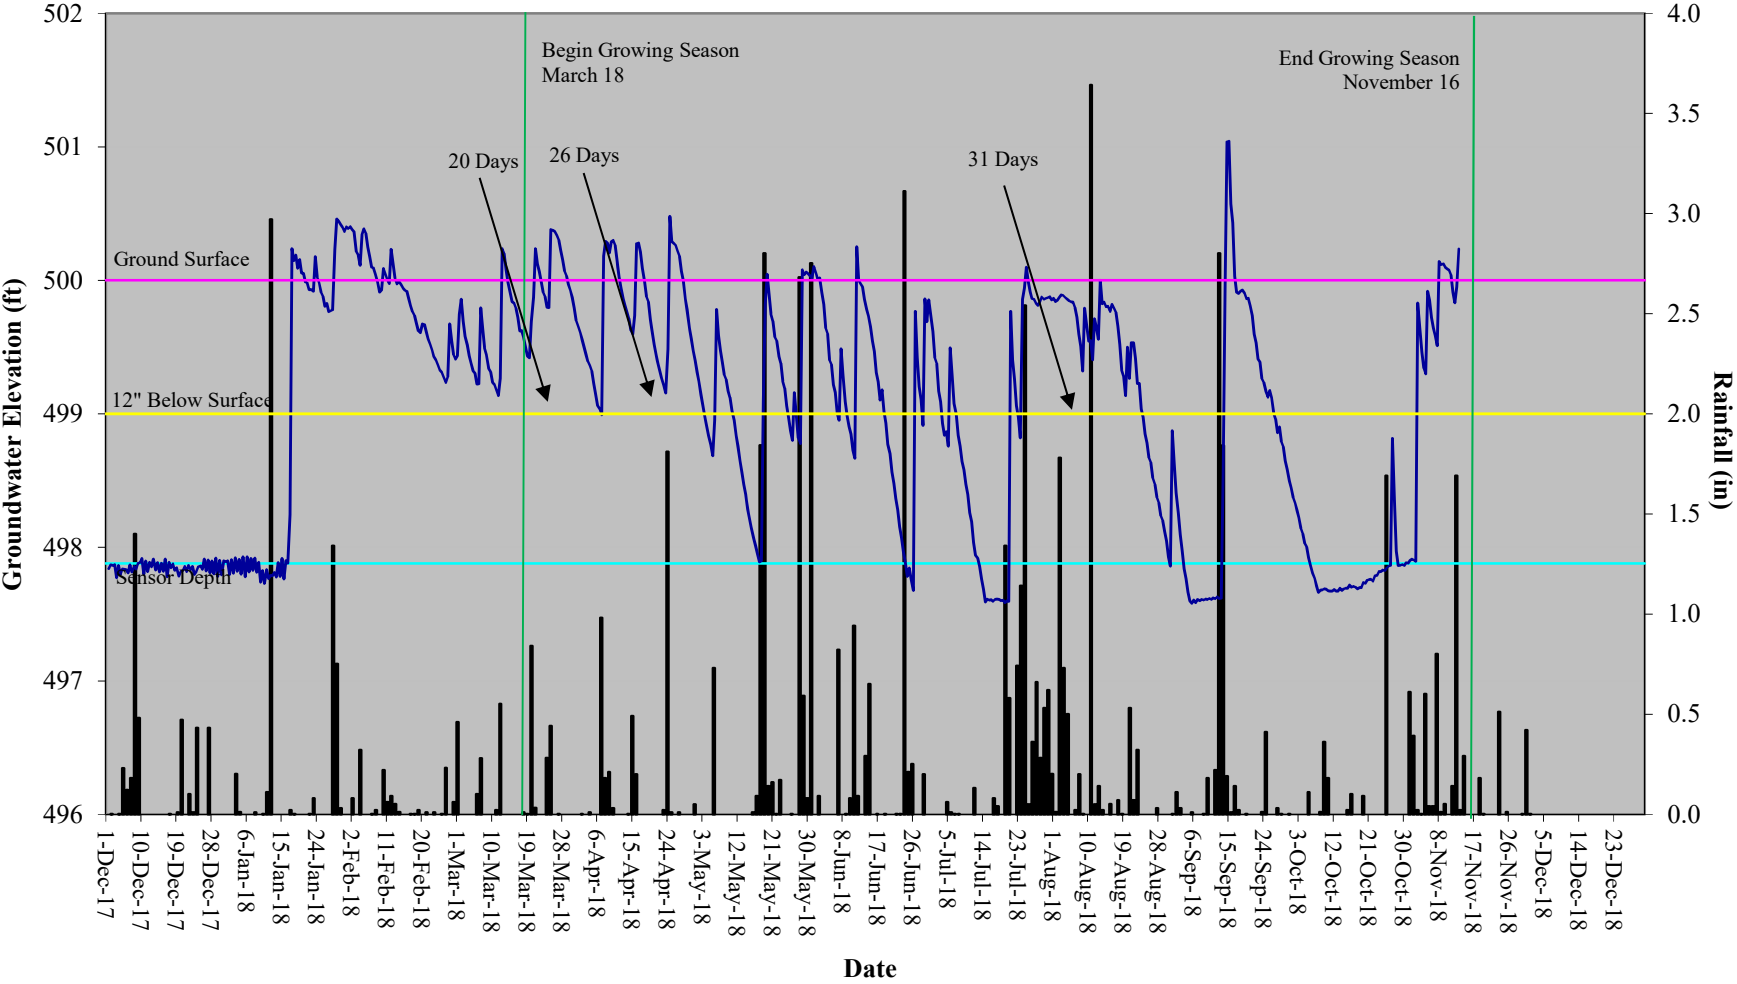
Bowl Basin Restoration Site Hydrograph Wetland Gauge 7

| Table 9. Wetland Hydrology Criteria Attainment Table | | | | | | | |
|---|---|---|---|---|---|---|---|
| Gauge 7 | Yes/25 (10.3%) | Yes/48 (15.6%) | No/12 (4.9%) | Yes/31 (12.8%) | | | |

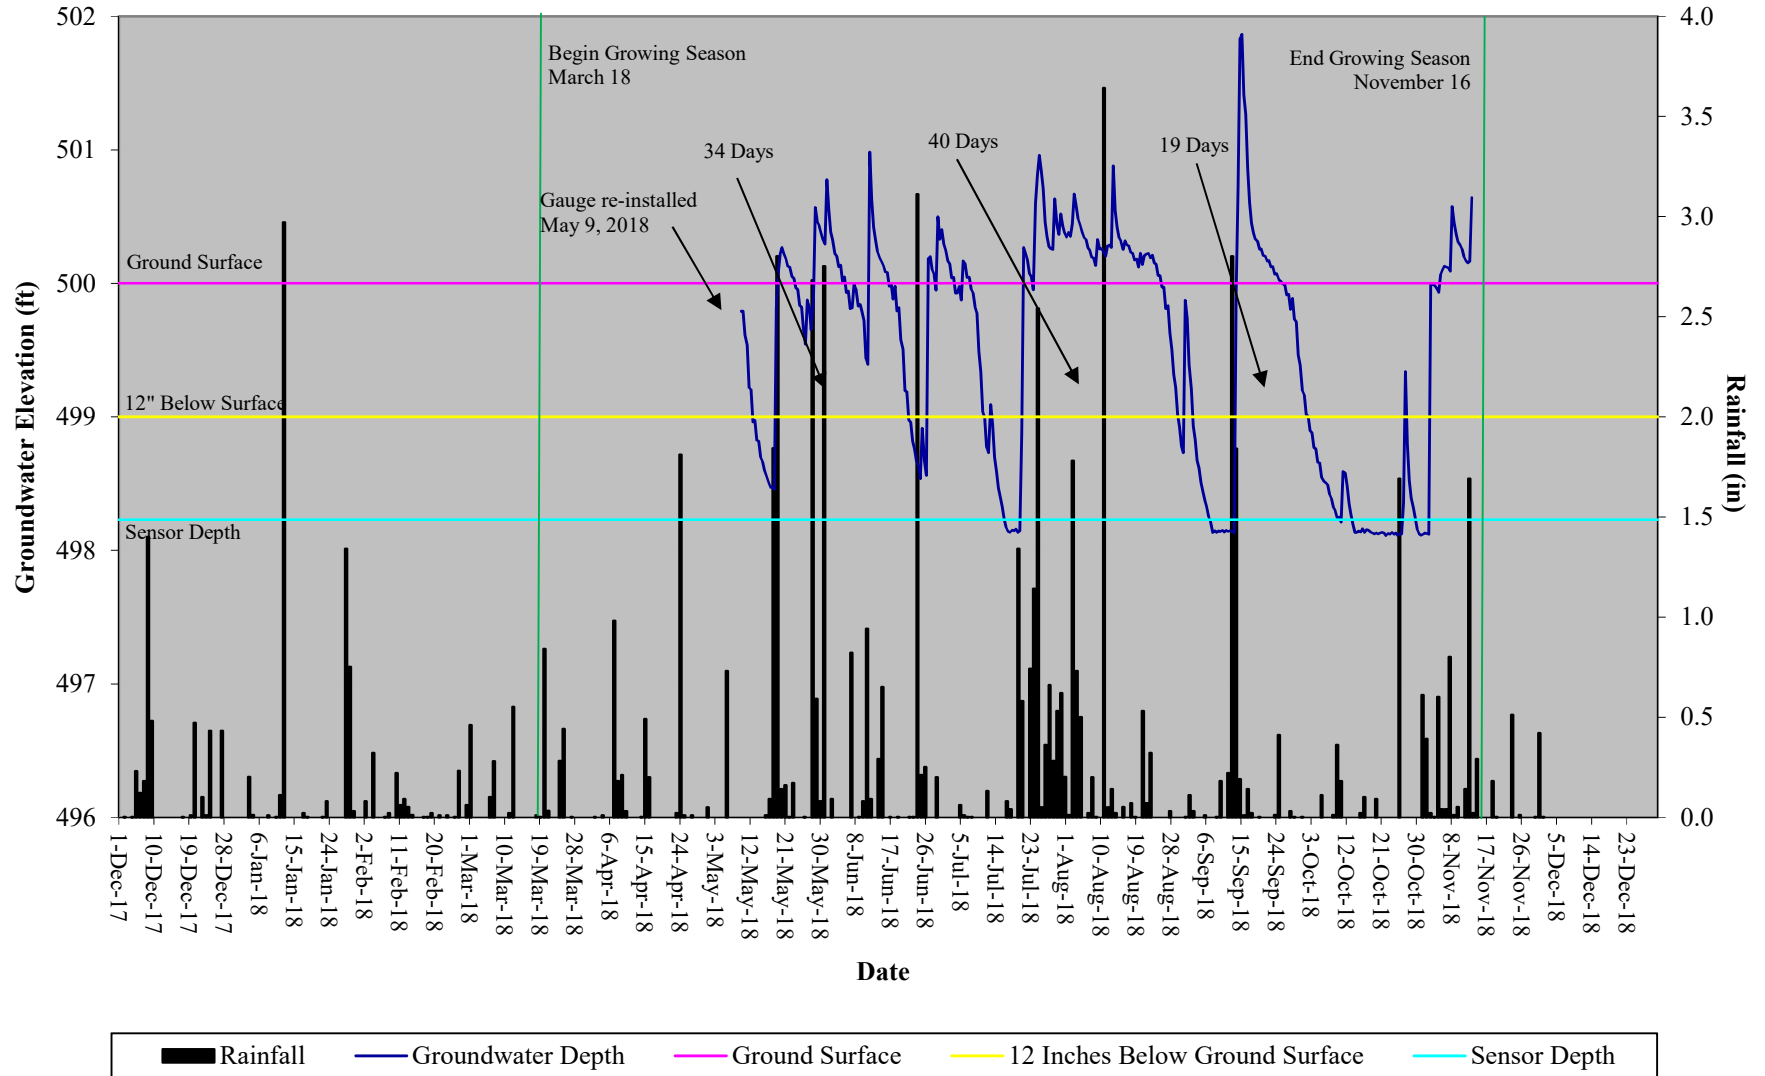
Bowl Basin Restoration Site Hydrograph Wetland Gauge 8

| Table 9. Wetland Hydrology Criteria Attainment Table | | | | | | | |
|---|---|---|---|---|---|---|---|
| Gauge 8 | Yes/37 (15.2%) | Yes/51 (21.0%) | Yes/49 (20.2%) | Yes/40 (16.5%) | | | |
