**Bowl Basin Restoration Site  
Monitoring Report MY05  
DMS Project # 95721  
DMS Contract # 005012**

**Onslow County, NC  
CU# 03020106  
DWR# 2013-0864  
SAW# 2013-00393**

**Construction Completed: February 2015  
Data Collection: 2019  
Submitted: December 2019**

**BOWL BASIN RESTORATION SITE**  
 DMS PROJECT #95721  
 ONSLOW COUNTY, NORTH CAROLINA  
 MONITORING YEAR 05

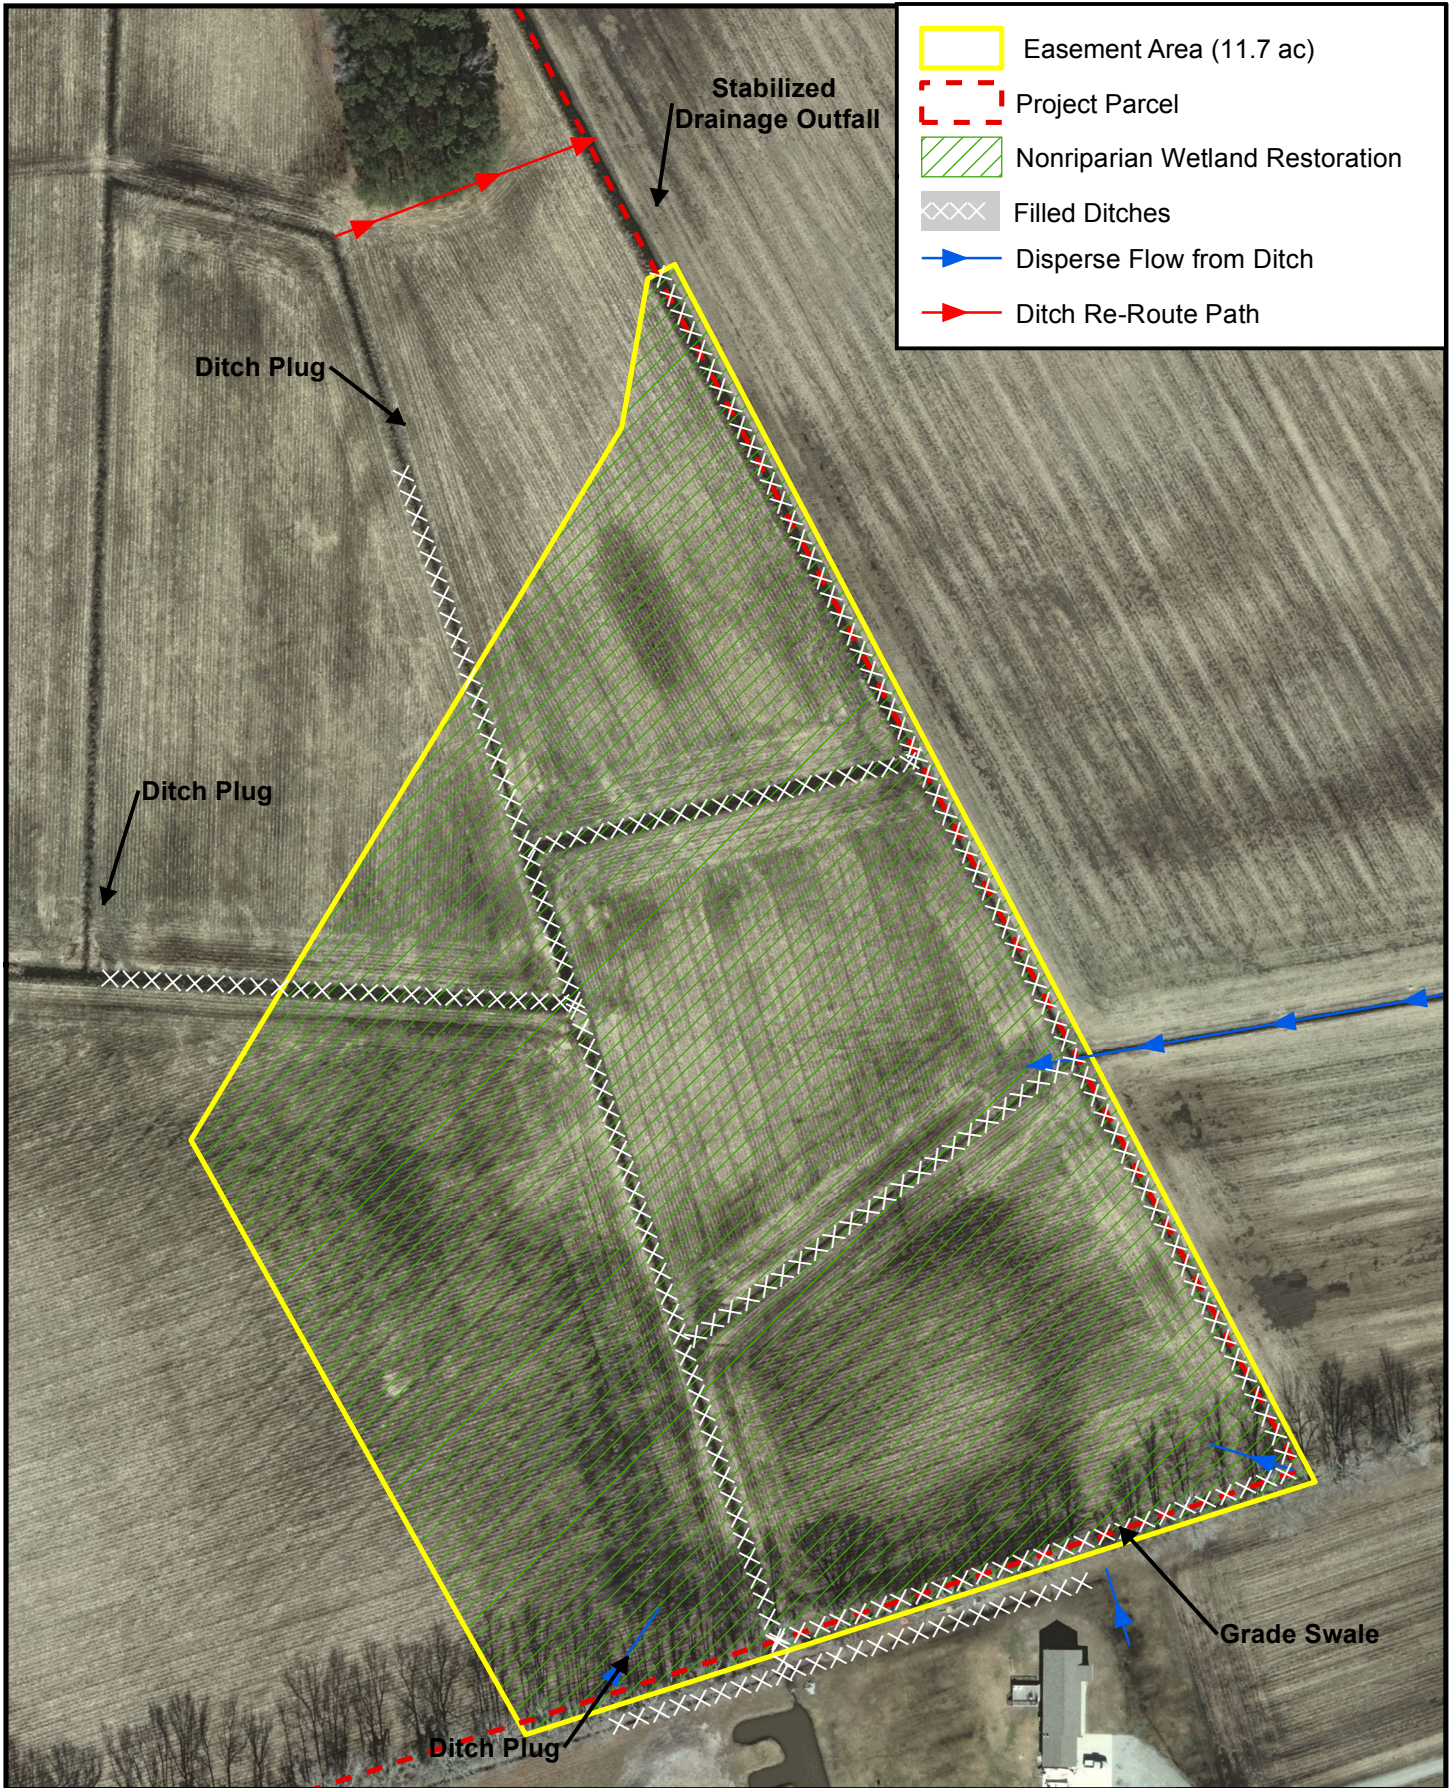
**FIGURE 2: PROJECT SITE MITIGATION PLAN VIEW  
BOWL BASIN WETLAND RESTORATION SITE  
ONslow COUNTY, NC**

- Easement Area (11.7 ac)
- Project Parcel
- Nonriparian Wetland Restoration
- Filled Ditches
- ➔ Disperse Flow from Ditch
- ➔ Ditch Re-Route Path

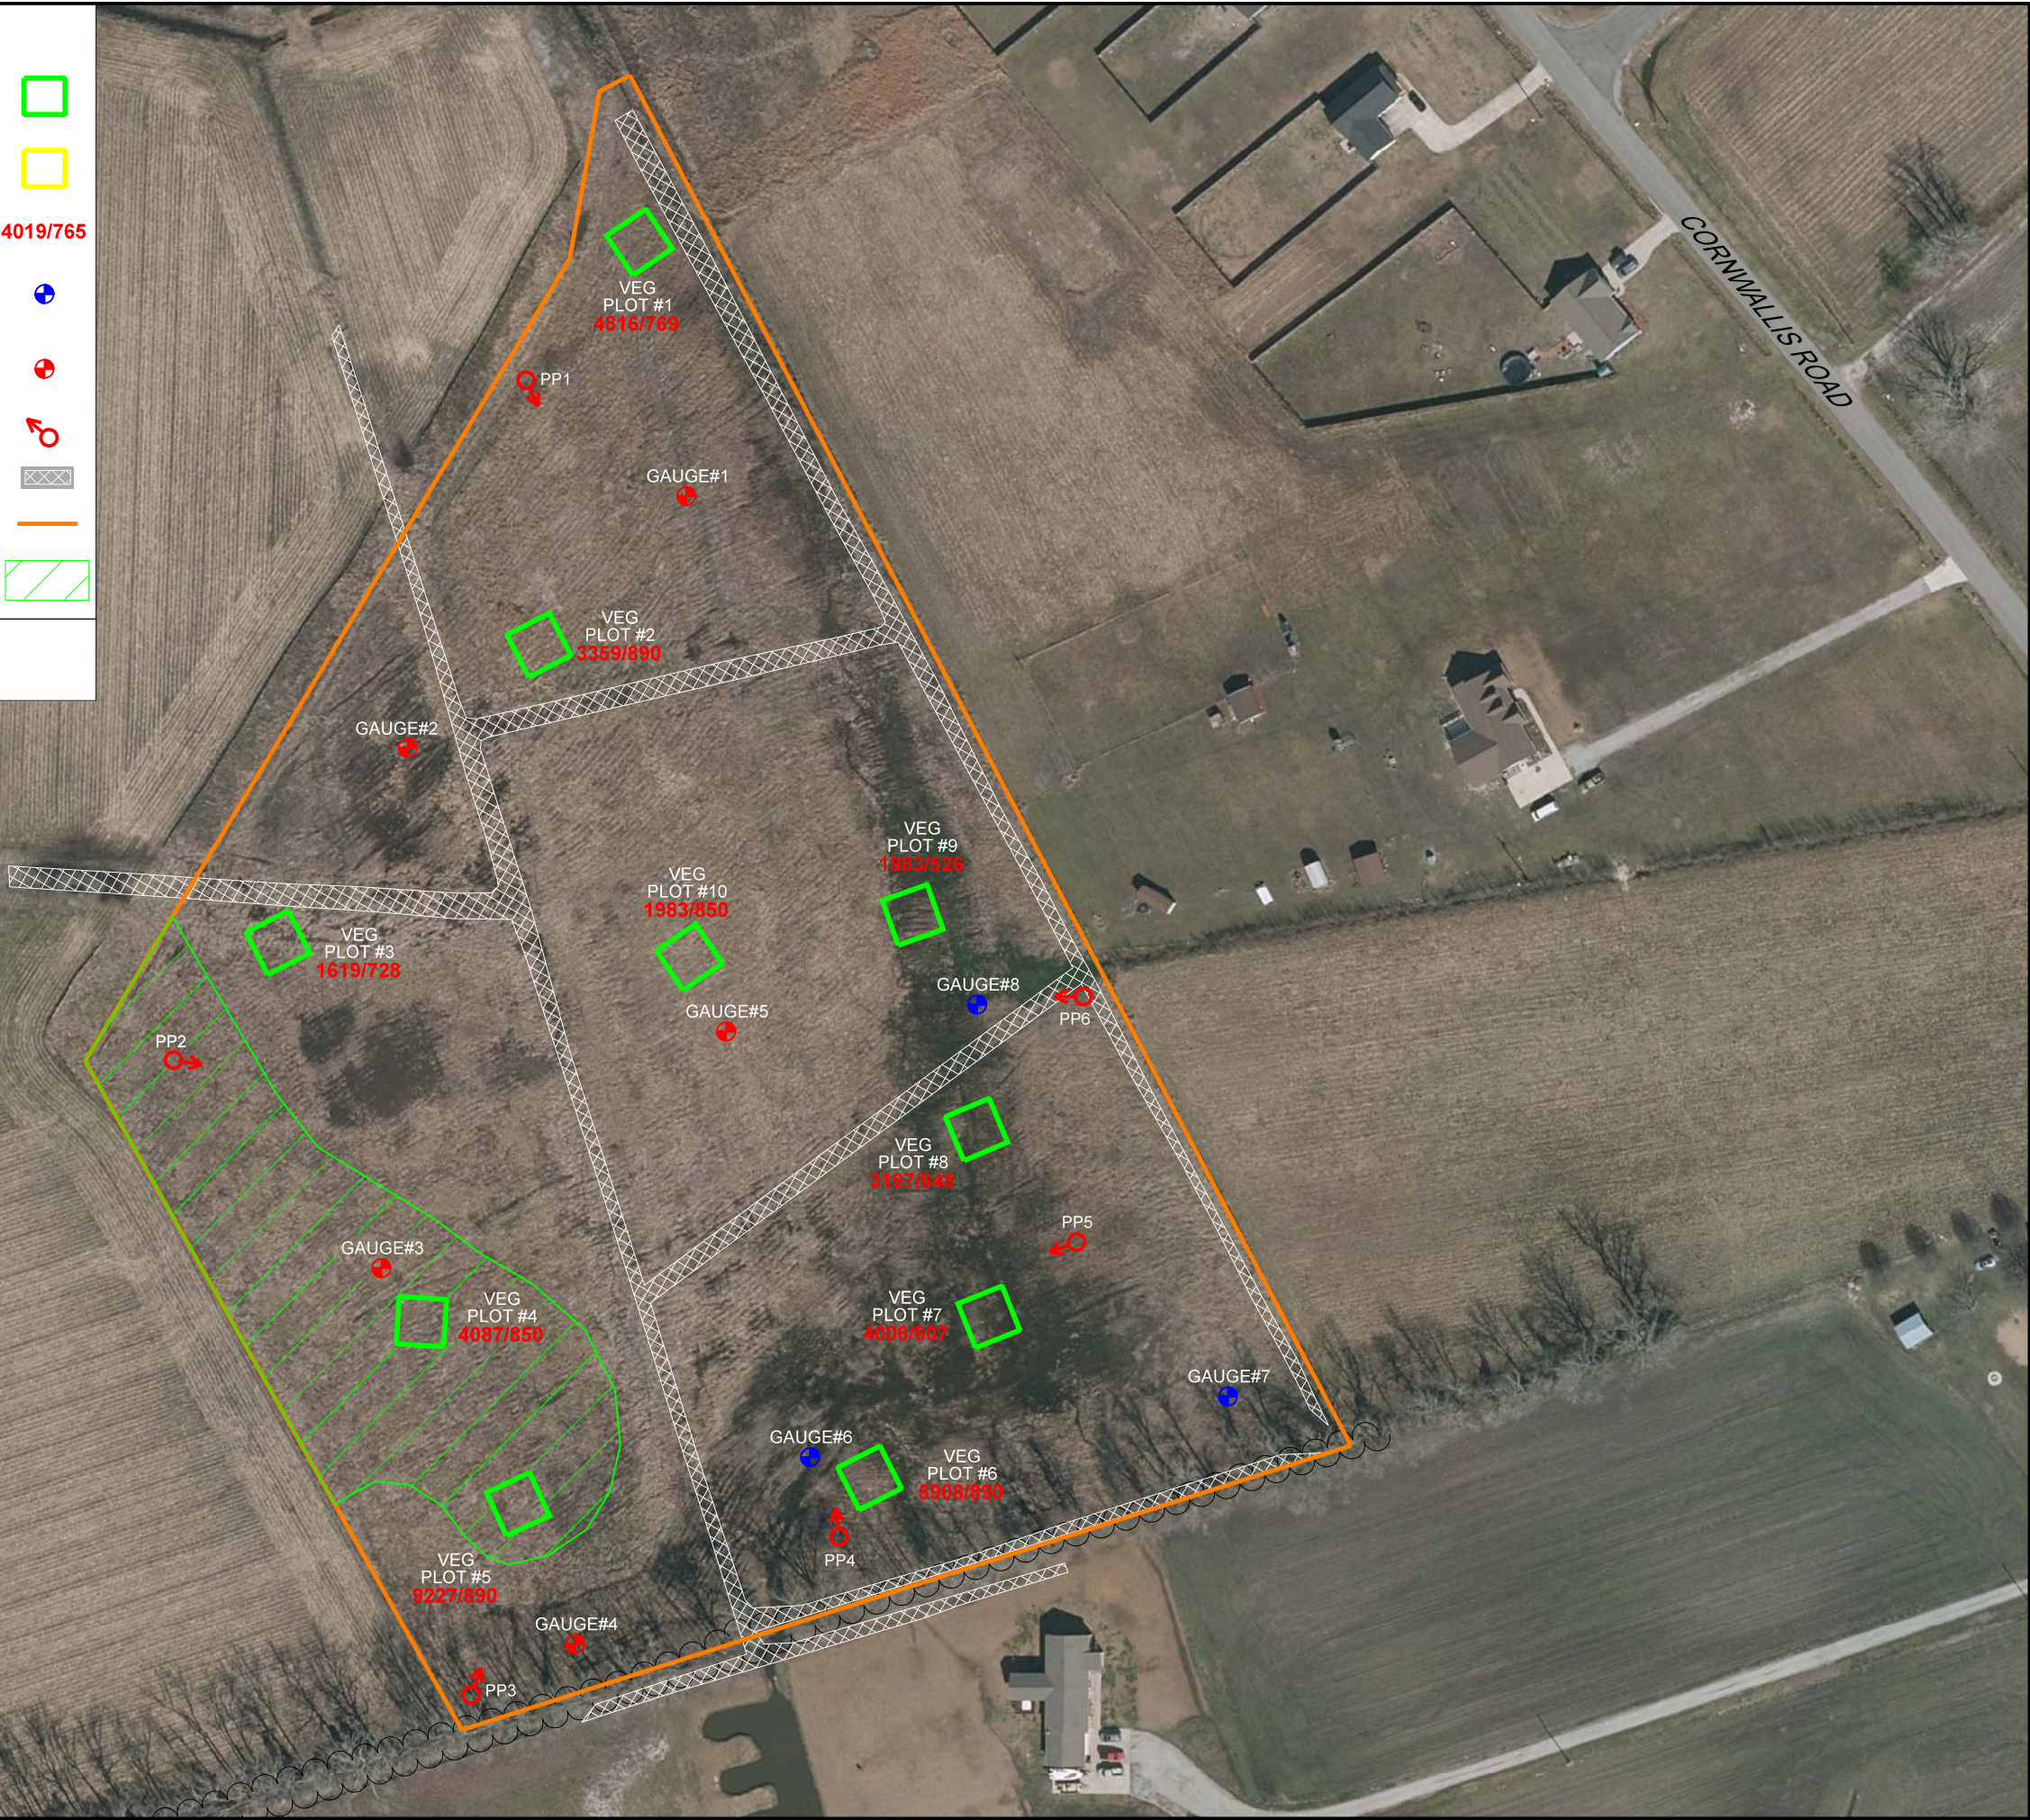
DATE: DEC 2019  
 SCALE: GRAPHIC  
 CURRENT CONDITION PLAN VIEW  
 SHEET 1 OF 1  
 FIGURE 3

- VEG PLOT ACHIEVING DENSITY CRITERION ..... □
- VEG PLOT BELOW DENSITY CRITERION ..... □
- VEG PLOT TOTAL / PLANTED STEM DENSITY ..... **4019/765**
- WETLAND GAUGE ACHIEVING HYDROLOGIC CRITERION ..... ●
- WETLAND GAUGE BELOW HYDROLOGIC CRITERION ..... ●
- PHOTO POINT (PP) ..... ⊕
- FILLED DITCHES .....
- CONSERVATION EASEMENT = .....
- NONRIPARIAN WETLAND RESTORATION = 11.7 ACRES
- SWEETGUM TREATMENT (2017 & 2019) .....

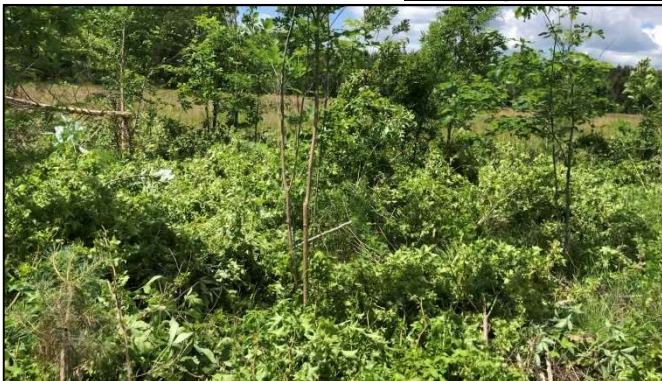
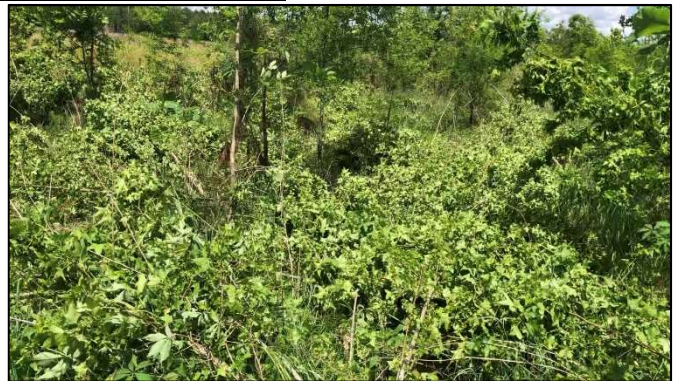
Sweetgum treatment area, just after treatment – 5/9/19

1. Provide information about how the sweetgums were treated (i.e. mechanical or chemical). If available, insert a picture of the area of concern for sweetgum.  
*KCI Response: Sweetgum was treated by first cutting the sweetgum and then spraying the stumps with herbicide. A note explaining this has been added to the report as well as pictures taken of the treated area.*

The fifth-year vegetation monitoring was based on the Level 2 CVS-EEP vegetation monitoring protocol. The site's average density for this monitoring period was 765 planted stems/acre. All ten plots had greater than 288 planted stems/acre. Including volunteers, the site averaged 4,019 total stems/acre. In general the site is well vegetated, with widespread herbaceous coverage and many tall, healthy, planted stems. Two of the ten plots (Plots 5 and 6) had greater than 100 sweetgum stems (*Liquidambar styraciflua*) growing in them and an additional five plots (Plots 1, 2, 4, 7, and 8) had between 35 and 75 sweetgum stems. With the exception of Plot 2, at least half of the sweetgums in each of these plots are less than 137 cm tall. The average height of the planted woody stems on the site is 192 cm, meaning that the sweetgums in these plots tend to be at least half a meter shorter than the planted stems, and in many cases are much shorter than the planted stems. In Plot 2, where most of the sweetgums are over 137 cm tall, there are 22 planted stems (890 stems/acre), with an average height of 268 cm. Since the majority of the sweetgum on the site are much smaller than the planted stems and do not seem to be negatively impacting the planted vegetation, they are not viewed as a threat to the site's success. Areas of the site that do contain dense areas of tall sweetgum were treated in the spring of 2017 and again during the spring of 2019. This treatment consisted of cutting the sweetgum and then spraying the stumps with an herbicide. This treatment will be repeated as necessary to ensure the sweetgum does not out-compete the planted stems.

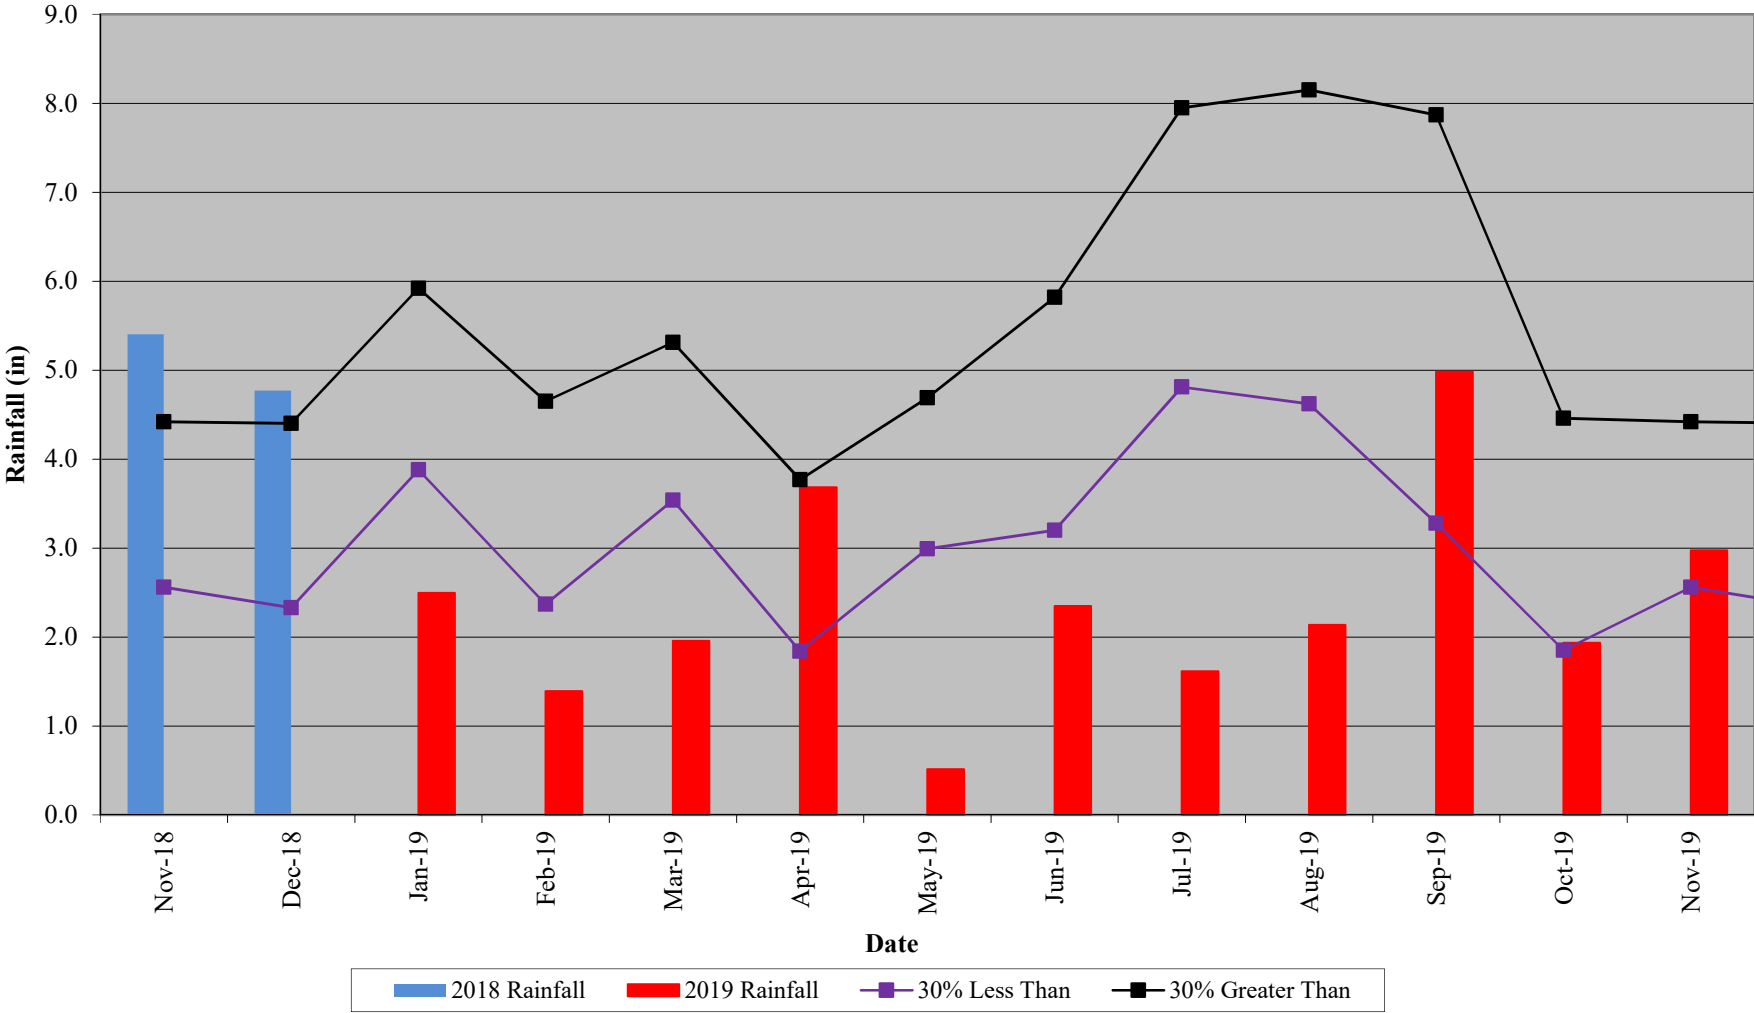
**Bowl Basin Wetland Restoration Site  
30-70 Percentile Graph  
WETS Station Name: Maysville, NC**

The daily rainfall data was obtained from a local weather station in Jacksonville, NC; provided by the NC State Climate Office. For the 2019 year, the months of April, September, October, and November experienced average rainfall, while January, February, March, May, June, July, and August experienced

below average rainfall. No months experienced above average rainfall in 2019. Overall, the area experienced well below average rainfall during the 2019 growing season.

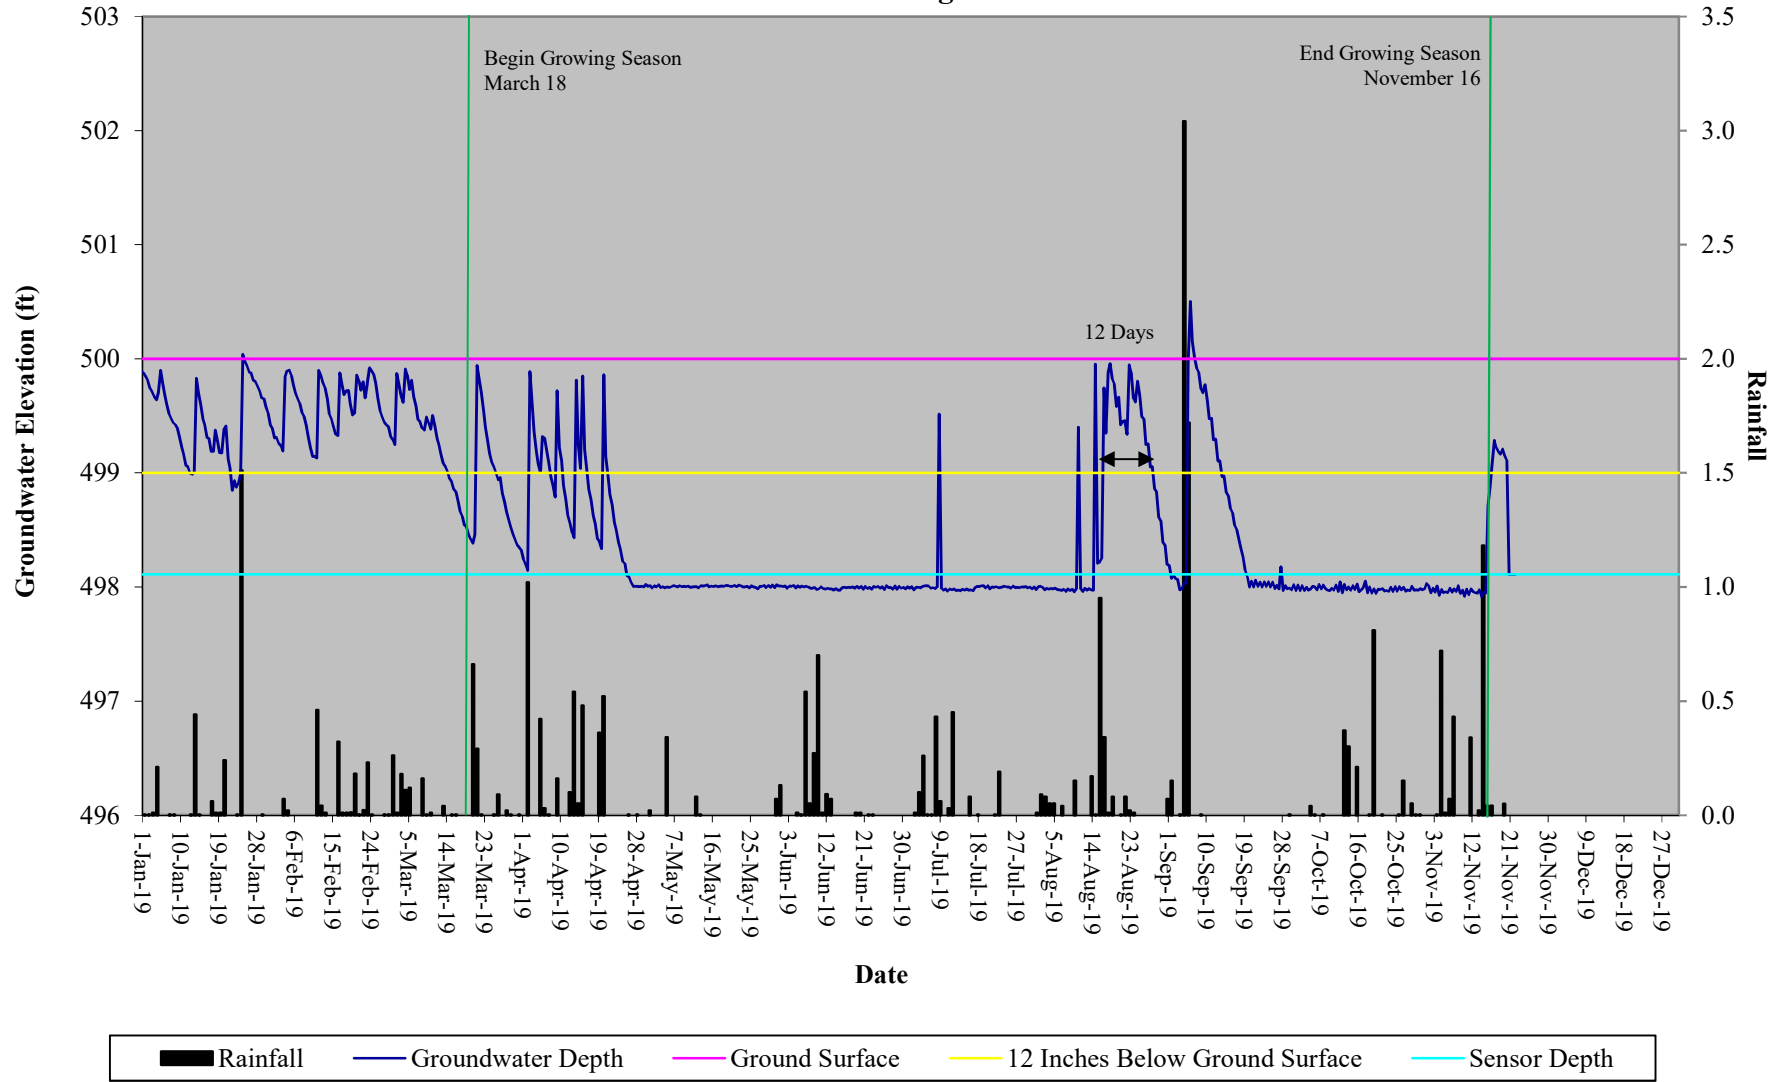
### Bowl Basin Restoration Site Hydrograph Wetland Gauge 1

During the site's fifth growing season, only 3 of the 8 gauges had continuous saturation within 12 inches of the ground surface for 9% (22 days) of the 243 day growing season (March 18 to November 16). Overall the gauges on site averaged 19 days (7.8%) of continuous saturation. The low amount of gauges achieving success can be attributed to the extremely low rainfall amount that the site received in 2019.
