**MITIGATION PLAN AND AS-BUILT BASELINE REPORT
for the
BOWLIN-PEAK CREEK MITIGATION SITE**

Ashe County, North Carolina

EEP Project Number: 92606
Contract Number: D06082; Task Order: 06NW01-1

Submitted: 15 April 2011

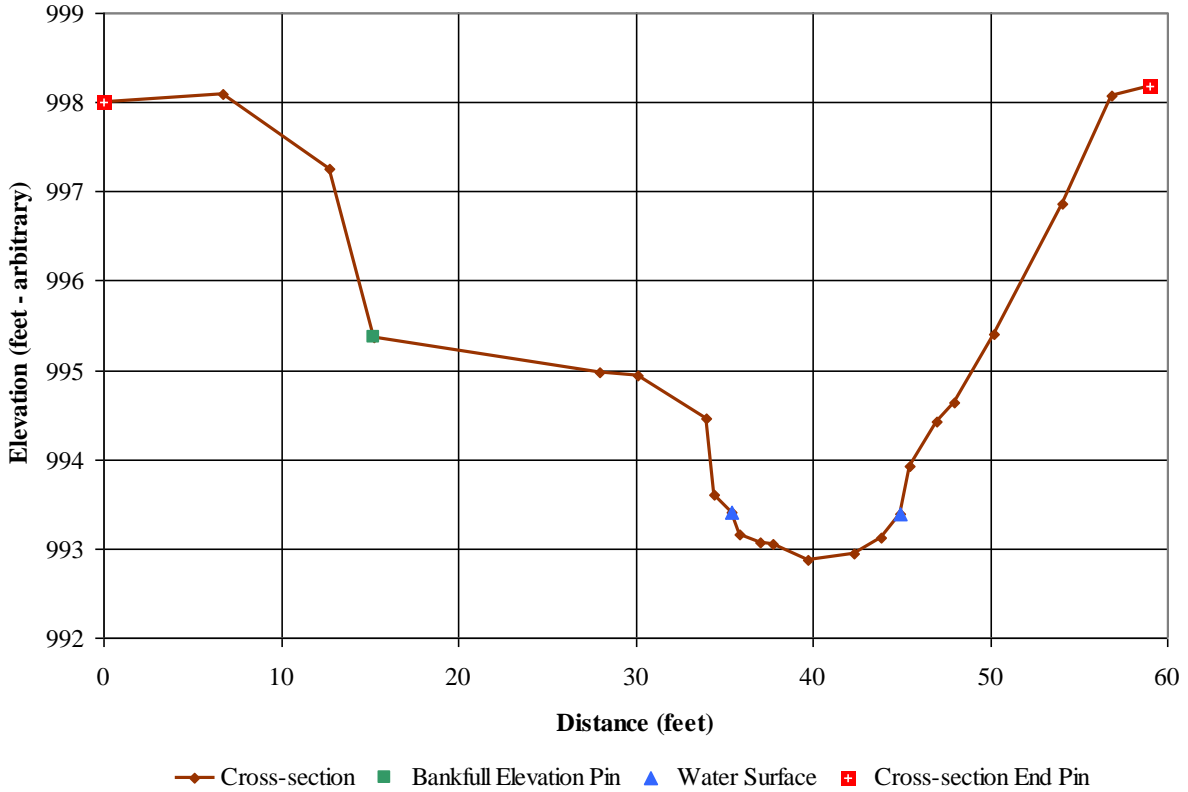
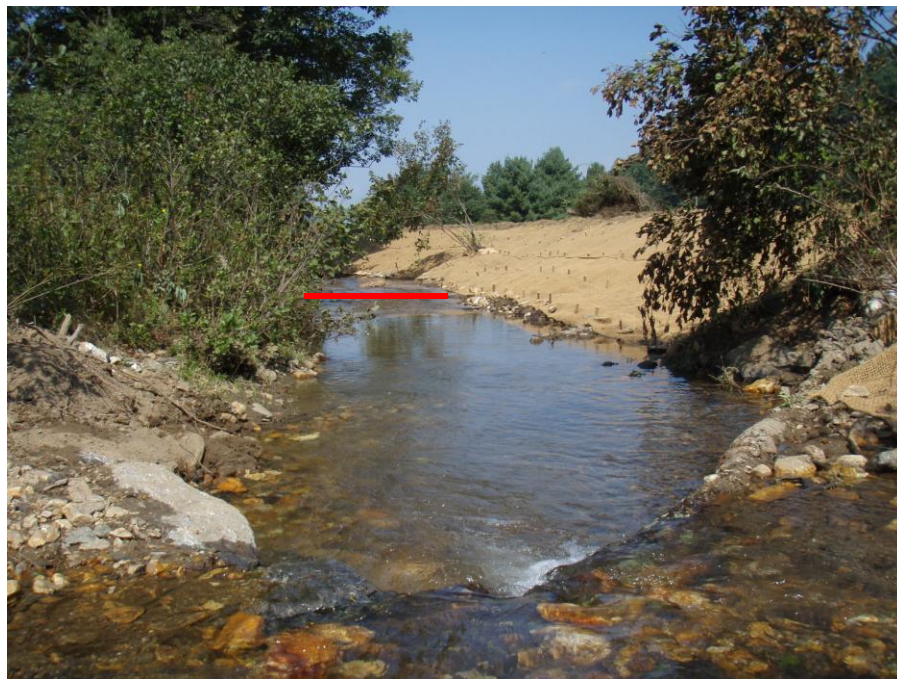
**Cross-section 1 at Station 3+56, Riffle
Bowlin-Peak Creek/Project Number: 92606**

Cross-section 1; 25 Sep 07.

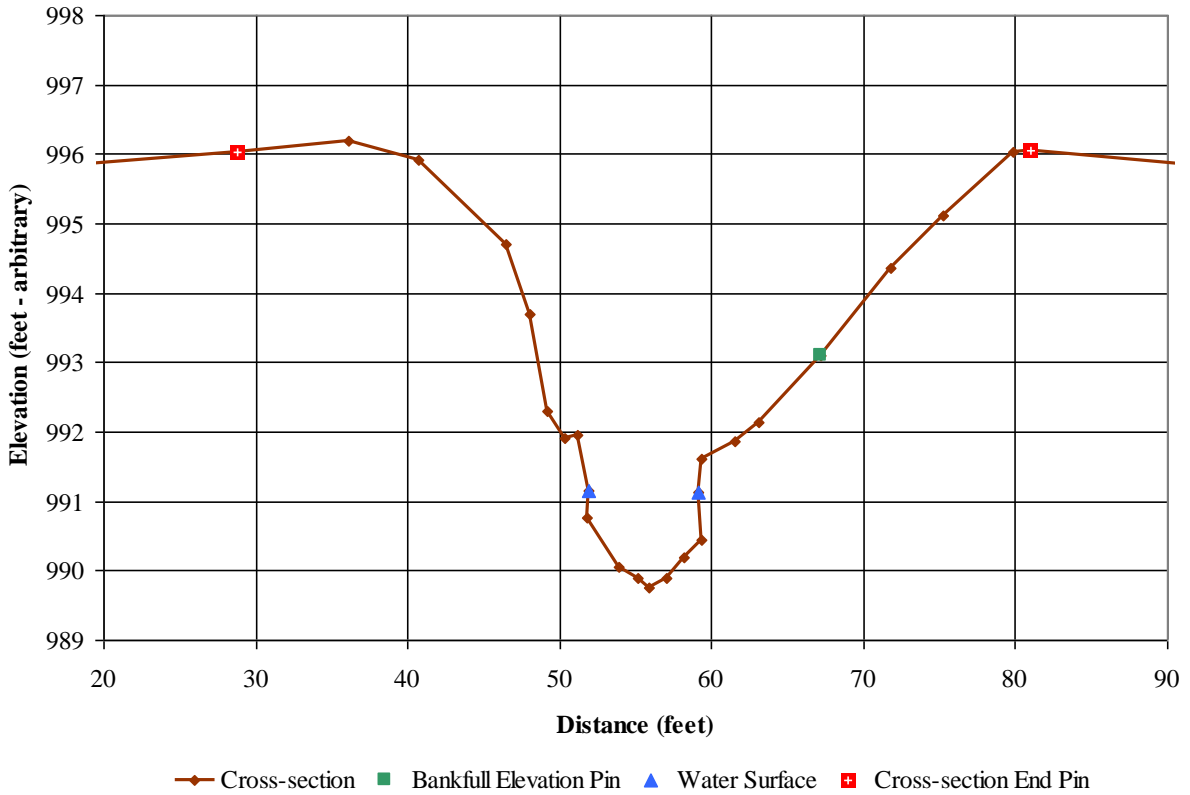
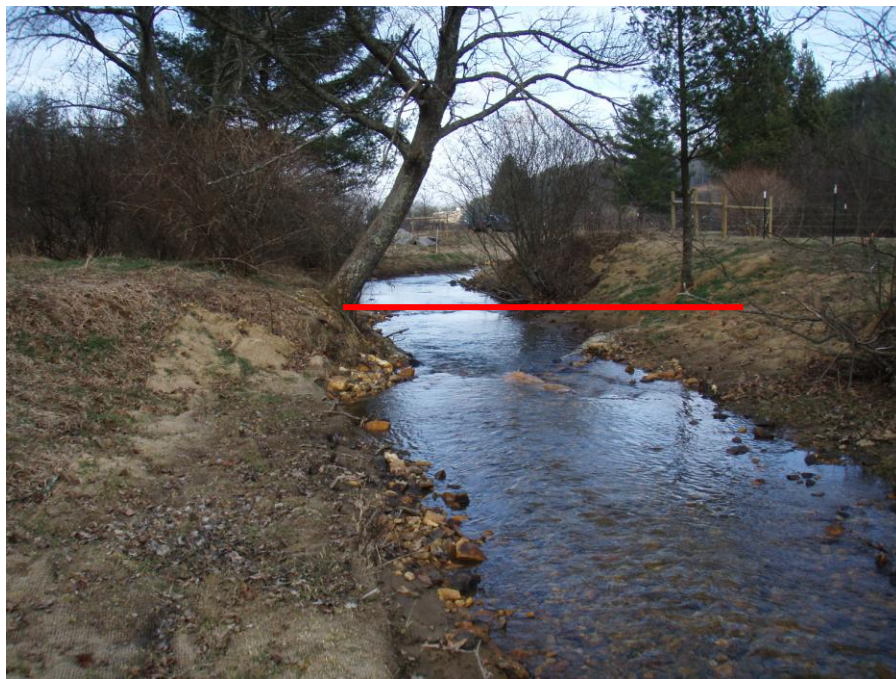
Cross-section 2 at Station 6+39, Pool
Bowlin-Peak Creek/Project Number: 92606

Cross-section 2; 08 Jan 08.

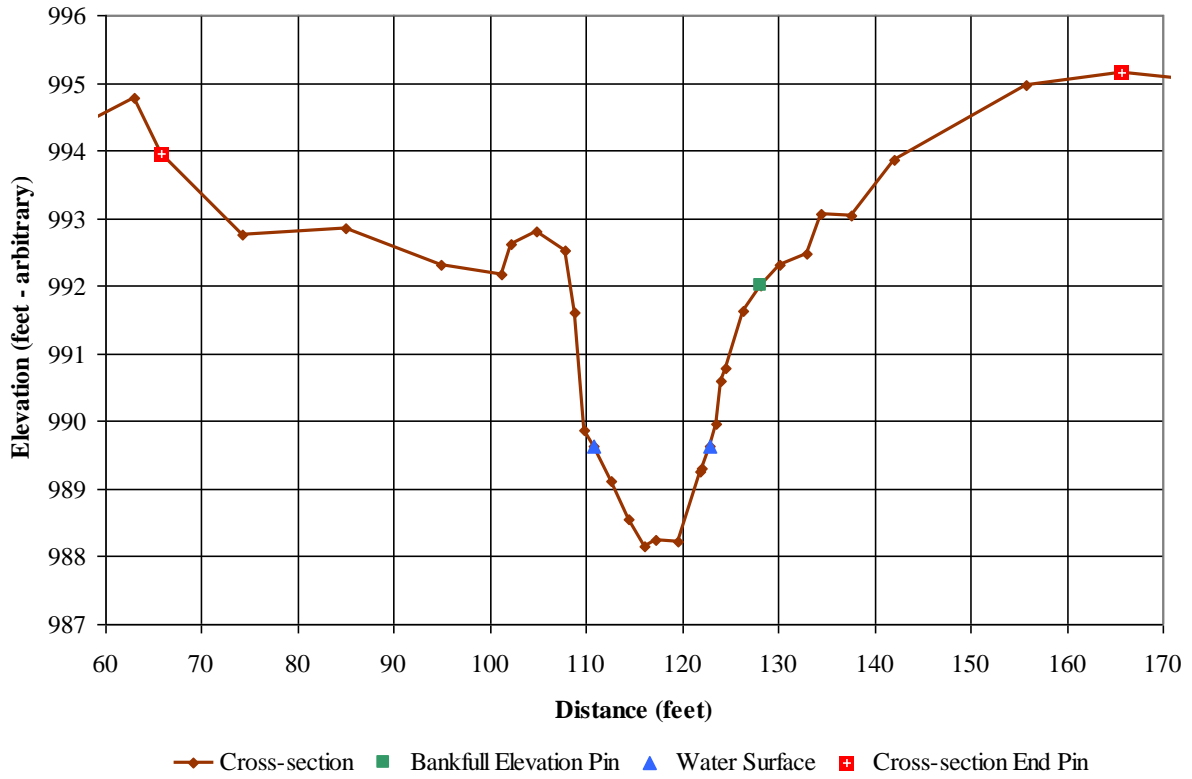
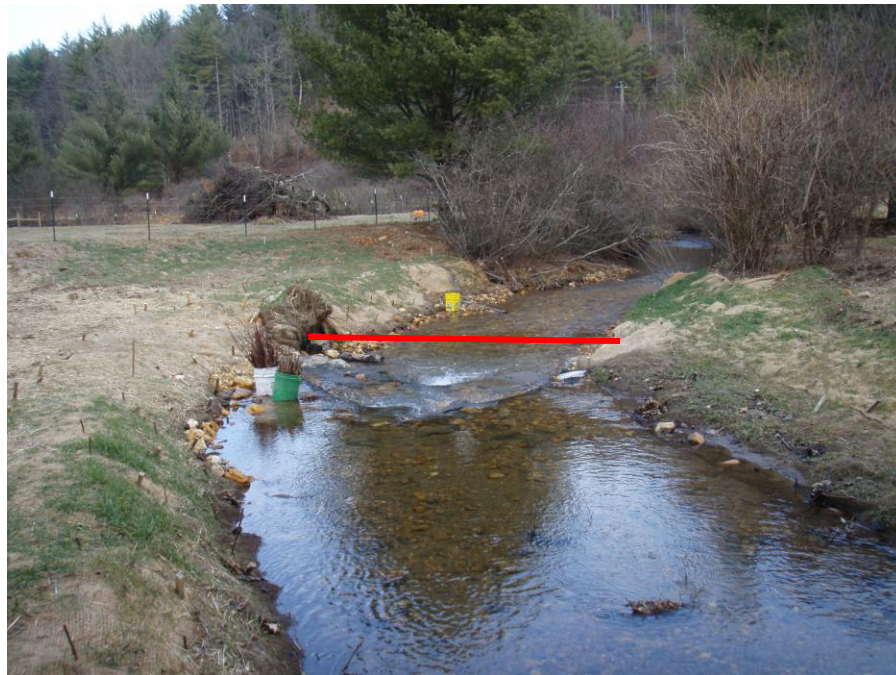
**Cross-section 3 at Station 7+62, Pool
Bowlin-Peak Creek/Project Number: 92606**

Cross-section 3; 08 Jan 08.

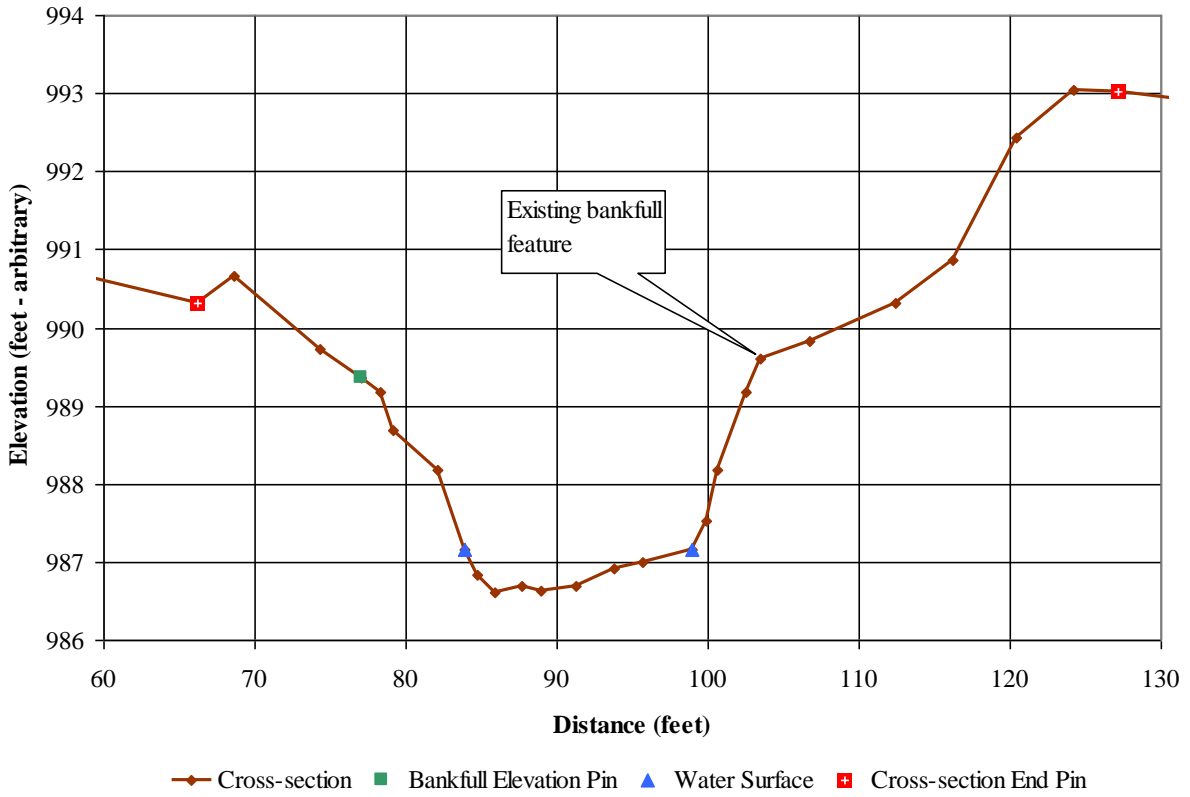
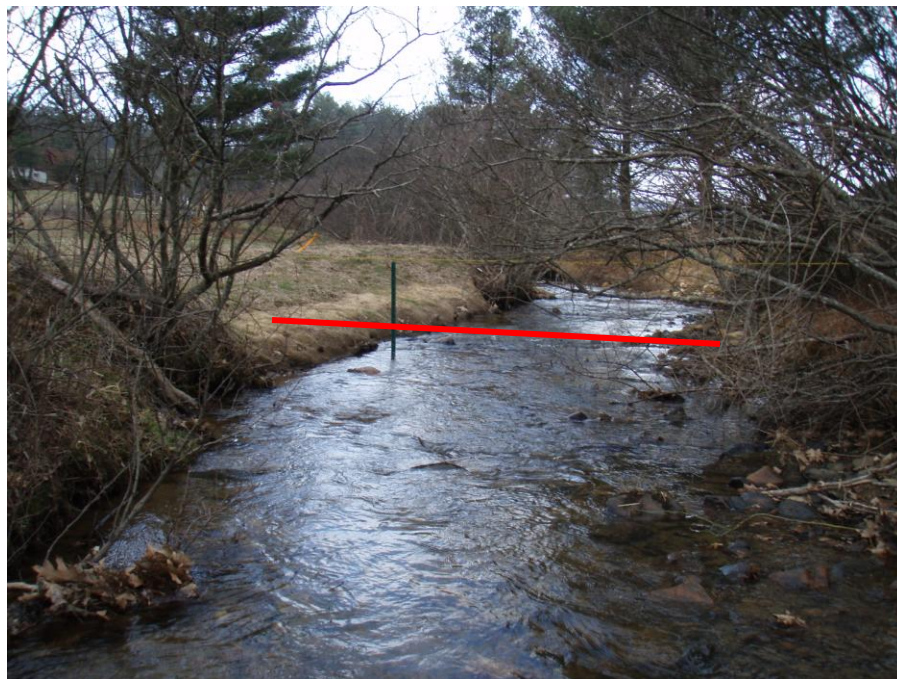
**Cross-section 4 at Station 10+43, Riffle
Bowlin-Peak Creek/Project Number: 92606**

Cross-section 4; 08 Jan 08.

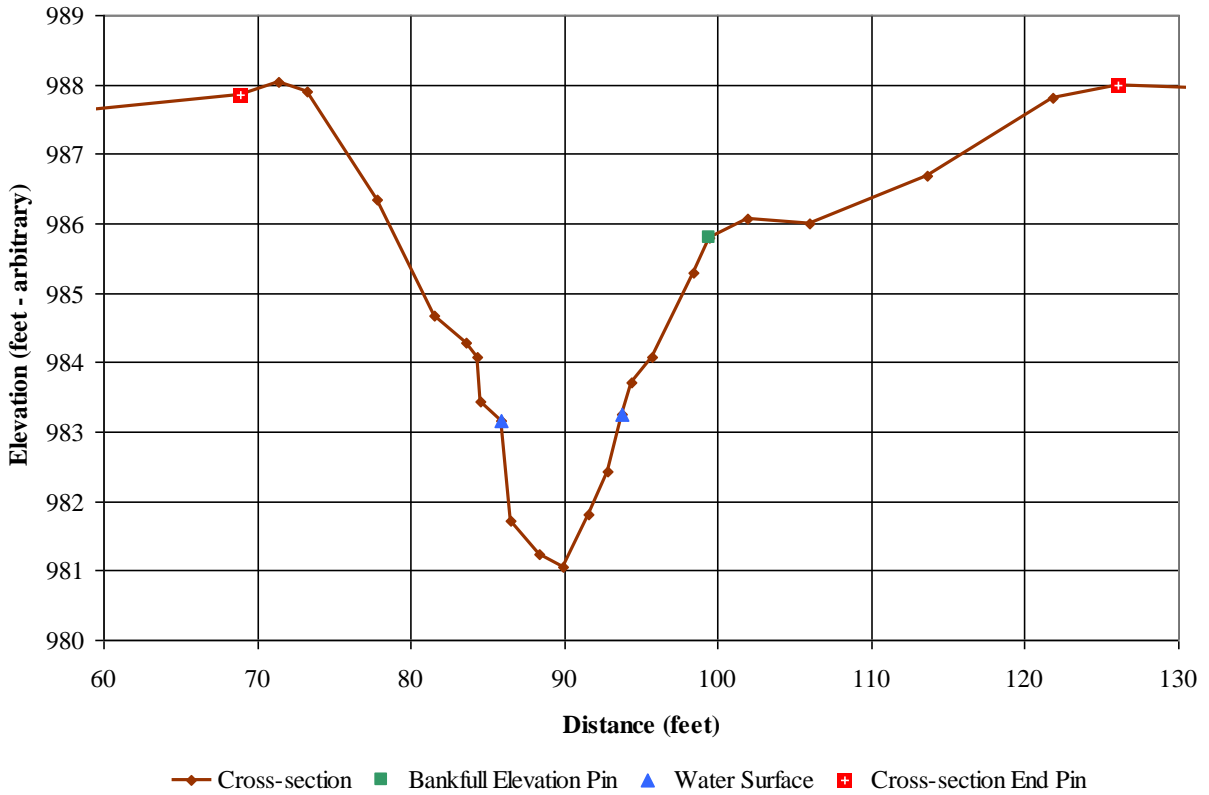
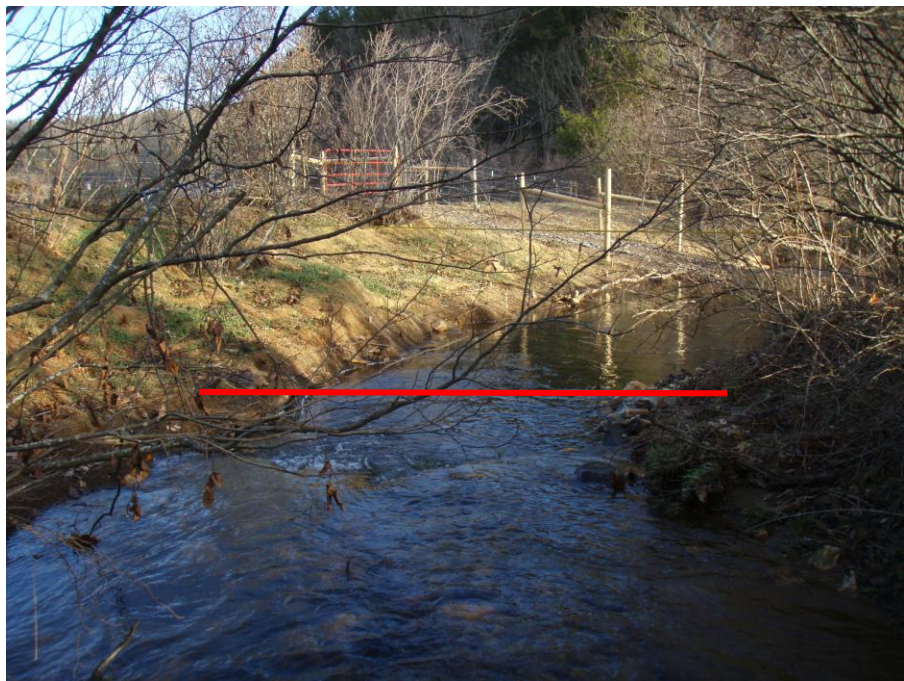
**Cross-section 5 at Station 14+80, Pool
Bowlin-Peak Creek/Project Number: 92606**

Cross-section 5; 26 Mar 08.

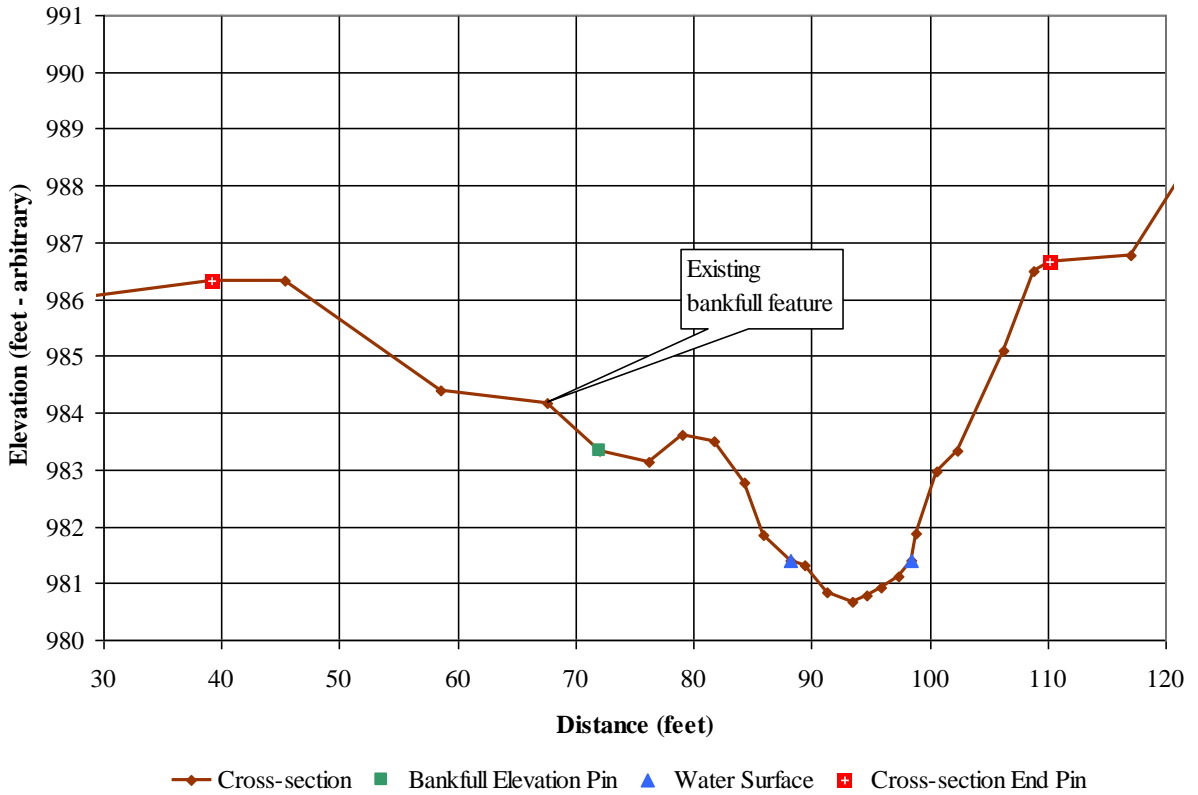
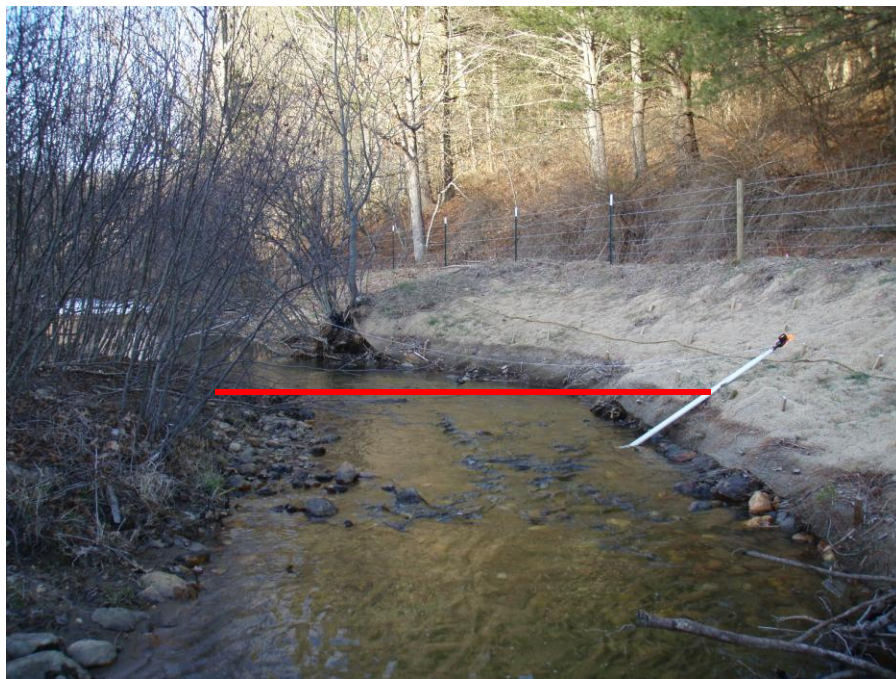
**Cross-section 6 at Station 16+80, Riffle
Bowlin-Peak Creek/Project Number: 92606**

Cross-section 6; 08 Jan 08.

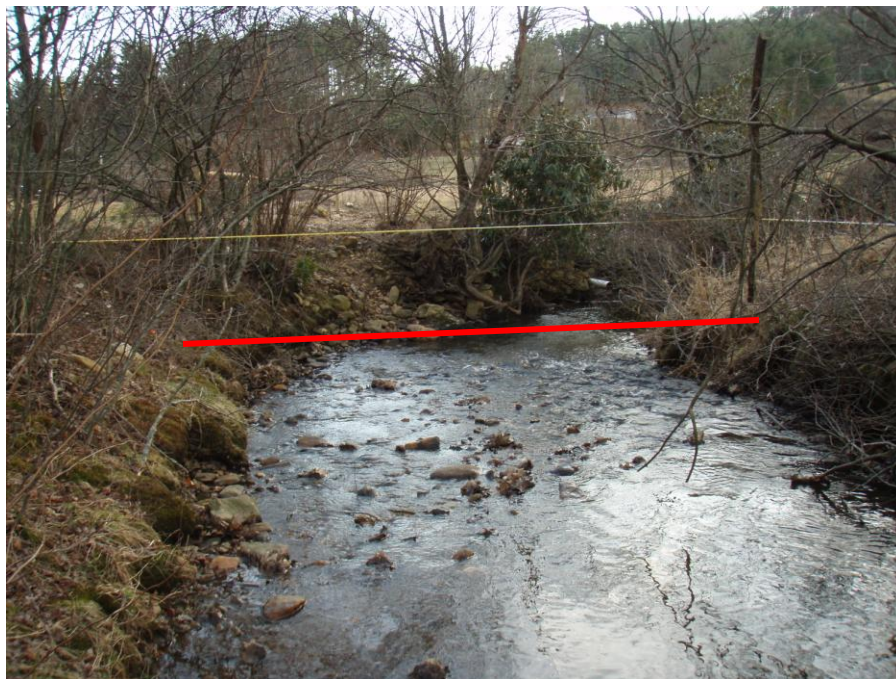
**Cross-section 7 at Station 20+90, Riffle
Bowlin-Peak Creek/Project Number: 92606**

Cross-section 7; 08 Jan 08.

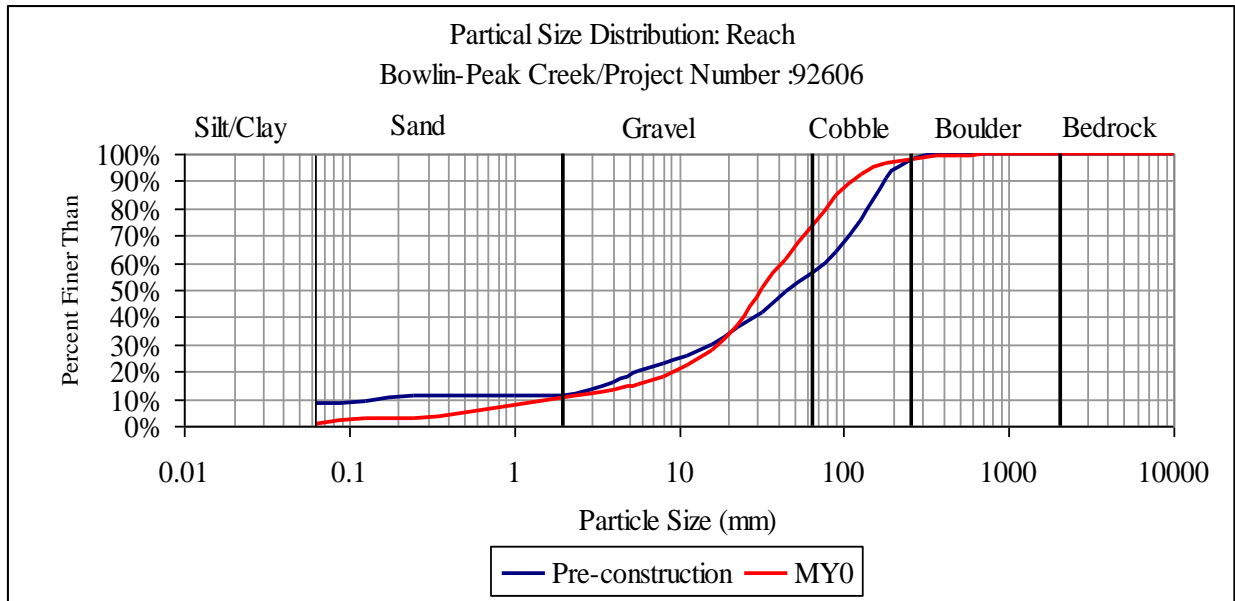
B.4 Pebble Count Cumulative Frequency Distribution Plots

Size Class Index	Particle size (mm) in year sampled	
	Pre-construction	MY0
D16	4.0	6.3
D35	21.5	21.1
D50	47.7	31.7
D84	155.7	88.3
D95	223.4	163.8
D100	362.0	1,024.0

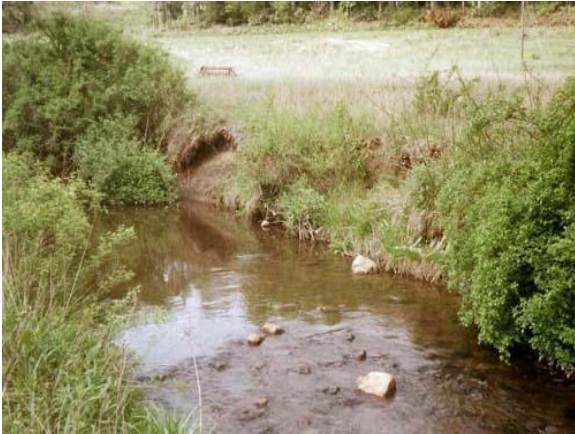
PS-1, bearing 230°: Pre-construction view of station 1+75 to station 2+48; 17 Apr 02.

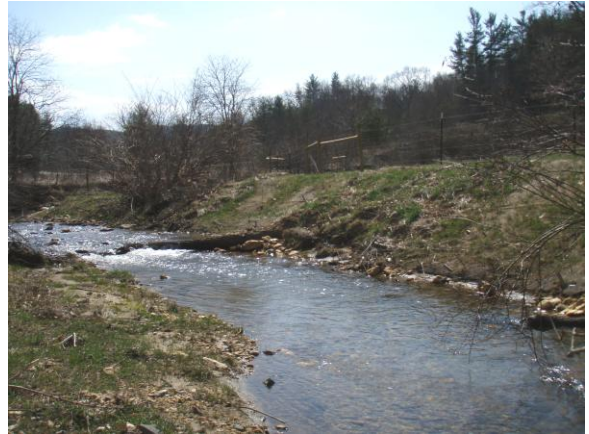
PS-1, bearing 230°: Post-construction view of station 1+75 to station 2+48; 26 Mar 08.

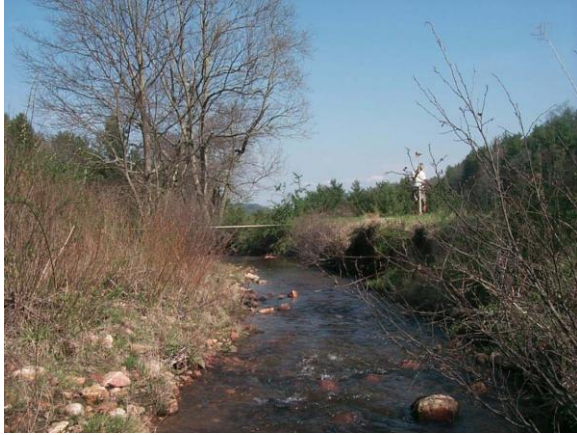
PS-3, bearing 330°: Pre-construction view of cross-section 1 at station 3+56; 17 Apr 02.

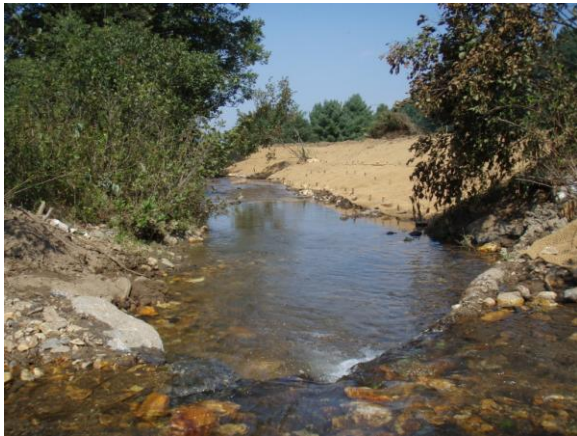
PS-3, bearing 330°: Post-construction view of cross-section 1 at station 3+56; 25 Sep 07.

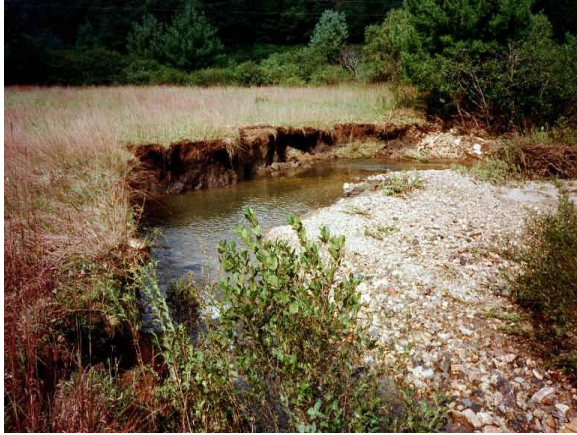
PS-5, bearing 35°: Pre-construction view of station 7+25 to station 8+50; 24 Sep 02.

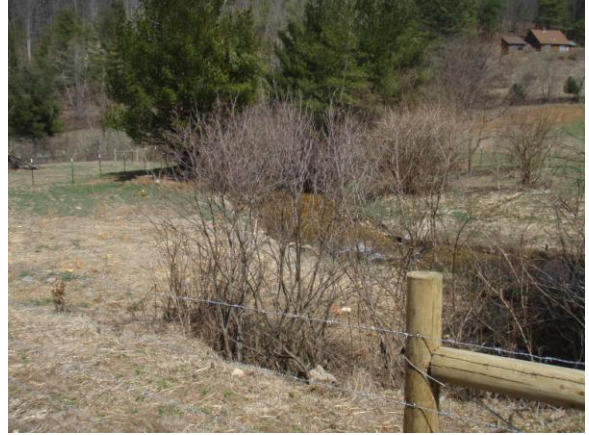
PS-5, bearing 45°: Post-construction view of station 7+25 to station 8+50; 26 Mar 08.
Note: stream channel moved to the right.

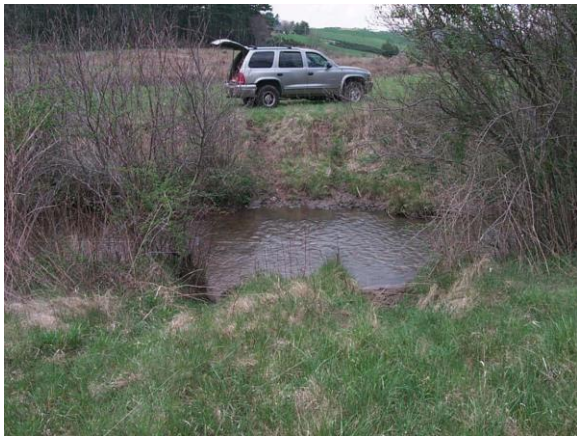
PS-9, bearing 310°: Pre-construction view of low water crossing at station 15+25; 17 Apr 02.

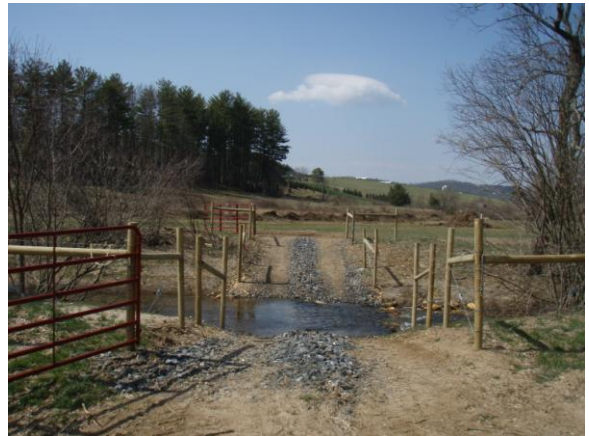
PS-9, bearing 310°: Post-construction view of low water crossing at station 15+25; 26 Mar 08.

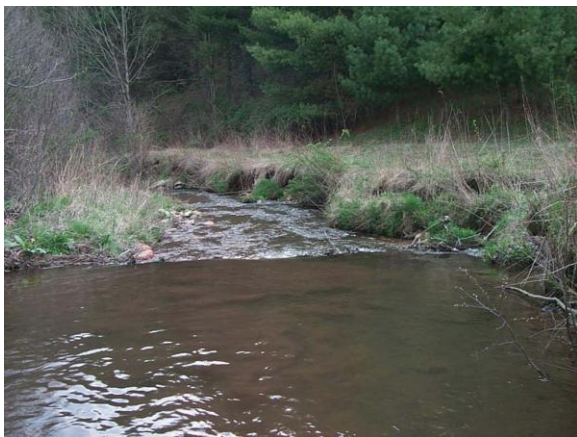
PS-10, bearing 25°: Pre-construction view of low water crossing at station 16+25; 17 Apr 02.

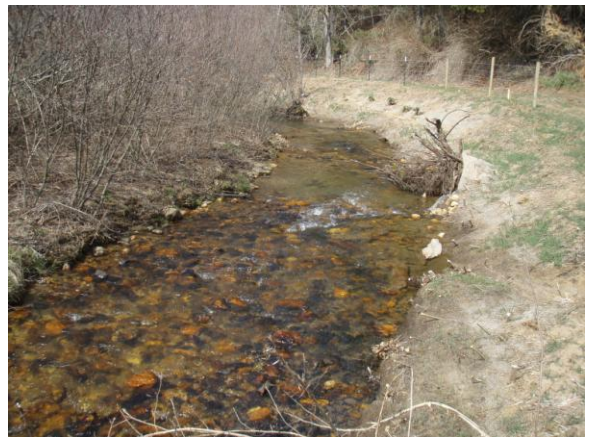
PS-10, bearing 25°: Post-construction view of low water crossing at station 16+25; 26 Mar 08.
