MITIGATION PLAN FINAL

Bridgefork Dairy Mitigation Site

Cleveland County, NC
NCDEQ Contract No. 0301-01
DMS ID No. 100171

MITIGATION PLAN

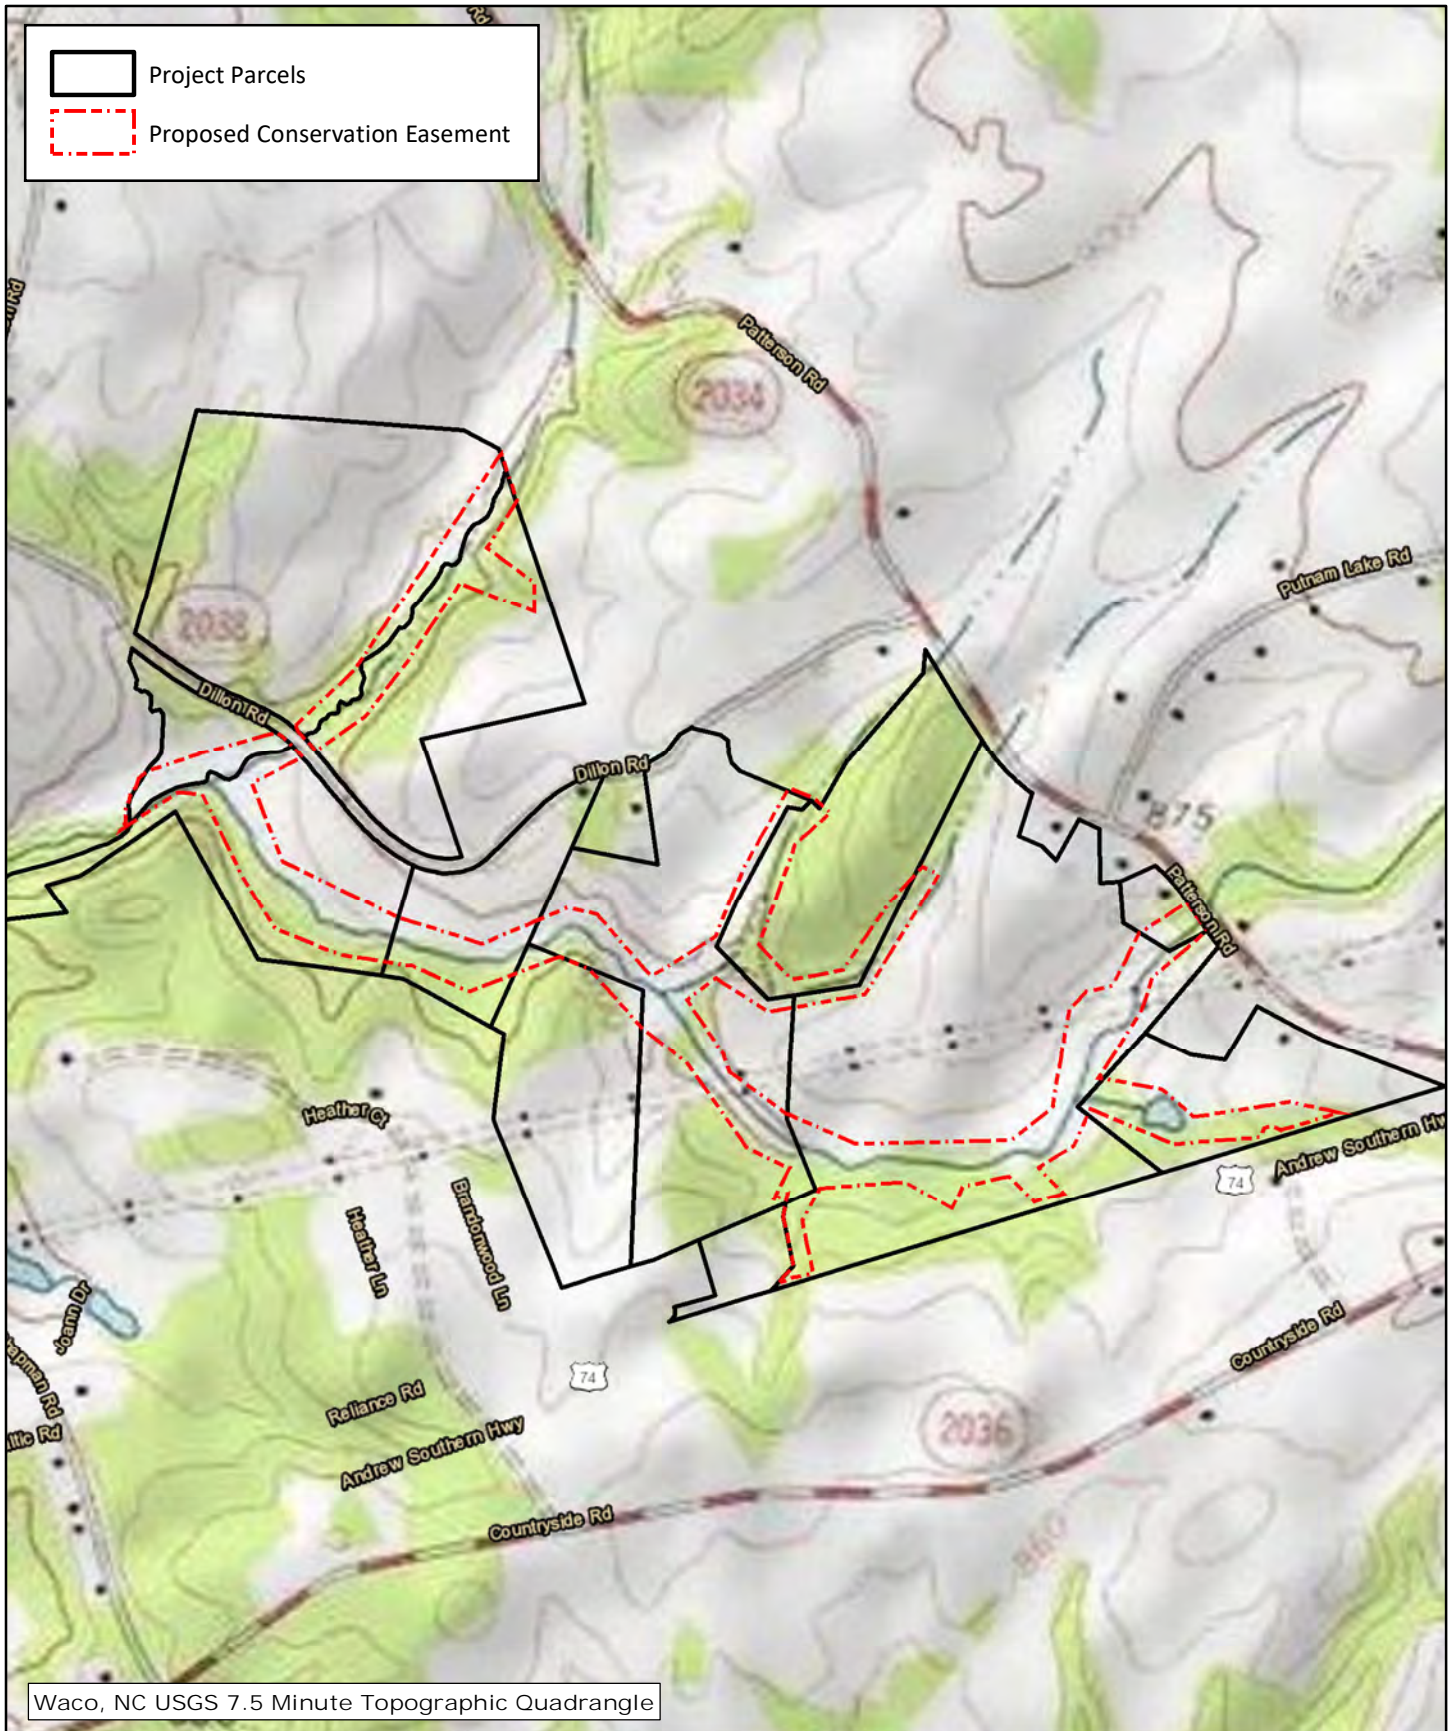
Figure 3 USGS Topographic Map
 Bridgefork Dairy Mitigation Site
 Broad River Basin 03050105

The Site topography, as is indicated on the Waco, NC USGS 7.5-minute topographic quadrangle, shows a moderately sloped and broad valley along Bridgefork Creek. Valleys for project tributaries are shown as steeper and more confined, which is typical of smaller drainages and headwater tributaries for this region (Figure 3).

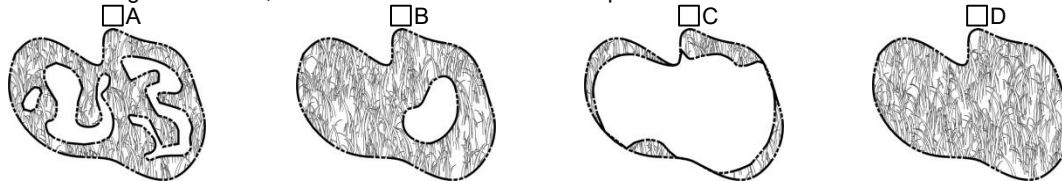
Select the figure that best describes the amount of interspersion between vegetation and open water in the growing season. Patterned areas indicate vegetated areas, while solid white areas indicate open water.

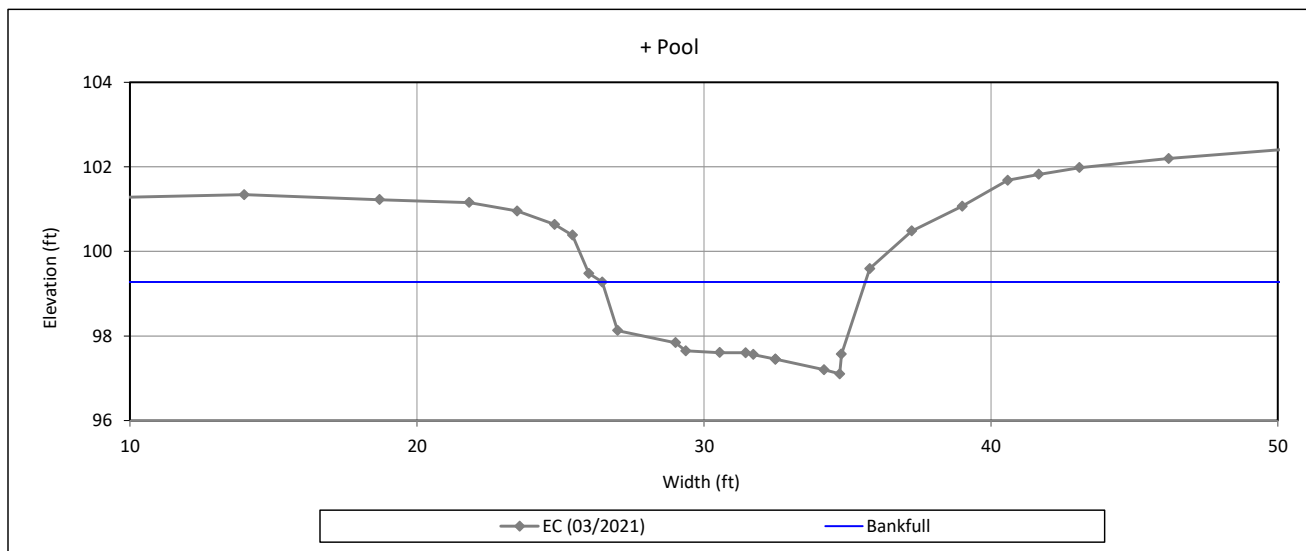
Cross-Section 15 - UT4 R2

14.0	x-section area (ft.sq.)
9.2	width (ft)
1.5	mean depth (ft)
2.2	max depth (ft)
11.5	wetted perimeter (ft)
1.2	hydraulic radius (ft)
6.0	width-depth ratio

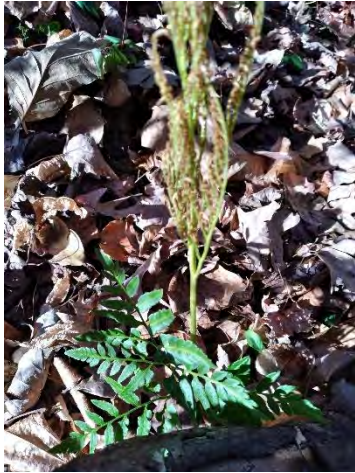
The following photographs support the decision to extend the growing season beyond the dates provided from a nearby WETS station. The photos document new growth after the end of the WETS growing season, and flowering that is occurring before the start of the WETS growing season.

Flowering *Sceptridium dissectum*. Cleveland County (Bridgefork Dairy Site). (12/02/2021)

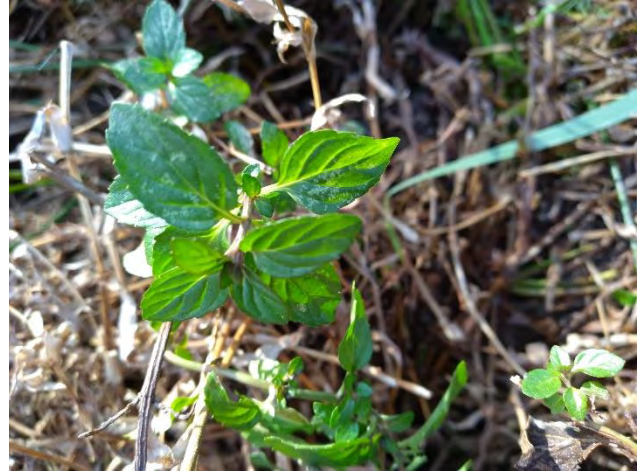
New Growth - *Mentha aquatica*. Cleveland County (Bridgefork Dairy Site). (12/02/2021)

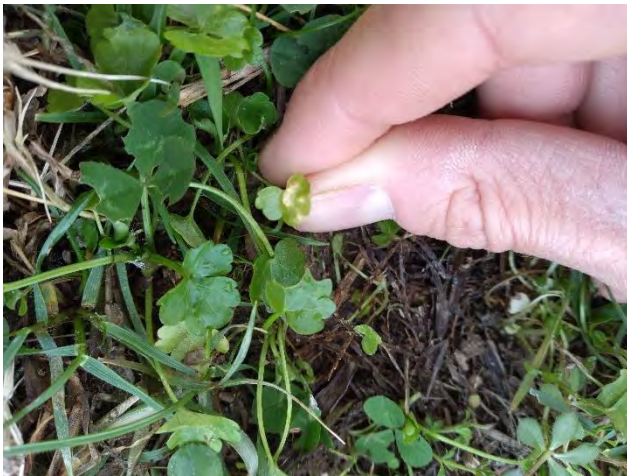
New Growth - *Ranunculus repens*. Cleveland County (Bridgefork Dairy Site). (12/02/2021)

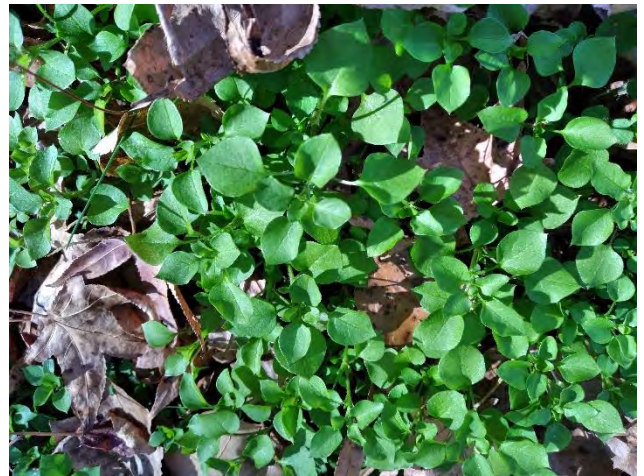
New Growth - *Stellaria media*. Cleveland County (Bridgefork Dairy Site). (12/02/2021)

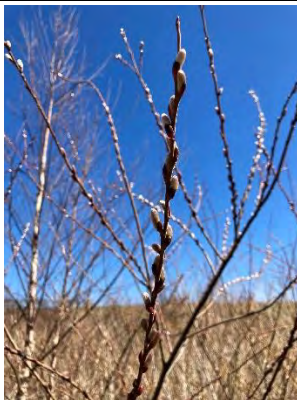
Flowering - *Salix sericea*. Cleveland County (Big Harris Site). (03/01/2022)

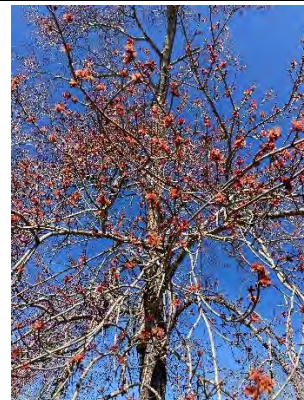
Flowering - *Acer rubrum*. Cleveland County (Big Harris Site). (03/01/2022)
