**BROCK STREAM ENHANCEMENT**  
**FINAL AS-BUILT & BASELINE MONITORING REPORT**

Jones County, North Carolina  
SCO Project Number 050650601-A  
EEP Project Number 92333

Status of Plan: Final  
Submission Date: August 2010

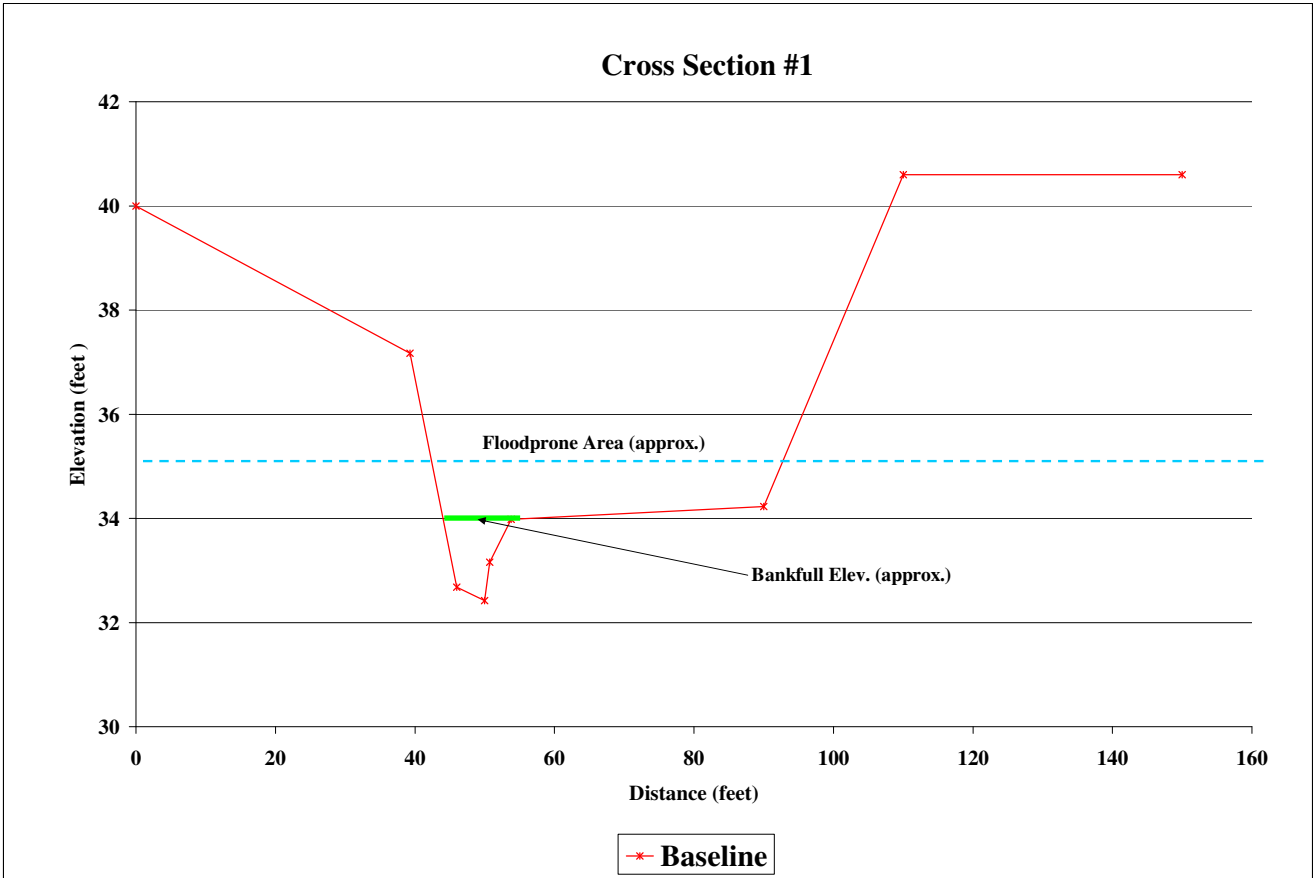
Project Name: Brock  
 Cross Section: Cross Section 2 Sta 15+00  
 Feature:  
 Date: As Built -7/23/2009  
 Crew:

Summary					
	Year 5	Year 4	Year 3	Year 1	Bench
Area					8.5
Width					8.0
Mean Depth					1.1
Max Depth					1.5
W/D					7.5

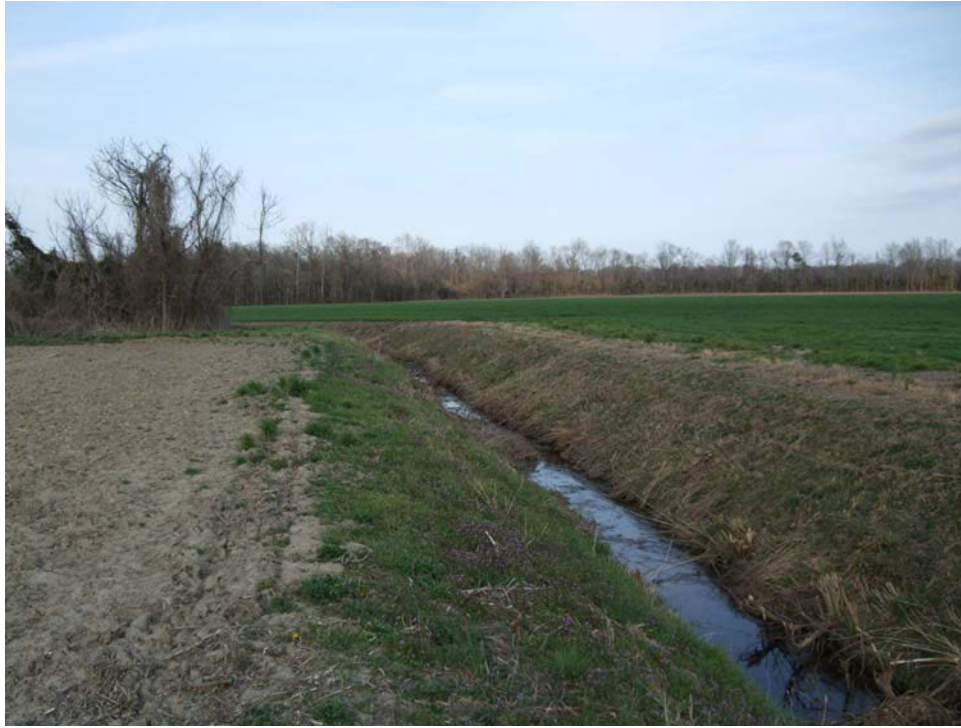
**Photo B1** – Pre-construction stream channel looking downstream near station 14+00 (3/10/09)

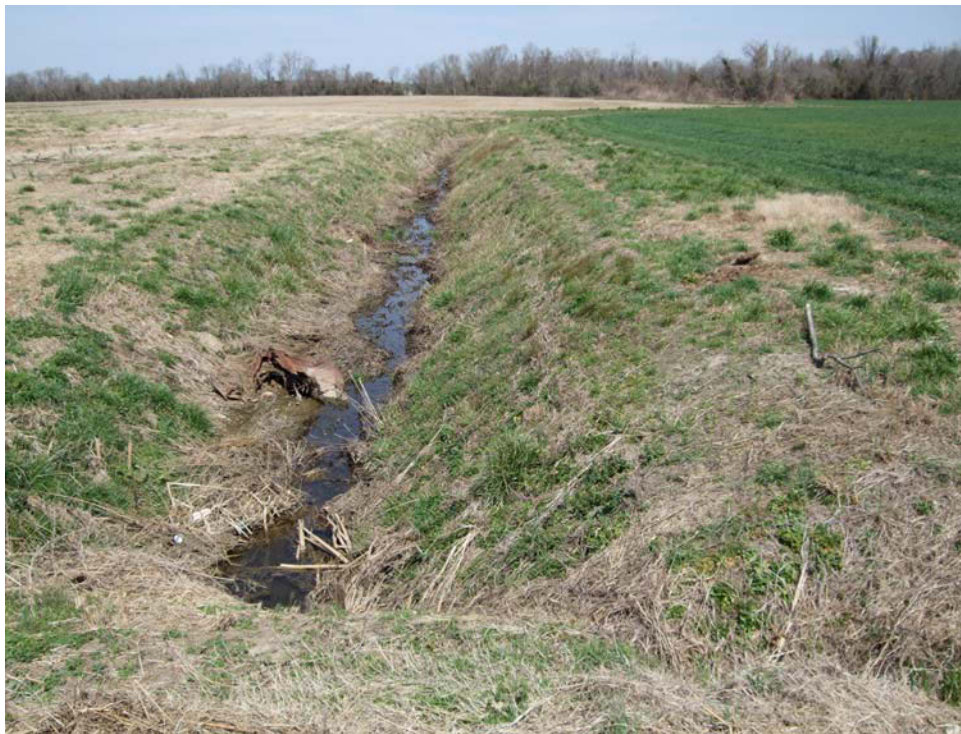
**Photo B2** – (Photo Station 1) Pre-construction, top of reach looking downstream to permanent cross-section 11+00 (3/10/2009)

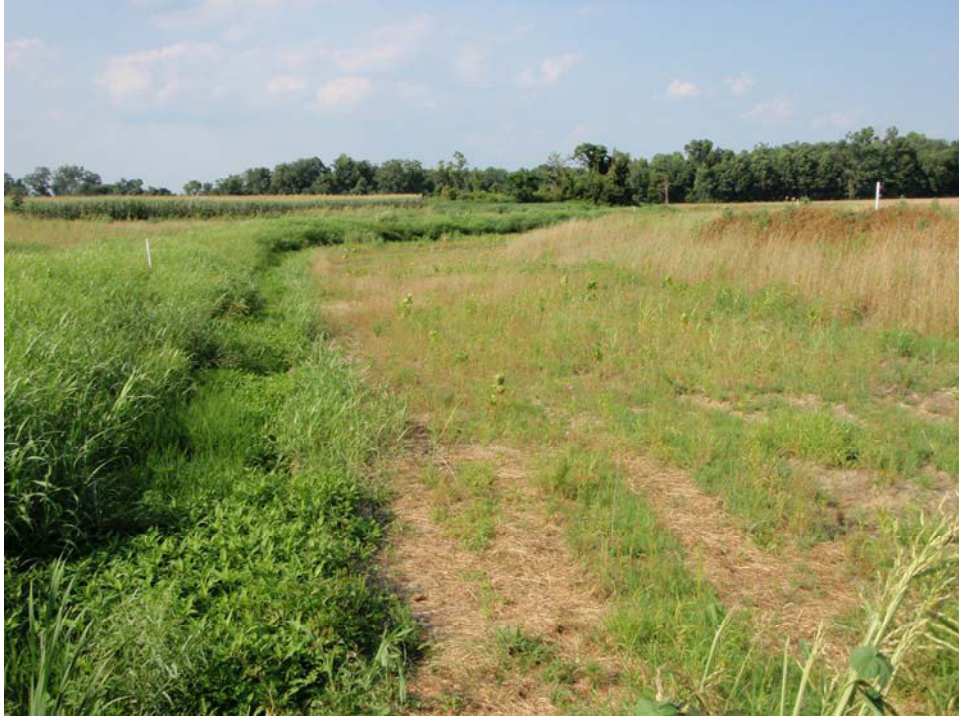
**Photo B3 – (Photo Station 1)** Post-construction, top of reach looking downstream to cross-section 11+00 (marked by PVC pipes) (7/2/2009 Year 0)

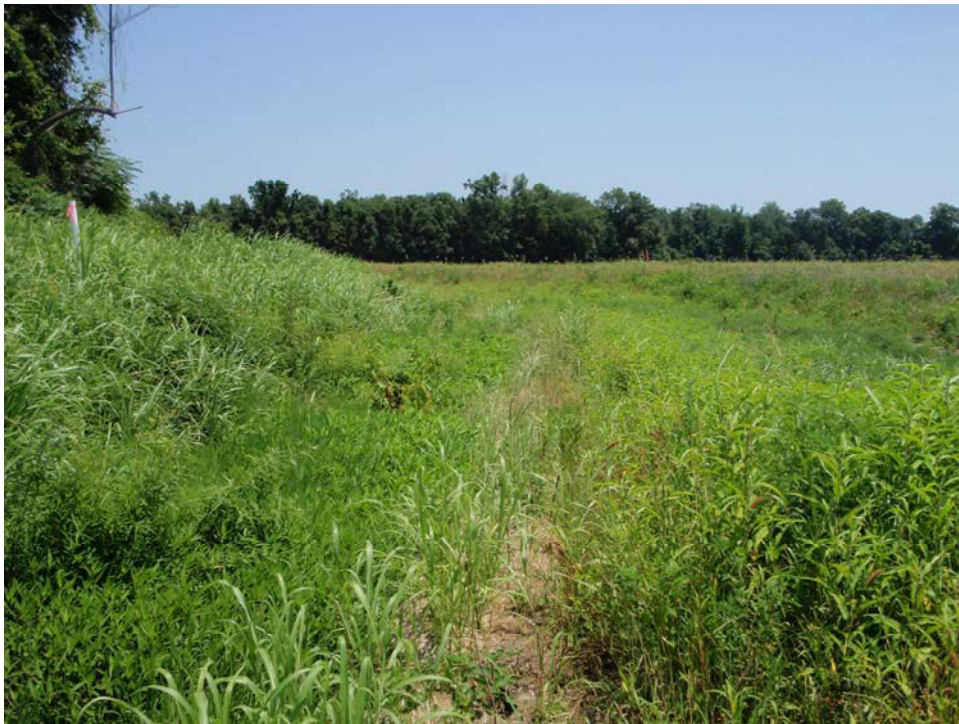
**Photo B4 – (Photo Station 4)** Stream channel looking downstream at cross-section 15+00 (7/2/2009 Year 0)

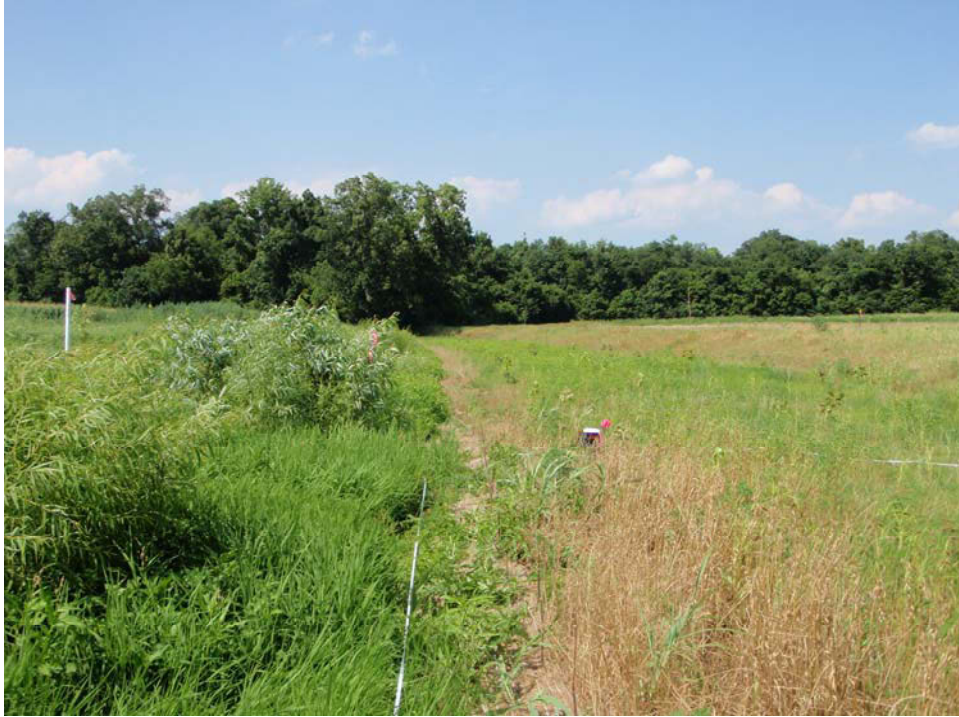
**Photo B5 – (Photo Station 10)** Stream channel looking downstream at cross-section 23+00 (marked by PVC poles just downstream of Veg Plot 4) (7/2/2009 Year 0)

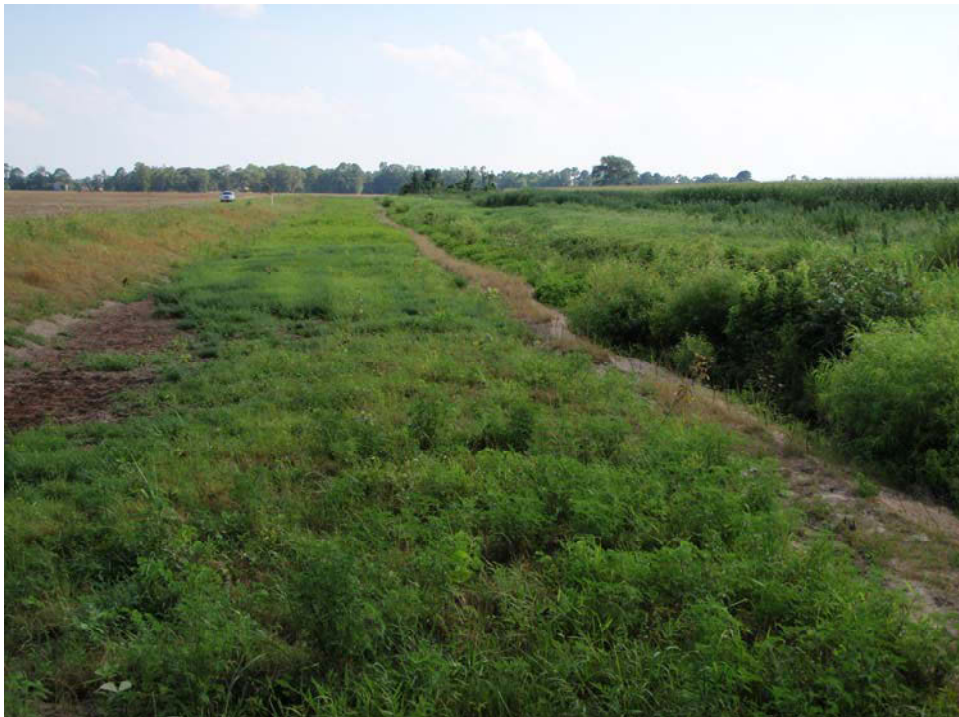
**Photo B6 – (Photo Station 13)** Lower end of stream enhancement looking upstream (7/2/2009 Year 0)

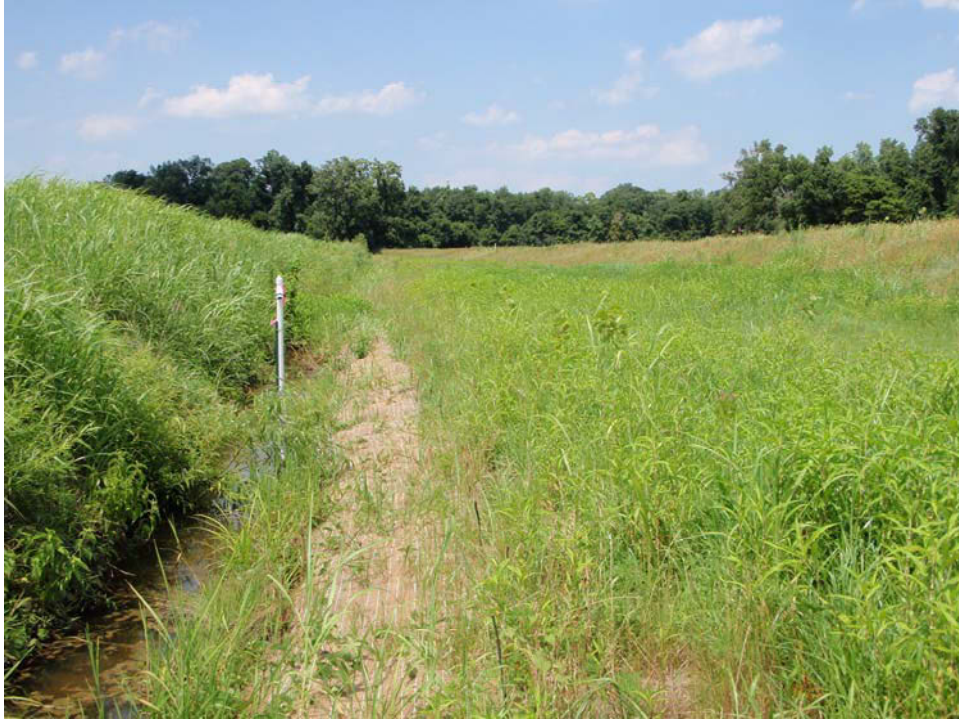
**Photo B7 – (Photo Station 7) – Crest gauge looking downstream (7/2/2009 Year 0)**

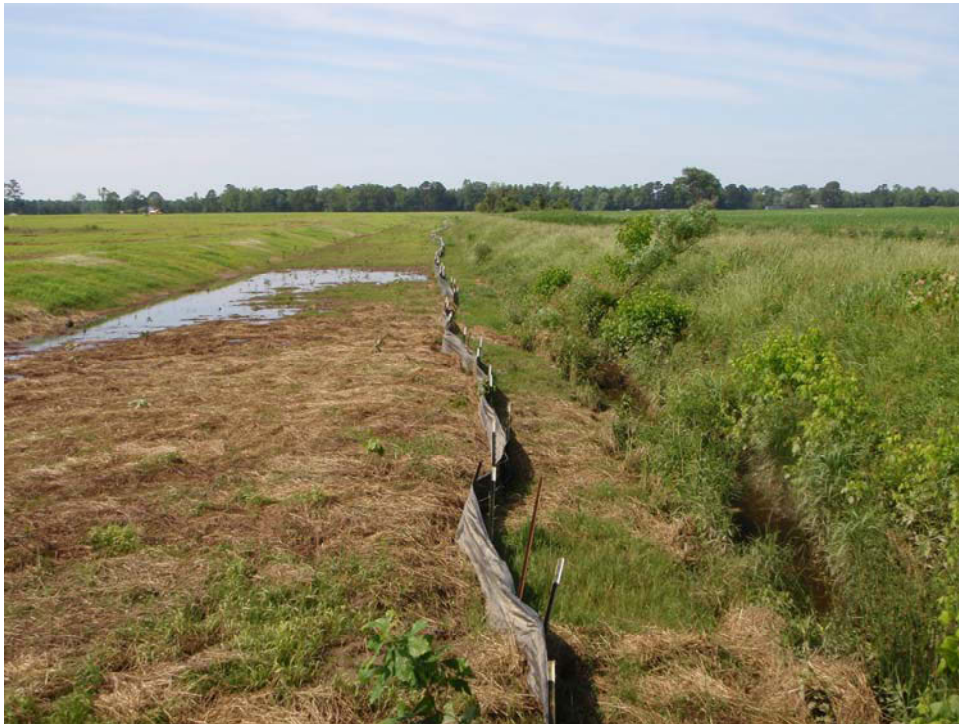
Large rain events onsite occurred in the middle of April and first half of May 2009. Bankfull flow is evidenced by the wrack lines of straw observed at the downstream end of the project reach on May 13,

**Photo B8 – Evidence of bankfull flow (wreck lines of straw and sediment on plants). Lower end of stream enhancement looking upstream (5/13/2009 Year 0)**

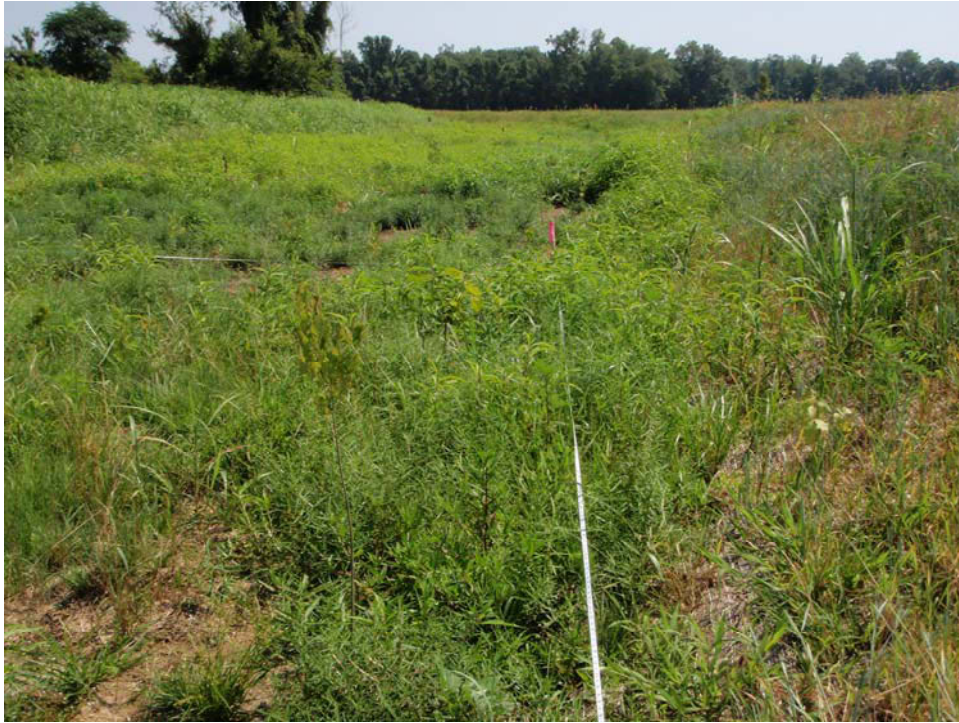
**Photo C1 – (Photo Station 2) Veg Plot 1 looking downstream (7/2/2009 Year 0)**

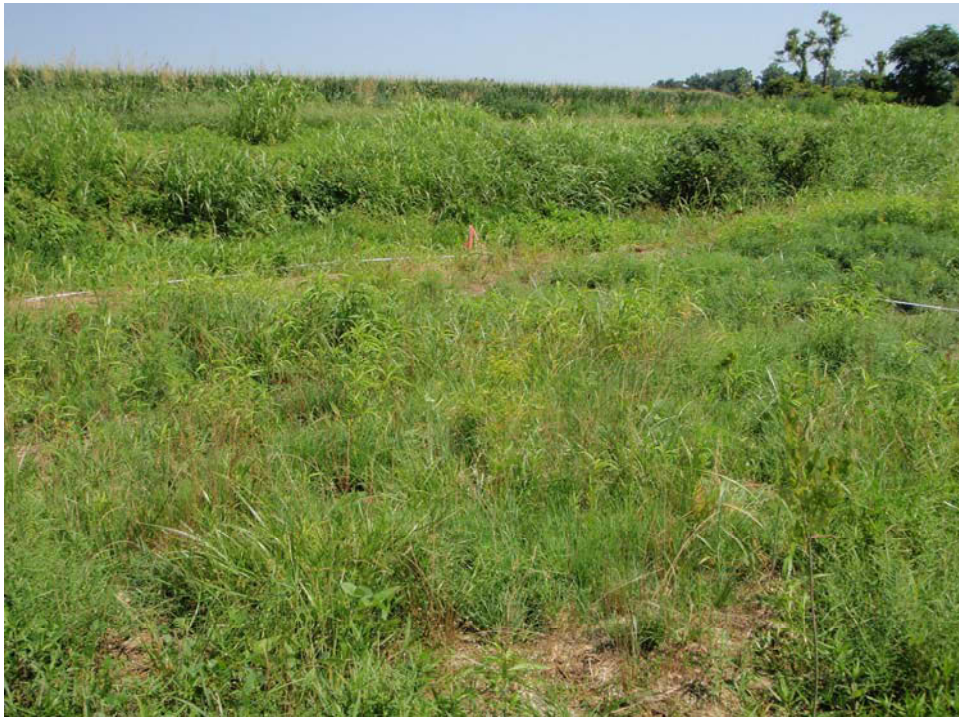
**Photo C2 – (Photo Station 3) Veg Plot 1 looking north across floodplain (7/2/2009 Year 0)**

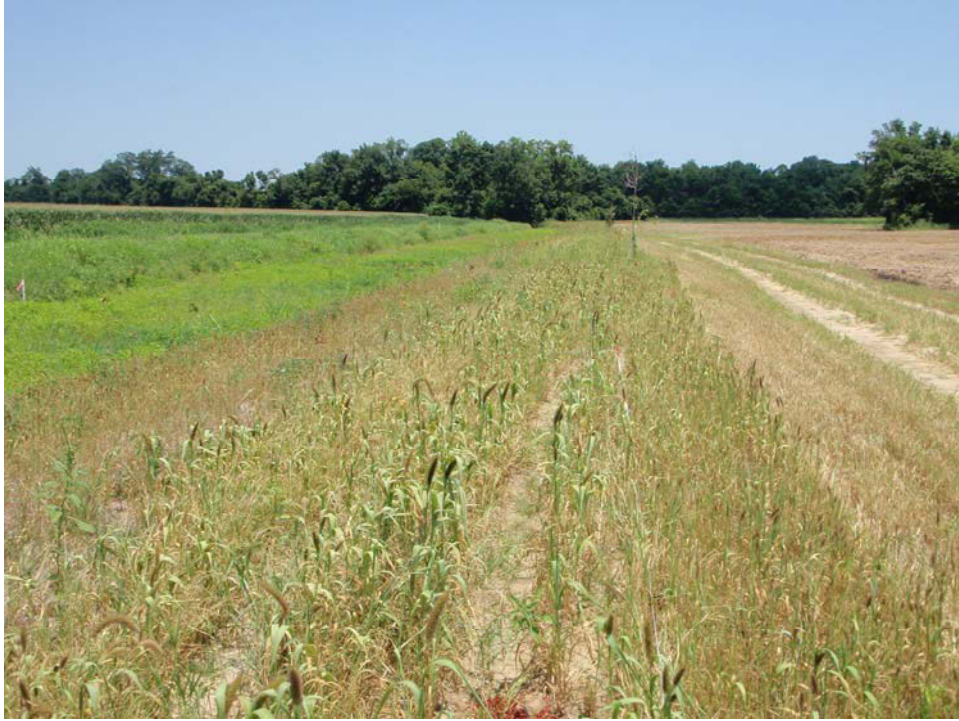
**Photo C4 - (Photo Station 5)** Veg Plot 2 looking downstream (crest gauge in far left of photo) (7/2/2009 Year 0)

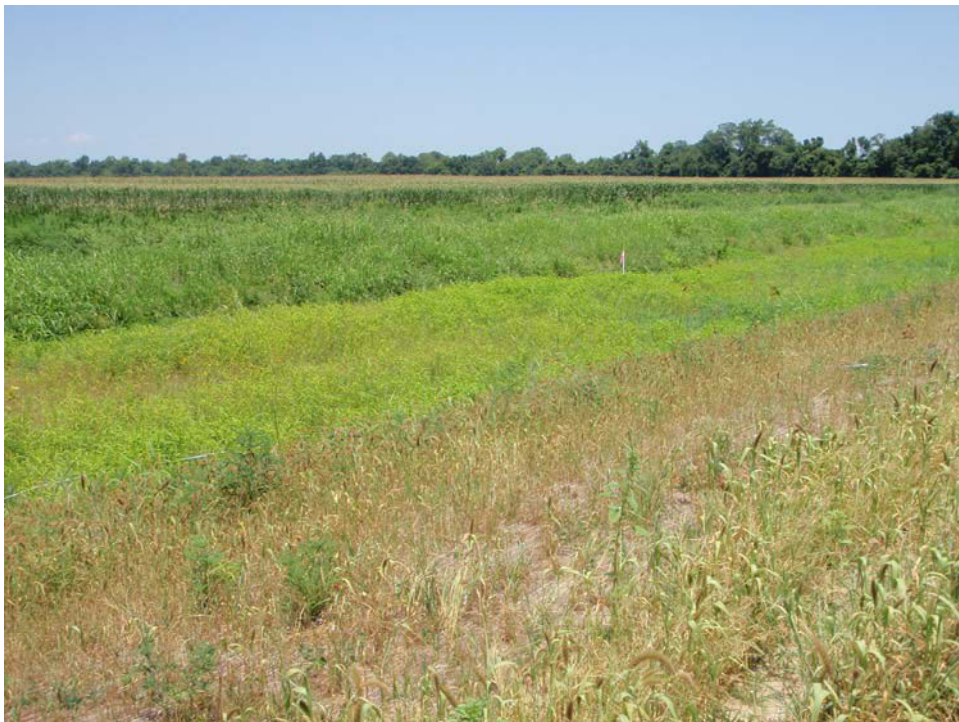
**Photo C5 - (Photo Station 6)** Veg Plot 2 looking northwest across floodplain (crest gauge in right portion of photo) (7/2/2009 Year 0)

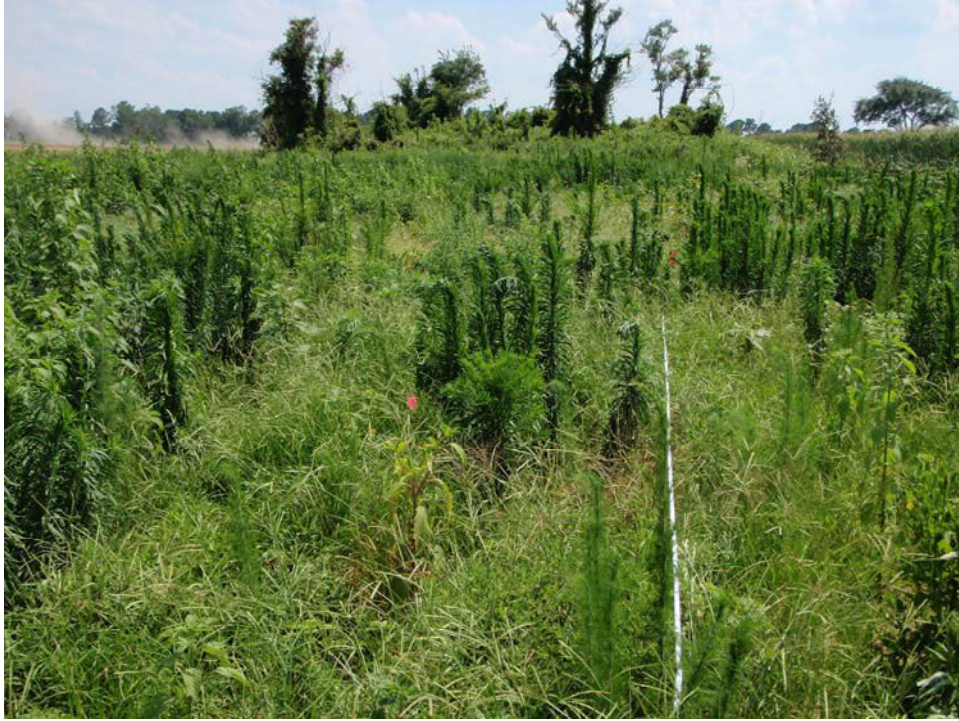
**Photo C6 – (Photo Station 8) Veg Plot 3 looking upstream (toward cemetery) (7/2/2009 Year 0)**

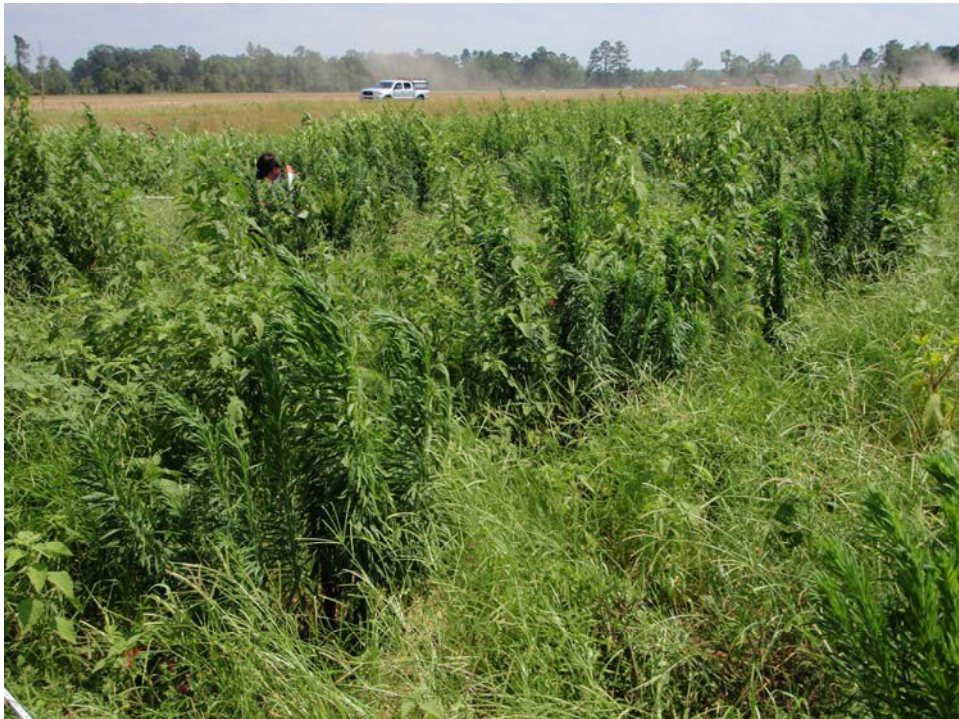
**Photo C7 – (Photo Station 9) Veg Plot 3 looking southeast across floodplain (7/2/2009 Year 0)**

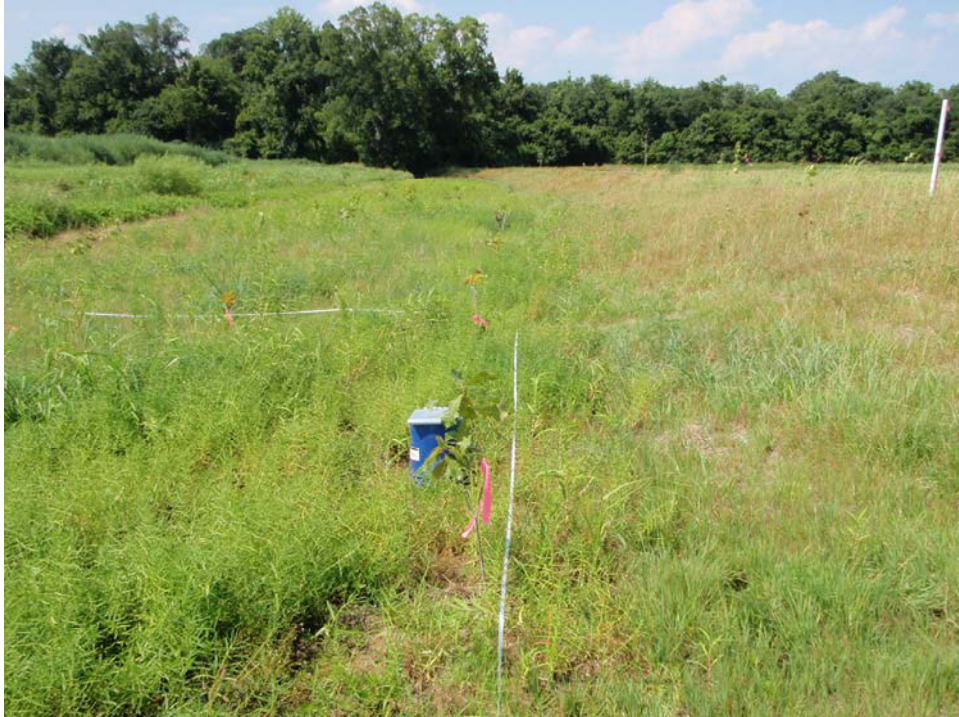
**Photo C8 – (Photo Station 11) Veg Plot 4 looking downstream (7/2/2009 Year 0)**

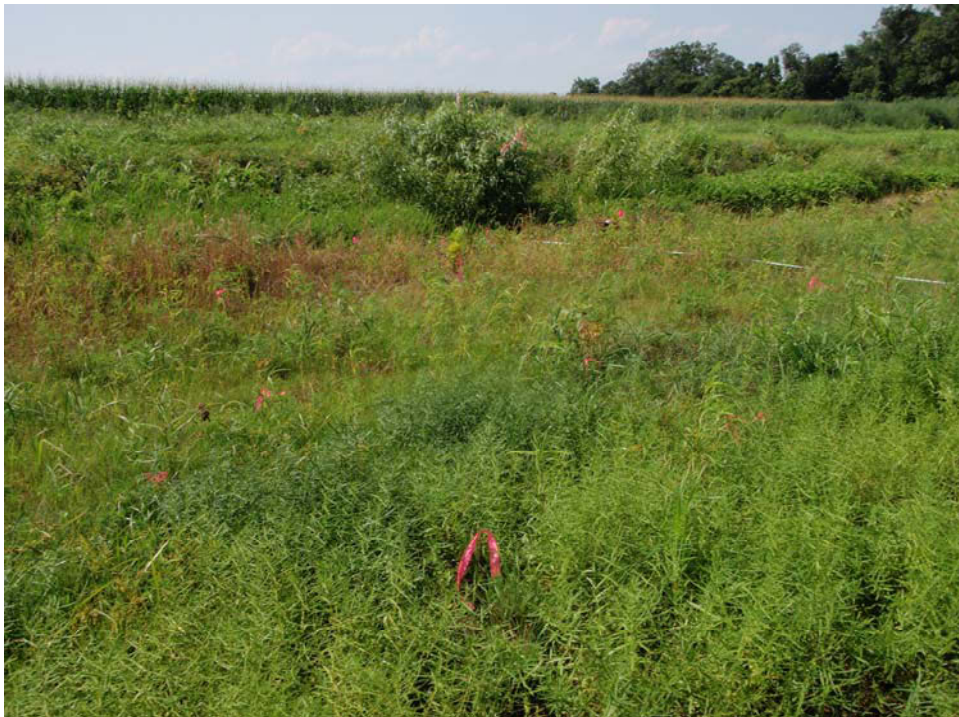
**Photo C9 – (Photo Station 12) Veg Plot 4 looking north across floodplain (7/2/2009 Year 0)**

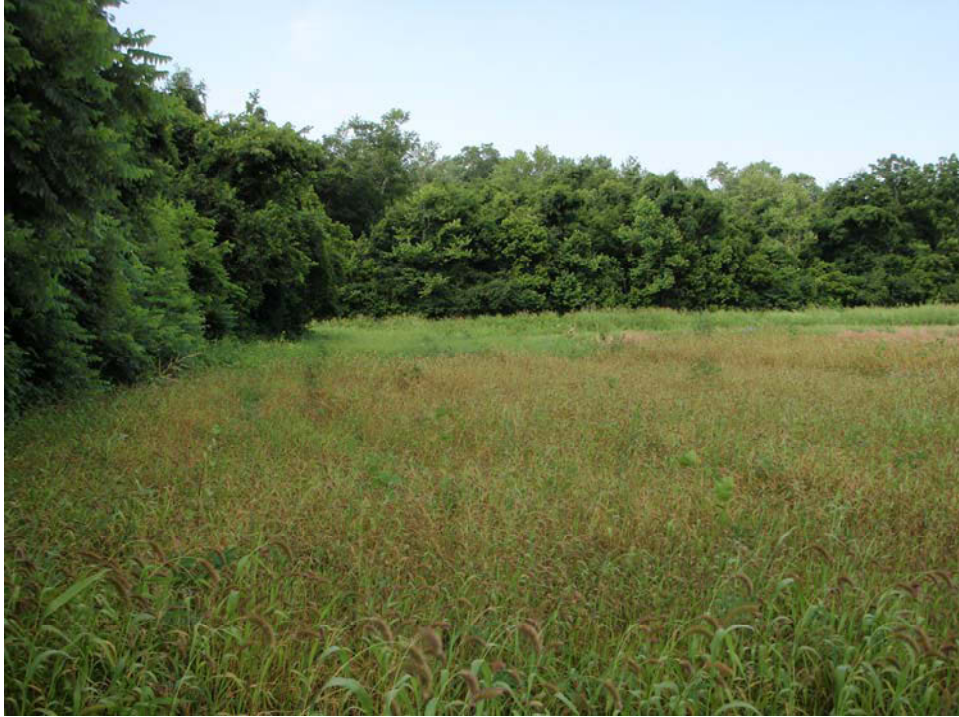
**Photo C10 – (Photo Station 14)** Upland Buffer planting zone looking toward Big Chinquapin Branch from lower end of stream enhancement reach (7/2/2009 Year 0)

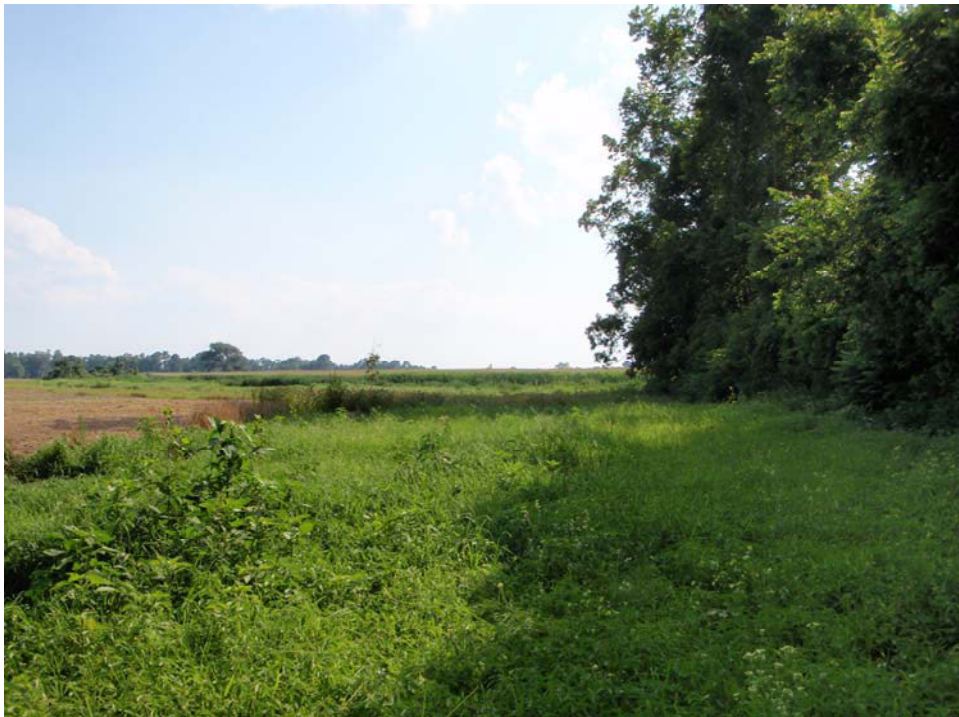
**Photo C11 – (Photo Station 15)** Upland buffer planting zone along UT near Big Chinquapin Branch, looking southwest (7/2/2009 Year 0)

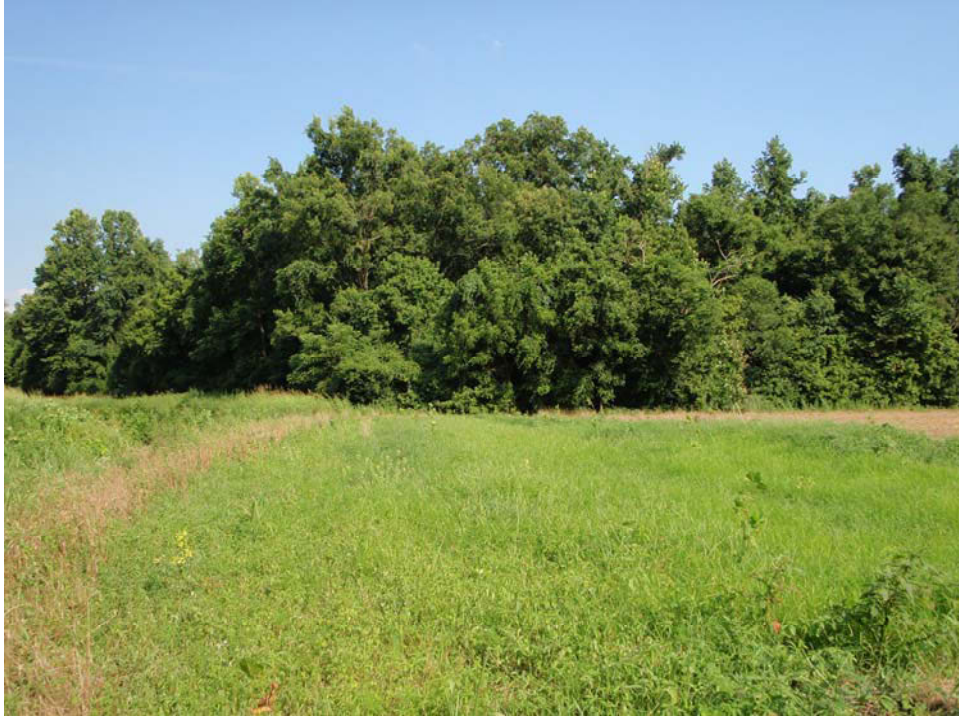
**Photo C12 – (Photo Station 16)** Upland Buffer planting zone along Big Chinquapin Branch, looking southeast (7/2/2009 Year 0)
