BROCK STREAM RESTORATION

FINAL RESTORATION PLAN

Jones County, North Carolina
SCO Project Number 050650601

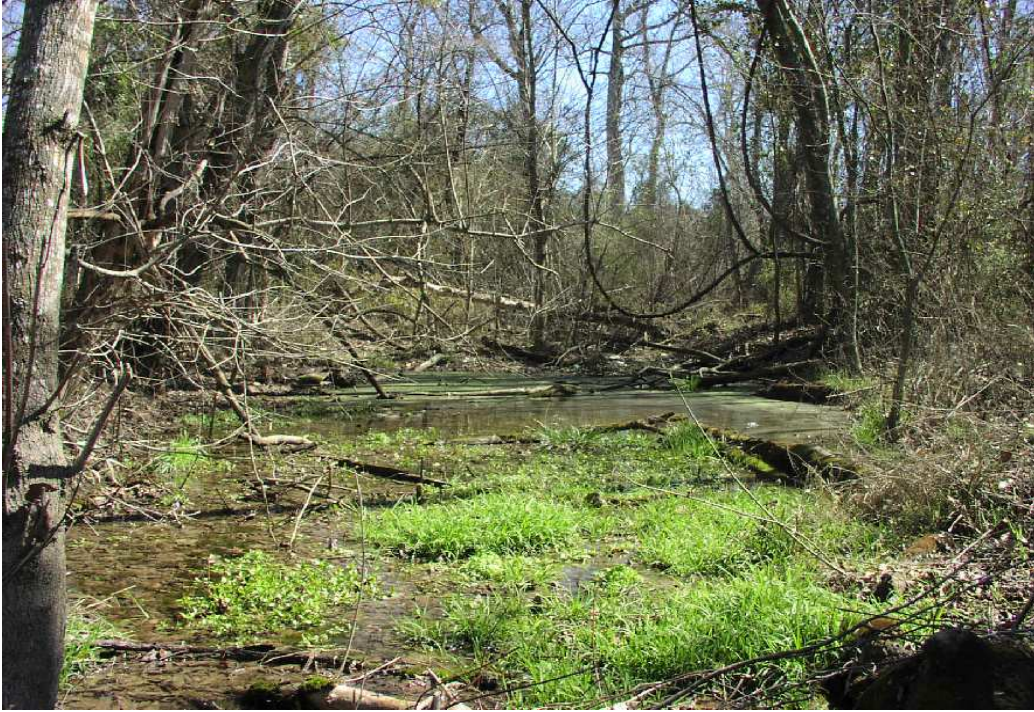
Photo 1. Coastal Plain Bottomland Hardwood Forest
Adjacent to Big Chinquapin Branch

Vegetative communities present on the Brock Site include agricultural row crops, Coastal Plain Bottomland Hardwood Forest, and a Mesic Hardwood Forest. The majority of the Brock and surrounding properties are used for agricultural crop production. On the Brock Site, this land use covers approximately 87 acres. Cotton was the dominant crop noted during Fall 2001 and 2005. The natural communities on the site were identified based on the classification system established by Schafale and Weakley (1990). Restoration of the stream channel and riparian buffer will provide additional wildlife habitat for terrestrial and aquatic species where very little habitat existed before.

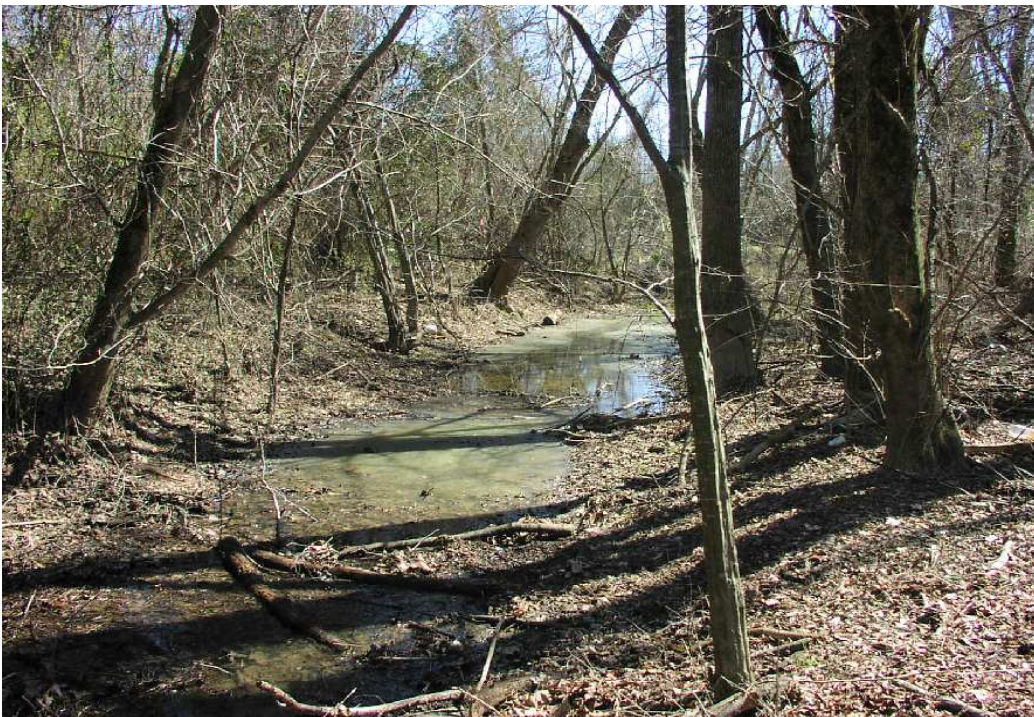
Photo 2. Former Channel of Big Chinquapin Branch
Located in Coastal Plain Bottomland Hardwood Forest

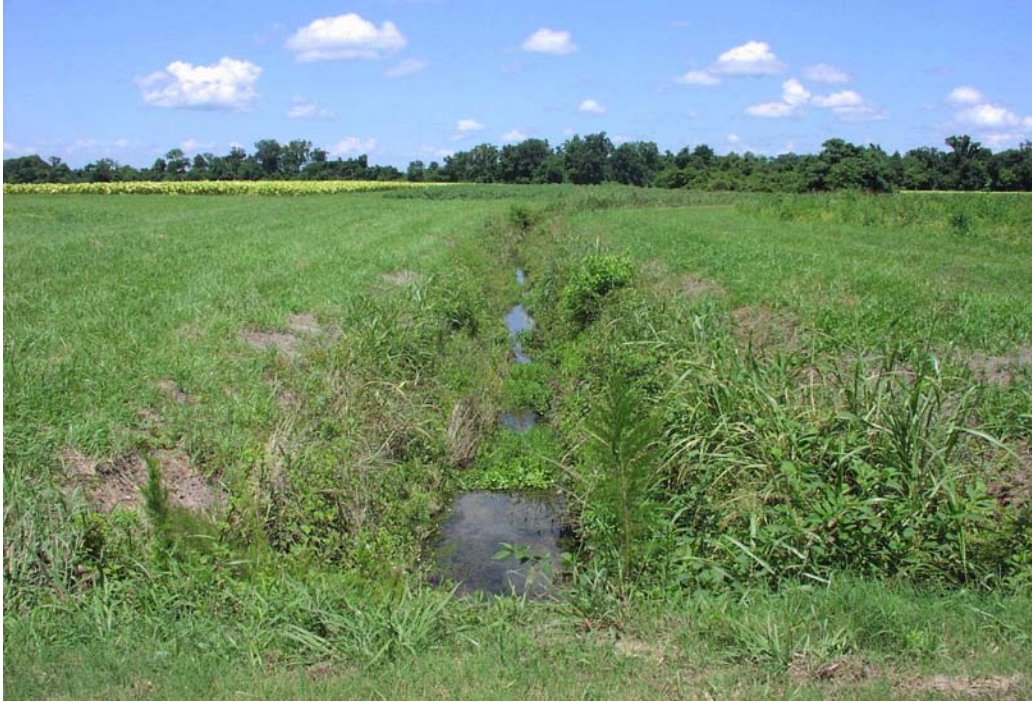
Photo 3. Existing Channel; Southern Property Limits Facing North
Looking Downstream Showing Entrenched Channel

The fluvial processes occurring have been causing instability and eroding banks. These trends may continue if the stream is not restored to a stable condition. The channel is also a pathway for nutrients from the surrounding agricultural areas to the nutrient sensitive waters of the Trent River. Impacts resulting from sediment and nutrient depositions will decrease once the channel and buffer are restored. Photographs of the channel are located in Appendix 1.

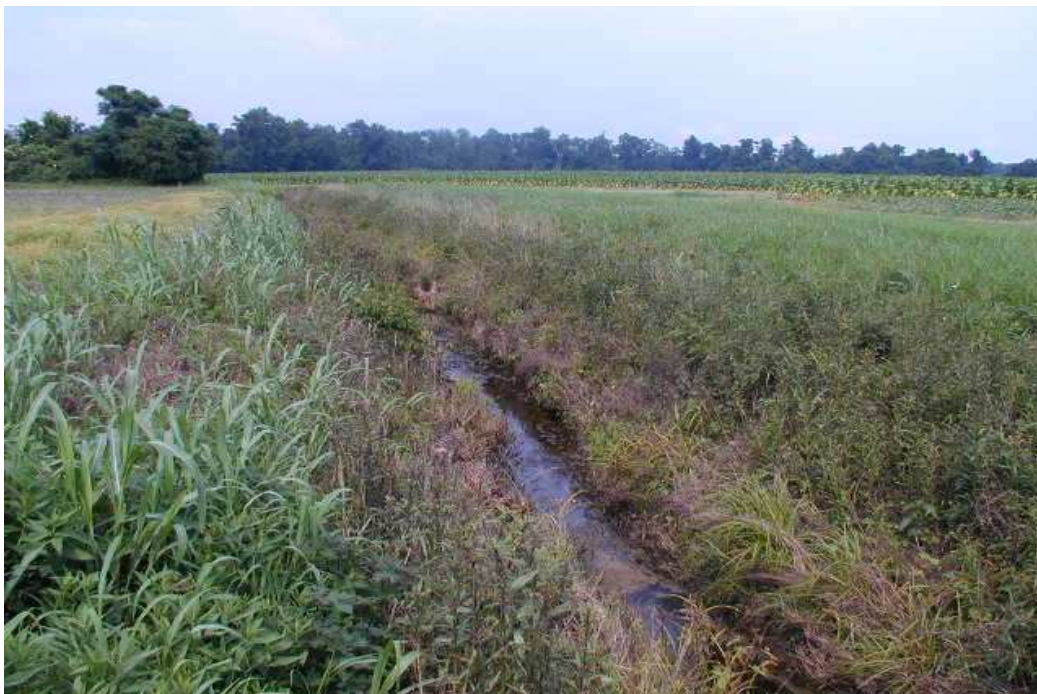
Photo 4. Existing Channel; Middle Reach Facing North
Looking Downstream Showing Mowed Buffer

The historic forested riparian buffer has been replaced with a narrow grassy border and row crops that provide only limited thermal and chemical moderating effects. The channel banks are sparsely vegetated
