**ANNUAL MONITORING REPORT
YEAR 4 (2009)
BROGDEN ROAD BUFFER RESTORATION SITE
JOHNSTON COUNTY, NORTH CAROLINA
(Contract Number D05015-3)**

**BROGDEN ROAD BUFFER RESTORATION SITE
ANNUAL MONITORING REPORT
YEAR 4 (2009)
JOHNSTON COUNTY, NORTH CAROLINA**

**Brogden Road Buffer Restoration Site
Year 4 (2009) Annual Monitoring
Vegetation Plot Pictures Taken June 2009**

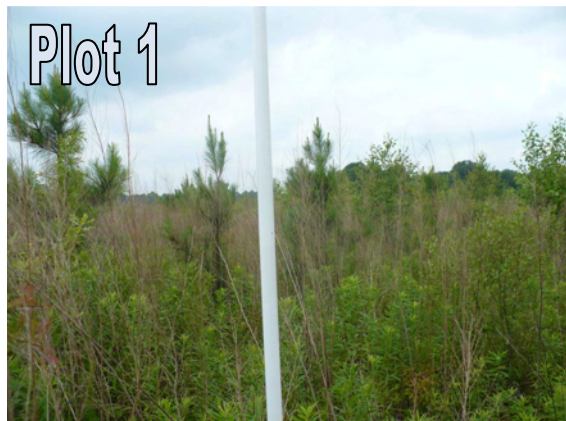
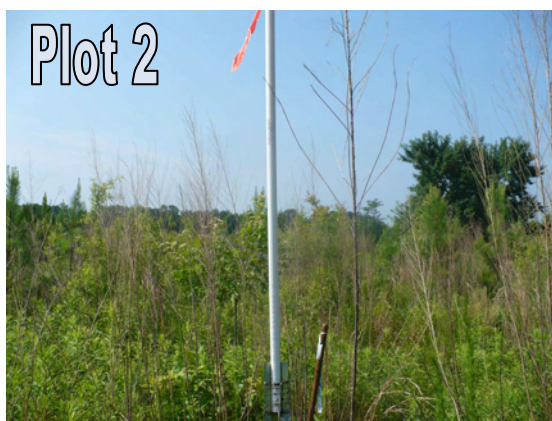
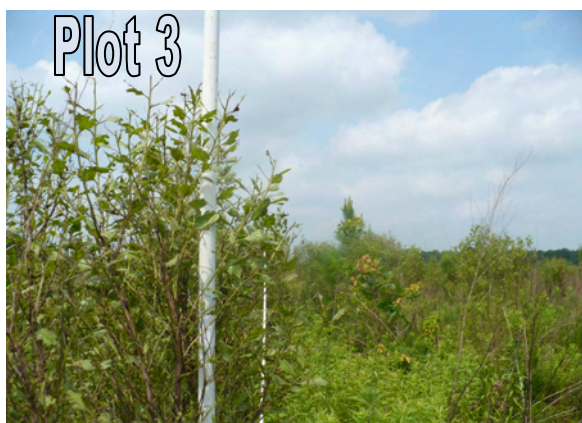
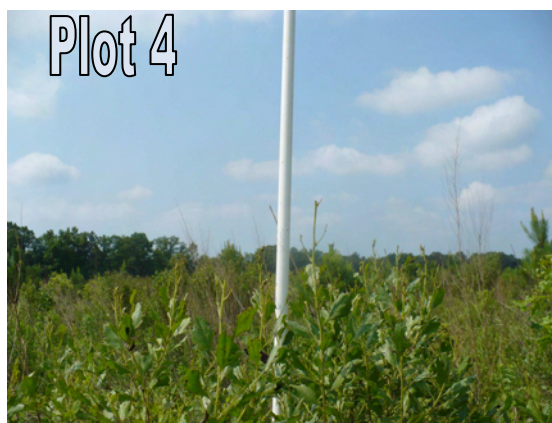
Quantitative sampling of vegetation was conducted in June 2009. Results are provided in Table 2. Vegetation success criteria for year 4 (320 stems per acre) were exceeded for the 2009 annual monitoring year with 1127 tree stems per acre across the Site. All individual vegetation plots met success criteria and had good species diversity with 7 to 13 Character Tree Species present within each plot.
