**ANNUAL MONITORING REPORT
YEAR 5 (2010)
BROGDEN ROAD BUFFER RESTORATION SITE
JOHNSTON COUNTY, NORTH CAROLINA
(Contract Number D05015-3)**

**BROGDEN ROAD BUFFER RESTORATION SITE
ANNUAL MONITORING REPORT
YEAR 5 (2010)
JOHNSTON COUNTY, NORTH CAROLINA**

**Brogden Road Buffer Restoration Site
Year 5 (2010) Annual Monitoring
Vegetation Plot Pictures Taken June 2010**

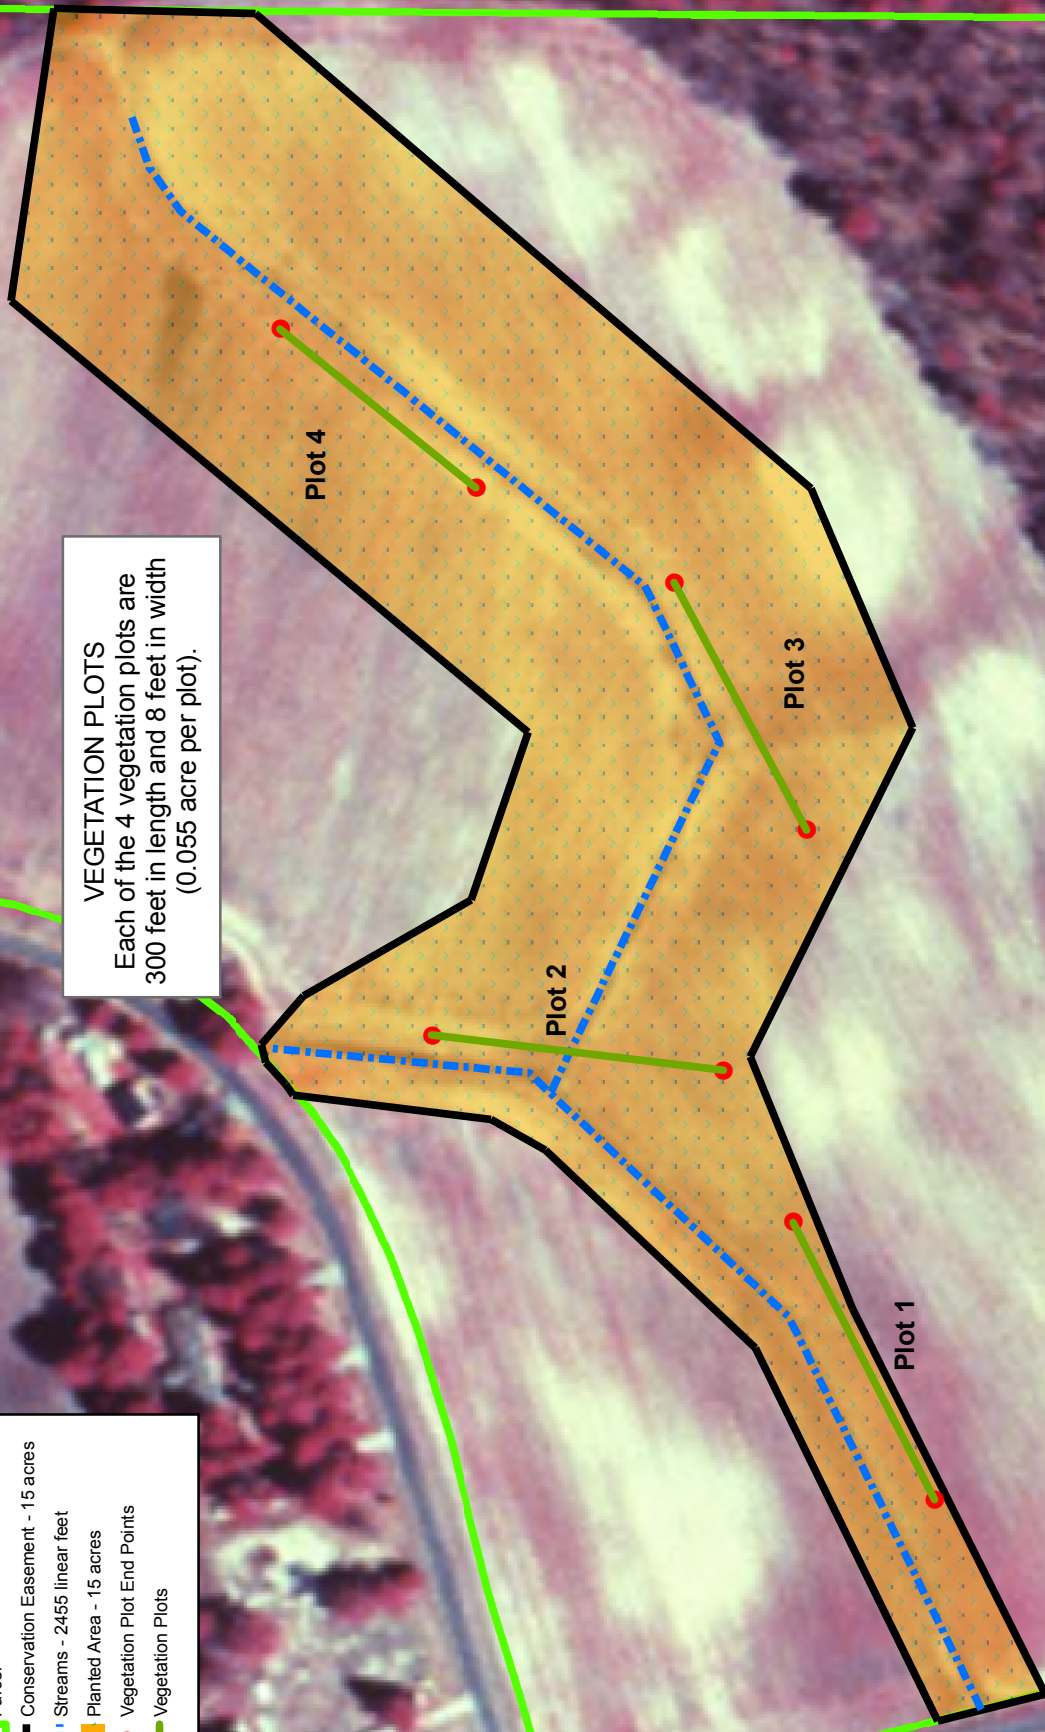
MONITORING PLAN
BROGDEN ROAD BUFFER RESTORATION SITE
 Johnston County, North Carolina

VEGETATION PLOTS
 Each of the 4 vegetation plots are
 300 feet in length and 8 feet in width
 (0.055 acre per plot).

Four linear sample plots were installed within planted areas to equally represent the Site (Figure 2). Each plot is 300 feet in length and 8 feet in width (0.055 acre). Vegetation parameters monitored within each plot include species composition and species density. Visual observations of the percent cover of shrub and herbaceous species were documented in photographs included in Appendix A.

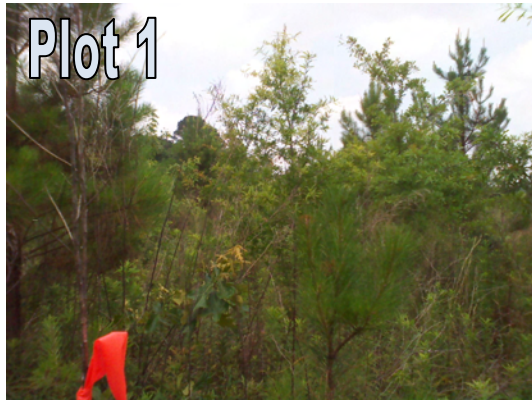
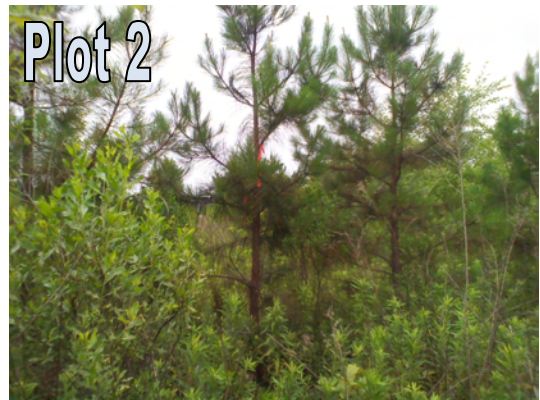
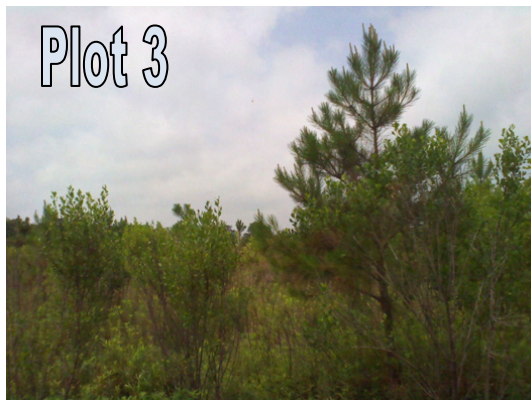
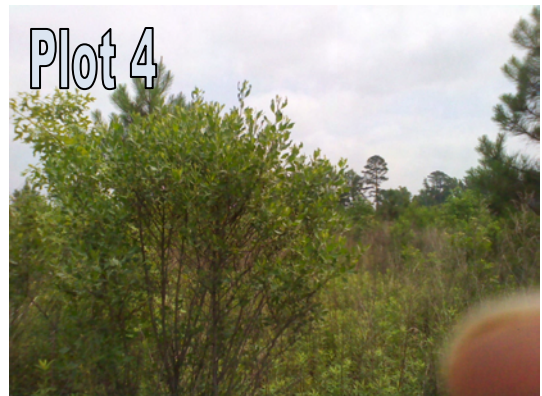
estimates of the percent cover of herbaceous species will be documented through periodic photographs. Photographs of the vegetation plots are included in Appendix A.

Quantitative sampling of vegetation was conducted in June 2010. Results are provided in Table 2. Vegetation success criteria for year 5 (320 stems per acre) were exceeded for the 2010 annual monitoring year with 1591 tree stems per acre across the Site. All individual vegetation plots met success criteria and had good species diversity with 8 to 16 Character Tree Species present within each plot.
