RESTORATION PLAN

BROWN MARSH SWAMP STREAM AND WETLAND RESTORATION SITE

Robeson County, North Carolina
Contract No. 16-D06038

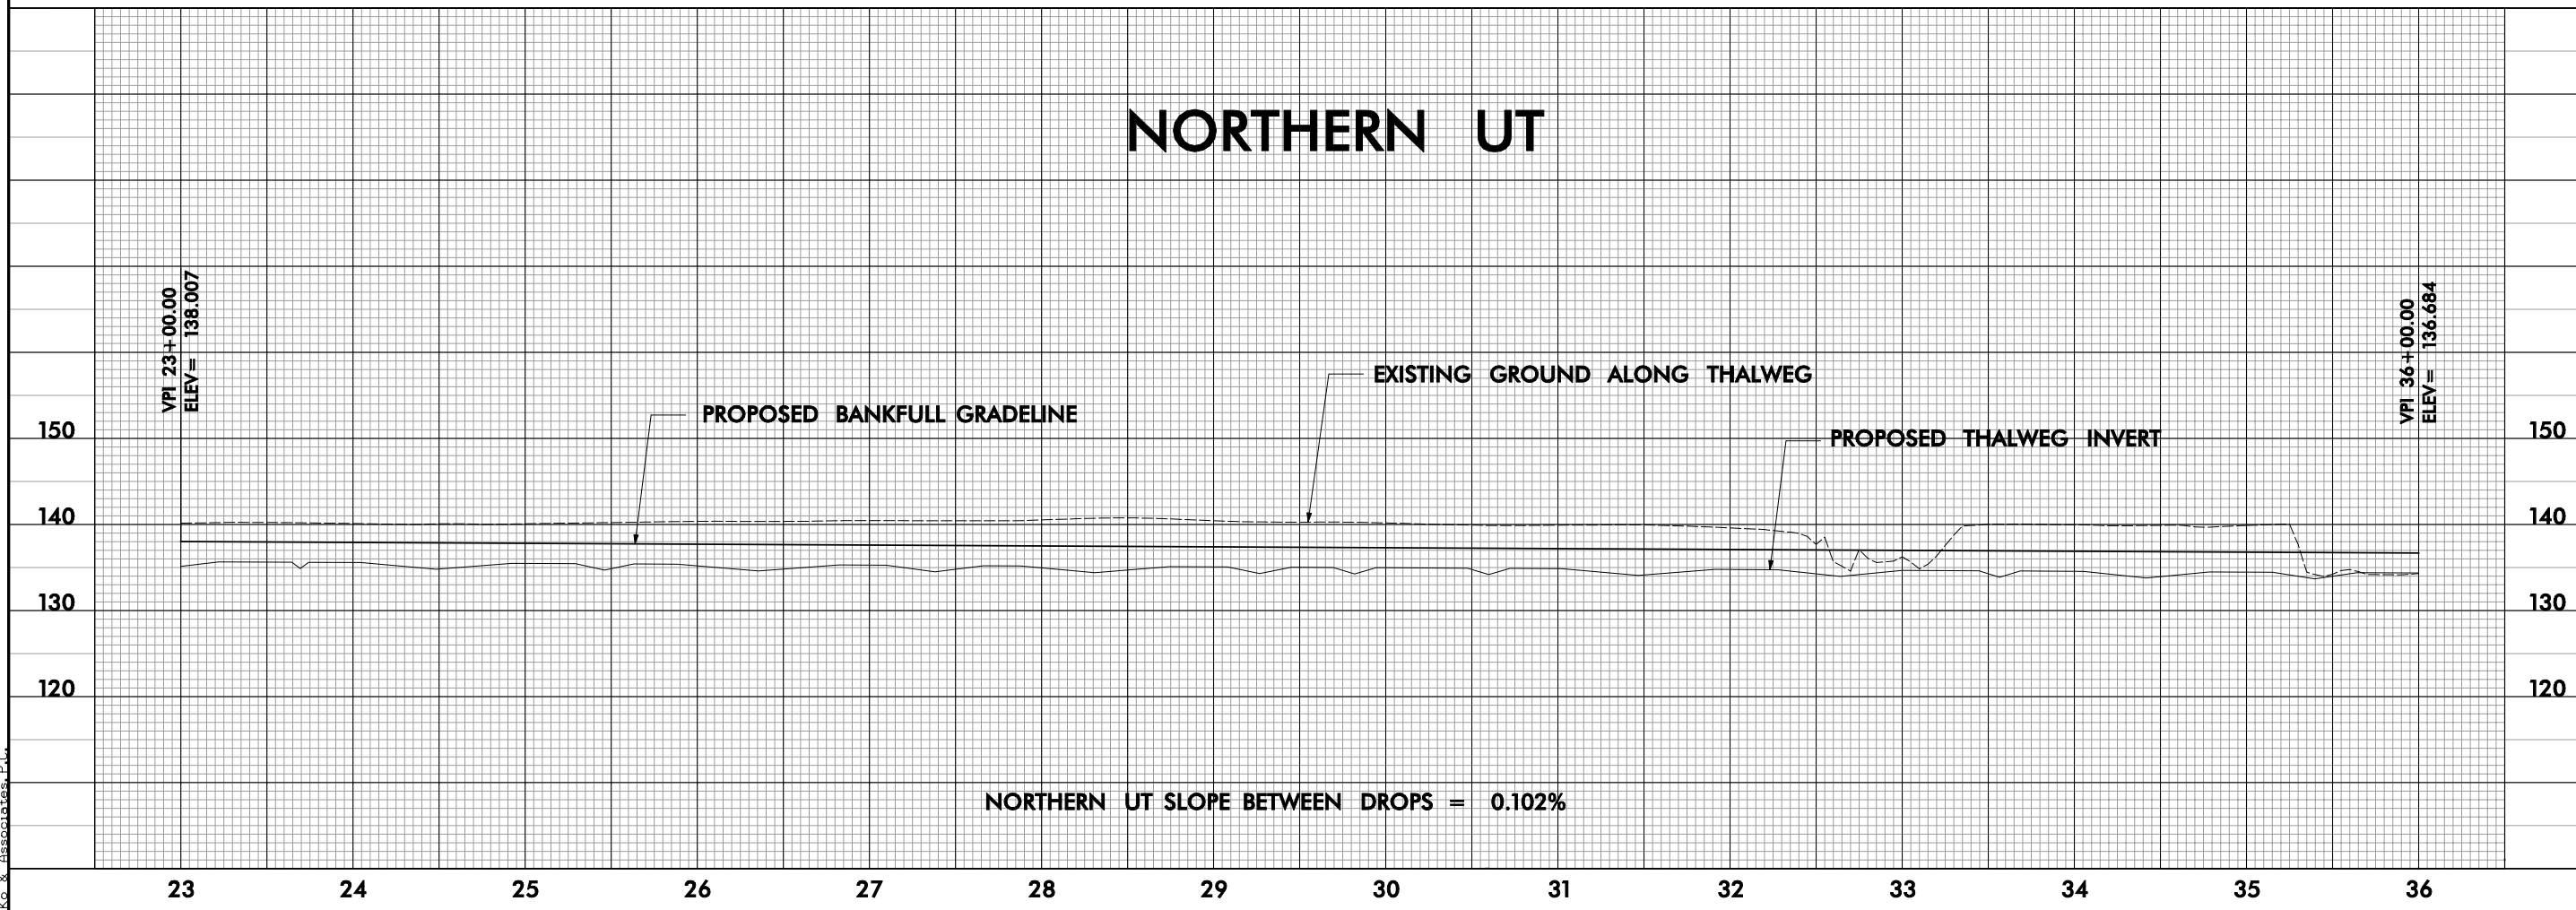
PROJECT REFERENCE NO.	SHEET NO.
BMS	Figure 19
PROJECT ENGINEER

BEGIN NORTHERN UT
STA 10+00.00
ELEV = 139.331

NORTHERN UT

This stream restoration effort is designed to restore a stable, meandering stream on new location that approximates hydrodynamics, stream geometry, and local microtopography relative to reference conditions. Geomorphic attributes for the existing channels, proposed channels, and reference channels are listed in the Morphologic Tables (Appendix B). Proposed conditions for the Northern and Southern UT's (plan view and profile) are depicted on Figures 13 through 20 (Appendix A).

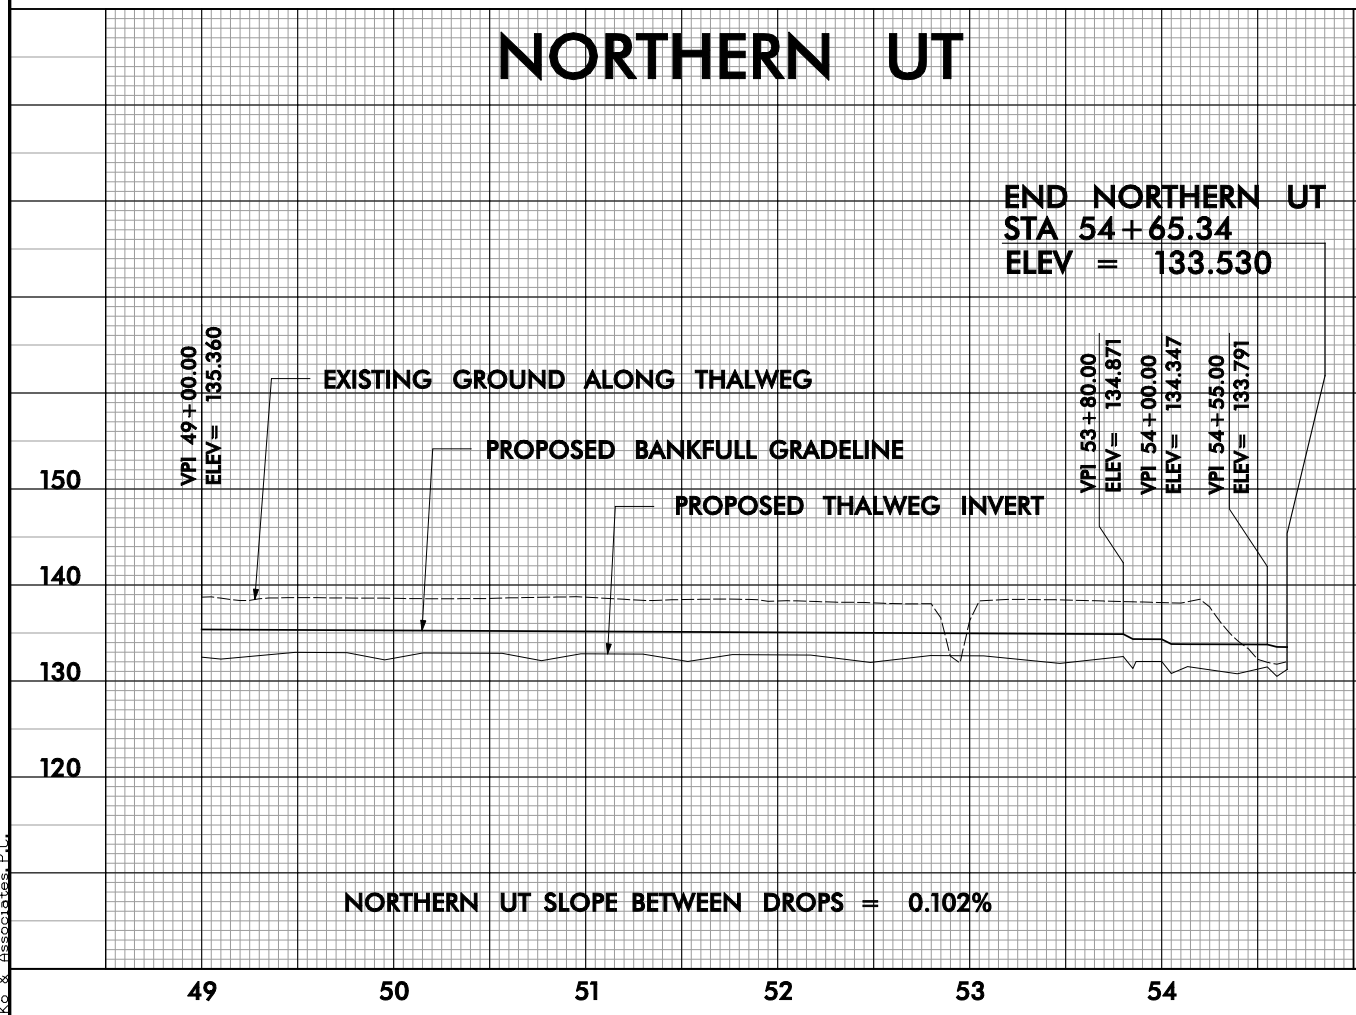
PROJECT REFERENCE NO. BMS
SHEET NO. Figure 20
PROJECT ENGINEER

NORTHERN UT

SOUTHERN UT

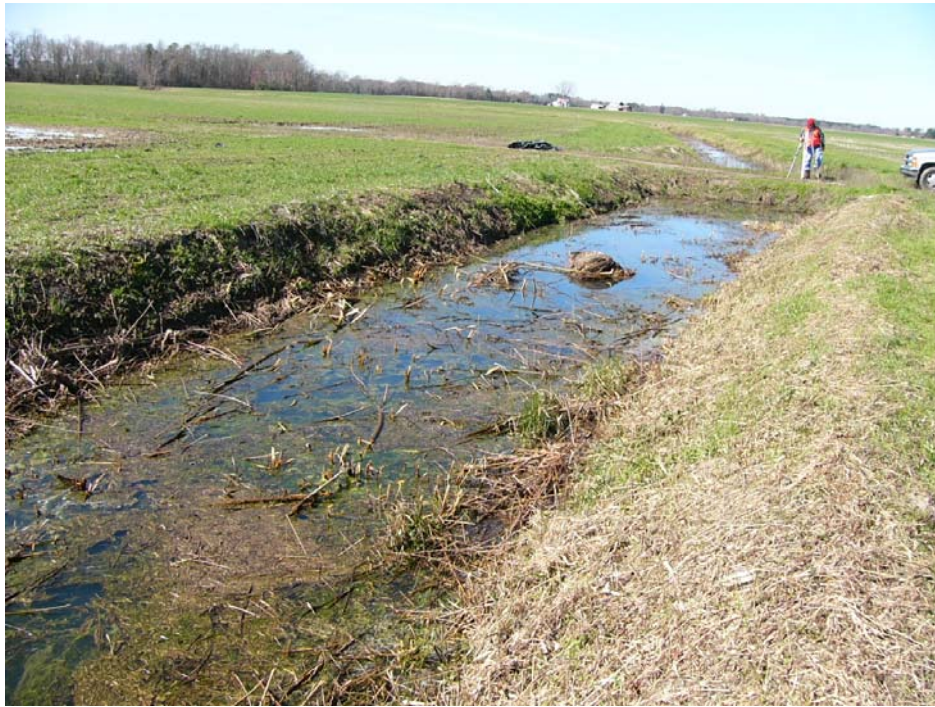
Northern UT looking downstream at recently mowed banks.

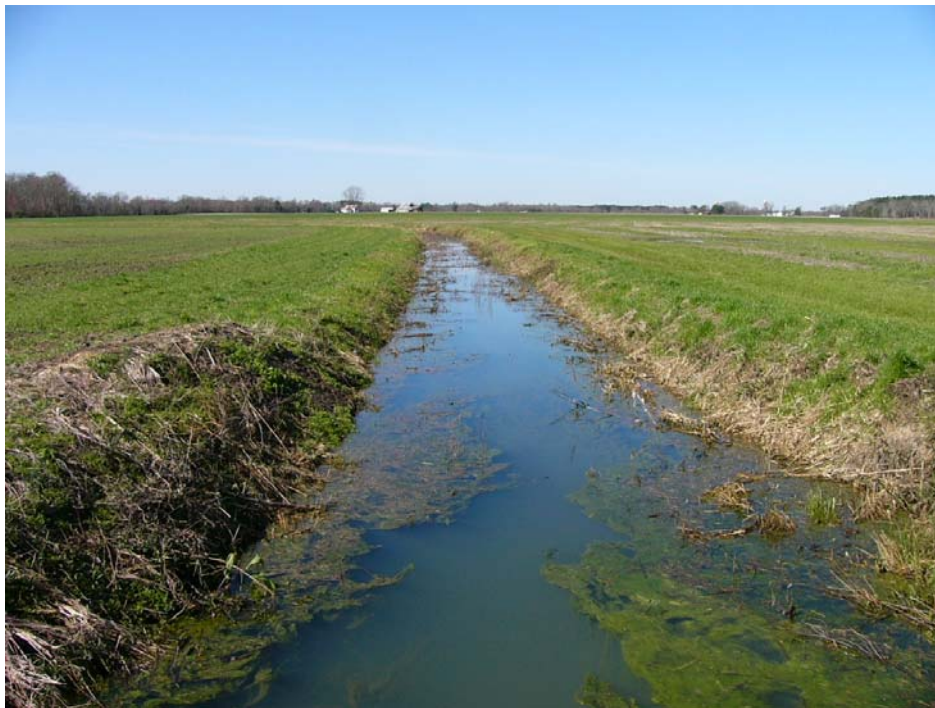
Northern UT looking downstream from crossing. Notice stream has been channelized and regularly maintained.

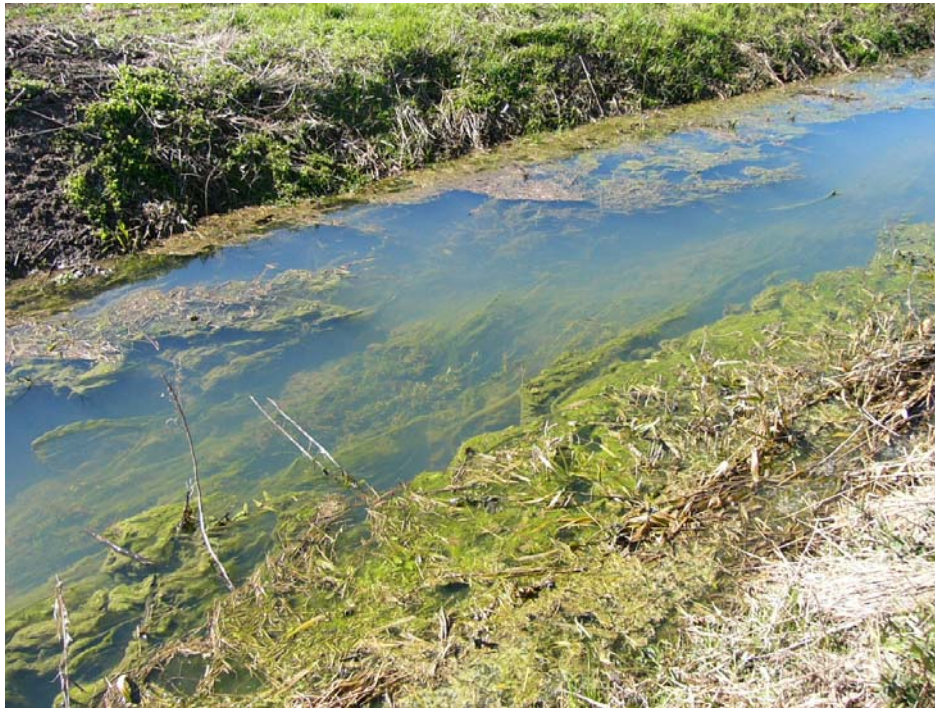
View of algal blooms growing in Northern UT from nutrient loading.

Algal blooms are causing low levels of DO which may be killing much of the biological indicators that may have naturally occurred in the channel.

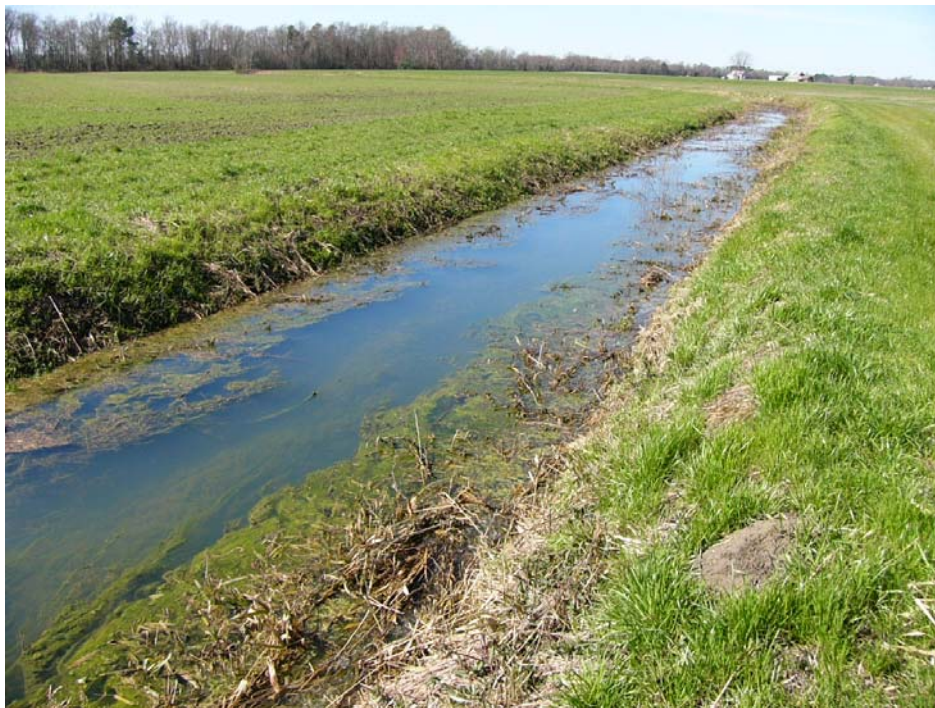
Northern UT looking downstream at maintained banks, algal blooms, and agricultural practices adjacent to stream banks

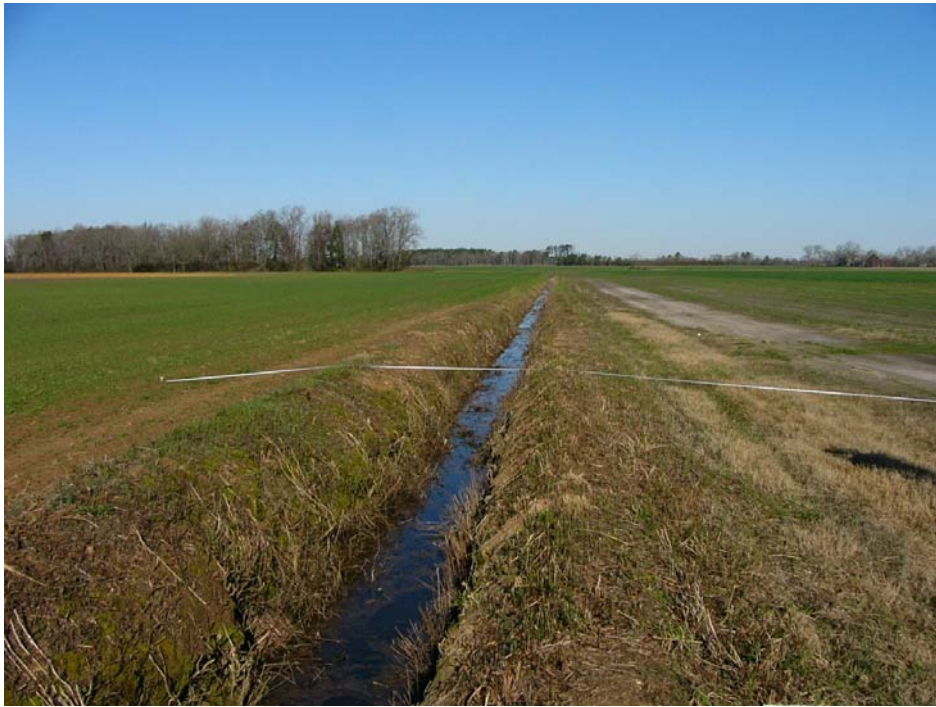
Southern UT looking downstream at recently mowed banks.

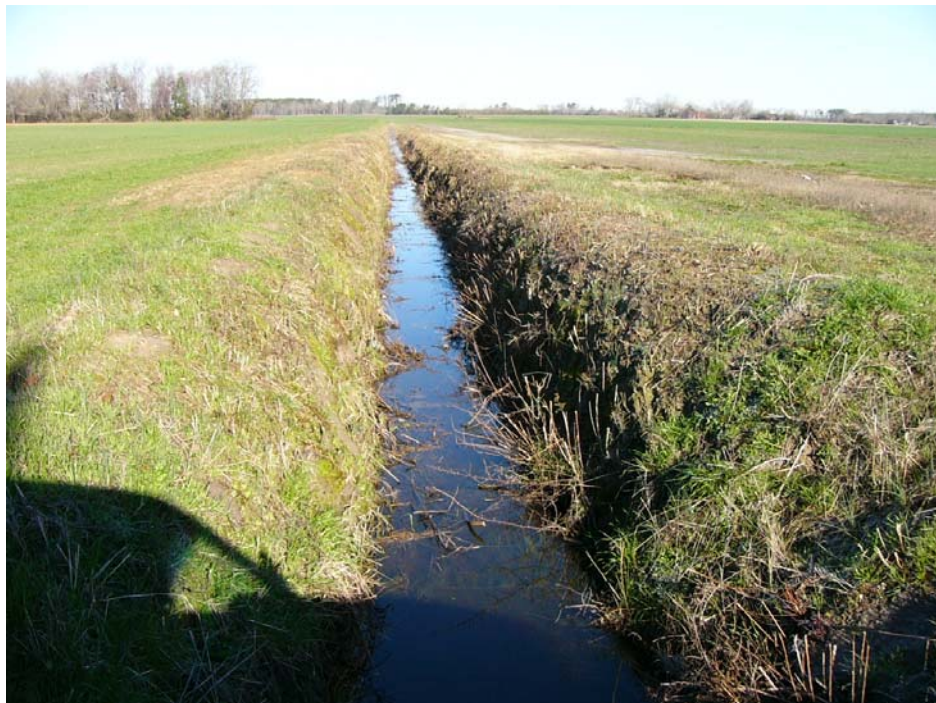
Southern UT looking upstream. Notice stream has been channelized and regularly maintained.

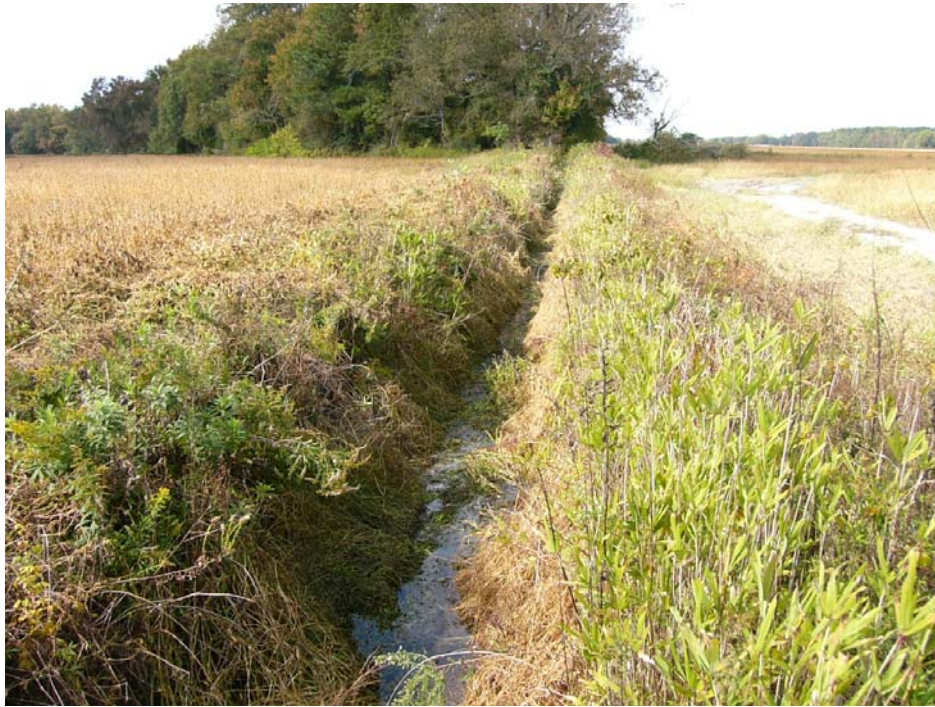
Southern UT looking downstream towards convergence with Northern UT. Notice agricultural practices adjacent to stream banks.

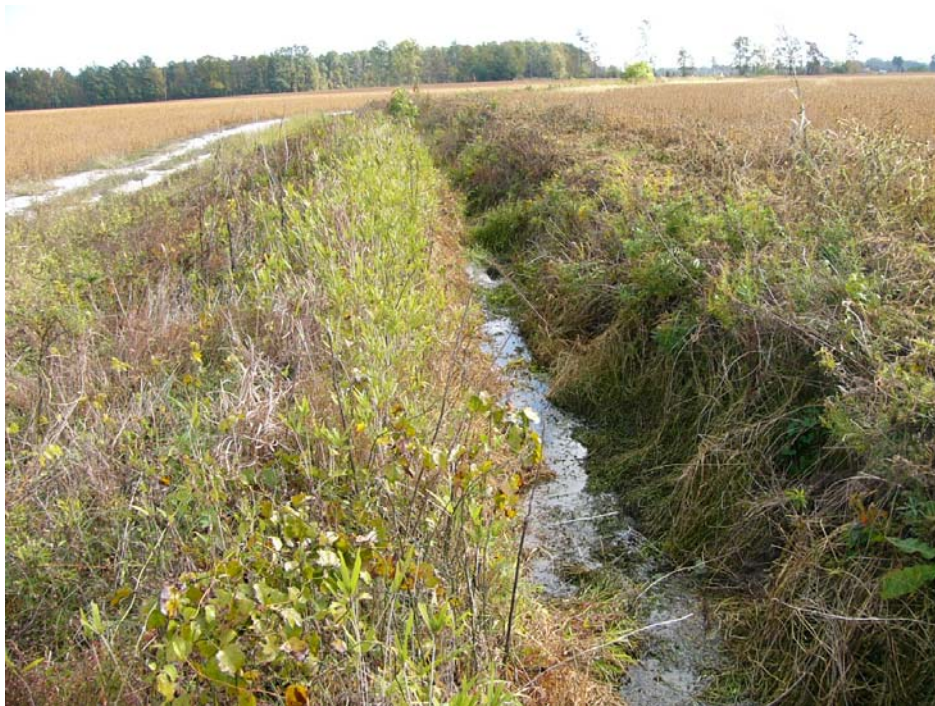
Southern UT looking upstream. Notice algal blooms and vegetation choking channel flow.

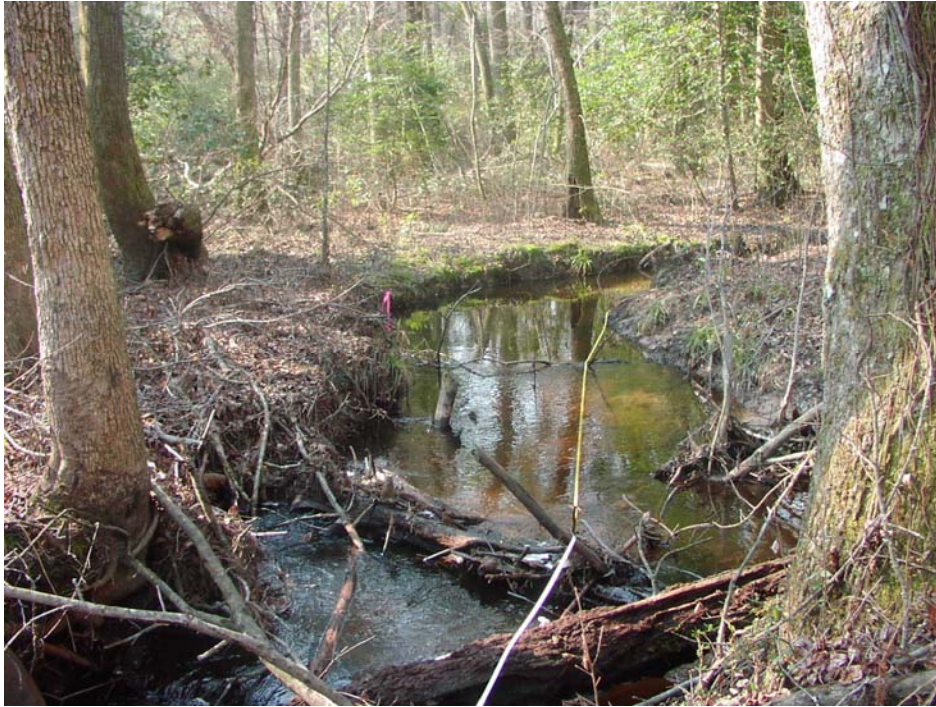
Mill Creek looking upstream. Notice mature vegetated riparian buffer and gently meandering pattern.

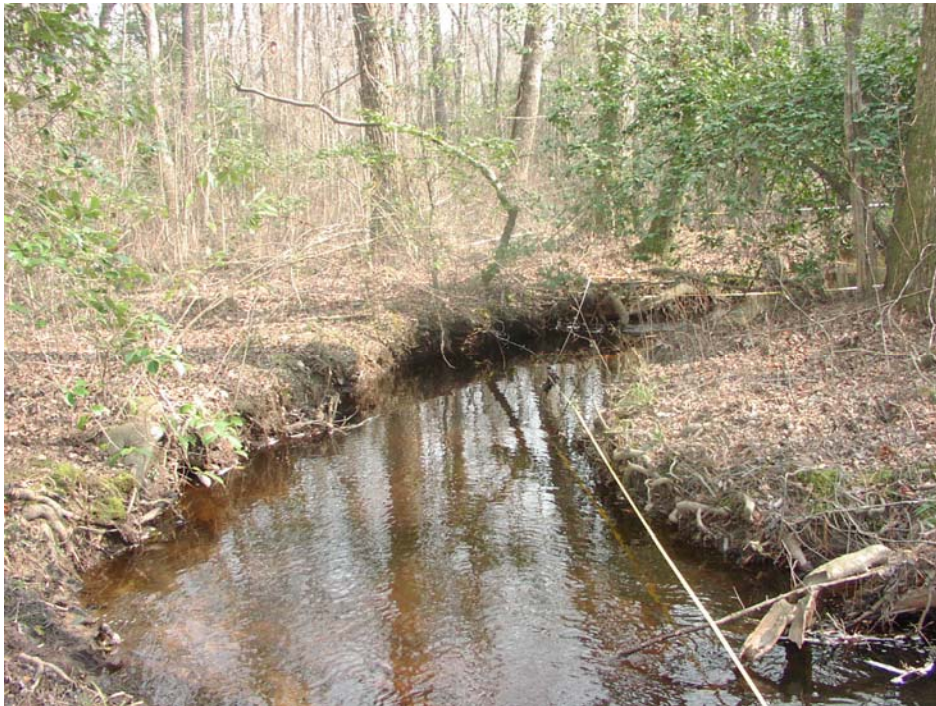
Mill Creek looking upstream. Notice roots along the banks which help to stabilize soils.

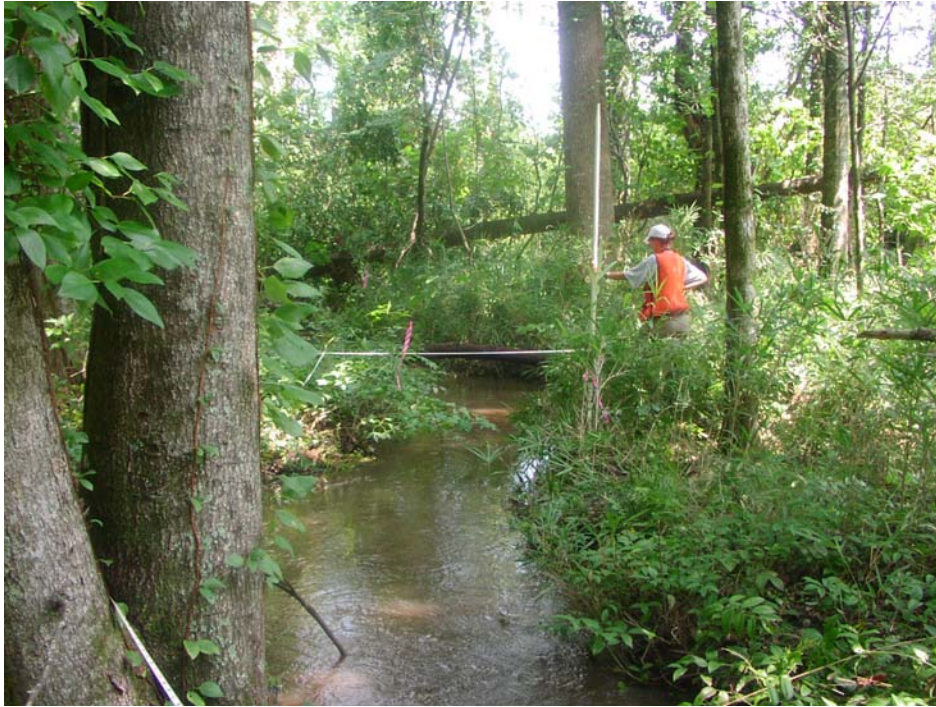
UT to Wildcat Branch looking upstream. Notice mature vegetated riparian buffer.

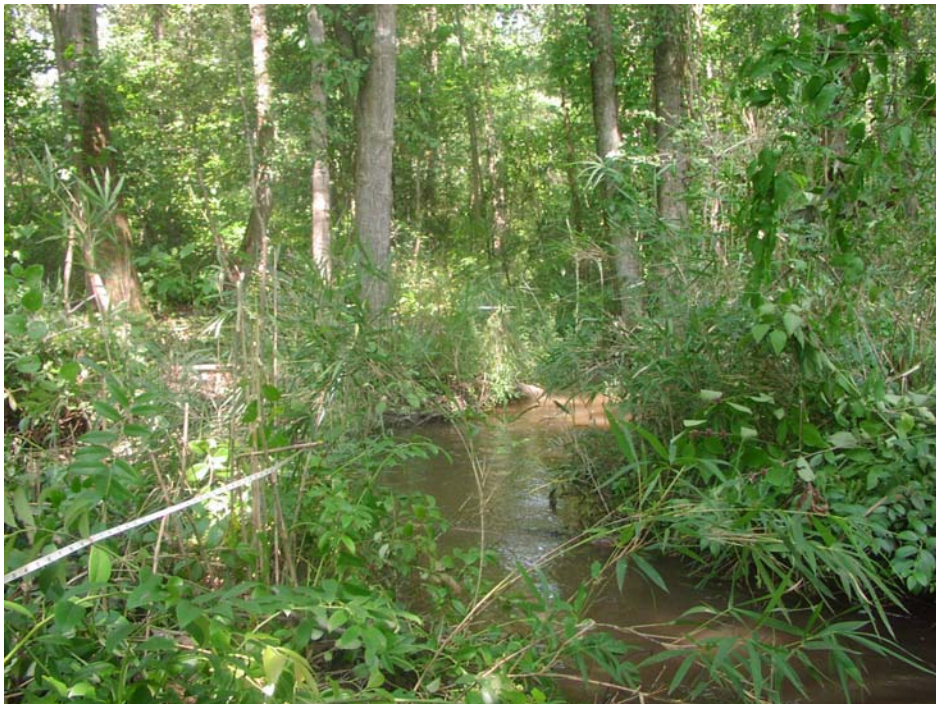
UT to Wildcat Branch looking upstream. Notice stable meandering pattern.

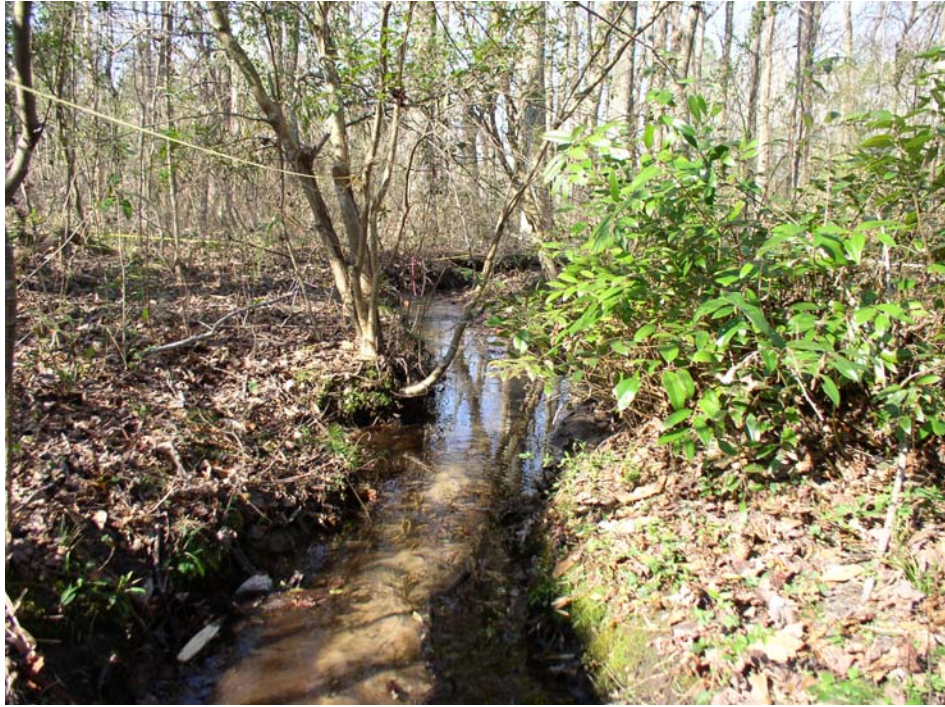
UT to Hog Swamp looking downstream. Notice vegetation on banks which help to stabilize soils.

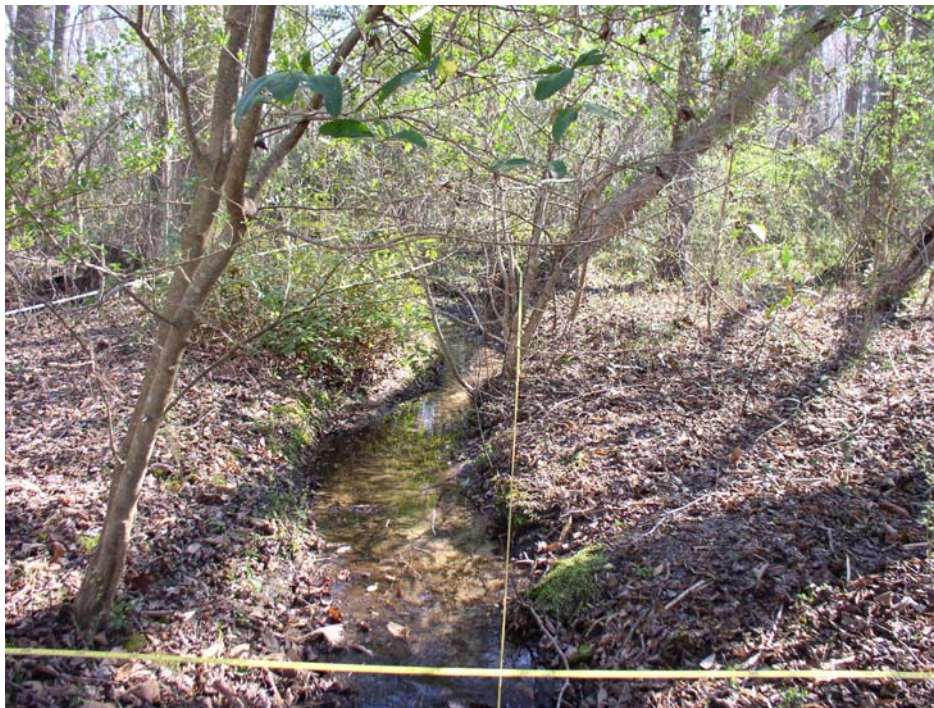
UT to Hog Swamp looking upstream at stable channel with consistent riffle-pool sequence.
