ANNUAL MONITORING REPORT YEAR 1 (2008) ANNUAL MONITORING

BROWN MARSH SWAMP STREAM AND WETLAND RESTORATION SITE

Robeson County, North Carolina

Contract No. 16-D06038

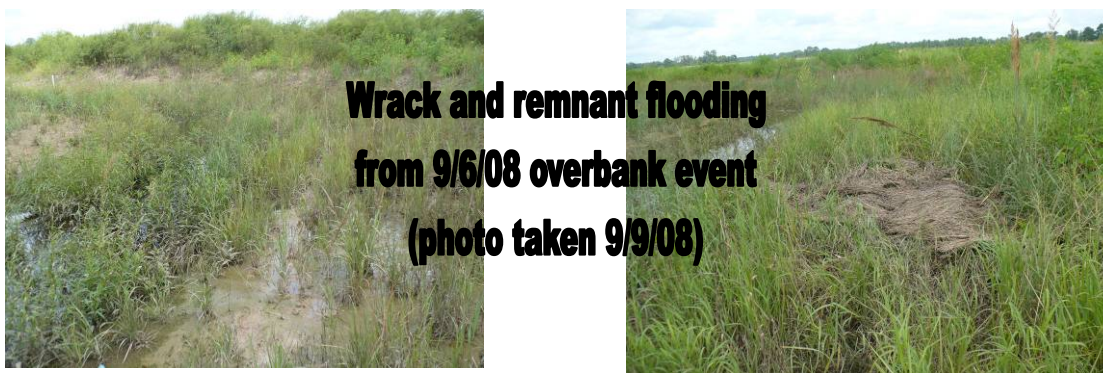
Date of Data Collection	Date of Occurrence	Method	Photo (if available)
April 5, 2008	April 5, 2008	A total of 3.73 inches of rain fell on April 5, 2008 as recorded by a nearby rain station in Lumberton*	--
September 6, 2008	September 6, 2008	A total of 4.6 inches of rain fell on September 5-6, 2008 as recorded by a nearby rain station in Lumberton*	See below

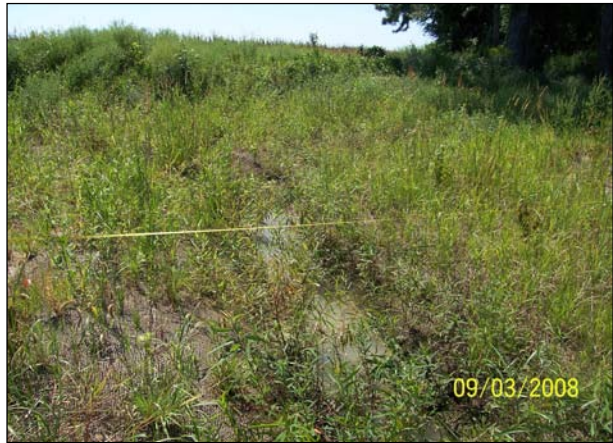
Photo of Cross-Section R1-17 - Looking Downstream @ STA 13+60

2008	2009	2010	2011	2012
Area	4.7				
Width	8.8				
Mean Depth	0.5				
Max Depth	1.3				
W/D	16.2

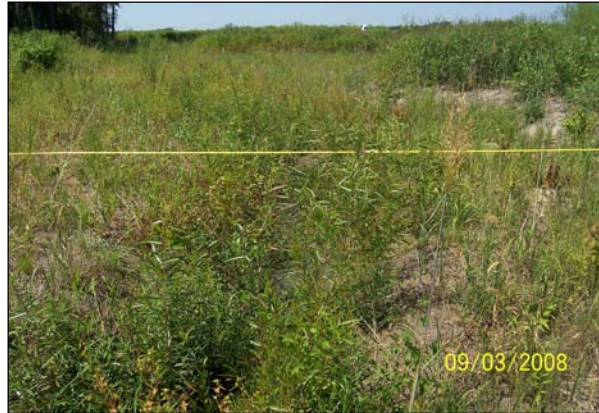
Photo of Cross-Section R1-18 - Looking Downstream @ STA 12+45

2008	2009	2010	2011	2012
Area	7.7				
Width	7.0				
Mean Depth	1.1				
Max Depth	2.1				
W/D	NA

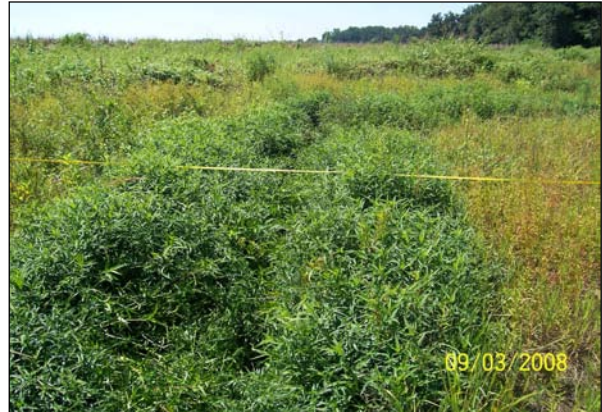
Photo of Cross-Section R1-19 - Looking Downstream @ STA 10+72

2008	2009	2010	2011	2012
Area	4.3				
Width	6.7				
Mean Depth	0.6				
Max Depth	1.1				
W/D	10.4

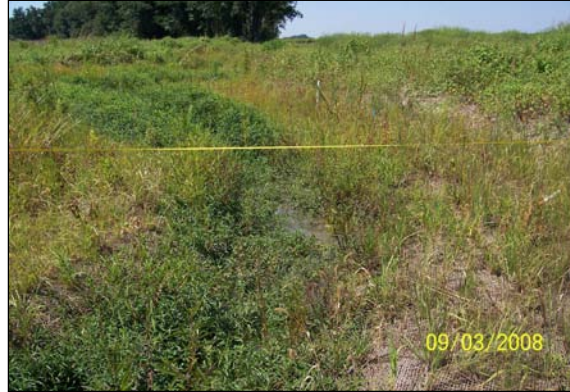
Photo of Cross-Section R1-20 - Looking Downstream @ STA 10+52

2008	2009	2010	2011	2012
Area	6.2				
Width	6.2				
Mean Depth	1.0				
Max Depth	1.9				
W/D	NA

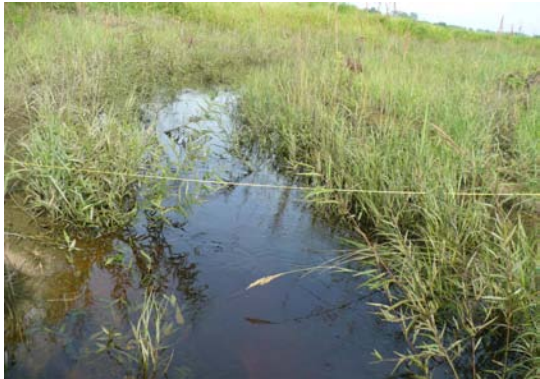
Photo of Cross-Section R2-13 - Looking Downstream @ STA 47+45

2008	2009	2010	2011	2012
Area	21.3				
Width	12.9				
Mean Depth	1.7				
Max Depth	3.1				
W/D	NA

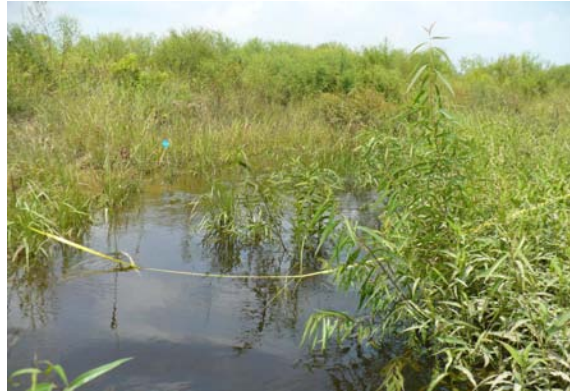
Photo of Cross-Section R2-14 - Looking Downstream @ STA 47+48

2008	2009	2010	2011	2012
Area	14.1				
Width	10.9				
Mean Depth	1.3				
Max Depth	2.1				
W/D	8.4

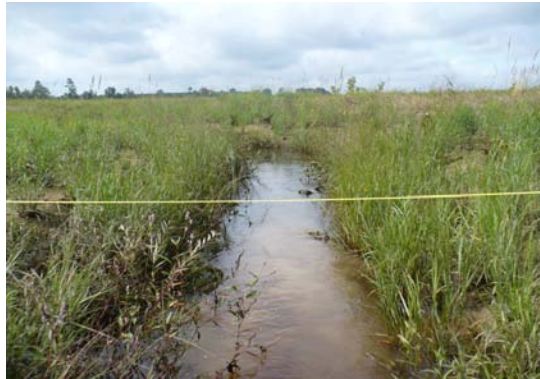
Photo of Cross-Section R2-15 - Looking Downstream @ STA 50+75

2008	2009	2010	2011	2012
Area	20.0				
Width	10.9				
Mean Depth	1.8				
Max Depth	3.3				
W/D	NA

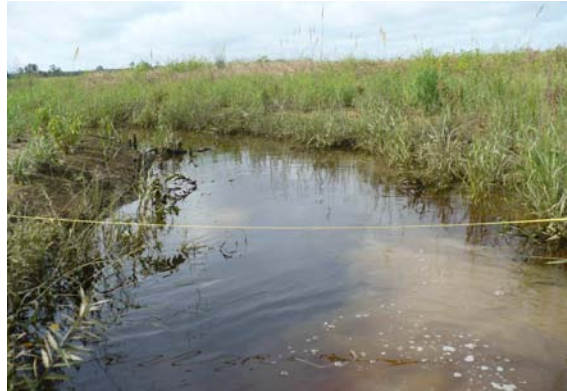
Photo of Cross-Section R2-16 - Looking Downstream @ STA 52+02

2008	2009	2010	2011	2012
Area	14.4				
Width	10.8				
Mean Depth	1.3				
Max Depth	2.3				
W/D	8.1

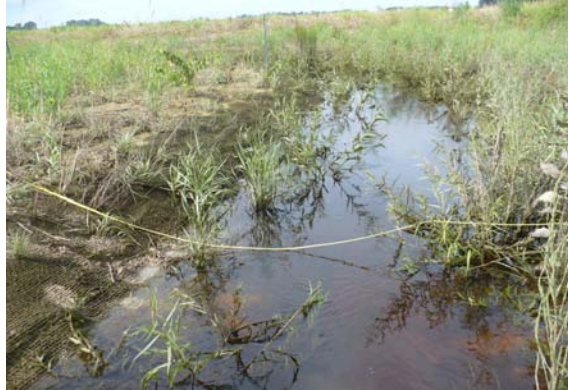
Photo of Cross-Section R3-9 - Looking Downstream @ STA 41+25

2008	2009	2010	2011	2012
Area	14.8				
Width	12.3				
Mean Depth	1.2				
Max Depth	2.3				
W/D	10.2

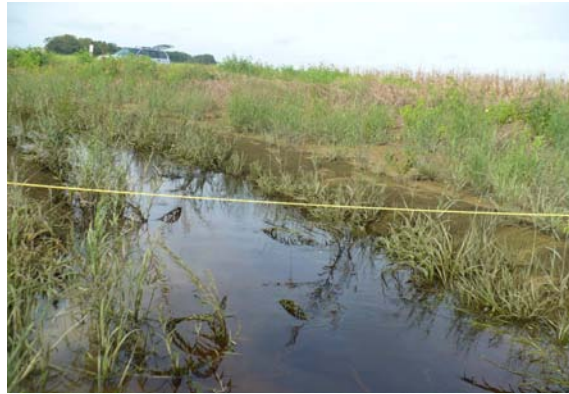
Photo of Cross-Section R3-10 - Looking Downstream @ STA 42+30

2008	2009	2010	2011	2012
Area	20.3				
Width	14.6				
Mean Depth	1.4				
Max Depth	3.6				
W/D	NA

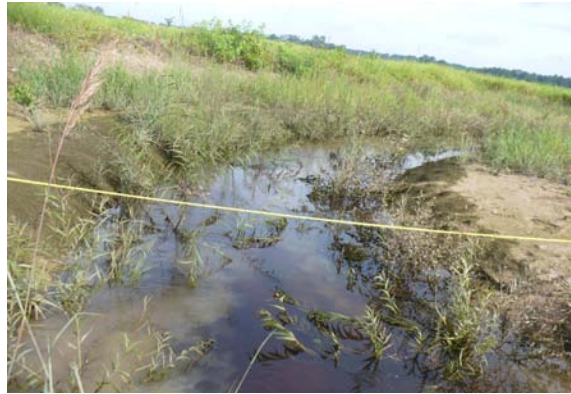
Photo of Cross-Section R3-11 - Looking Downstream @ STA 43+75

2008	2009	2010	2011	2012
Area	16.4				
Width	12.6				
Mean Depth	1.3				
Max Depth	2.5				
W/D	9.7

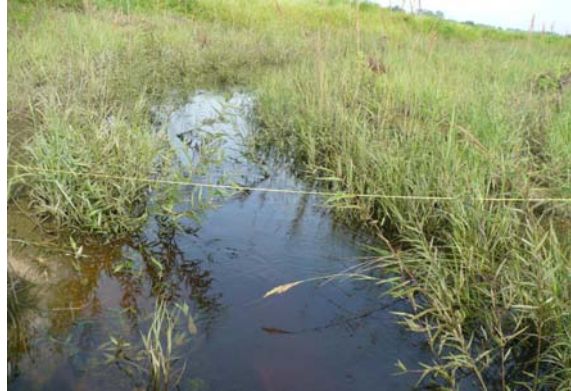
Photo of Cross-Section R3-12 - Looking Downstream @ STA 45+05

2008	2009	2010	2011	2012
Area	18.6				
Width	12.0				
Mean Depth	1.6				
Max Depth	2.9				
W/D	NA

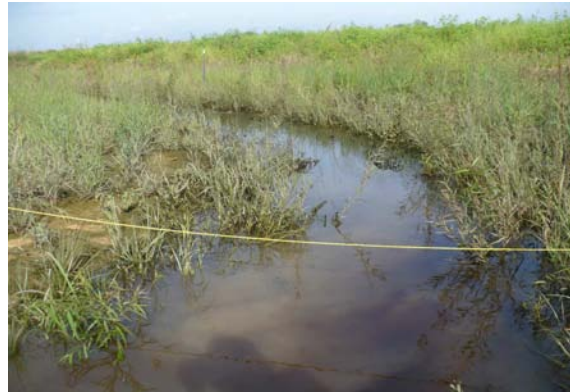
Photo of Cross-Section R4-X5 - Looking Downstream @ STA 20+55

2008	2009	2010	2011	2012
Area	19.0				
Width	11.1				
Mean Depth	1.7				
Max Depth	3.2				
W/D	NA

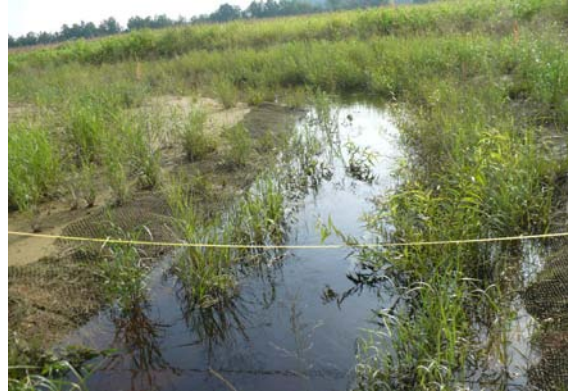
Photo of Cross-Section R4-6 - Looking Downstream @ STA 21+80

2008	2009	2010	2011	2012
Area	13.9				
Width	11.3				
Mean Depth	1.2				
Max Depth	2.4				
W/D	9.1

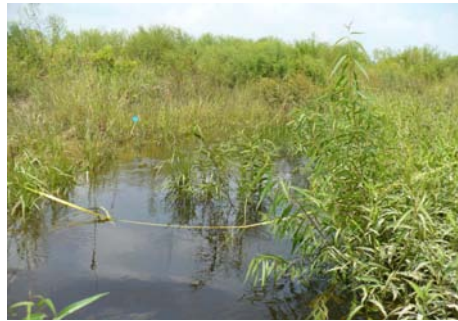
Project Name Brown Marsh
Cross Section Reach 4 - XS 7
Feature Pool
Date 9/9/08
Crew Adasme, St.Clair

Photo of Cross-Section R4-7 - Looking Downstream @ STA 22+95

2008	2009	2010	2011	2012
Area	21.8				
Width	13.6				
Mean Depth	1.6				
Max Depth	3.2				
W/D	NA

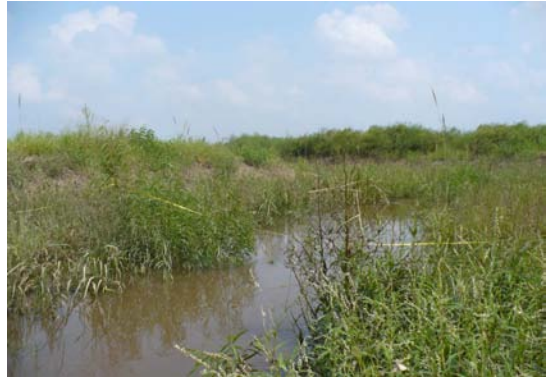
Photo of Cross-Section R4-8 - Looking Downstream @ STA 25+80

2008	2009	2010	2011	2012
Area	11.2				
Width	11.2				
Mean Depth	1.0				
Max Depth	2.2				
W/D	11.3

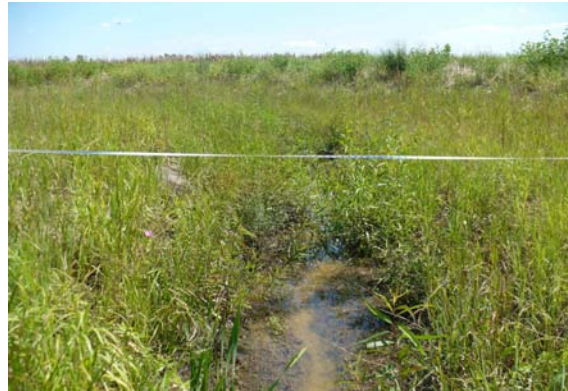
Photo of Cross-Section R5-1 - Looking Downstream @ STA 11+60

2008	2009	2010	2011	2012
Area	21.0				
Width	17.2				
Mean Depth	1.2				
Max Depth	2.4				
W/D	14.2

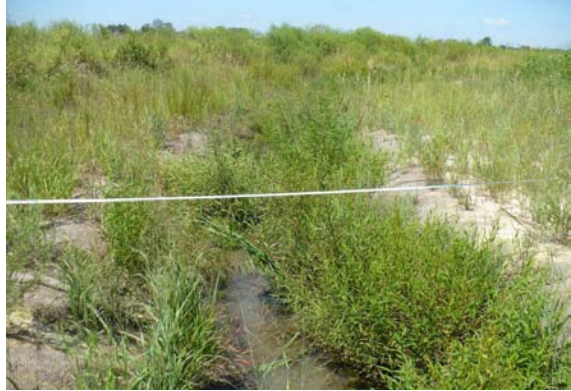
Photo of Cross-Section R5-2 - Looking Downstream @ STA 13+70

2008	2009	2010	2011	2012
Area	22.2				
Width	16.2				
Mean Depth	1.4				
Max Depth	2.8				
W/D	NA

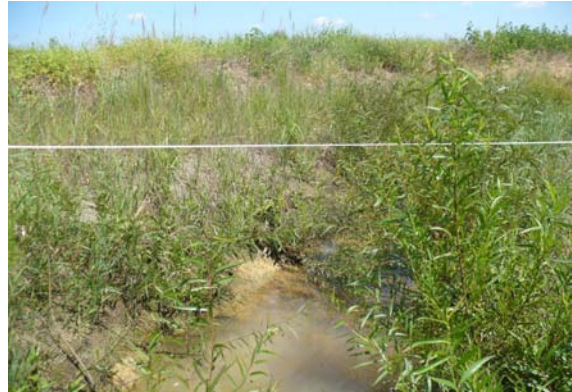
Photo of Cross-Section R5-3 - Looking Downstream @ STA 14+90

2008	2009	2010	2011	2012
Area	13.6				
Width	12.0				
Mean Depth	1.1				
Max Depth	2.2				
W/D	10.6

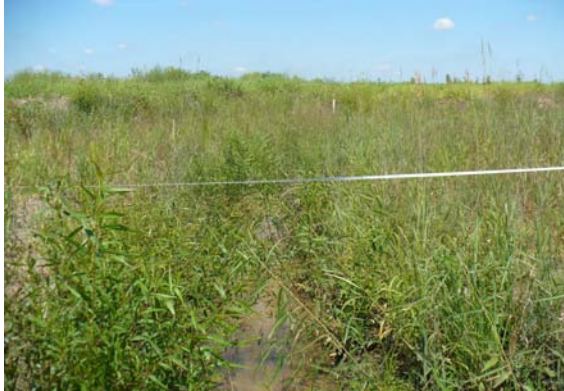
Photo of Cross-Section R5-4 - Looking Downstream @ STA 17+40

2008	2009	2010	2011	2012
Area	19.1				
Width	13.6				
Mean Depth	1.4				
Max Depth	3.0				
W/D	NA
