***ANNUAL MONITORING REPORT
YEAR 2 (2009) ANNUAL MONITORING***

**BROWN MARSH SWAMP STREAM AND WETLAND
RESTORATION SITE**

Robeson County, North Carolina

Contract No. 16-D06038

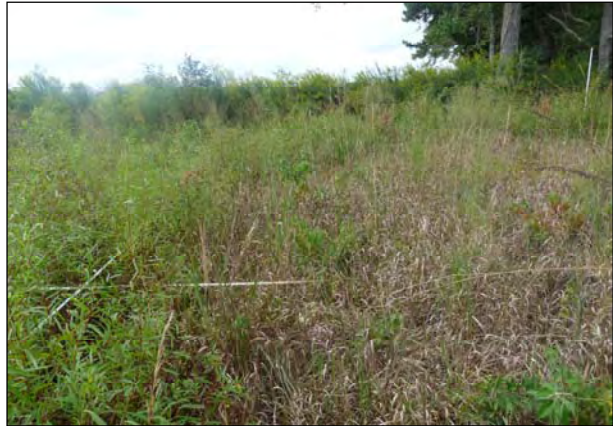
Photo of Cross-Section R1-17 - Looking Downstream @ STA 13+60

2008	2009	2010	2011	2012
Area	4.7	4.9			
Width	8.8	7.8			
Mean Depth	0.5	0.6			
Max Depth	1.3	1.3			
W/D	16.2	12.6

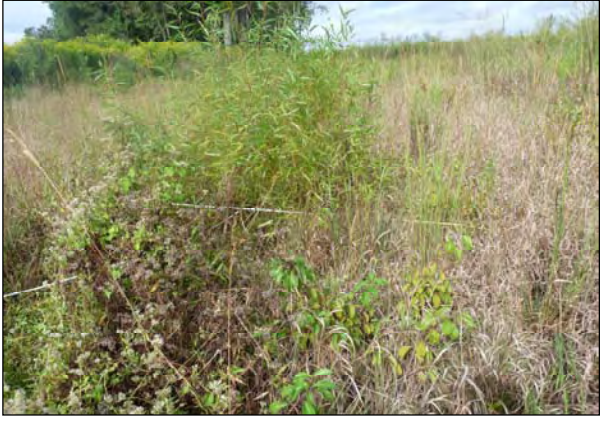
Photo of Cross-Section R1-18 - Looking Downstream @ STA 12+45

2008	2009	2010	2011	2012
Area	7.7	6.9			
Width	7.0	8.2			
Mean Depth	1.1	0.8			
Max Depth	2.1	1.6			
W/D	NA	NA

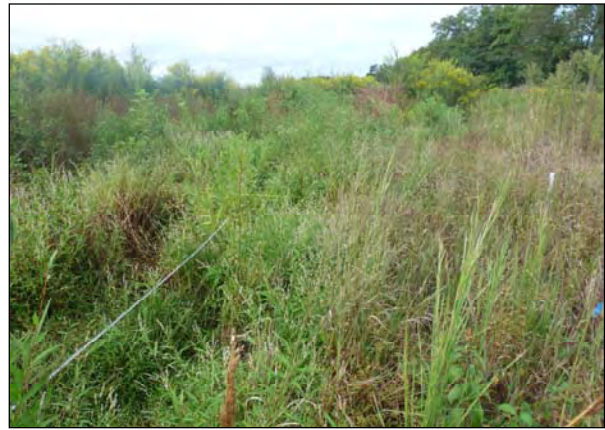
Photo of Cross-Section R1-19 - Looking Downstream @ STA 10+72

2008	2009	2010	2011	2012
Area	4.3	3.8			
Width	6.7	7.2			
Mean Depth	0.6	0.5			
Max Depth	1.1	1.0			
W/D	10.4	13.6

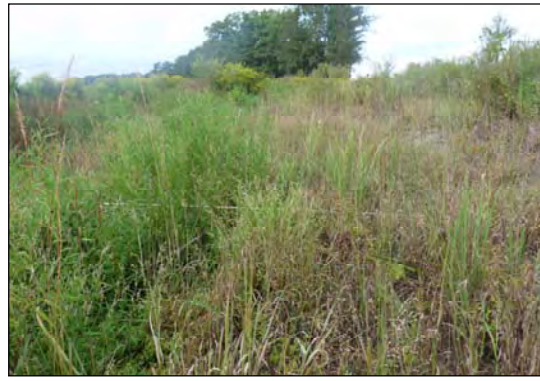
Photo of Cross-Section R1-20 - Looking Downstream @ STA 10+52

2008	2009	2010	2011	2012
Area	6.2	5.4			
Width	6.2	6.9			
Mean Depth	1.0	0.8			
Max Depth	1.9	1.5			
W/D	NA	NA

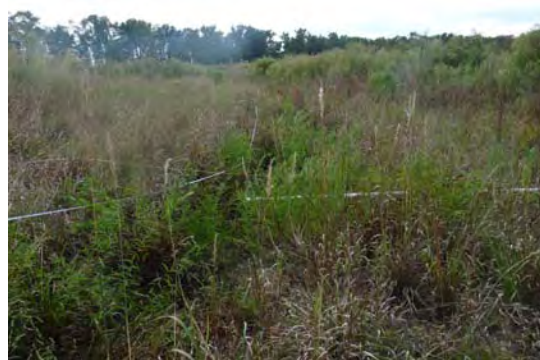
Photo of Cross-Section R2-13 - Looking Downstream @ STA 47+45

Project Name Brown Marsh
Cross Section Reach 2 - XS 13
Feature Pool
Date 10/1/09
Crew Smith, Lamb

2008	2009	2010	2011	2012
Area	21.3	20.1			
Width	12.9	12.5			
Mean Depth	1.7	1.6			
Max Depth	3.1	3.0			
W/D	NA	NA

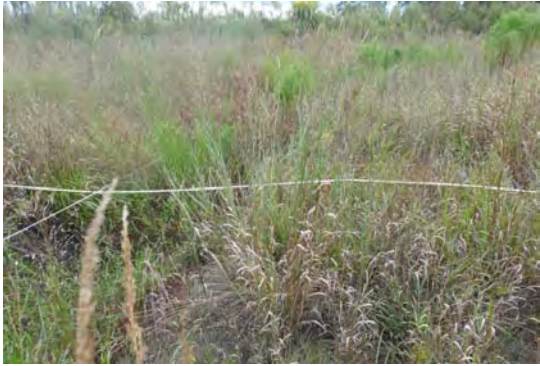
Photo of Cross-Section R2-14 - Looking Downstream @ STA 47+48

2008	2009	2010	2011	2012
Area	14.1	12.8			
Width	10.9	10.9			
Mean Depth	1.3	1.2			
Max Depth	2.1	2.3			
W/D	8.4	9.2

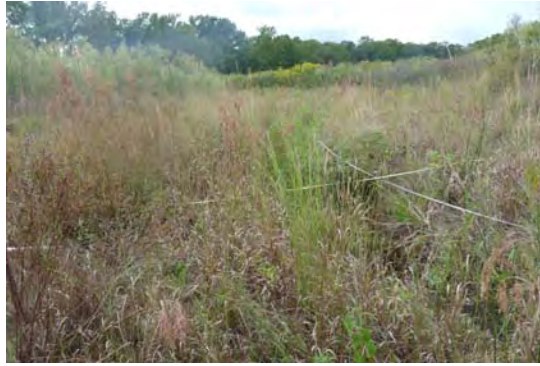
Photo of Cross-Section R2-15 - Looking Downstream @ STA 50+75

Project Name		Brown Marsh					
Cross Section		Reach 2 - XS 15					
Feature		Pool					
Date		10/1/09					
Crew		Smith, Lamb					
2008 As-built Survey		2008 YR 1 Survey		2009 YR 2 Survey		2010 YR 3 Survey	
Station	Elevation	Station	Elevation	Station	Elevation	Station	Elevation
-13.6	139.2	0.0	135.3	-0.8	135.5		
-1.4	135.2	4.8	135.3	4.2	135.3		
5.4	135.1	6.5	134.9	6.0	135.1		
8.1	132.7	7.6	133.7	7.7	134.0		
10.3	131.7	8.7	132.8	8.4	133.3		
12.1	132.6	9.6	132.3	9.2	132.4		
16.7	135.0	10.2	131.7	11.0	131.8		
25.4	135.4	11.2	131.9	13.0	132.5		
33.7	138.8	12.8	132.3	13.8	133.4		
		14.5	133.6	15.2	134.2		
		16.7	135.1	16.2	134.6		
		25.9	135.6	17.4	135.1		
				21.2	135.1		
				25.9	135.6

2008	2009	2010	2011	2012
Area	20.0	20.1			
Width	10.9	11.4			
Mean Depth	1.8	1.8			
Max Depth	3.3	3.4			
W/D	NA	NA

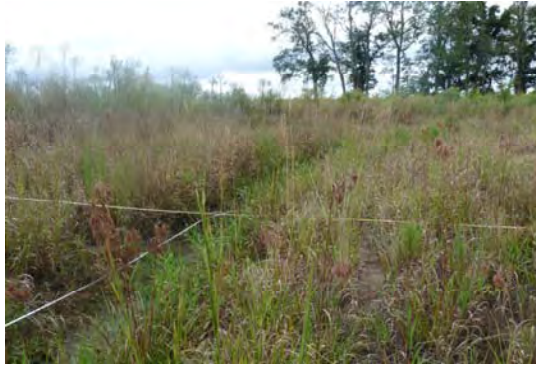
Photo of Cross-Section R2-16 - Looking Downstream @ STA 52+02

Project Name Brown Marsh
Cross Section Reach 2 - XS 16
Feature Riffle
Date 10/1/09
Crew Smith, Lamb

2008	2009	2010	2011	2012
Area	14.4	13.9			
Width	10.8	12.0			
Mean Depth	1.3	1.2			
Max Depth	2.3	2.4			
W/D	8.1	10.4

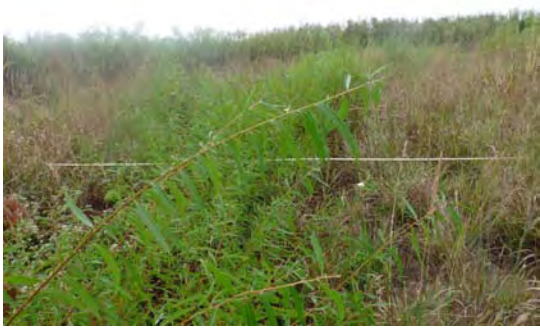
Photo of Cross-Section R3-9 - Looking Downstream @ STA 41+25

Project Name		Brown Marsh					
Cross Section		Reach 3 - XS 9					
Feature		Riffle					
Date		10/1/09					
Crew		Smith, Lamb					
2008 As-built Survey		2008 YR 1 Survey		2009 YR 2 Survey		2010 YR 3 Survey	
Station	Elevation	Station	Elevation	Station	Elevation	Station	Elevation
-9.1	139.3	0.0	136.0	5.0	135.7		
-0.2	136.4	5.6	136.0	7.4	135.6		
7.2	136.0	8.7	135.0	9.5	134.8		
11.9	133.7	10.6	134.5	11.0	134.1		
13.7	133.8	12.1	133.5	11.8	133.7		
18.6	135.9	14.0	133.7	12.6	133.5		
25.1	136.1	15.4	134.1	14.0	133.5		
36.5	139.7	18.6	135.8	15.5	134.2		
		22.3	135.8	17.2	135.0		
		25.0	135.9	19.0	135.6		
				22.5	135.6		
				25.7	135.9

2008	2009	2010	2011	2012
Area	14.8	13.1			
Width	12.3	11.6			
Mean Depth	1.2	1.1			
Max Depth	2.3	2.1			
W/D	10.2	10.2

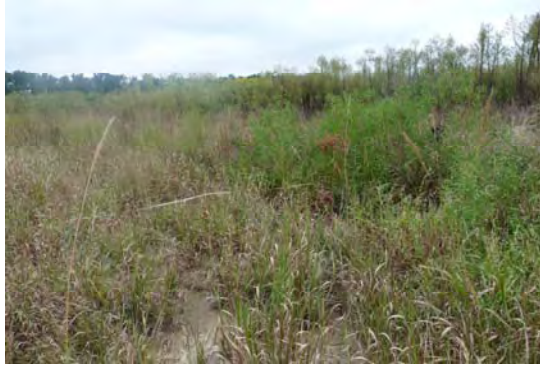
Photo of Cross-Section R3-10 - Looking Downstream @ STA 42+30

2008	2009	2010	2011	2012
Area	20.3	17.4			
Width	14.6	11.7			
Mean Depth	1.4	1.5			
Max Depth	3.6	2.8			
W/D	NA	NA

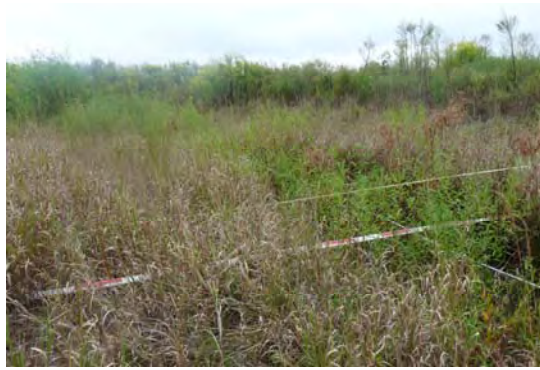
Photo of Cross-Section R3-11 - Looking Downstream @ STA 43+75

2008	2009	2010	2011	2012
Area	16.4	11.1			
Width	12.6	10.4			
Mean Depth	1.3	1.1			
Max Depth	2.5	2.1			
W/D	9.7	9.8

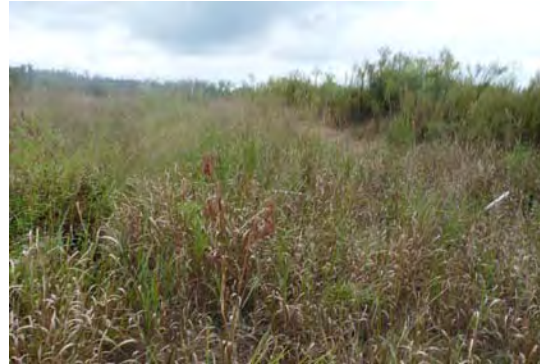
Photo of Cross-Section R3-12 - Looking Downstream @ STA 45+05

Project Name Brown Marsh
Cross Section Reach 3 - XS 12
Feature Pool
Date 10/1/09
Crew Smith, Lamb

2008	2009	2010	2011	2012
Area	18.6	10.5			
Width	12.0	9.3			
Mean Depth	1.6	1.1			
Max Depth	2.9	2.1			
W/D	NA	NA

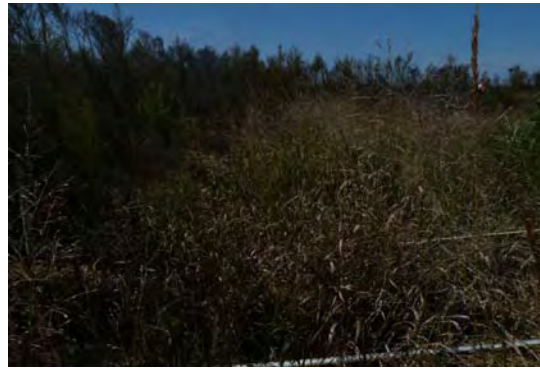
Photo of Cross-Section R4-X5 - Looking Downstream @ STA 20+55

2008	2009	2010	2011	2012
Area	19.0	15.1			
Width	11.1	11.2			
Mean Depth	1.7	1.4			
Max Depth	3.2	2.6			
W/D	NA	NA

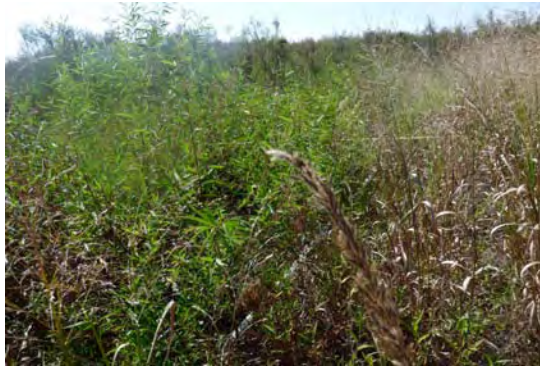
Photo of Cross-Section R4-6 - Looking Downstream @ STA 21+80

2008	2009	2010	2011	2012
Area	13.9	13.2			
Width	11.3	11.5			
Mean Depth	1.2	1.1			
Max Depth	2.4	2.3			
W/D	9.1	10.1

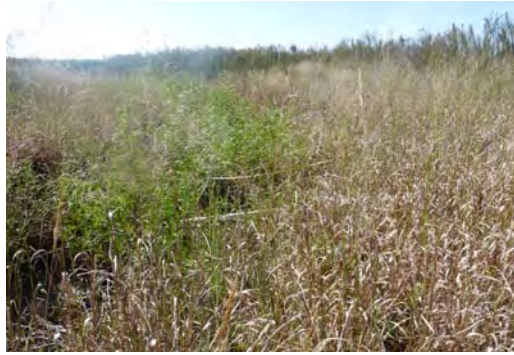
Photo of Cross-Section R4-7 - Looking Downstream @ STA 22+95

Project Name		Brown Marsh					
Cross Section		Reach 4 - XS 7					
Feature		Pool					
Date		10/1/09					
Crew		Smith, Lamb					
2008 As-built Survey		2008 YR 1 Survey		2009 YR 2 Survey		2010 YR 3 Survey	
Station	Elevation	Station	Elevation	Station	Elevation	Station	Elevation
-9.5	140.7	0.0	138.0	28.8	137.9		
0.4	138.1	3.9	137.7	23.8	137.6		
7.7	137.7	7.1	137.7	20.4	137.6		
12.1	134.9	9.2	136.6	18.5	136.9		
14.9	134.7	11.4	135.6	17.3	136.2		
20.9	137.5	11.9	135.2	15.8	135.5		
28.7	137.7	12.2	134.6	15.0	135.1		
38.8	140.4	13.0	134.5	13.7	134.9		
		14.5	134.4	12.3	135.0		
		15.1	135.1	11.1	135.7		
		15.7	135.6	9.3	136.9		
		18.3	136.6	7.2	137.7		
		20.9	137.6	3.8	137.8		
		28.2	137.6	0.0	138.0

2008	2009	2010	2011	2012
Area	21.8	18.9			
Width	13.6	12.9			
Mean Depth	1.6	1.5			
Max Depth	3.2	2.7			
W/D	NA	NA

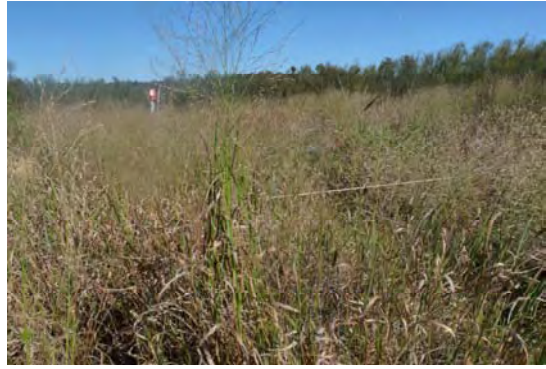
Photo of Cross-Section R4-8 - Looking Downstream @ STA 25+80

2008	2009	2010	2011	2012
Area	11.2	12.3			
Width	11.2	12.0			
Mean Depth	1.0	1.0			
Max Depth	2.2	2.2			
W/D	11.3	11.7

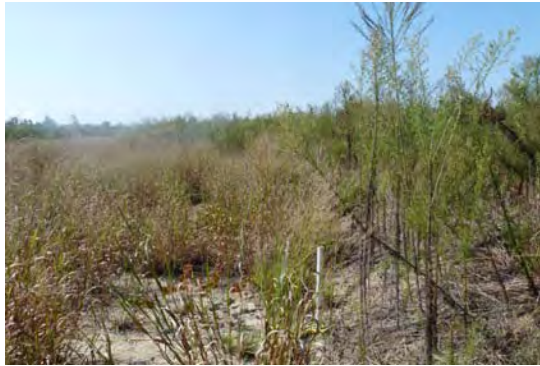
Photo of Cross-Section R5-1 - Looking Downstream @ STA 11+60

Project Name Brown Marsh
Cross Section Reach 5 - XS 1
Feature Riffle
Date 10/1/09
Crew Smith, Lamb

2008	2009	2010	2011	2012
Area	21.0	13.5			
Width	17.2	13.7			
Mean Depth	1.2	1.0			
Max Depth	2.4	2.0			
W/D	14.2	13.9

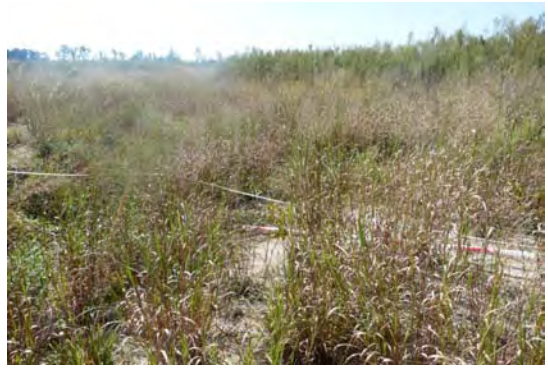
Photo of Cross-Section R5-2 - Looking Downstream @ STA 13+70

2008	2009	2010	2011	2012
Area	22.2	20.9			
Width	16.2	17.5			
Mean Depth	1.4	1.2			
Max Depth	2.8	2.5			
W/D	NA	NA

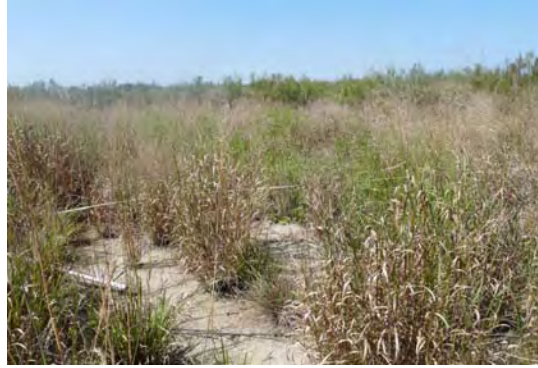
Photo of Cross-Section R5-3 - Looking Downstream @ STA 14+90

2008	2009	2010	2011	2012
Area	13.6	15.4			
Width	12.0	16.4			
Mean Depth	1.1	0.9			
Max Depth	2.2	2.2			
W/D	10.6	17.6

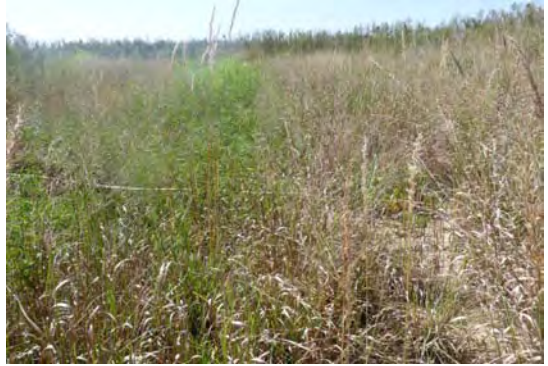
Photo of Cross-Section R5-4 - Looking Downstream @ STA 17+40

2008	2009	2010	2011	2012
Area	19.1	15.4			
Width	13.6	11.9			
Mean Depth	1.4	1.3			
Max Depth	3.0	2.5			
W/D	NA	NA

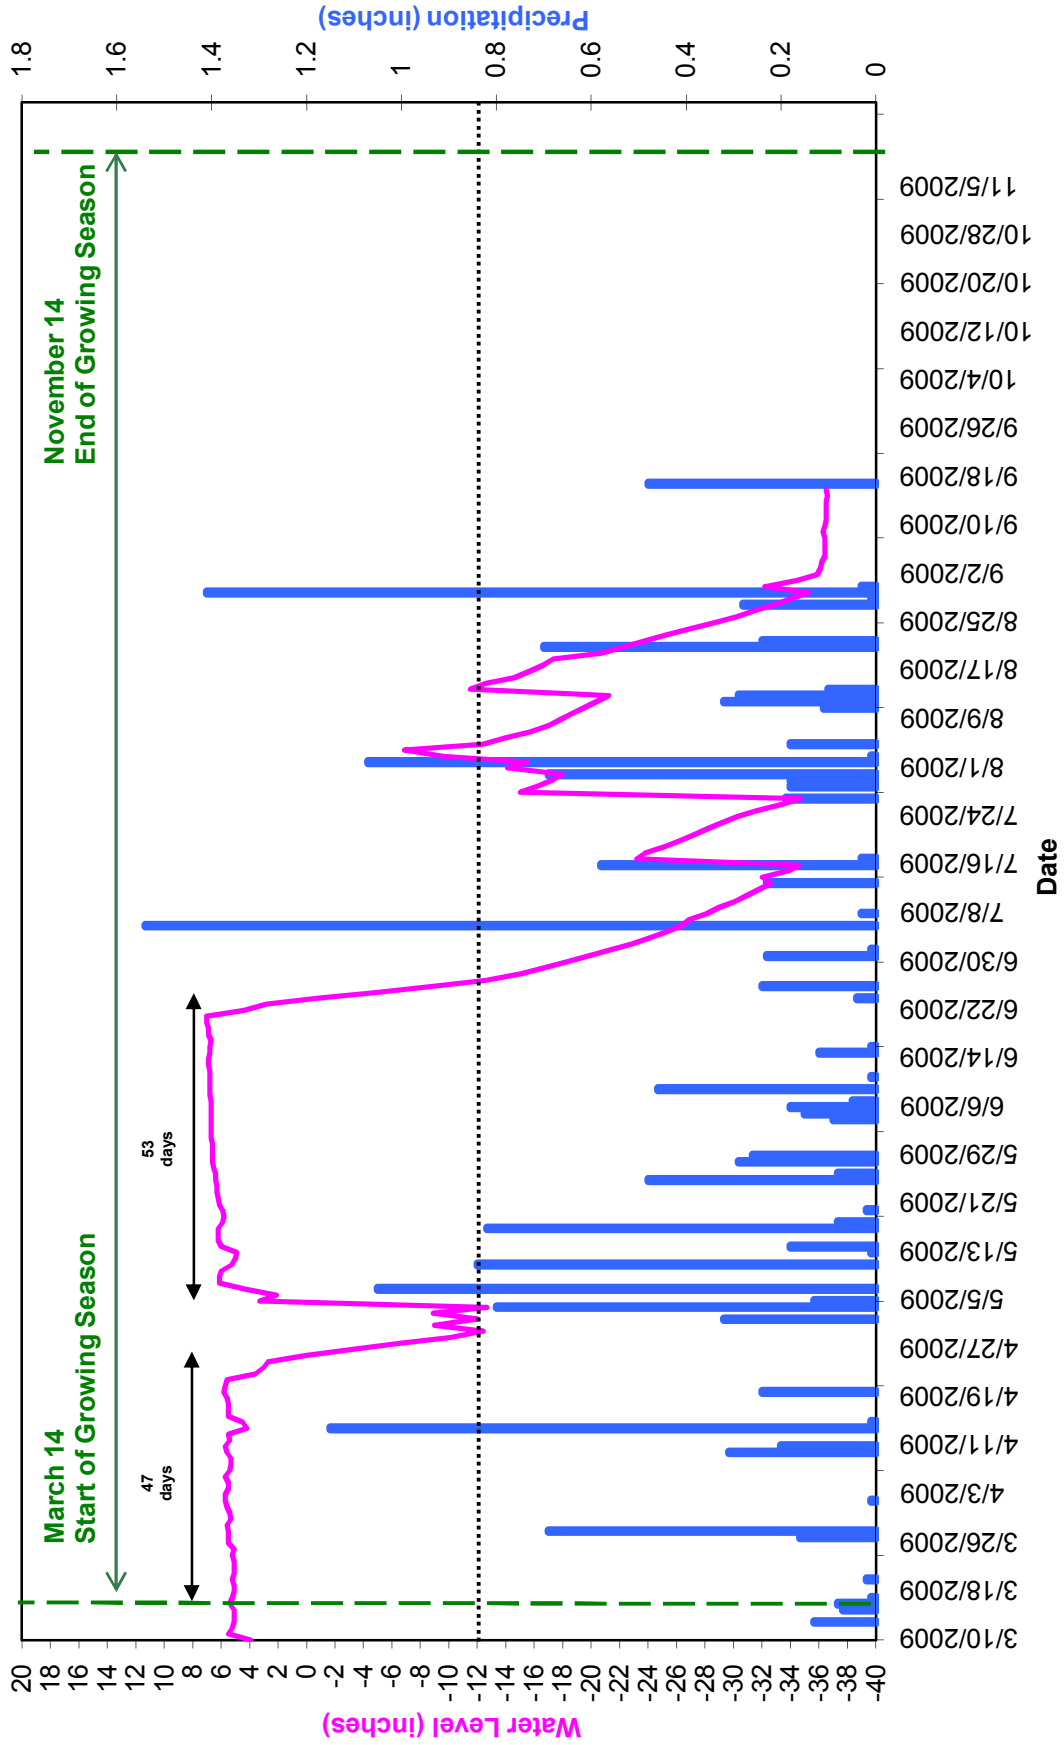
Brown Marsh Swamp Ground Water Gauge 1 Year 2 (2009 Data)

All monitored gauges within restoration areas were inundated/saturated within 12 inches of the surface for greater than 12.5 percent of the growing season (Table 10). Hydrographs containing groundwater and precipitation data for each gauge can be found in Appendix C. Data has been collected through September 16, 2009 and will continue to be collected for the remainder of the growing season (until November 14, 2009).
