***ANNUAL MONITORING REPORT  
YEAR 3 (2010) ANNUAL MONITORING***

**BROWN MARSH SWAMP STREAM AND WETLAND  
RESTORATION SITE**

Robeson County, North Carolina

Contract No. 16-D06038

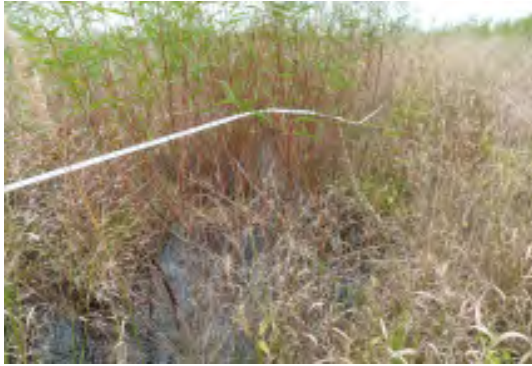
Photo of Cross-Section R4-7 - Looking Downstream @ STA 22+95

**Project Name** Brown Marsh  
**Cross Section** Reach 4 - XS 7  
**Feature** Pool  
**Date** 10/1/10  
**Crew** Corbin, Smith

2008	2009	2010	2011	2012
Area	21.8	18.9	20.2		
Width	13.6	12.9	13.2		
Mean Depth	1.6	1.5	1.5		
Max Depth	3.2	2.7	2.7		
W/D	NA	NA	NA

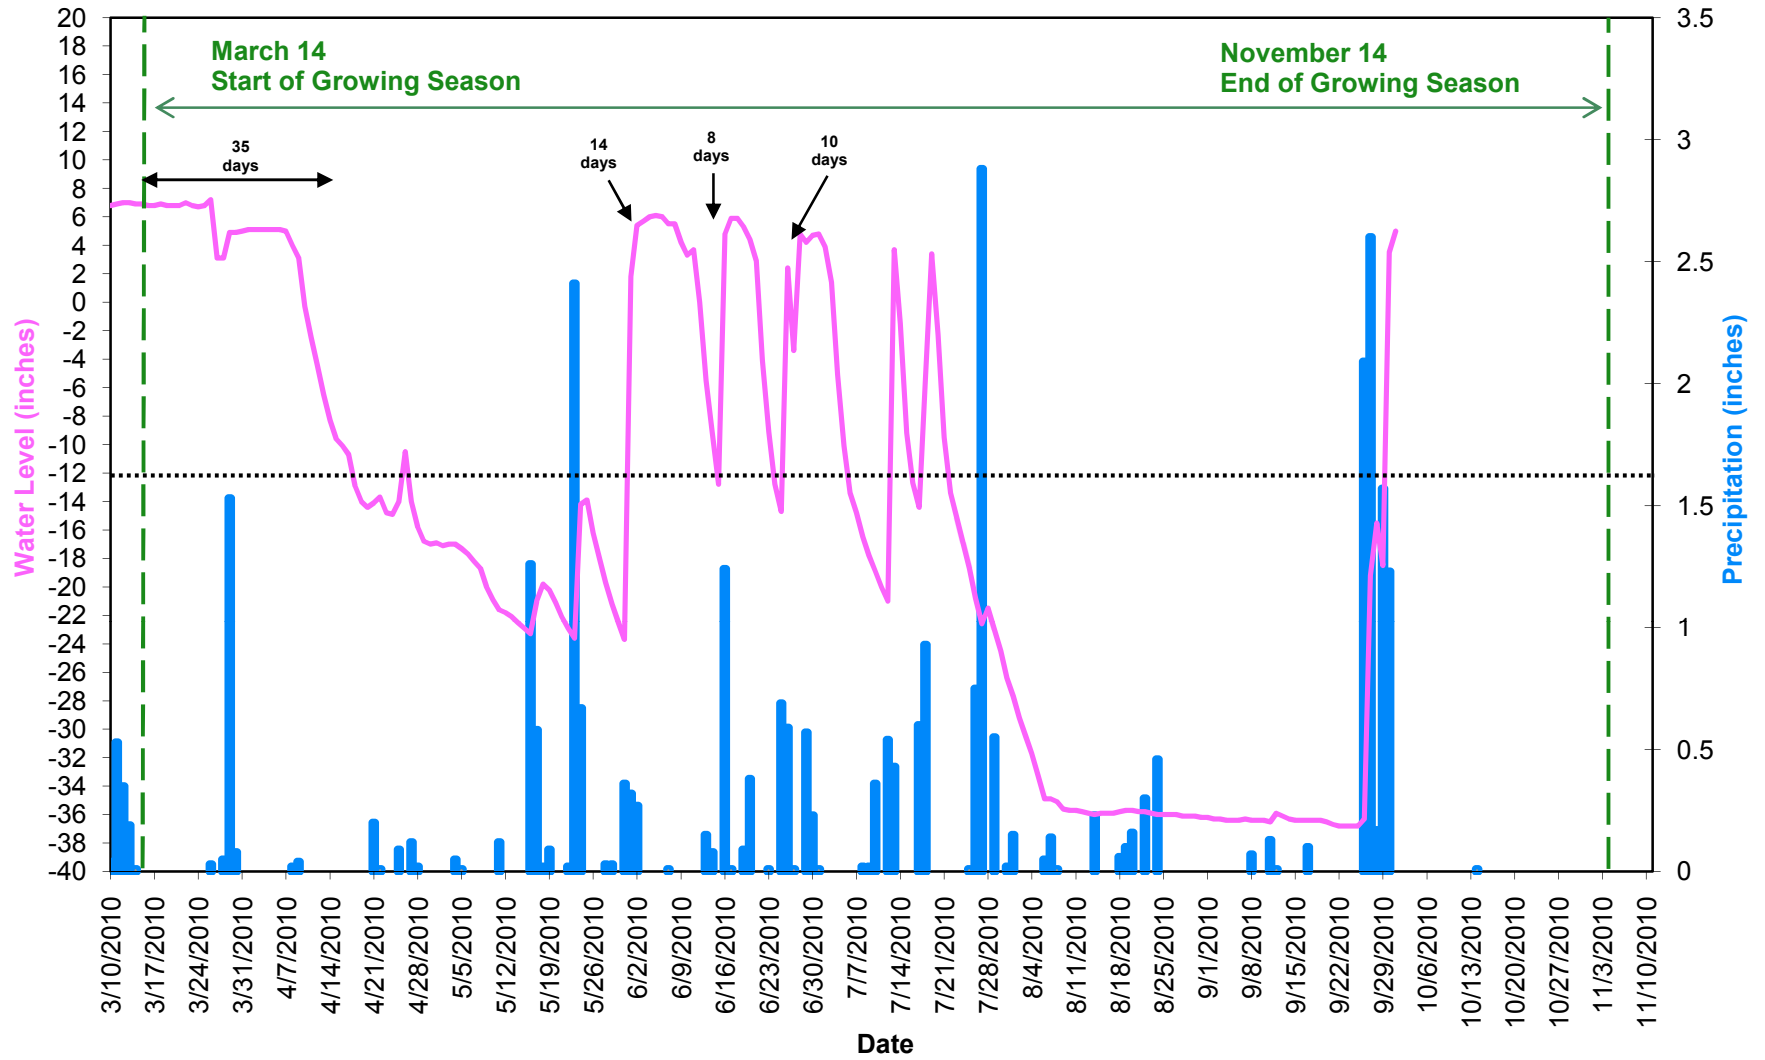
### Brown Marsh Swamp Ground Water Gauge 2 Year 3 (2010 Data)

Monitoring Gauge 2 was inundated/saturated within 12 inches of the surface for greater than 12.5 percent of the growing season while Gauge 1 was just shy of success criteria with inundation/saturation within 12 inches of the surface for 11.8 percent of the growing season. In addition, the reference gauge did not meet success criteria for the Year 3 (2010) monitoring season and rainfall was well-below normal for the month of April (Table 10 and Figure C1, Appendix C). Hydrographs containing groundwater and precipitation data for each gauge can be found in Appendix C in addition to a graph depicting annual rainfall at the Lumberton Airport versus 30-year historic rainfall data collected in Lumberton (Weatherunderground 2010, NOAA 2004). Groundwater data has been collected through October 1, 2010 and will continue to be collected for the remainder of the growing season (until November 14, 2010).
