Stream and Wetland Mitigation Plan

Browns Summit Creek Restoration Project

Guilford County, North Carolina

NCDMS Project ID No. 96313

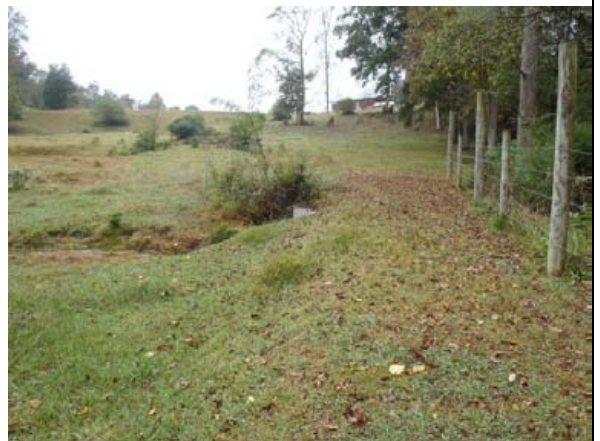
Culvert at downstream end of project will be replaced and the dam will be enhanced to prevent piping. (10/10/13)

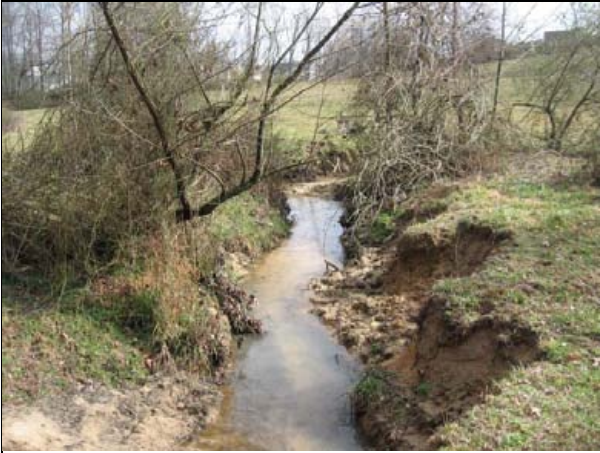
View looking downstream on Reach R2. (2/27/12)

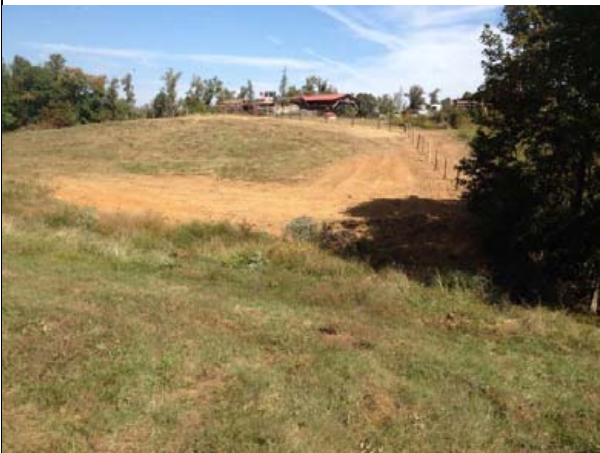
View looking across Reach R2 at plowed land and deficient riparian buffer. (10/3/13)

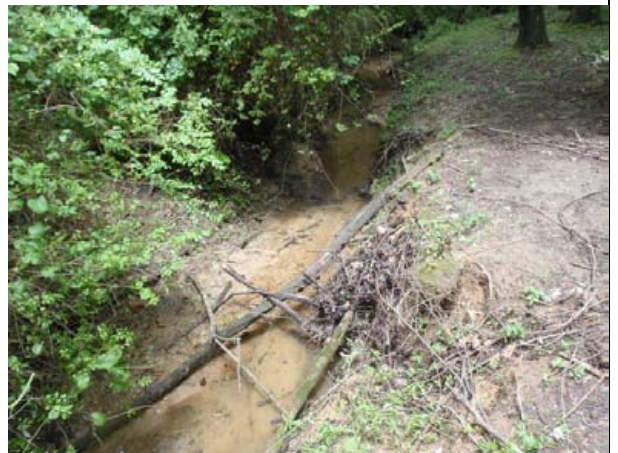
View looking downstream along Reach R2 shows active erosion and deficient riparian buffer. (6/4/13)

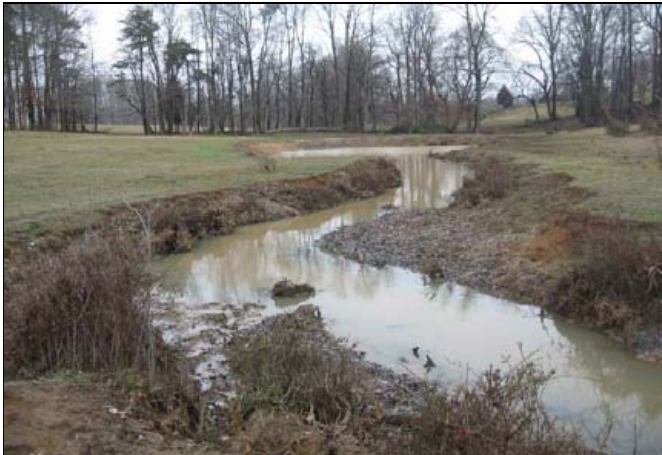
View looking downstream from where Reach R3 begins. The farm pond in the background will be removed. (2/27/12)

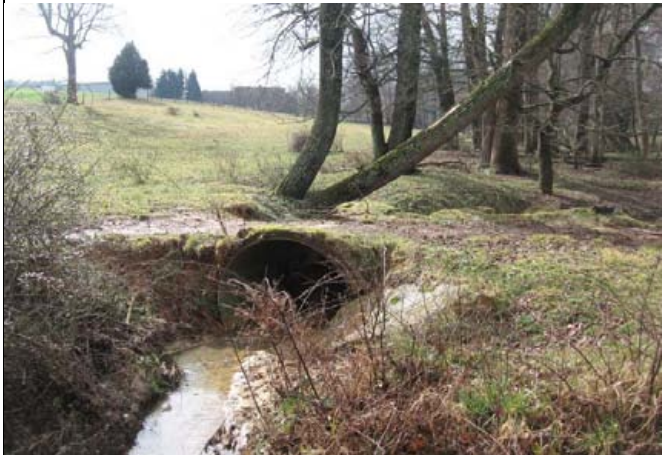
Existing stream crossing on Reach R3. This culvert will be replaced and the crossing will be widened. (2/27/12)

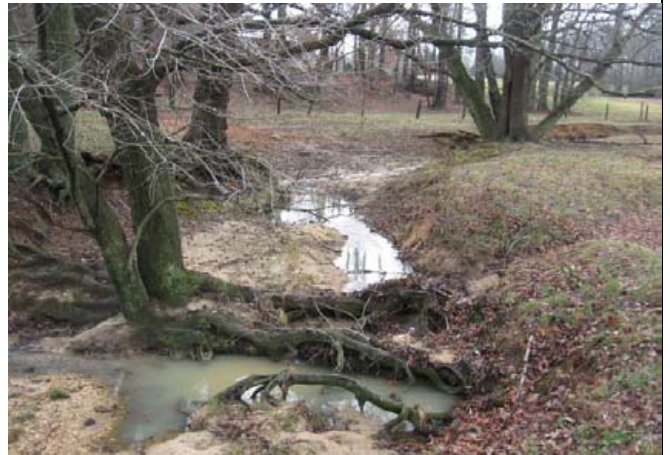
Reach R3 where tree roots are holding the grade. The design will attempt to preserve this and other mature trees. (2/27/12)

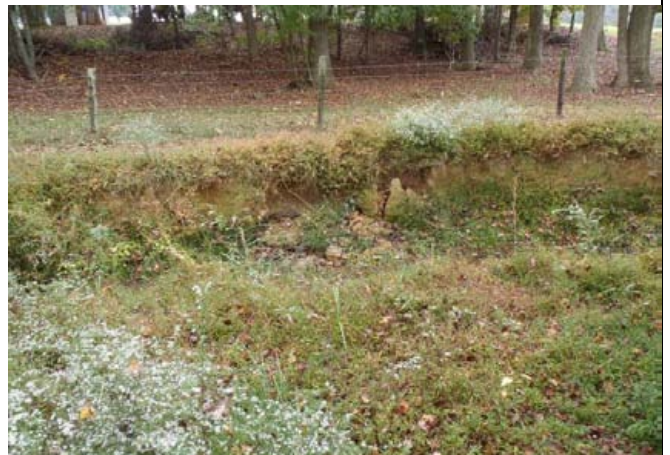
Unstable section of Reach R3 showing vertical banks and lack of floodplain access, mass wasting/failing streambank, and lack of riparian buffer. (10/17/13)

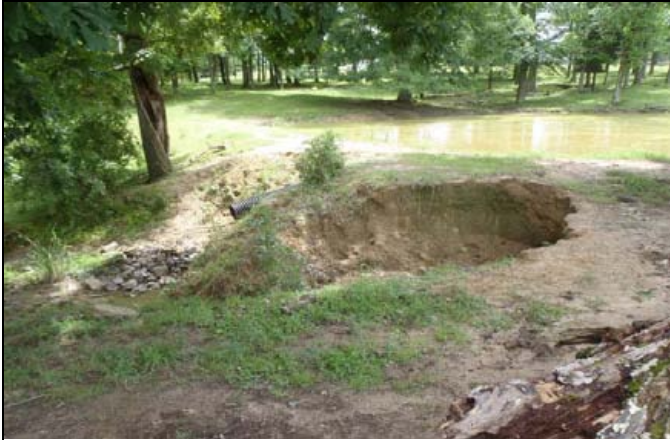
Lower end of pond on Reach R4. Headcut threatens pond dam. Pond will be removed as part of restoration. (9/10/13)

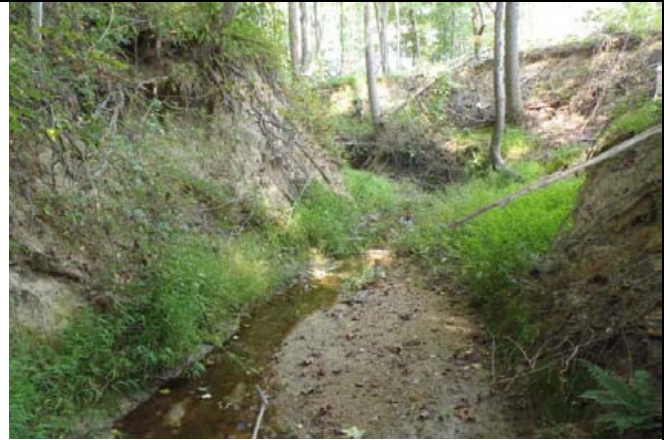
View looking downstream along Reach R4 along Broad Ridge Ct. Dam failure lead to deep incision. (9/10/13)

A failed dam situated along Reach 4 does not appear to have historical significance. The aerial photograph from 1951 (Figure 2.5b) clearly does not show a dam and its associated pond. This

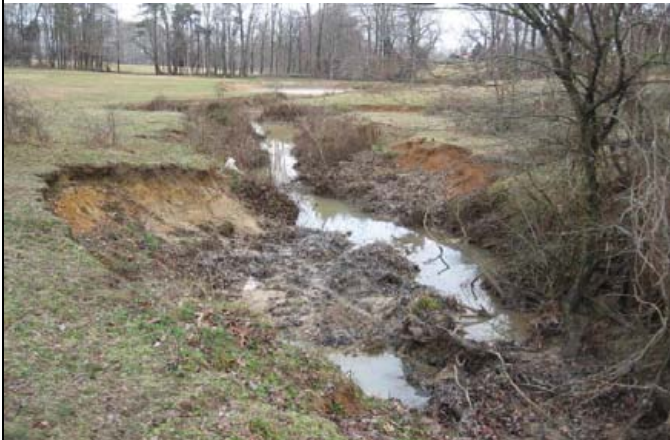
Downstream view along lower Reach R4. Reach T3 enters in background on right, marking the beginning of R3. (2/27/12)

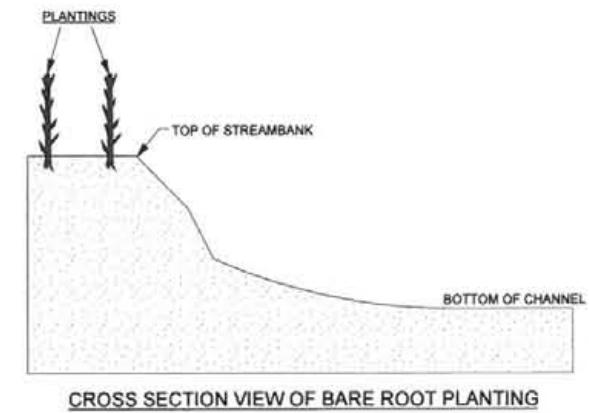
PLANTING SPECIFICATIONS

- NOTES:**
1. PLANT BARE ROOT SHRUBS AND TREES TO THE WIDTH OF THE BUFFER/PLANTING ZONE AS SHOWN ON THE PLANS.
 2. ALLOW FOR 6-10 FEET BETWEEN PLANTINGS, DEPENDING ON SIZE.
 3. LOOSEN COMPACTED SOIL.
 4. PLANT IN HOLES MADE BY A MATTOCK, DIBBLE, PLANTING BAR, OR OTHER APPROVED MEANS.
 5. PLANT IN HOLES DEEP AND WIDE ENOUGH TO ALLOW THE ROOTS TO SPREAD OUT AND DOWN WITHOUT J-ROOTING.
 6. KEEP ROOTS MOIST WHILE DISTRIBUTING OR WAITING TO PLANT BY MEANS OF WET CANVAS, BURLAP, OR STRAW.
 7. HEEL-IN PLANTS IN MOIST SOIL OR SAWDUST IF NOT PROMPTLY PLANTED UPON ARRIVAL TO PROJECT SITE.

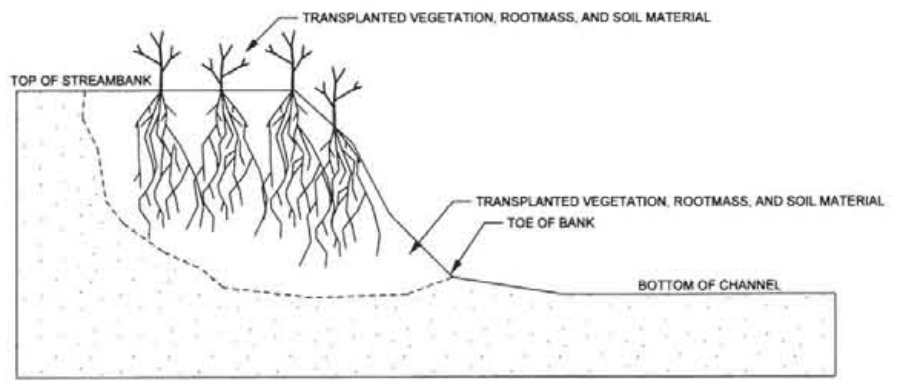
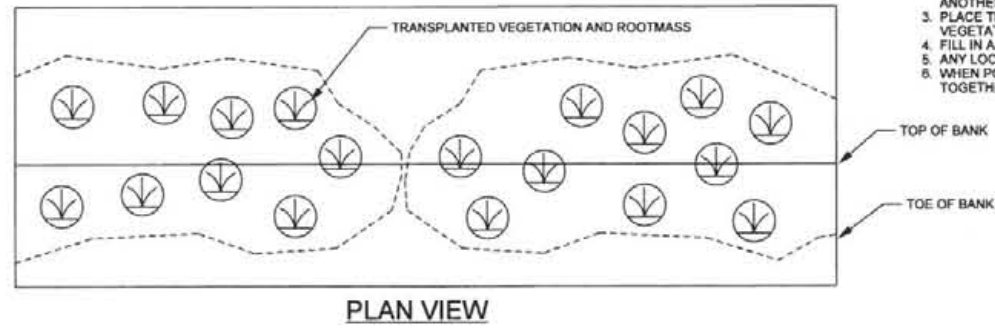
TRANSPLANTED VEGETATION

- NOTES:**
1. EXCAVATE A HOLE IN THE BANK TO BE STABILIZED THAT WILL ACCOMMODATE THE SIZE OF TRANSPLANT TO BE PLACED. BEGIN EXCAVATION AT THE TOE OF THE BANK.
 2. EXCAVATE THE ENTIRE ROOT MASS AND AS MUCH ADDITIONAL SOIL MATERIAL AS POSSIBLE. IF ENTIRE ROOT MASS CAN NOT BE EXCAVATED AT ONCE, THE TRANSPLANT IS TOO LARGE AND ANOTHER SHOULD BE SELECTED.
 3. PLACE TRANSPLANT IN THE BANK TO BE STABILIZED SO THAT VEGETATION IS ORIENTATED VERTICALLY.
 4. FILL IN ANY HOLES AROUND THE TRANSPLANT AND COMPACT.
 5. ANY LOOSE SOIL LEFT IN THE STREAM SHOULD BE REMOVED.
 6. WHEN POSSIBLE, PLACE MULTIPLE TRANSPLANTS CLOSE TOGETHER SUCH THAT THEY TOUCH.

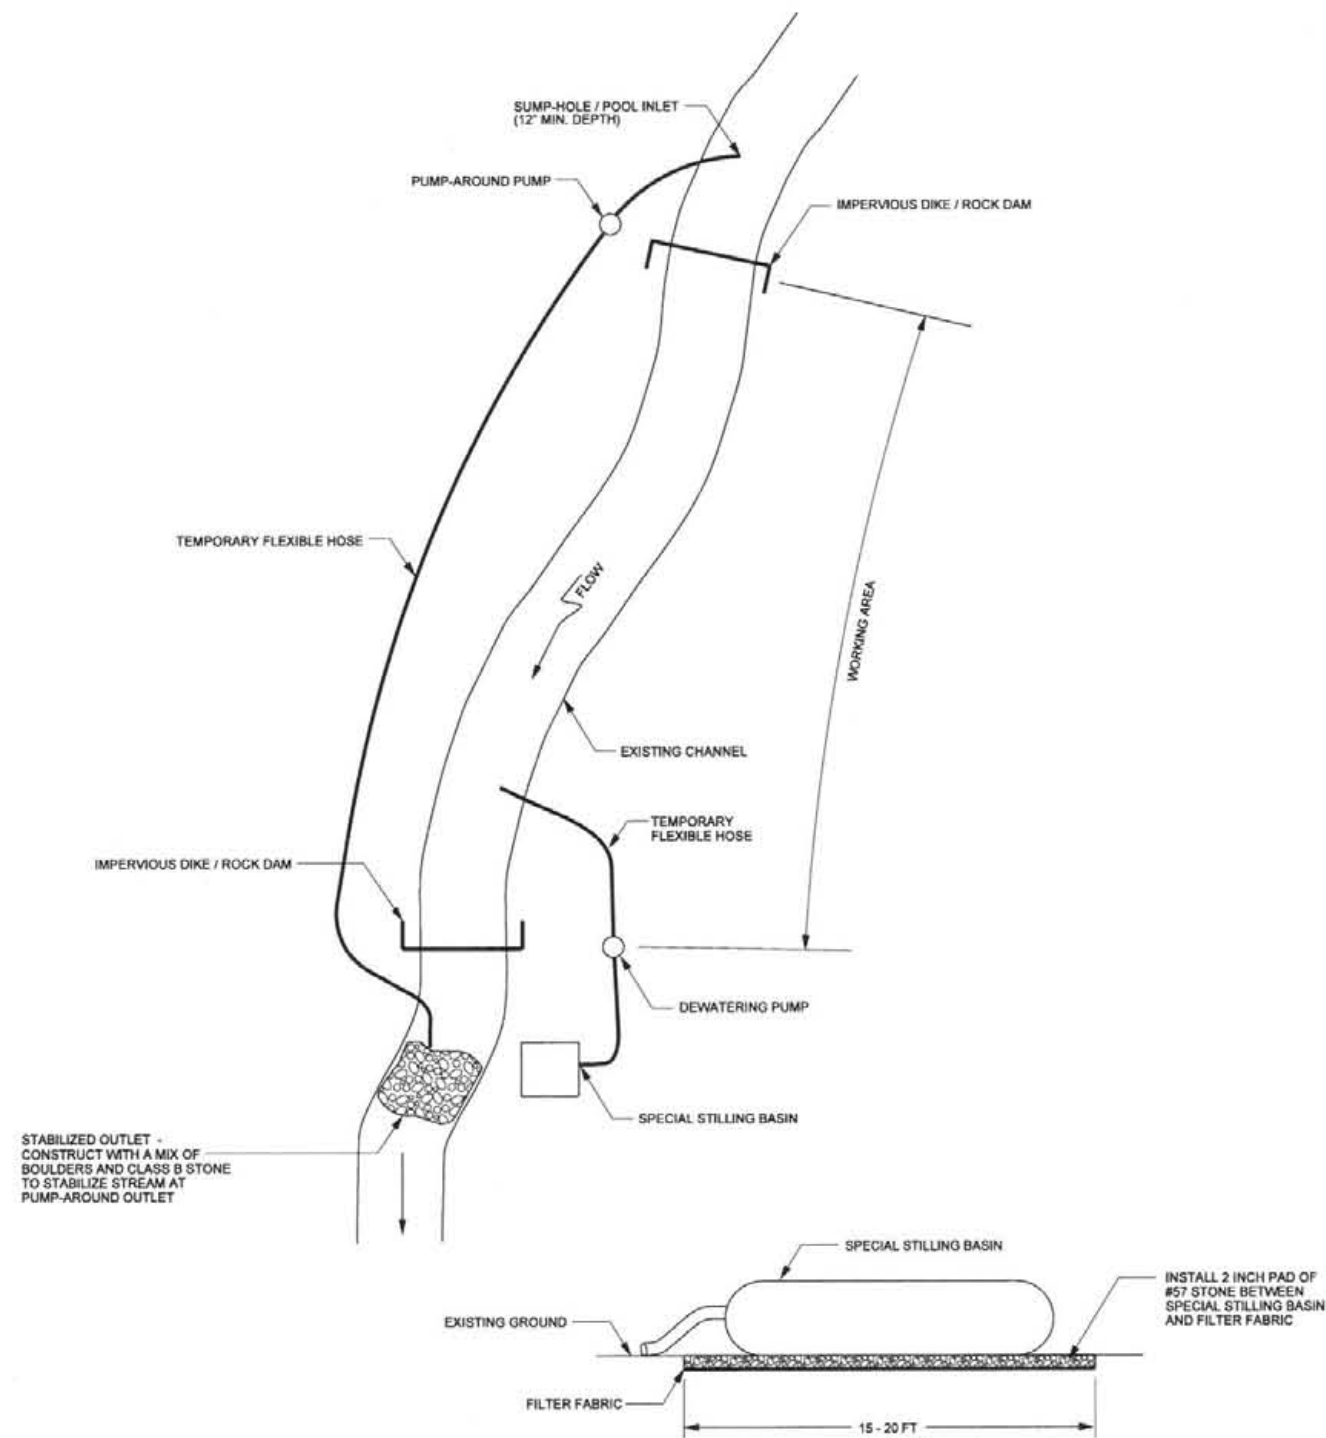
TYPICAL PUMP-AROUND OPERATION

SEQUENCE OF CONSTRUCTION FOR TYPICAL PUMP-AROUND
