Site Characterization and Conceptual Plans

BRUSH CREEK PROJECT

Alleghany County,
North Carolina

October 2000

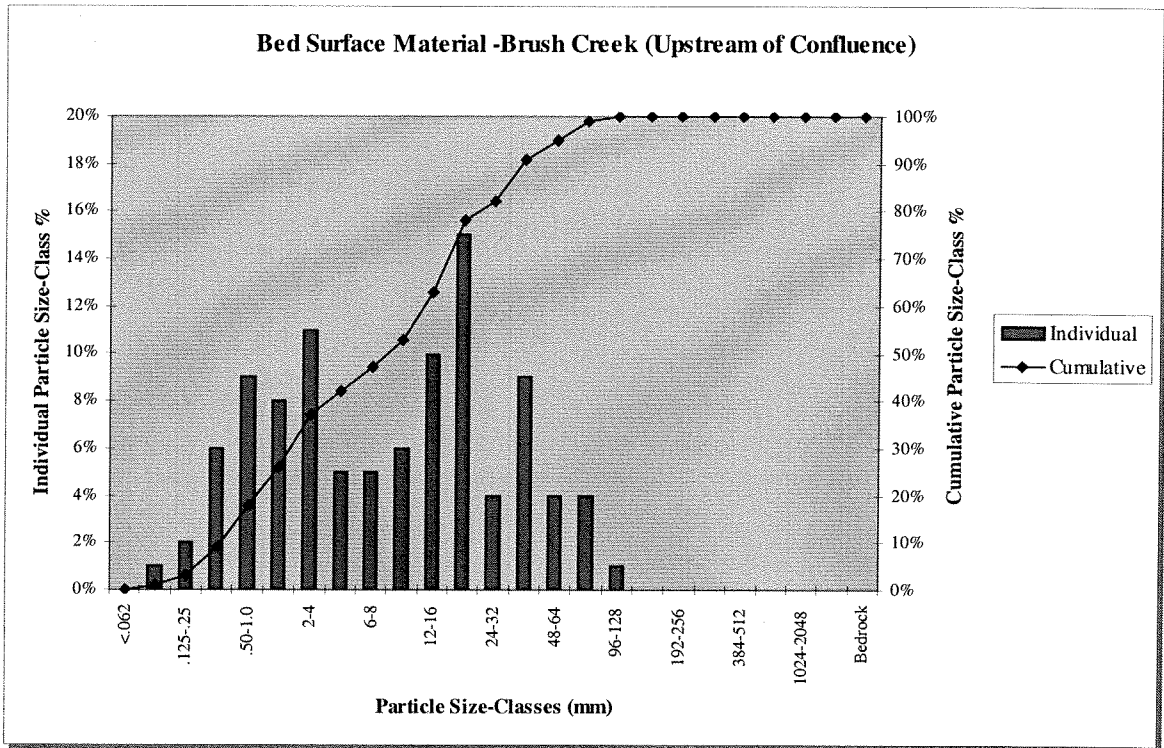
Figure 9 – Brush Creek Pebble Count Upstream of Confluence

Brush Creek substrate materials were characterized by an average D_{16} diameter of 0.5 mm, D_{50} diameter of 11 mm, and D_{84} diameter of 45 mm. Bedrock exposures within both the Little Pine Creek channel and the Brush Creek channel were also observed during field investigations (refer to Figure 11). These bedrock exposures are presently acting as natural grade control features within each channel. This is particularly evident in Reach 4 of Brush Creek, with bedrock at both the upstream and downstream limits of this reach. These substrate features will be considered in the restoration plan for both streams.

Creek (Figures 9 and 10).

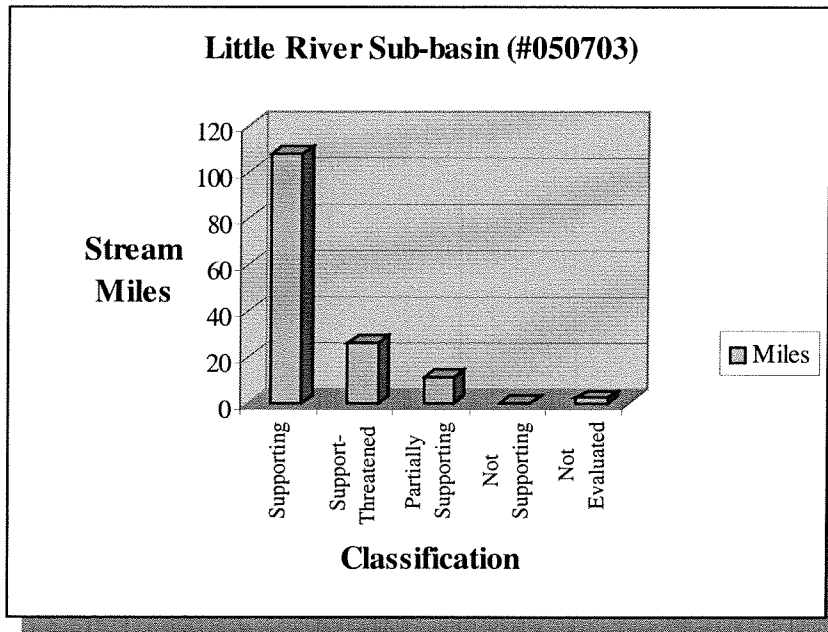
Figure 13 – Little River Sub-basin Support Ratings

During 1993 NCDENR sampling, overall water quality within most of this sub-basin's streams was classified as good or excellent (refer to Figure 13). According to the Division of Water Quality, the greatest water quality concern in this sub-basin is nonpoint source pollution. Agricultural land use, residential construction, and golf course development appear to be the primary activities responsible for this pollution. Water quality remains good, however, and the Little River itself has subsequently been recommended for evaluation for potential High Quality Water (HQW) classification. A total of 147.7 miles of streams are present within the Little River sub-basin.
